## **Phase I Environmental Site Assessment**

<b>Type of Services</b>	<b>Phase I Environmental Site Assessment</b>
<b>Project Name</b>	<b>Walmart Store (#2077-07)</b>
<b>Location</b>	<b>Lake Elsinore, California</b>
<b>Client</b>	<b>GreenbergFarrow</b>
<b>Client Address</b>	<b>19000 MacArthur Boulevard, #250 Irvine, California 92612</b>
<b>Project Number</b>	<b>329-15-1</b>
<b>Report Issuance Date</b>	<b>October 12, 2011</b>
<b>Report Viability Date</b>	<b>December 3, 2011</b>

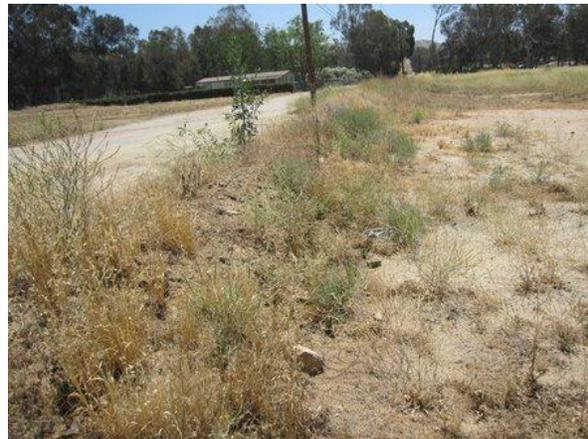
At the time of our visit, the northwest portion of the Site was undeveloped and consisted of a grass and weed covered field. A berm of soil was observed on-Site along Cambern Avenue (a mostly unpaved, gravel road). The piles of fill soil shown on the 2009 aerial photograph obtained from Google Earth (see Figure 2), were not readily apparent. This mounded soil appeared to have either been removed or spread across the Site. Grass and weeds covered the area where the apparent fill piles were present. A seasonal creek/storm water drainage was observed on the southeast portion of the undeveloped area of the Site (just to the northwest of the four residential parcels). Several trees were observed near the creek.

Photograph 2. View of mounded fill on-Site along Cambern Avenue (looking southeast).

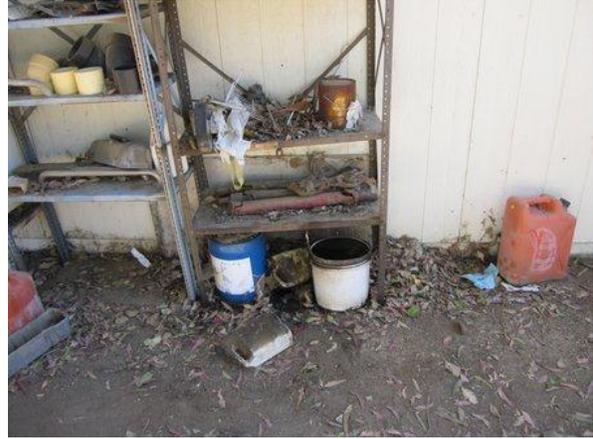
A mobile home was observed on the parcel at 29401 3<sup>rd</sup> Street. A detached garage with wood frame construction and a concrete floor slab was present to the north of the mobile home. The garage was observed to contain miscellaneous household items. An open 5-gallon bucket of used motor oil was observed on the southeast side of the garage. What appeared to be minor oil staining of the soil near the bucket was observed.

Photograph 10. View of used oil bucket on side of garage at 29421 3<sup>rd</sup> Street.

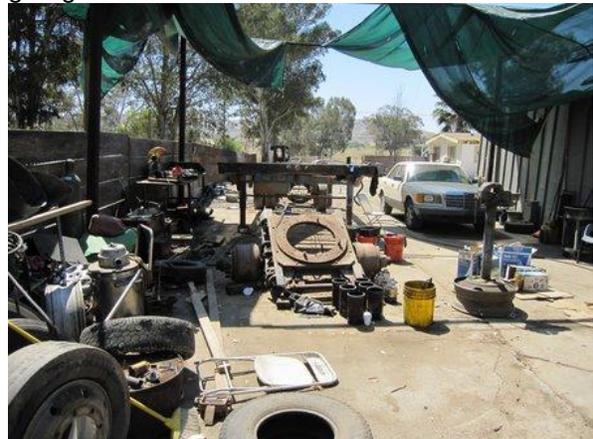
A mobile home was observed on the parcel at 29445 3<sup>rd</sup> Street. To the north of the mobile home, a semi-truck trailer (used for storage) was present along with an adjacent concrete pad that was partially covered by an awning. Truck and automobile repair work appeared to be in progress on the concrete slab. An approximately 4 foot deep pit with concrete block walls and an apparent concrete base was present within the vehicle repair area. A car was parked over

Photograph 12. View of awning covered vehicle maintenance area at 29445 3<sup>rd</sup> Street (looking southeast).

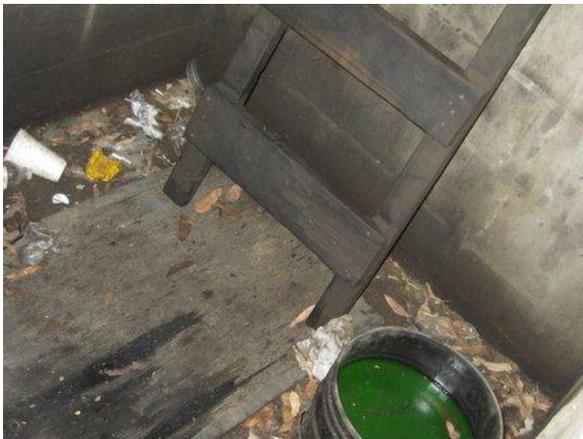
the pit, which restricted access; however, the pit appeared to be used for auto maintenance purposes. An open 5-gallon bucket of what appeared to be antifreeze was present at the base of the pit. The walls and base of the pit appeared to be oil stained. What appeared to be oil staining also was observed on portions of the surrounding concrete slab; areas of oil stained soil also were noted. The areas of oil stained soil appeared limited in extent, likely resulting from parked vehicles or heavy equipment. Several 5-gallon buckets of what appeared to be used motor oil, a 55-gallon drum of gear oil, and two drums of grease were observed in the general vicinity of the concrete slab (i.e., on the northern portion of the Site).

Photograph 13. Base of auto maintenance pit at 29445 3<sup>rd</sup> Street. Pit is located below the car shown in Photograph 12.

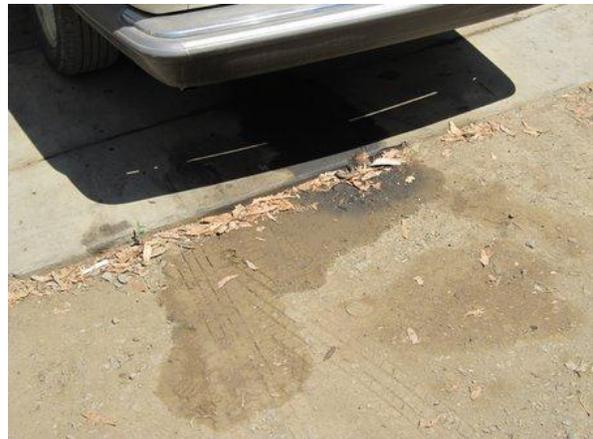
Areas of oil stained soil were observed on the parcel at 29445 3<sup>rd</sup> Street, along with oil staining of the vehicle maintenance pit and spilled oil within the adjacent storage trailer. A small area of oil stained soil also was noted at 29421 3<sup>rd</sup> Street. The potential for the observed staining and spilled oil to have a significant impact on the planned use of the Site for commercial retail purposes appears low. However, further evaluation and cleanup of the impacted areas could increase development costs and schedules.

Photograph 14. Oil staining on soil and concrete pad at 29445 3<sup>rd</sup> Street.

We understand that Walmart is planning to construct a new approximately 151,000 square-foot retail store and associated parking areas, driveways and landscaping. As summarized in Section 10.2, proper disposal of the remaining hazardous materials, if not performed by the current owners, could increase Site development costs. Additionally, further evaluation and cleanup of the areas where oil staining was observed could increase development costs and schedules.

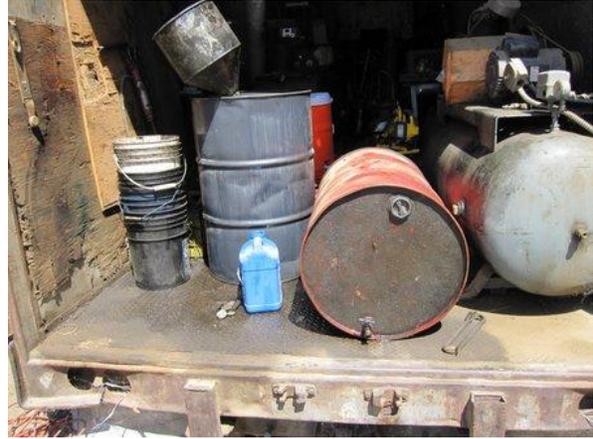
The semi-truck trailer was observed to be used for storage and was resting on the ground; the wheels of the trailer had been removed. Stored items appeared to consist mainly of tools, vehicle parts and an air compressor. Two 55-gallon drums that appeared to contain new and used oil were present in the trailer, along with smaller containers of automotive related products that were observed on shelving. An open 5-gallon bucket of used oil also was noted. Spilled oil was apparent on the metal floor of the trailer, mainly near the 55-gallon drums.

Photograph 16. Oil drums and spilled oil on floor of trailer at 29445 3<sup>rd</sup> Street.

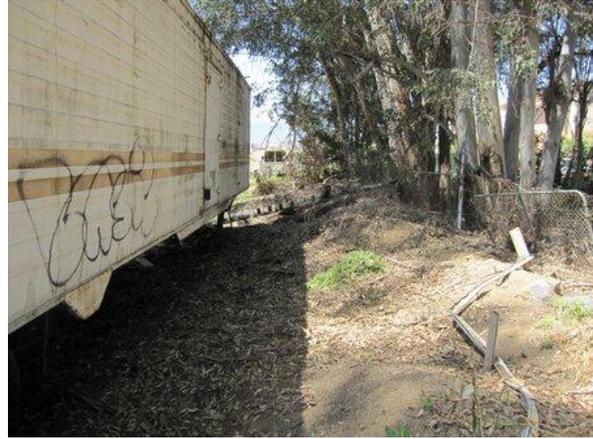
Mounded piles of fill soil were observed along the northwest border of the parcel that appeared to have been placed to control storm water drainage near the seasonal creek. Another pile of soil was observed on-Site near the southwest border of the parcel.

Photograph 22. View of semi-truck trailer and mounded fill soil along northwest border of 29467 3<sup>rd</sup> Street (looking southwest).

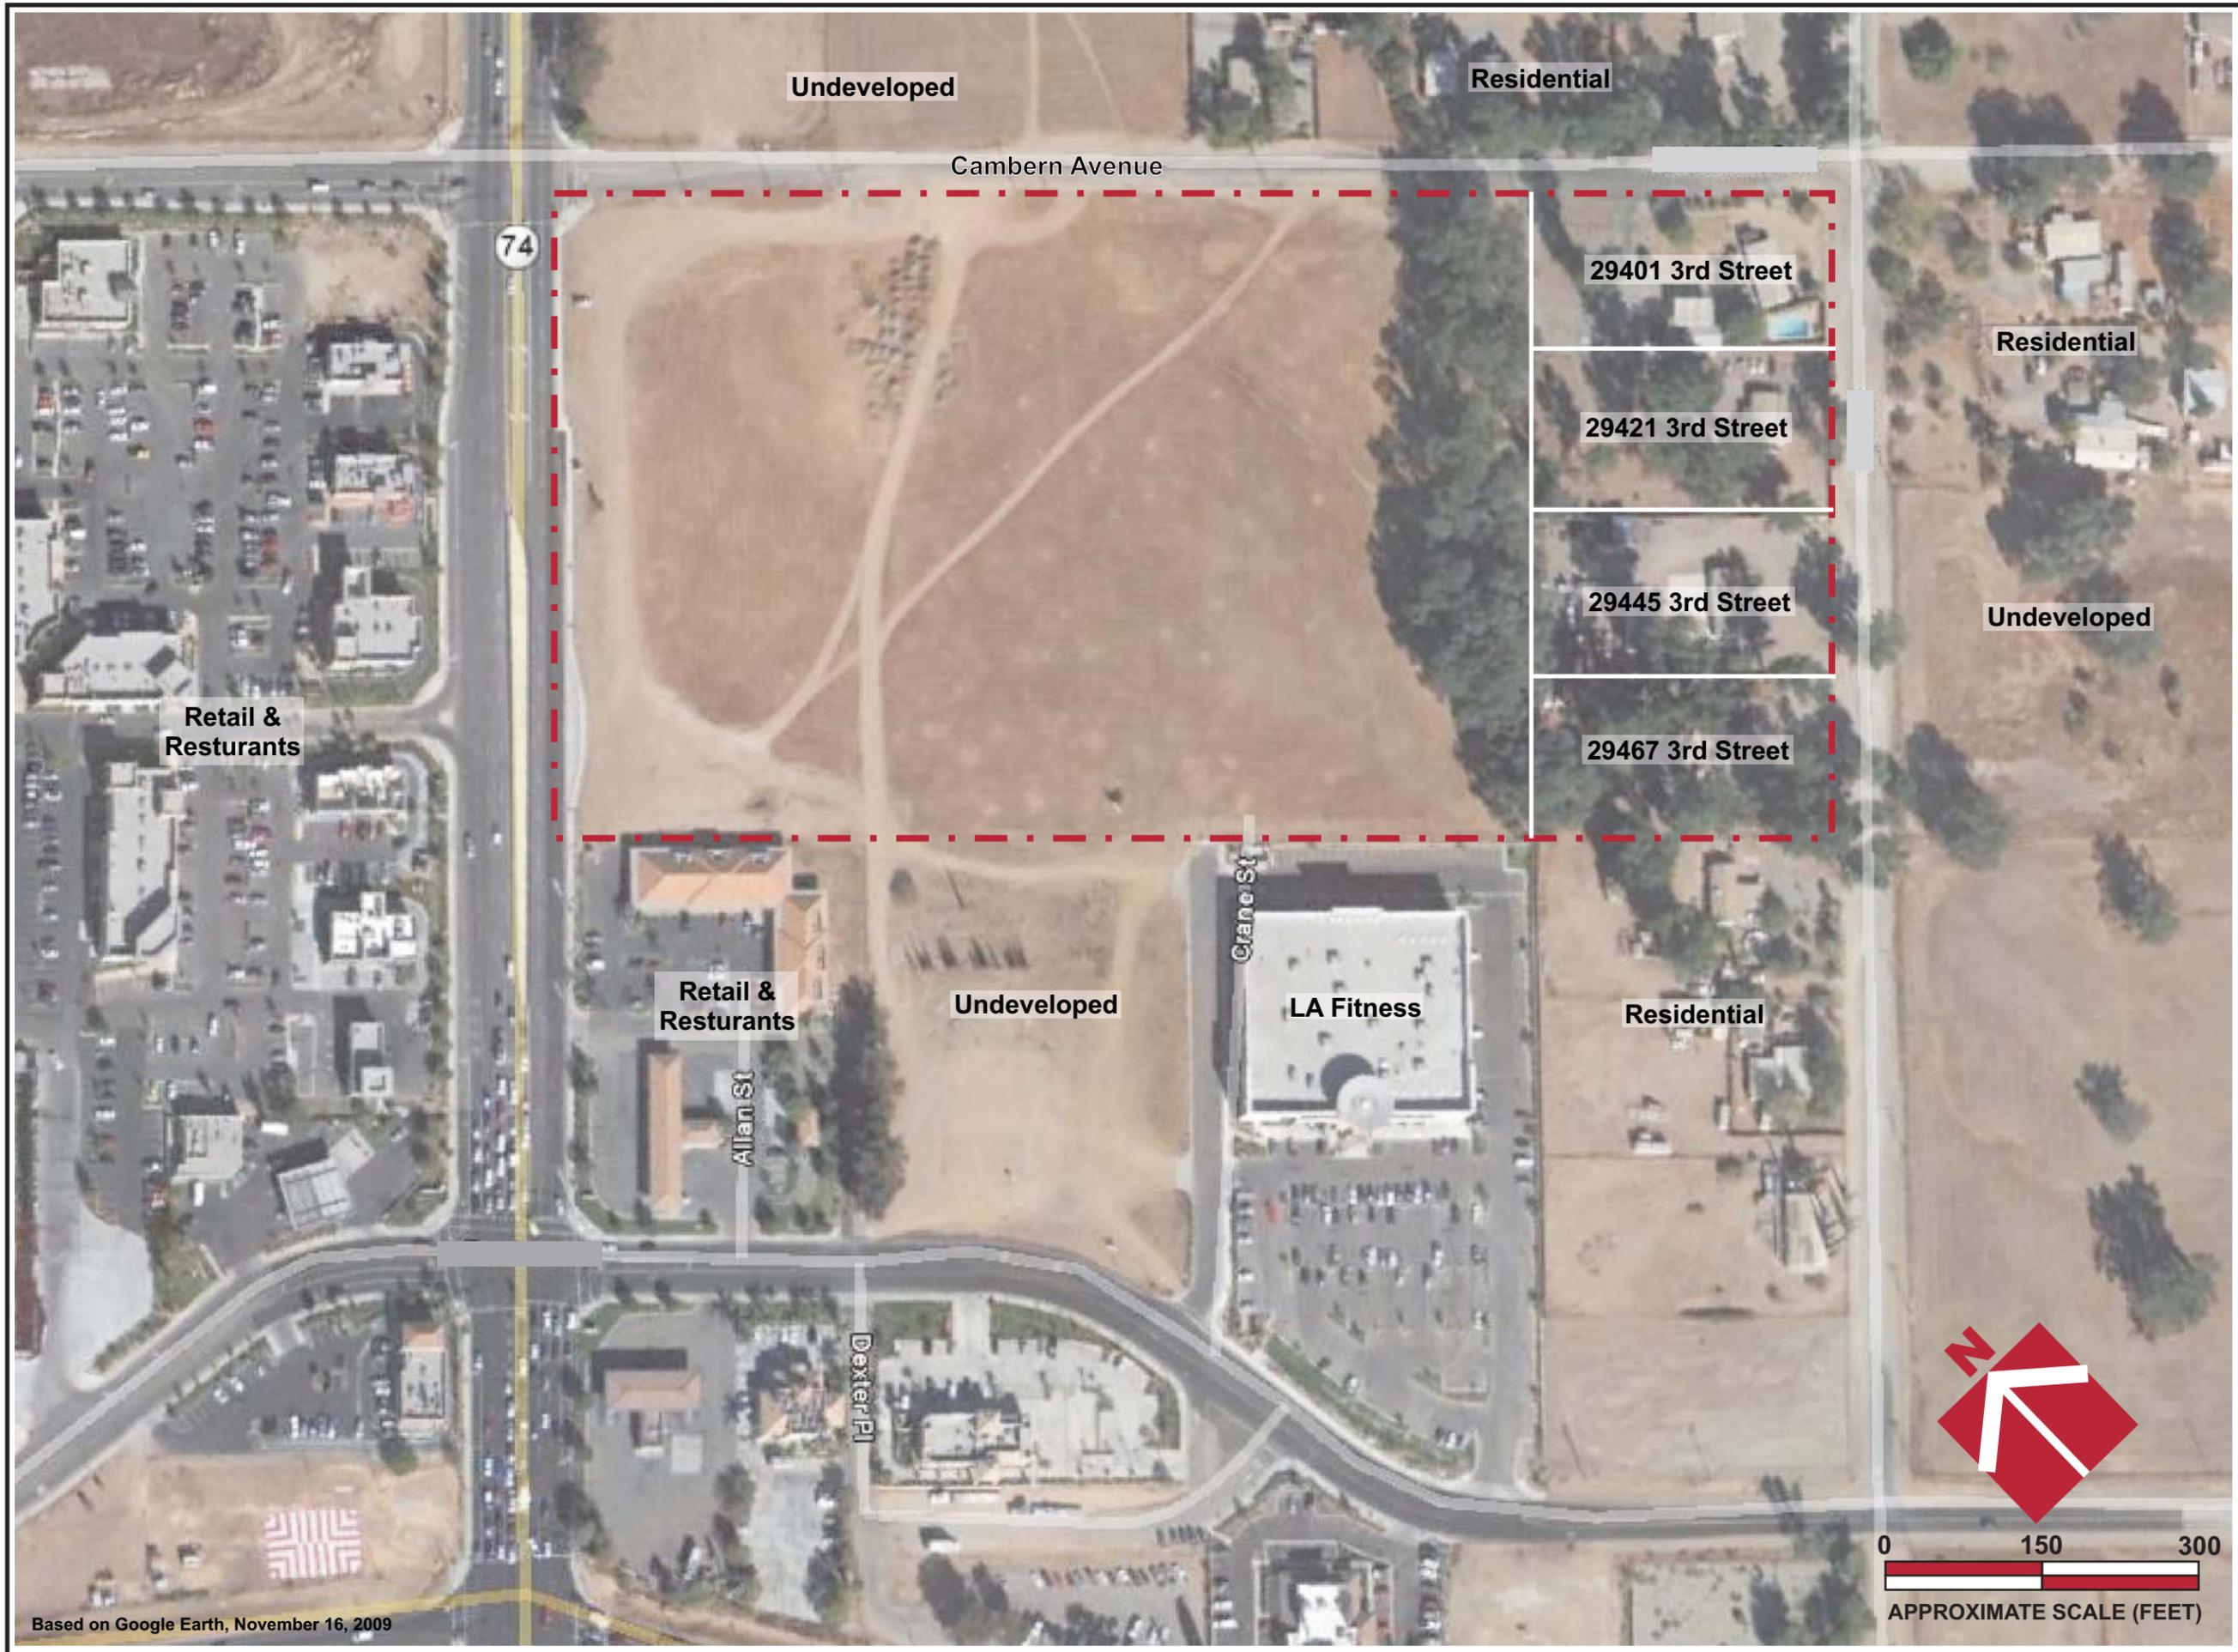
Project Number	329-15-1
Figure Number	Figure 2
Date	June 2011
Drawn By	RRN

The 2009 aerial photograph obtained from Google Earth (see Figure 2) shows several piles of fill soil on the northern portion of the Site near the area where a small pit or pond was shown on prior photographs. During our Site visit, these fill piles were not readily apparent. A berm of soil was, however, observed on-Site along Cambern Avenue. Additional fill piles were observed on the 29467 3<sup>rd</sup> Street parcel. The owners of 29445 3<sup>rd</sup> Street additionally reported on the provided questionnaire that fill was present on that parcel; however, the fill was not readily apparent at the time of our Site visit.
