## **APPENDIX 1**

### **Geotechnical Information and Analysis**

**SUBJECT: RESPONSE TO COMMENT #8, LETTER OF INCOMPLETENESS FOR  
AMENDMENT TO RECLAMATION PLAN RP112 DATED JUNE 9, 2011  
Lake Elsinore, California**

ENGINEERING GEOLOGY REPORT  
ON  
SLOPE STABILITY:  
MINE RECLAMATION PLANS  
FOR  
SLOAN, CORONA & THOMAS MINES  
RIVERSIDE COUNTY, CALIFORNIA

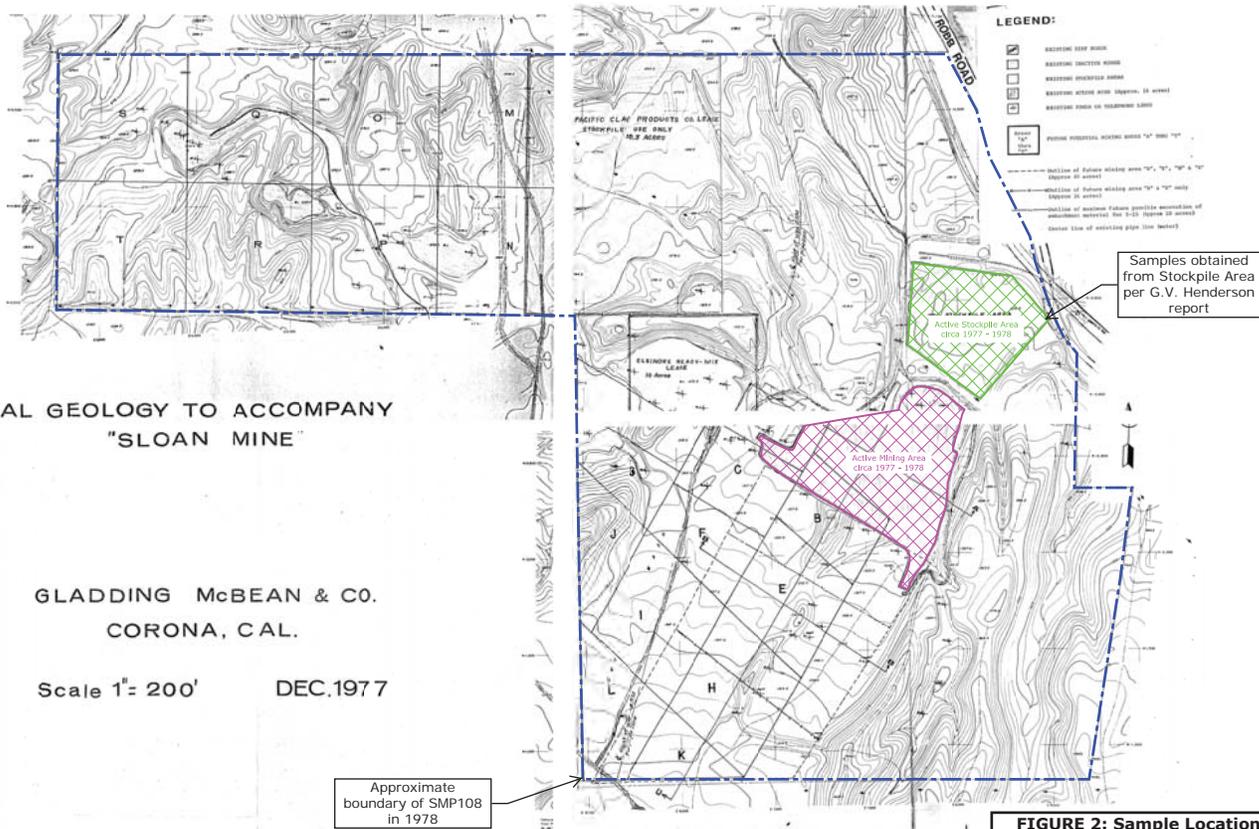
**FIGURE 2: Sample Location Map**

Two bulk samples and two drive (ring) samples were taken at the Sloan Mine on March 11, 1978 in order to perform laboratory testing and slope stability analysis. The enclosed maps, Figures 1 and 2, present the approximate location that the samples were taken from.

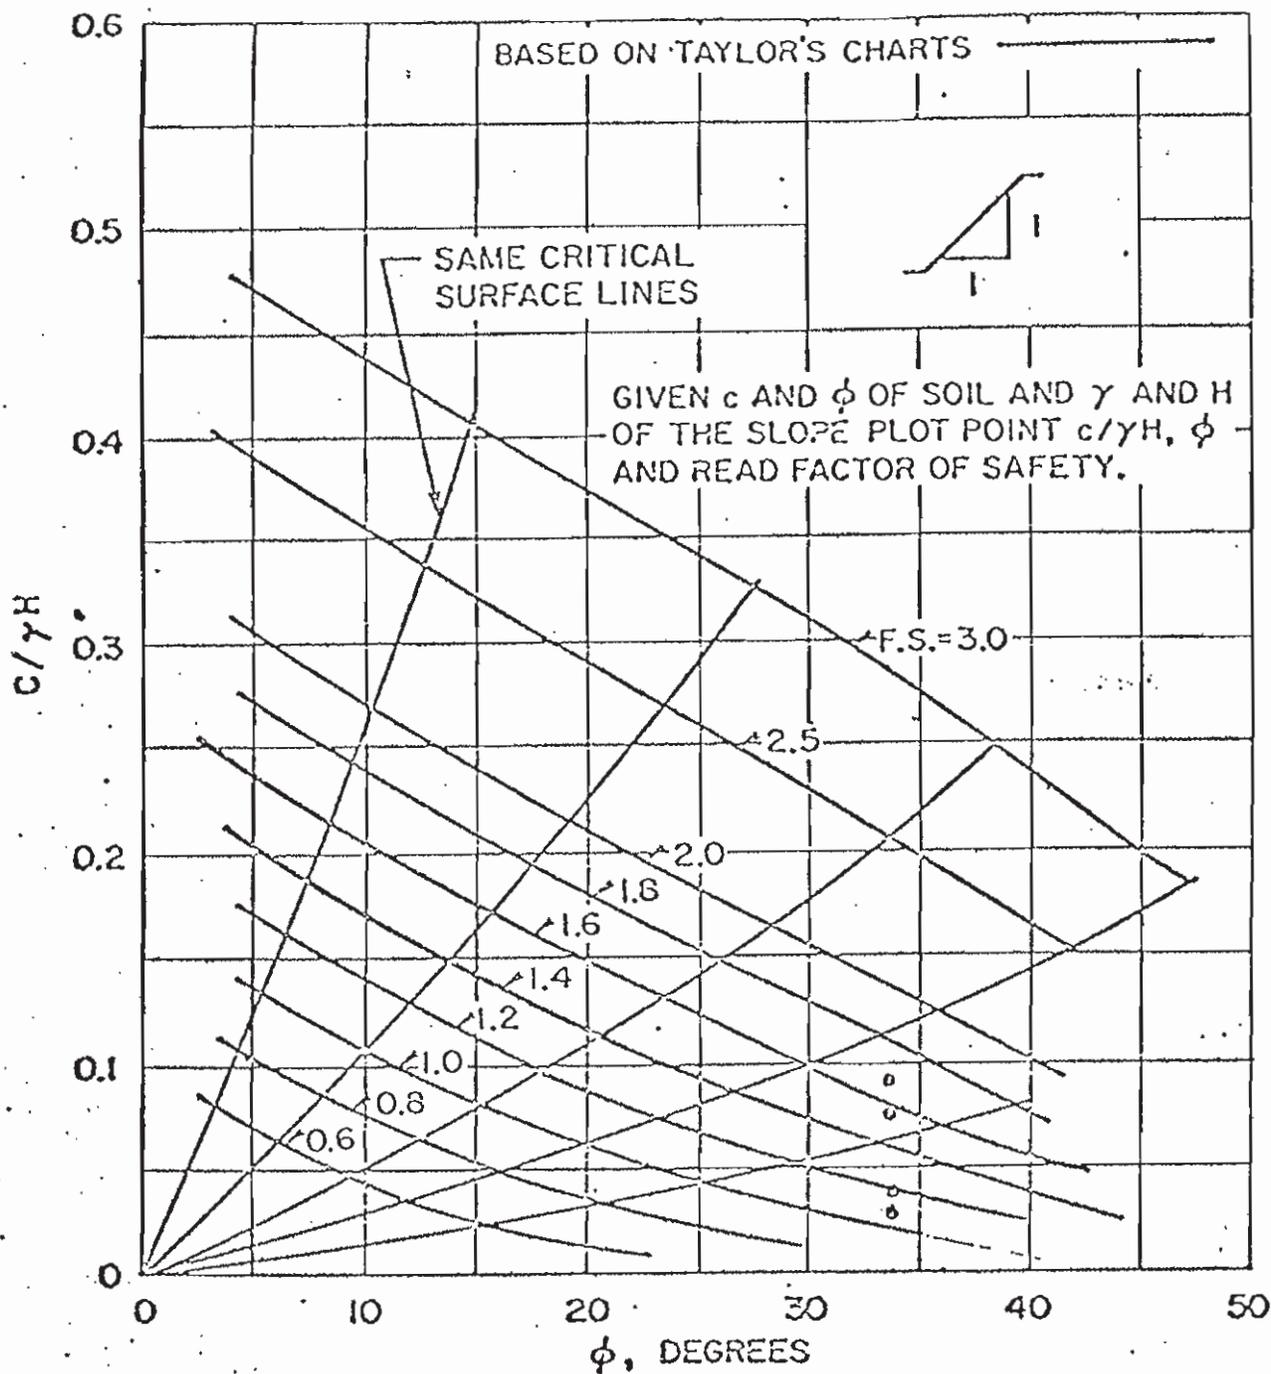
FIG. 10.—F-CONTOURS FOR SLOPE 1:1

Laboratory test data is summarized in Table 1. It shows calculated slope ratios to slope heights and factors of safety. The slope heights and factors of safety were calculated on the basis of the standard Taylor charts shown in Figures 10 and 11 for 1:1 and 1.5:1 slopes.
