# GLENN LUKOS ASSOCIATES

**SUBJECT:** Results of Biological Resource Assessment and Focused Plant Surveys for the Temescal Creek Bridge Project, an Approximately 56.7-Acre Property Located Within Unincorporated Riverside County, California

# TEMESCAL CREEK BRIDGE PROJECT

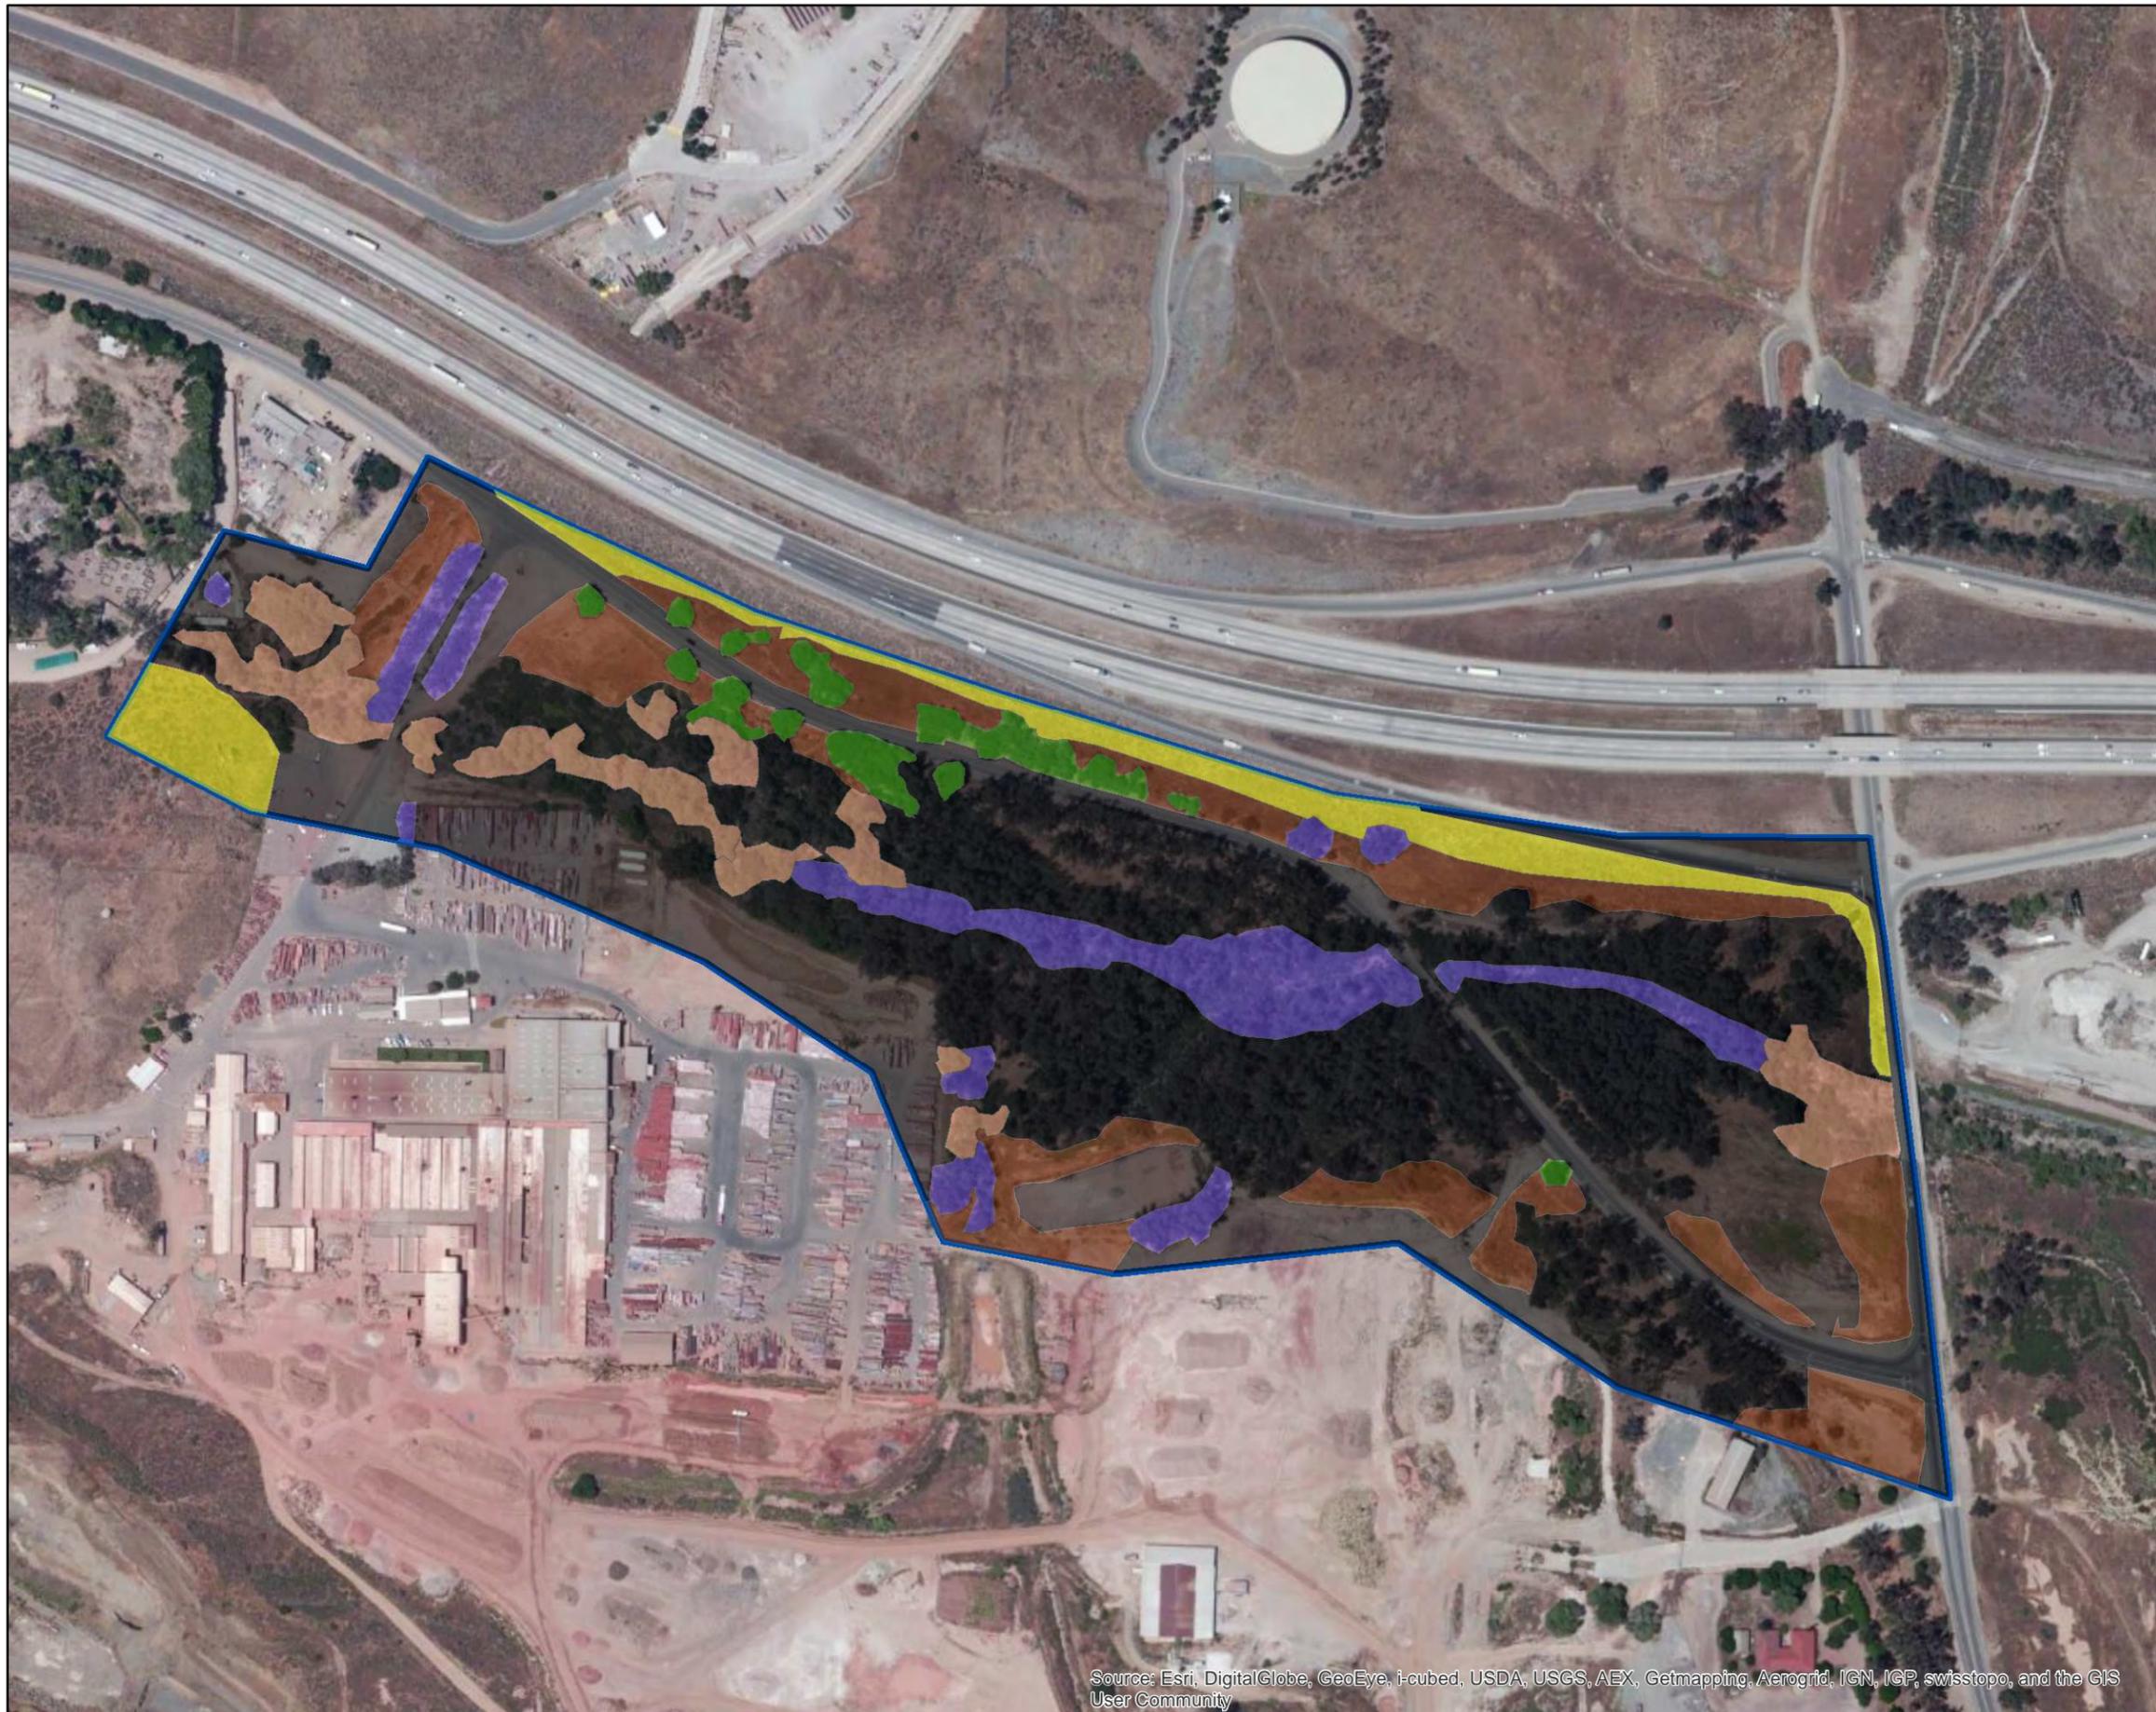
Exhibit 3

The site comprises an area of approximately 56.7 acres. Six different vegetation communities/land use types were mapped at the site including, disturbed/developed areas, non-native grassland, eucalyptus woodland, disturbed Riversidean sage scrub, disturbed willow riparian, and coast live oak woodland [Exhibit 3]. All six vegetation communities/land use types are described in detail below.

Vegetation Map

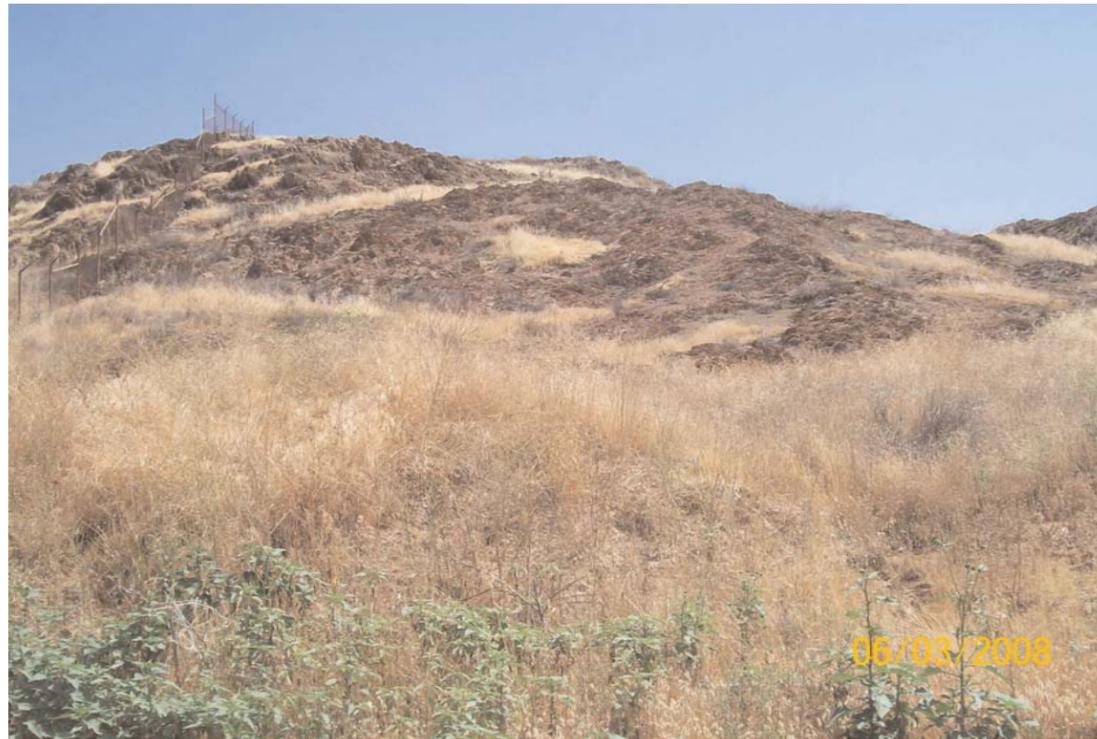
Photograph 1: Looking up the hill located just west of the entrance to the Pacific Clay Mine Site. This photograph depicts an area on site where Parry's spine-flower was observed.

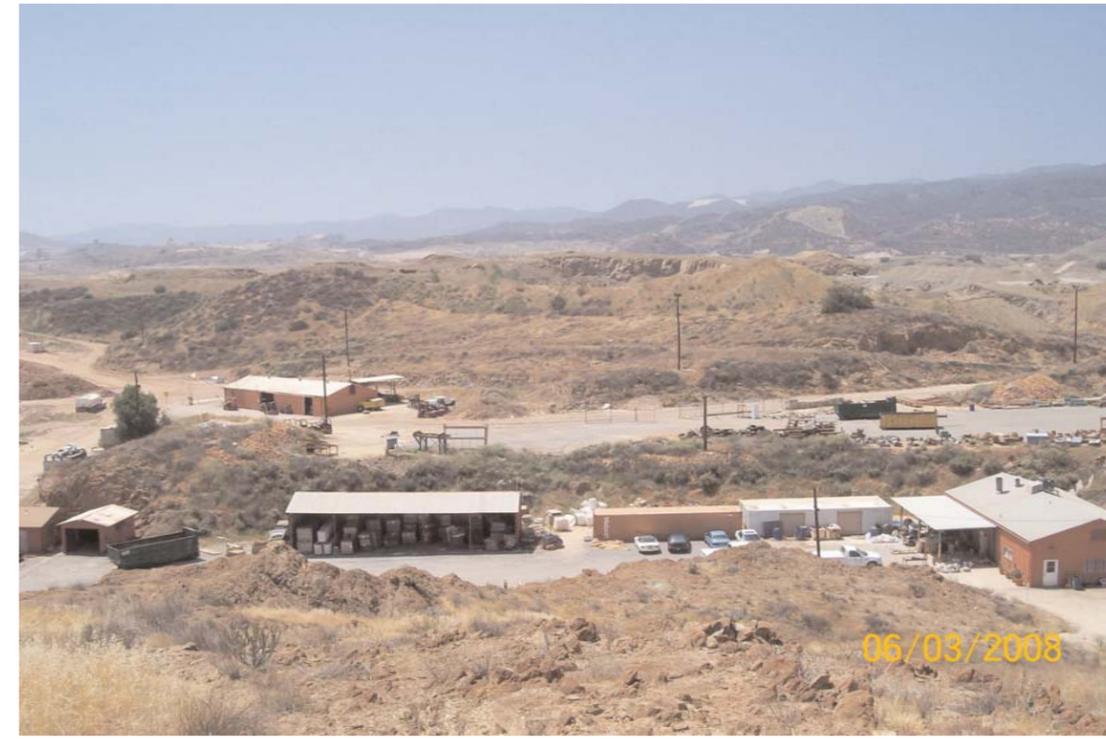
Photograph 2: This photograph depicts some of the mining facilities in the foreground, in the background you can see some of the typical habitat located in the central portion of the Project Site. This photograph is looking south over the Site.

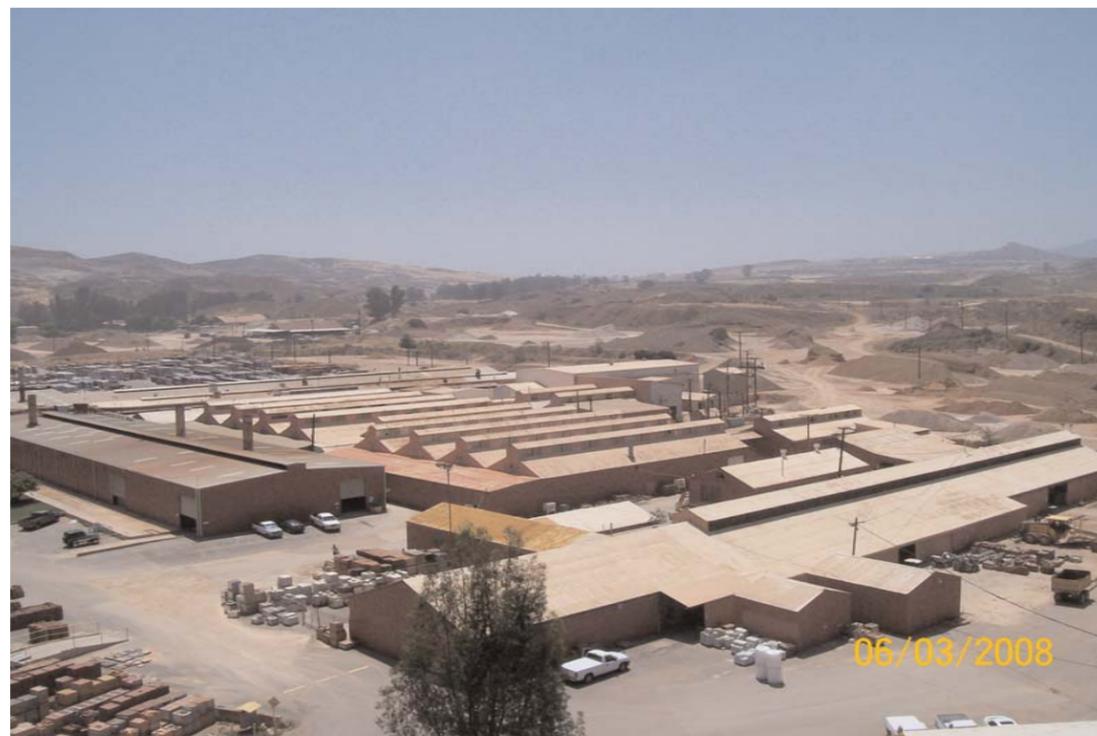
Photograph 3: View from the top of the hill depicted in Photograph 1. This photograph is looking southeast over the mining facilities.

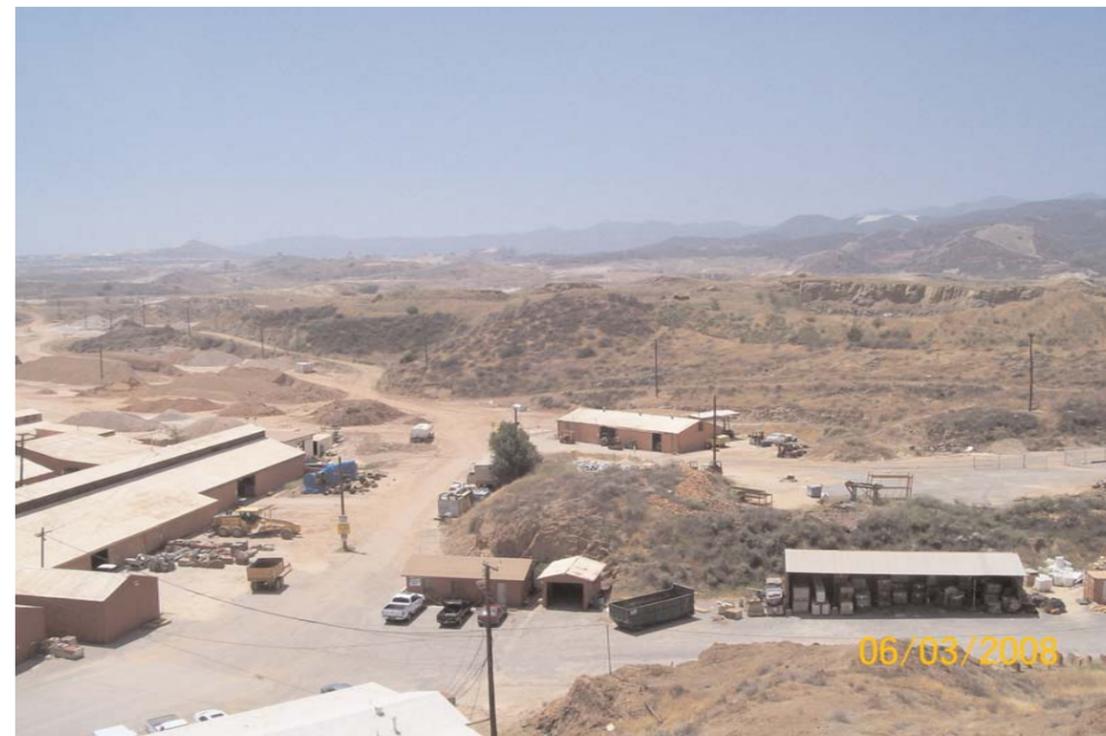
Photograph 4: This photograph is looking south-southeast over some of the mining facilities.

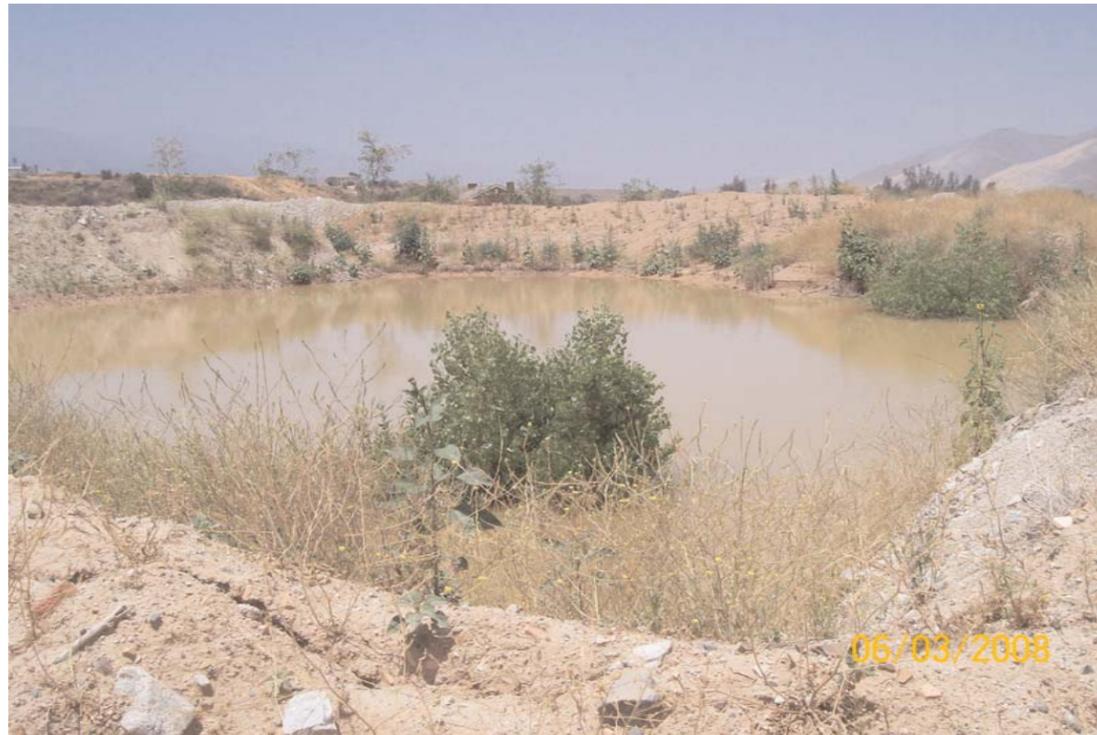
Photograph 5: This photograph depicts a typical holding pond on site, This artificial pond contained tadpoles of western toad.

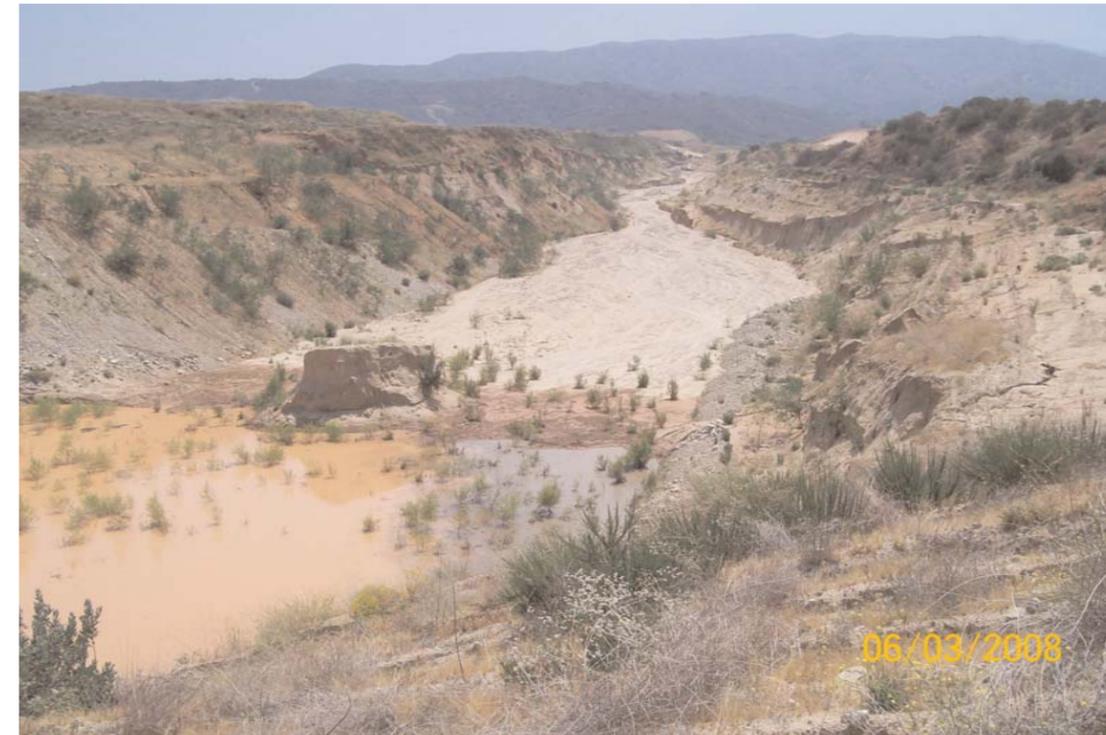
Photograph 6: This Photograph depicts the largest drainage on site. Photograph is facing south looking upstream.

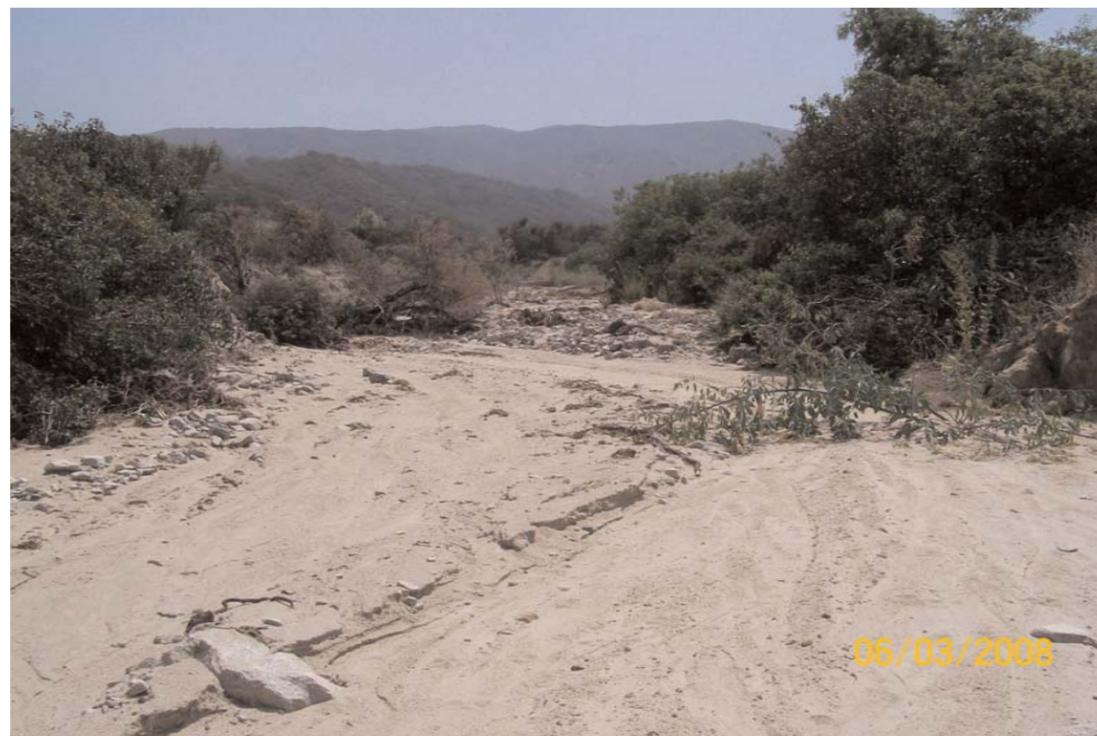
Photograph 7: This photograph depicts the upper portion of the drainage in Photograph 6. Photograph is facing downstream and north.

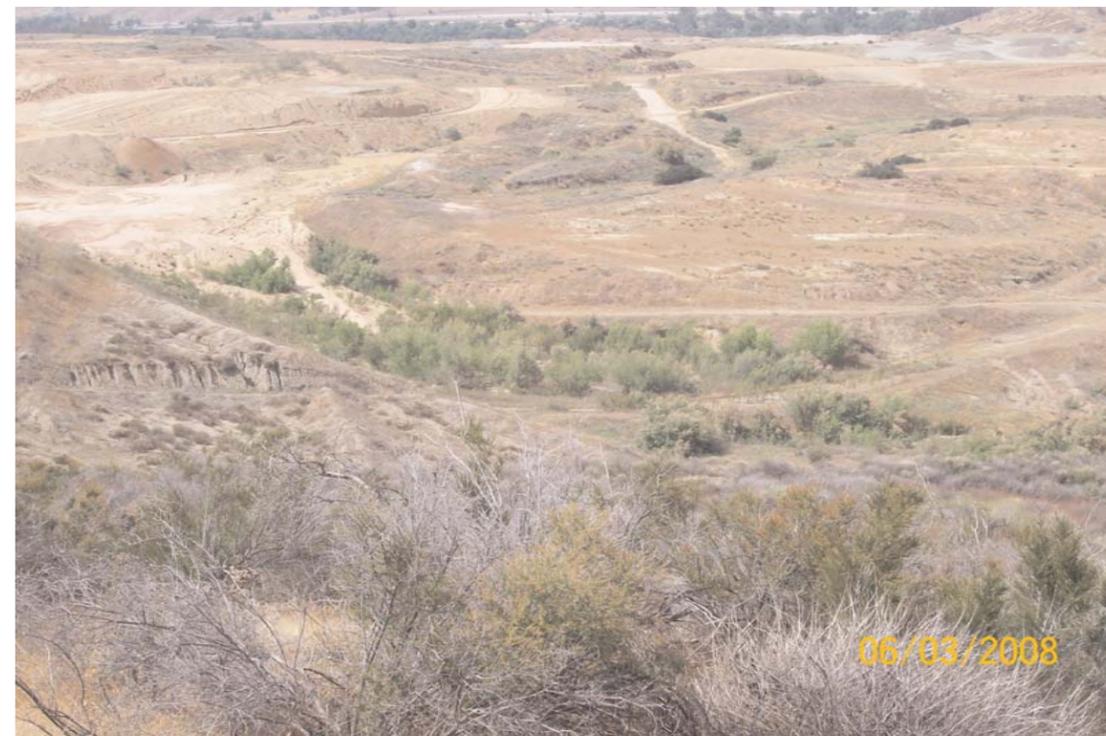
Photograph 8: This photograph depicts some of the riparian vegetation and surrounding lands in the central portion of the Project Site.

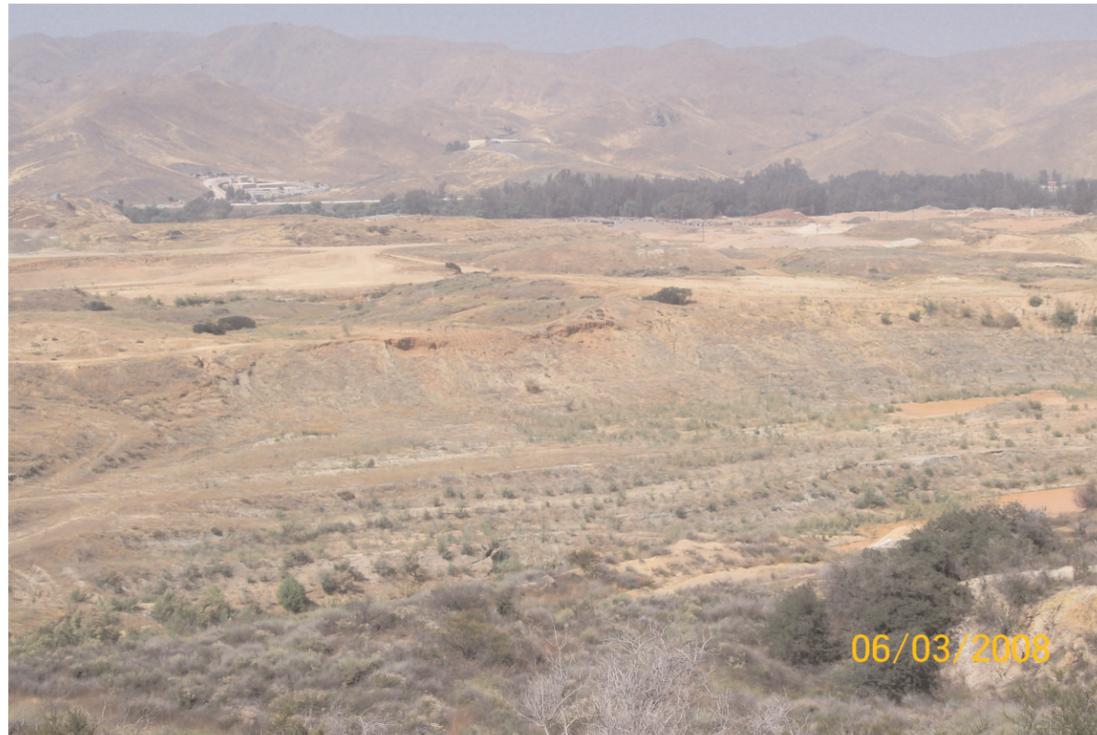
Photograph 9: This photograph depicts the vegetation and land use in the central portion of the Project Site. Photo is looking north-northeast.

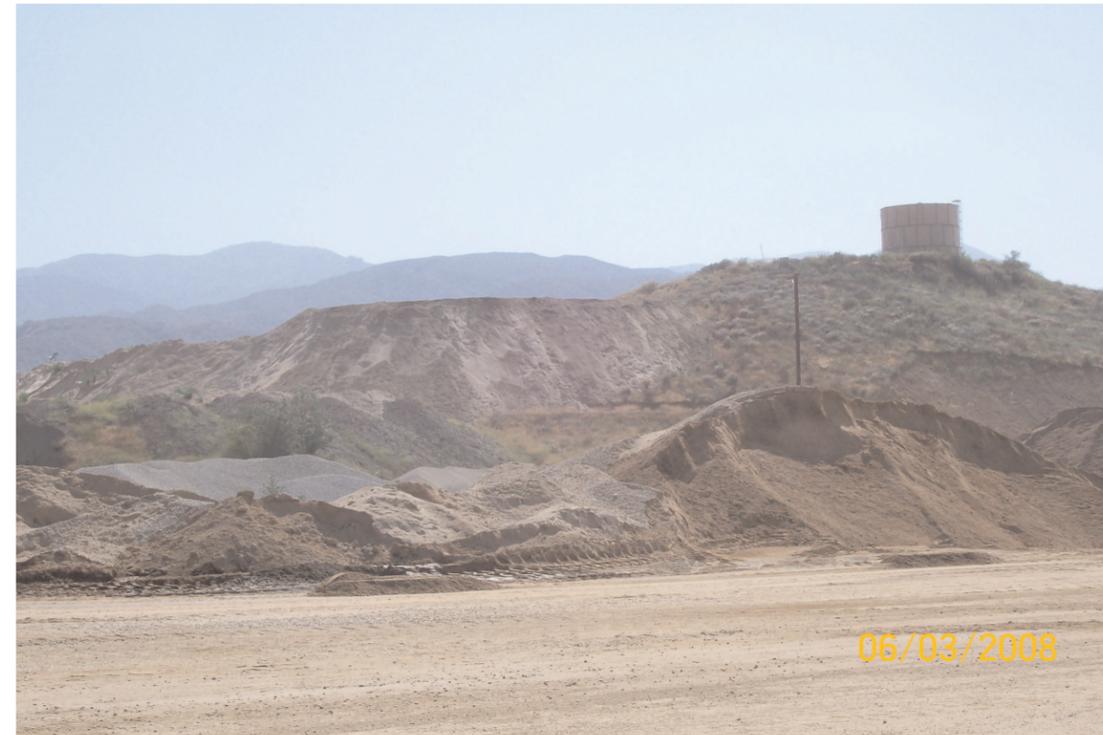
Photograph 10: This photograph depicts the disturbed mining operation on site. The area to the left of the hill was historically mapped as containing altamont clay soils.

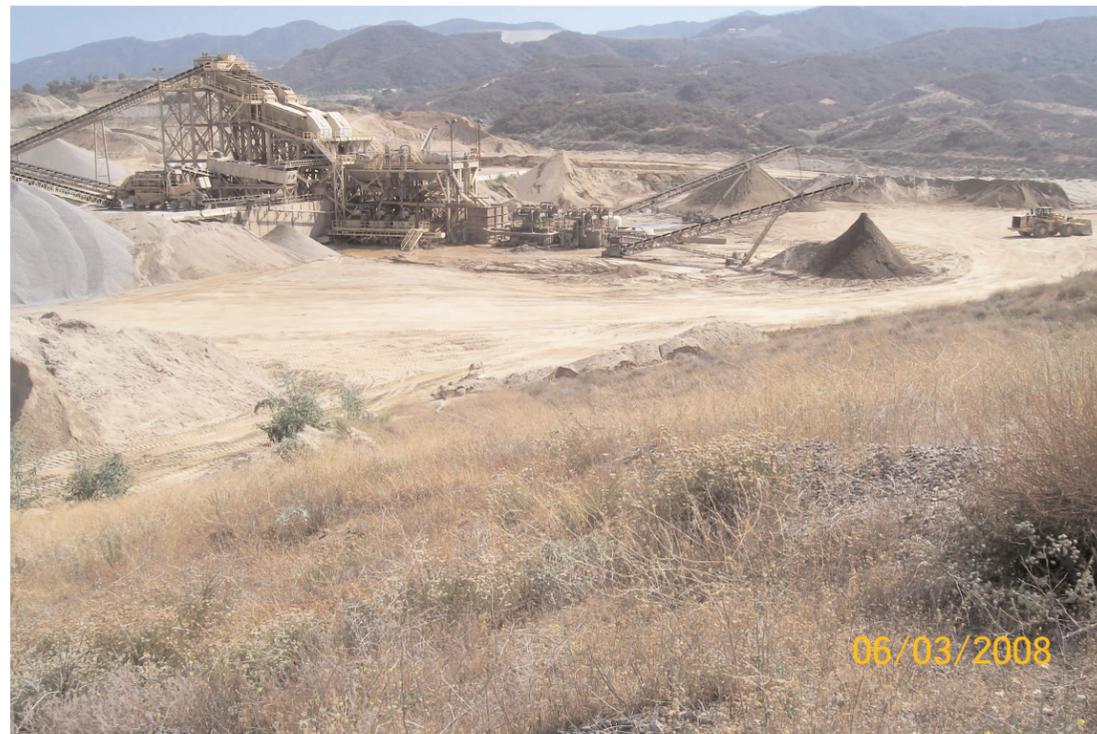
Photograph 11: This photograph depicts the large mining operation located on site mentioned in the previous photograph.

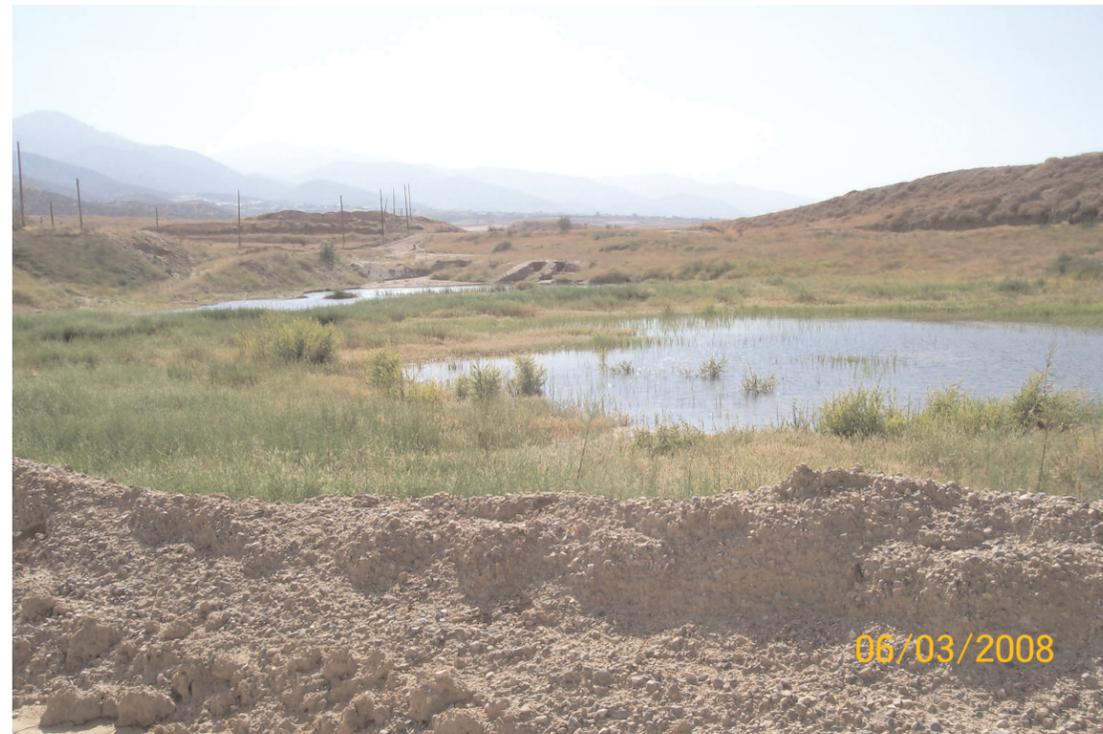
Photograph 12: This photograph depicts some of the ponds and associated habitat located on site. This photograph is facing southwest.

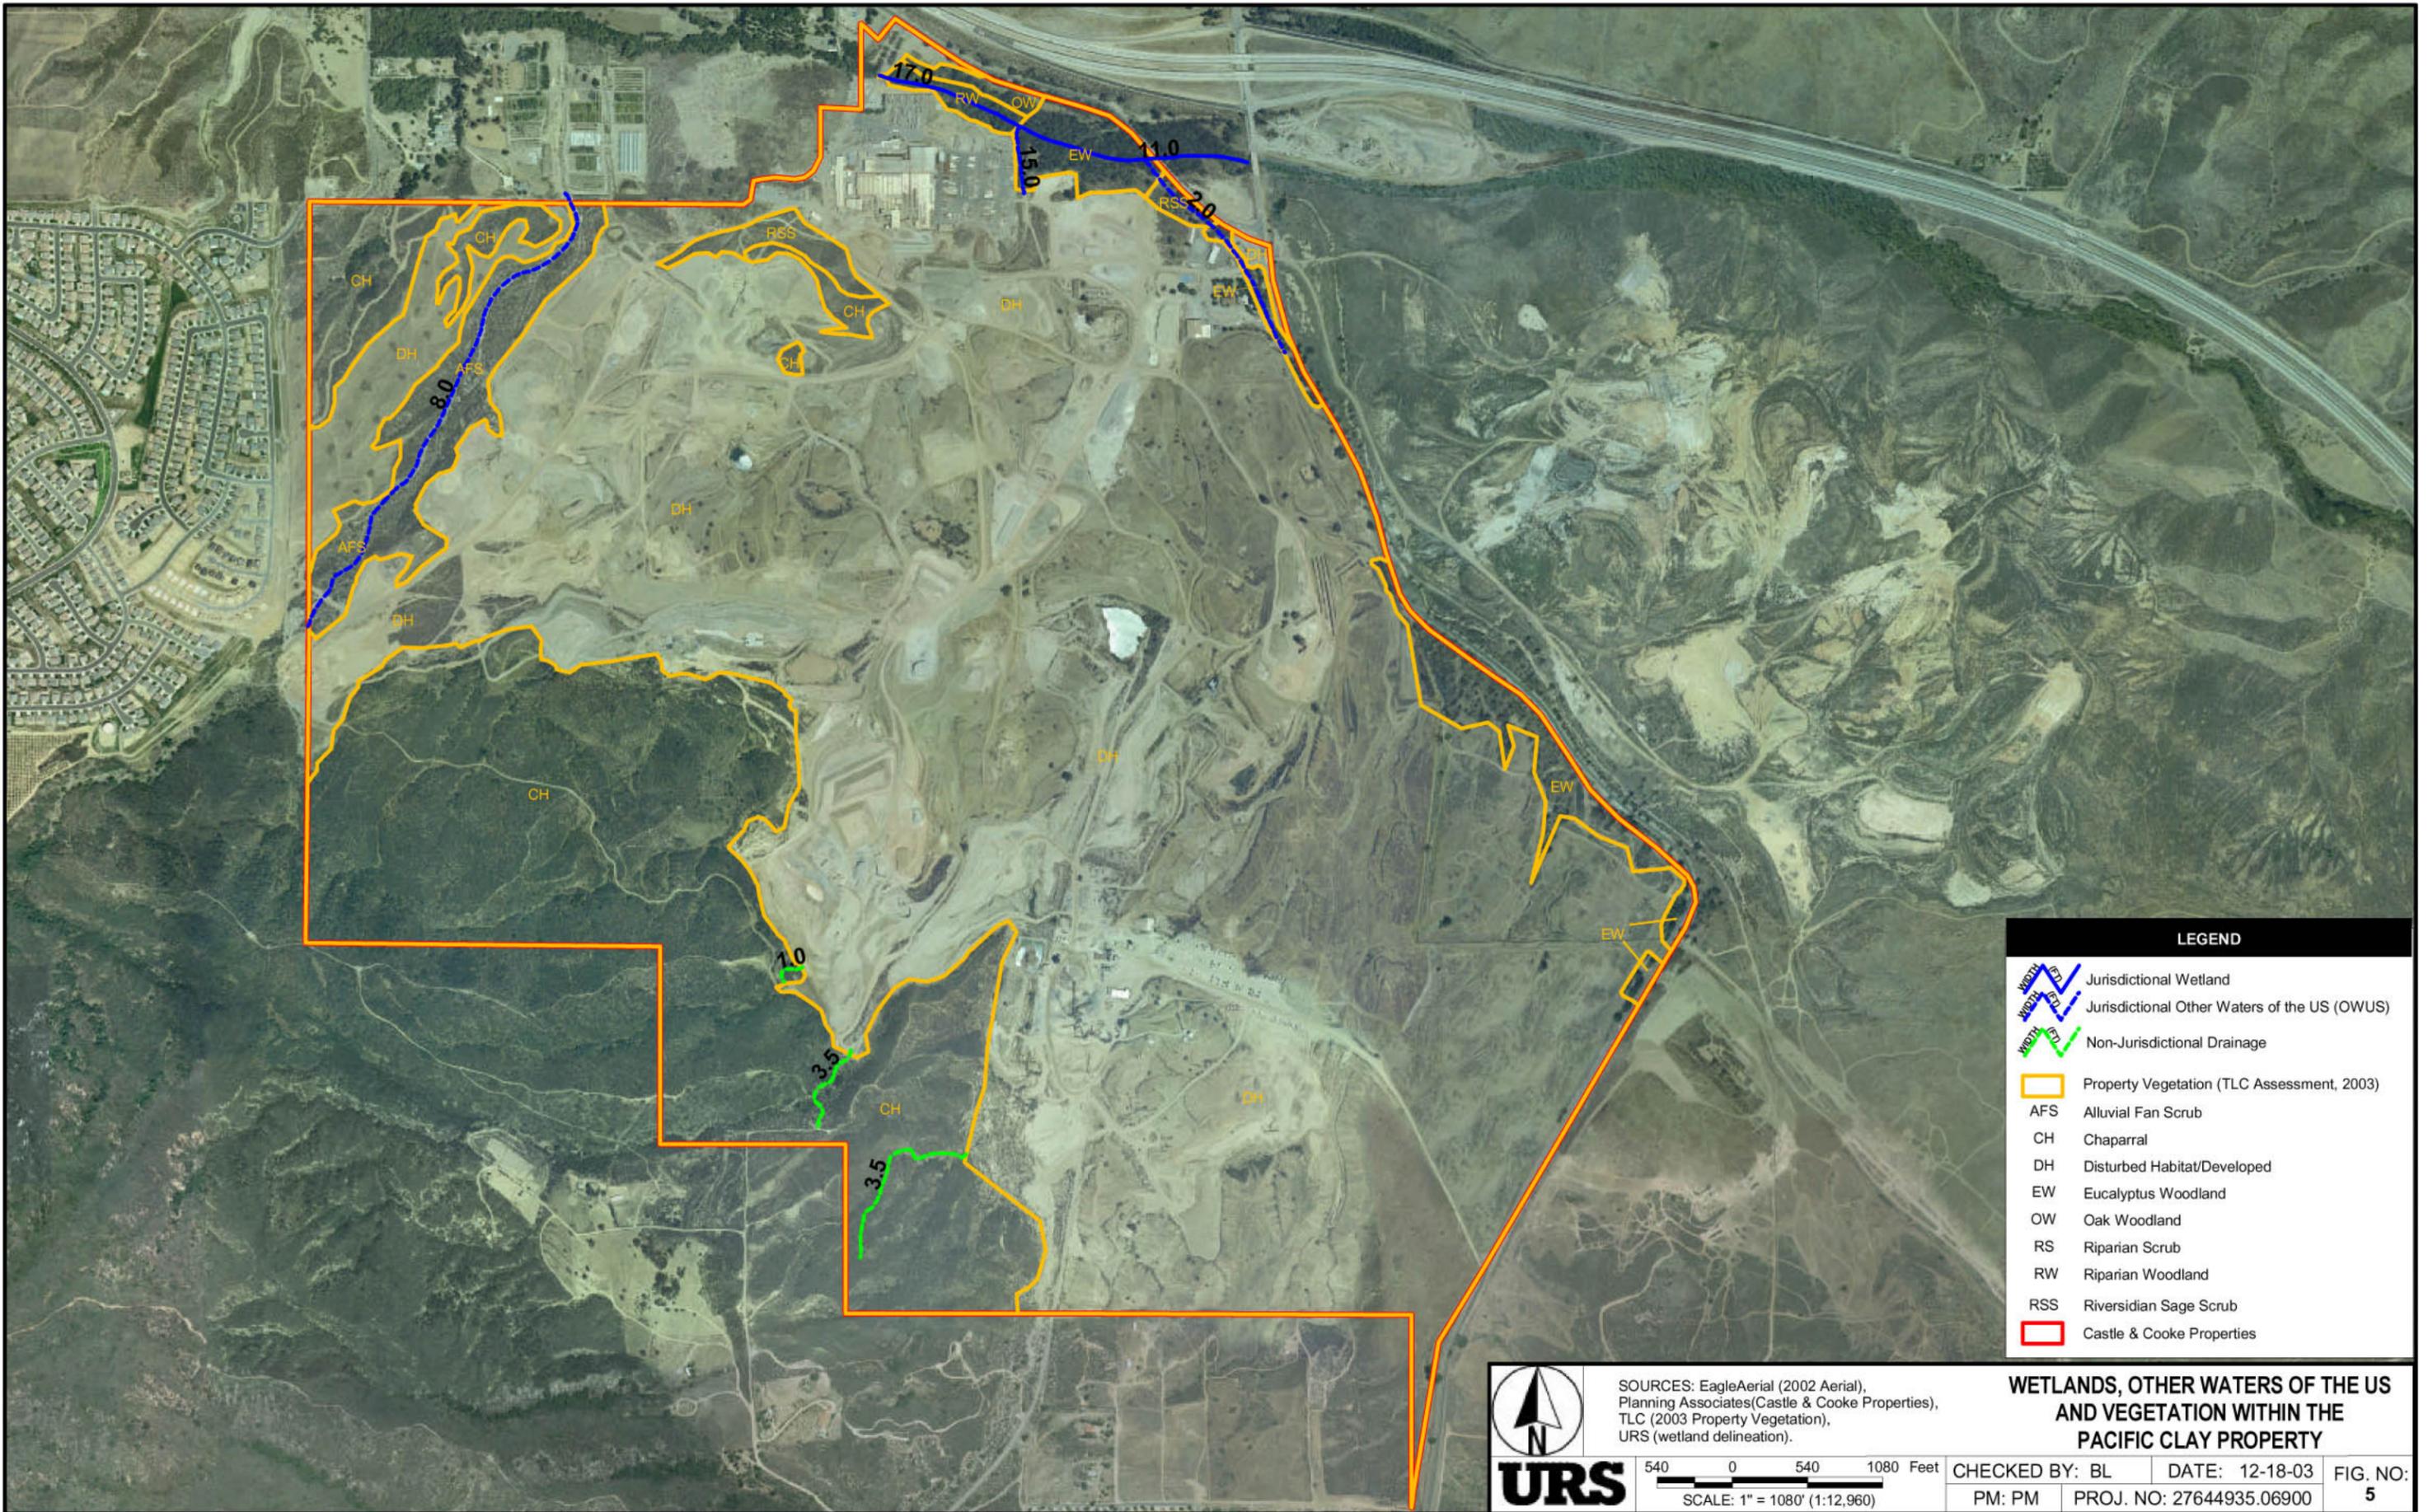
**WETLANDS, OTHER WATERS OF THE US AND VEGETATION WITHIN THE PACIFIC CLAY PROPERTY**
