**PHASE I ENVIRONMENTAL SITE ASSESSMENT AND  
LIMITED PHASE II SOIL SCREENING EVALUATION  
PROPOSED WAVE RIDER BEACH PROJECT, MARK AVENUE  
LAKE ELSINORE, RIVERSIDE COUNTY, CALIFORNIA 92530  
APN 381-040-005**

**W.O. E6562-SC      JUNE 28, 2013**

Subject: Phase I Environmental Site Assessment and Limited Phase II Soil Screening Evaluation, Proposed Wave Rider Beach, Mark Avenue, Lake Elsinore, Riverside County, California, 92530, APN 381-050-005

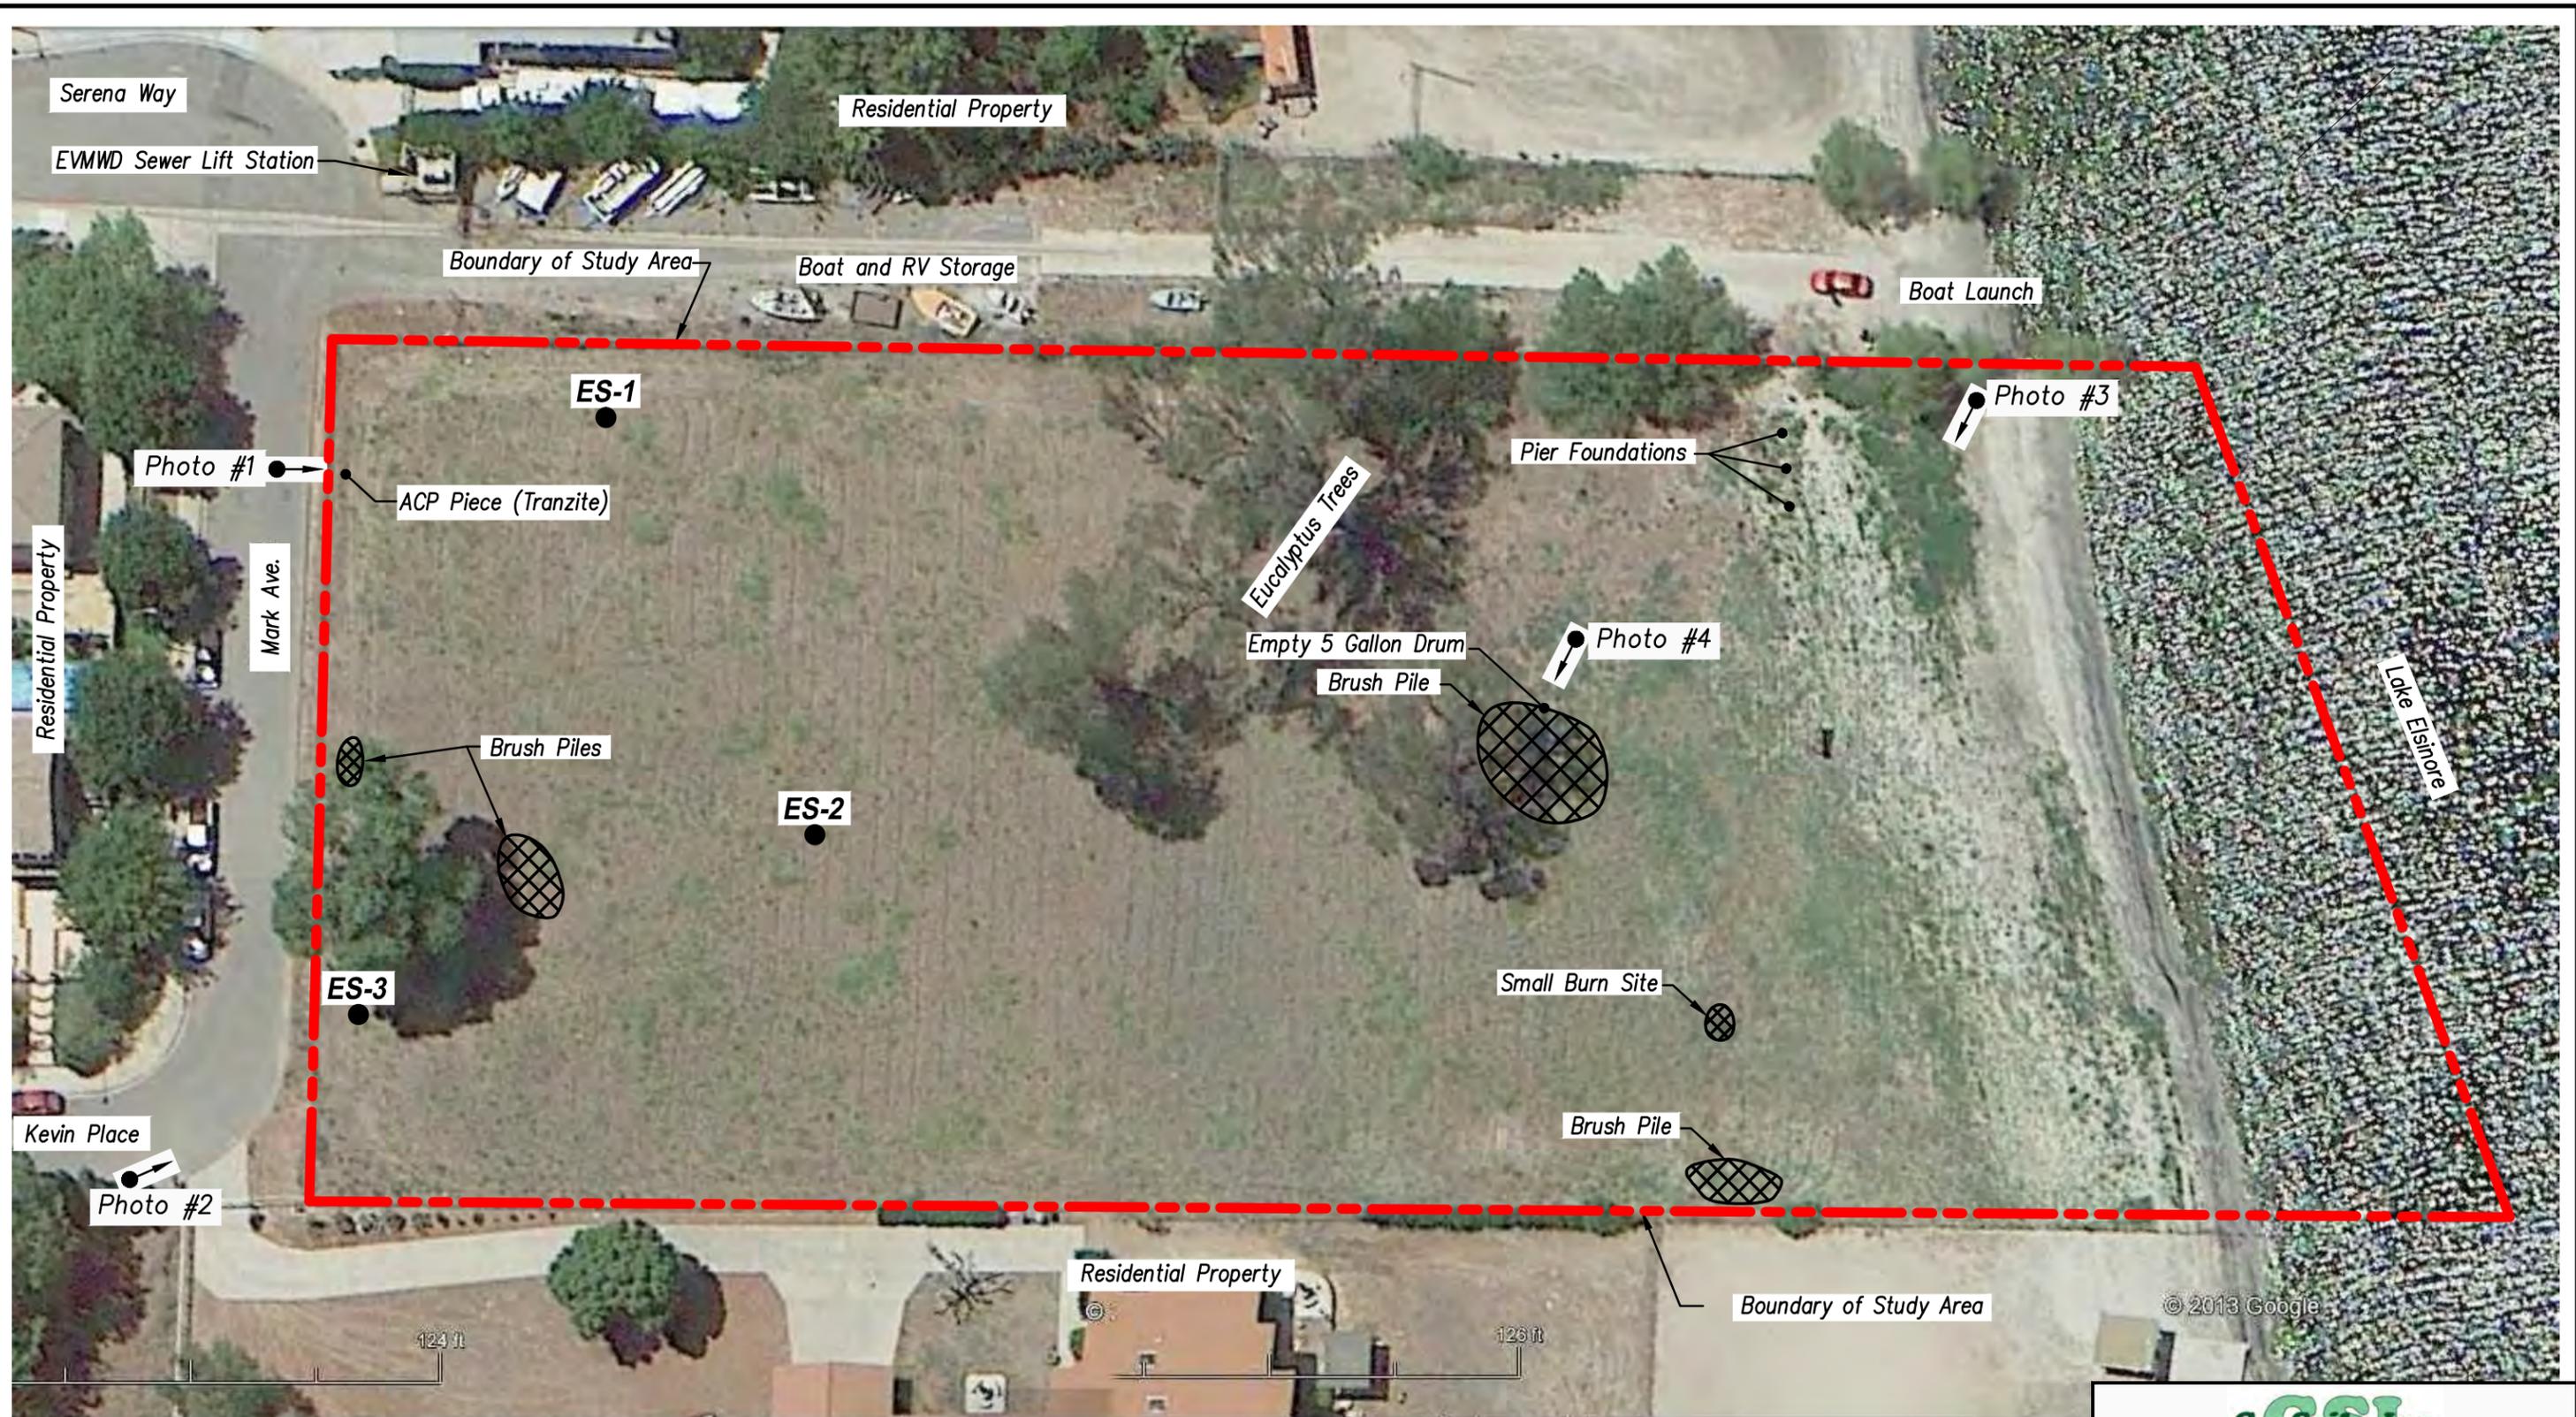
On June 10, 2013, a GSI representative (Mr. Ryan B. Boehmer) visited the subject property to assess current site utilization and observe for signs of possible surface contamination, which included walking the site and remote sensing the surrounding properties from the subject site. Features observed during the site reconnaissance are described below and illustrated on the Site Map (see Figure 2) which uses Google Earth imagery as a base. Photographs of the subject property are presented in Appendix B on the CD data disc. The photograph locations and viewpoints are also indicated on Figure 2 (Site Map).

- Photo #4 — APPROXIMATE LOCATION OF SITE PHOTOGRAPH SHOWING DIRECTION OF VIEW
- ES-3 — APPROXIMATE LOCATION OF ENVIRONMENTAL SOIL SAMPLE

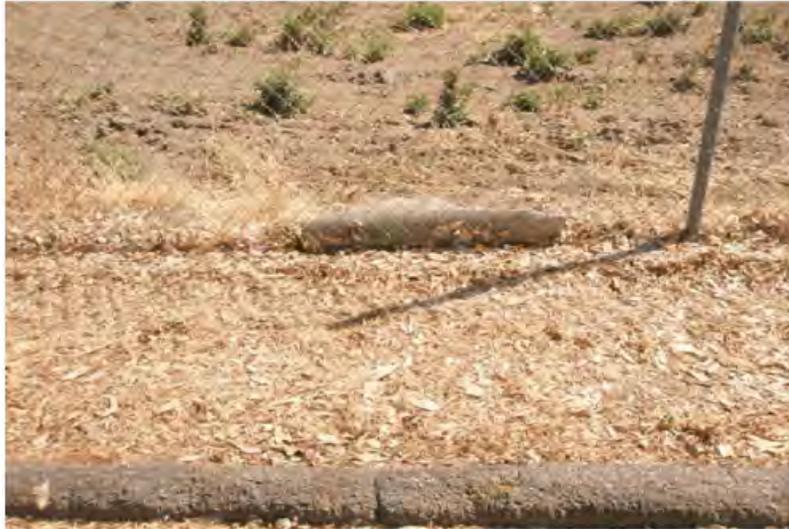
- Currently, there are no buildings or structures on the subject site that could contain asbestos containing materials (ACMs) or lead-based paints (LBPs). However, GSI did observe a piece of asbestos cement pipe (ACP) near the southwesterly site boundary. Thus, there is a potential for ACP to exist in the subsurface of the property, especially near the southwesterly site margin. LBPs are not considered a Recognized Environmental Condition (REC).

1. Photograph of a piece of broken Asbestos Cement Pipe (ACP) near the southwesterly corner of the subject site. Photographic viewpoint is to the northeast.

With the exception of possible ACP in the subsurface of the site, this assessment has revealed no readily apparent evidence of recognized environmental conditions in connection with the subject property that could pose environmental risks to human health.

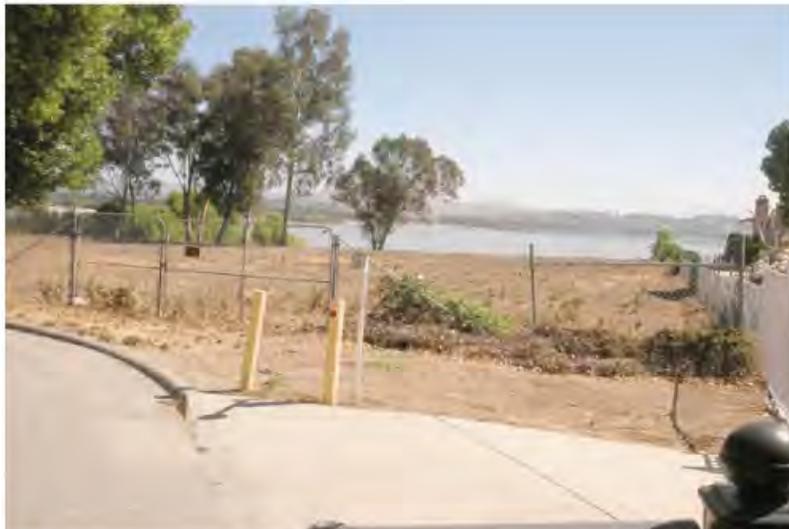
2. Photograph of the site taken from the southeasterly property corner. Lake Elsinore is visible in the background. Photographic viewpoint is to the northwest.

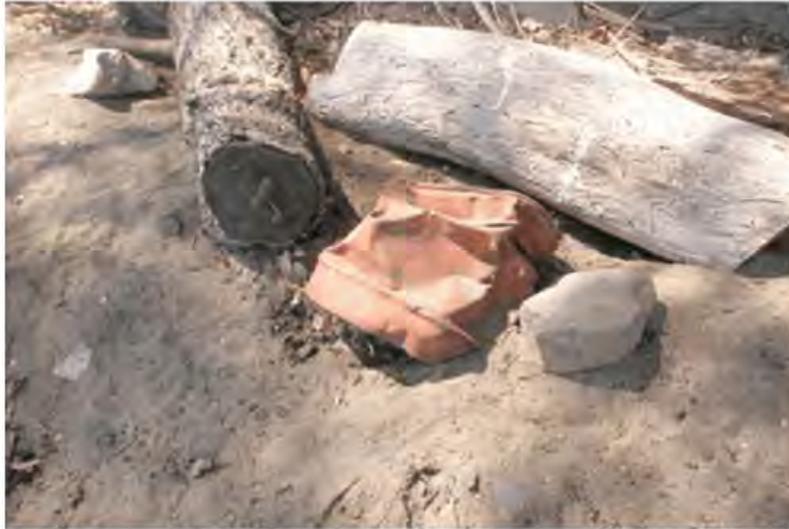
- **Buildings on Property, and General Usage** - The site is currently vacant/undeveloped. Thus, there are no buildings on the subject property.
- **Drum Storage** - No readily visible evidence of drum storage was observed during our site reconnaissance. GSI did observe one (1) discarded, 5-gallon metal drum near the base of a eucalyptus tree, within the central portion of the property. The drum was empty and there were no indications of soil staining around the drum. Therefore, drum storage is not considered an REC.

3. Photograph of a discarded, approximately 5-gallon metal drum. The drum was empty and there was no readily visible evidence of stained soil in proximity to the drum. Photographic viewpoint is to the southeast.

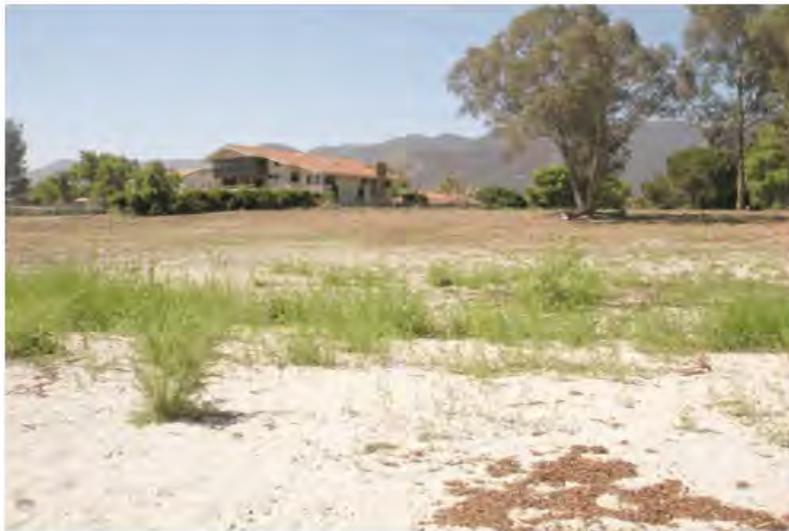
4. Photograph of the site taken near the northwesterly property corner. An adjacent residential structure is visible in the background. Photographic viewpoint is to the southeast.
