**PHASE I ENVIRONMENTAL SITE ASSESSMENT  
APN 381-030-005, LAKE ELSINORE  
RIVERSIDE COUNTY, CALIFORNIA 92530**

**GRAND SOLUTIONS LLC  
601-C CRANE STREET  
LAKE ELSINORE, CALIFORNIA 92530**

**W.O. E5043-SC      JANUARY 2, 2008**

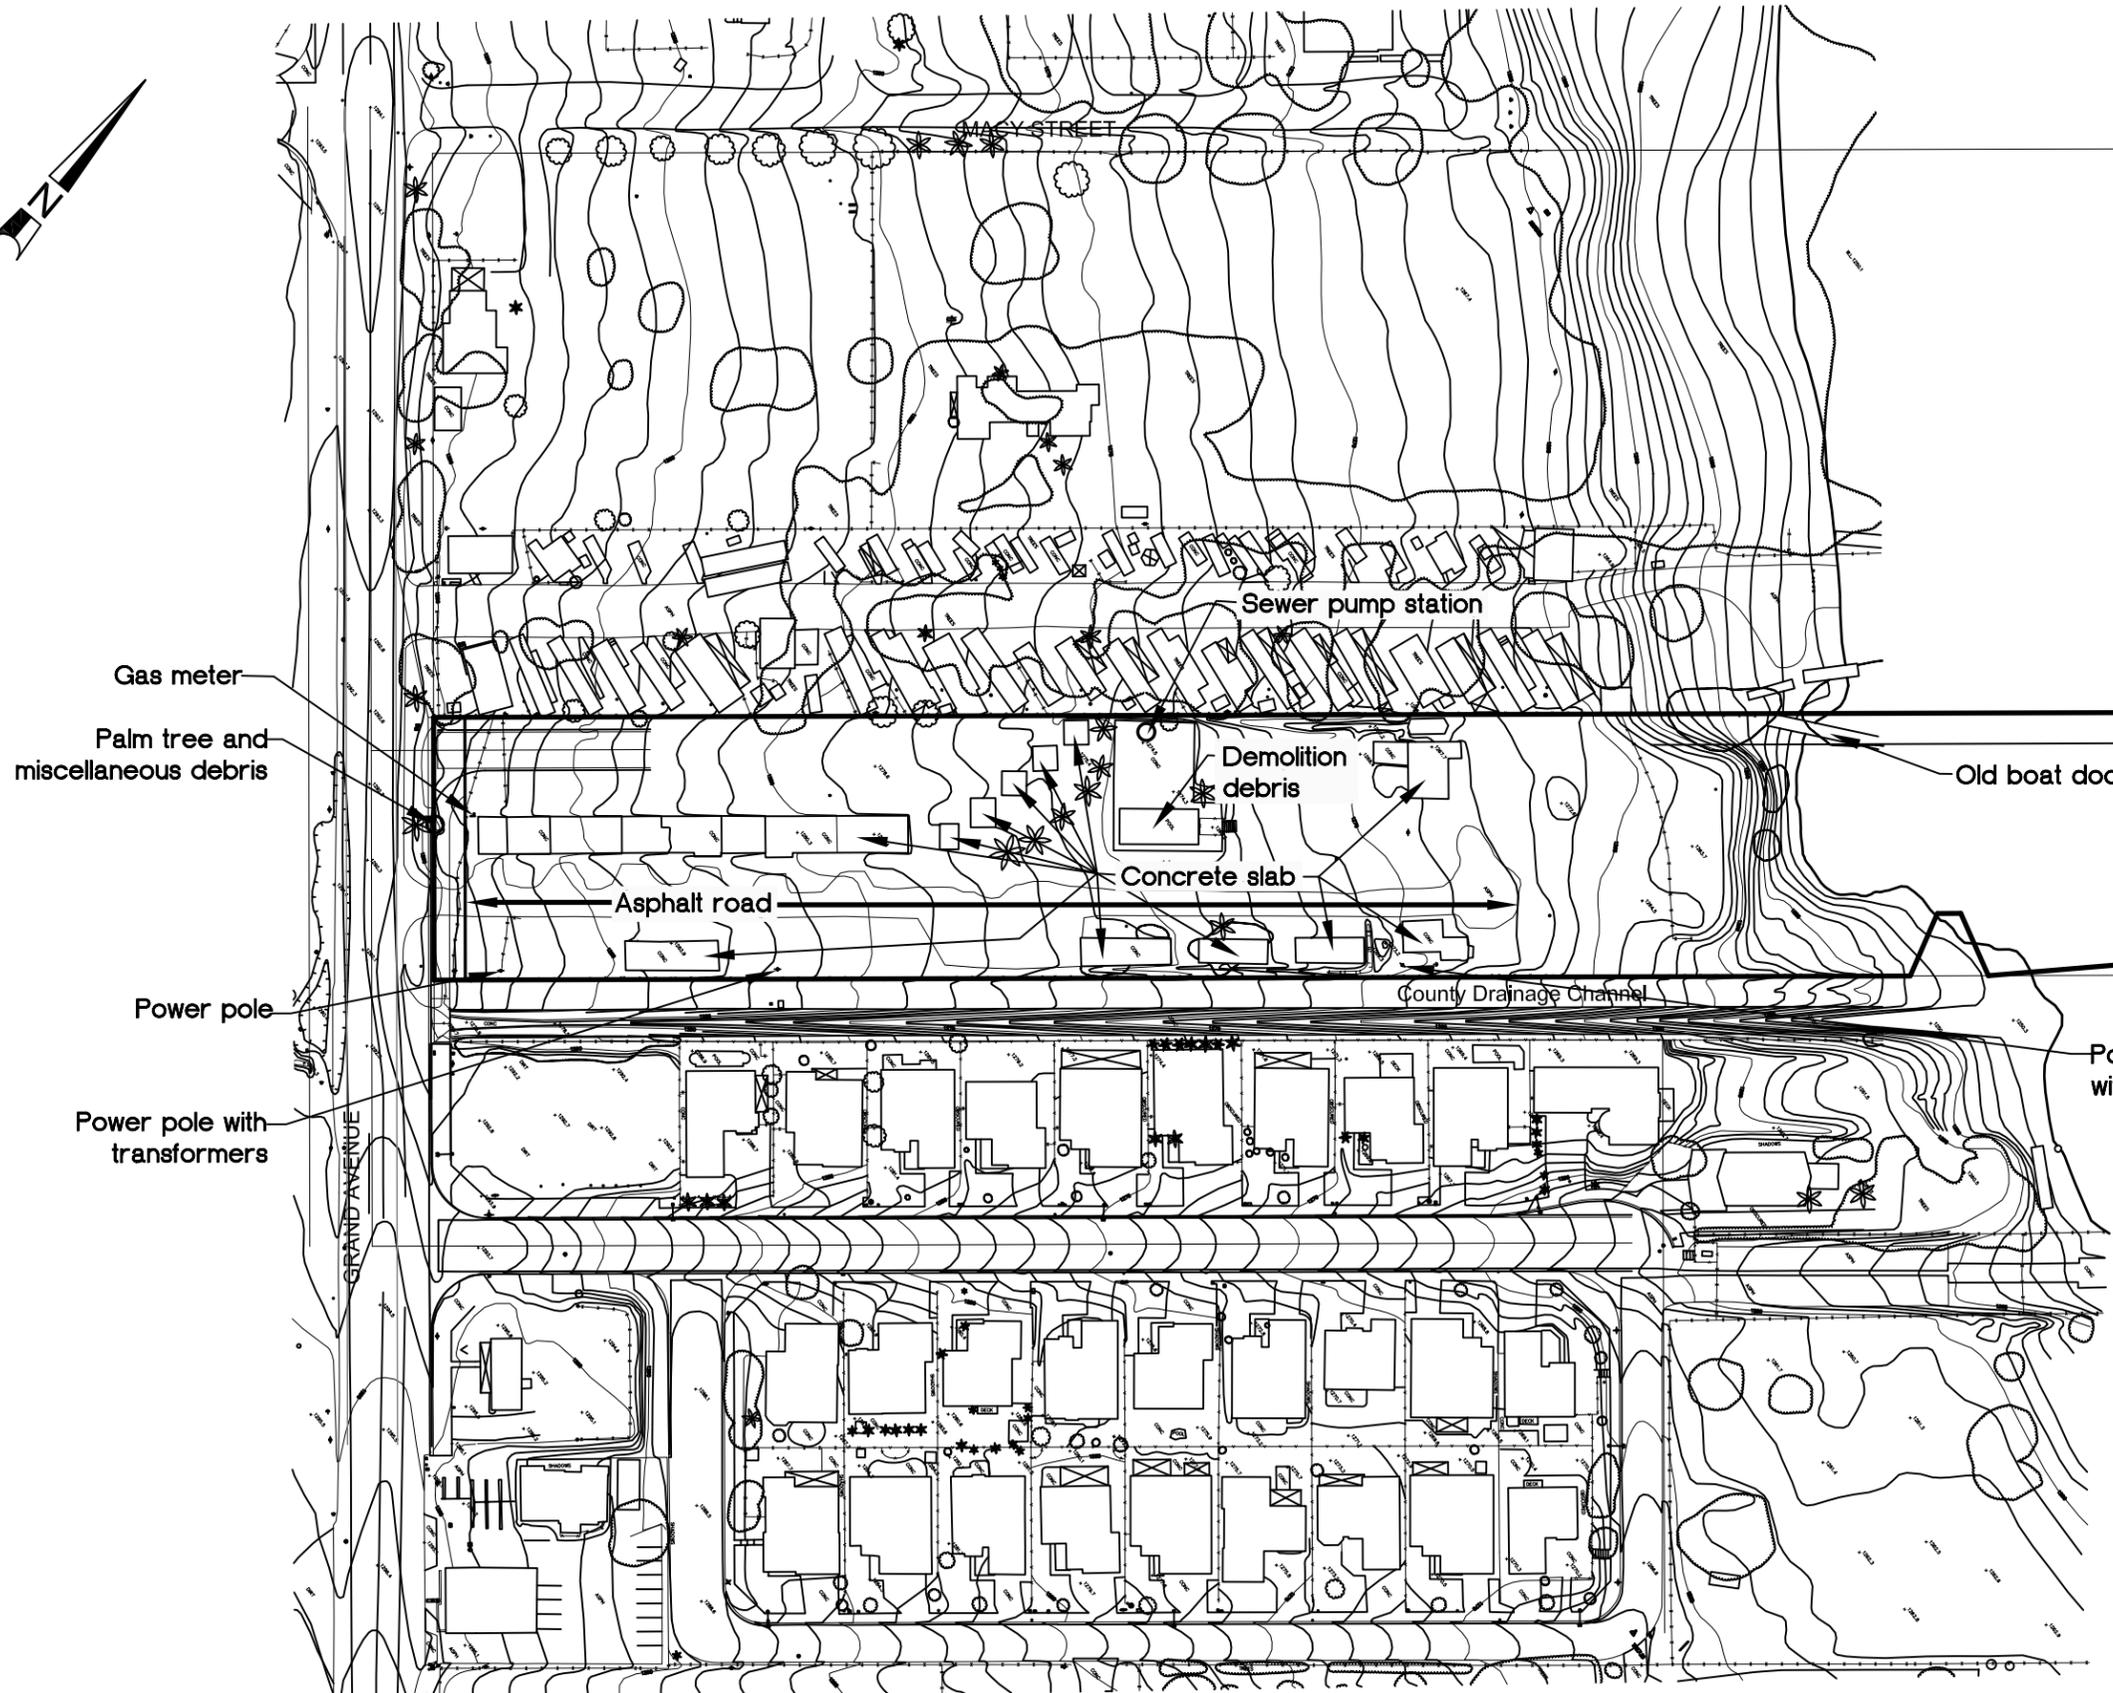
On December 5 and 26, 2007, a GSI representative visited the subject site to assess current site utilization and observe for signs of possible surface contamination, which included both driving and walking the property. Features observed during the site visit are described below and illustrated on the Site Map (see Figure 2). Photographs of the subject property are presented in Appendix B.

A chain-link fence is located at the entrance of the property. Concrete slabs are present on the northwest and southwest portions of the property. A drained swimming pool also is present at the northeast portion of the property, and it appears that a sewer pump station is present north of the drained swimming pool. Demolition debris was observed in the drained swimming pool. An old boat dock exists at the eastern portion of the property. A Riverside County Flood Control District (RCFCD) drainage channel is located along the southeast border of the property. Septic systems may exist in the location of the former structures.

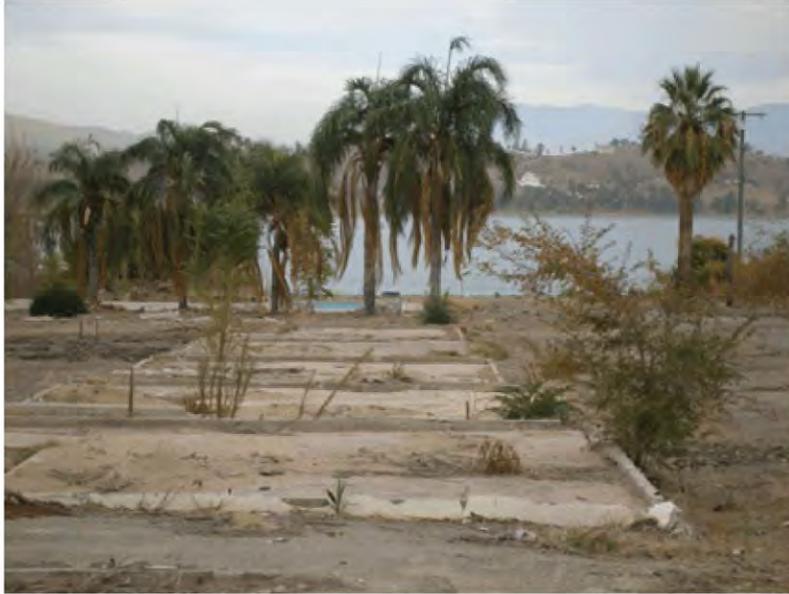
1. Northeast view of concrete pads and drained pool. Note Lake Elsinore in background.

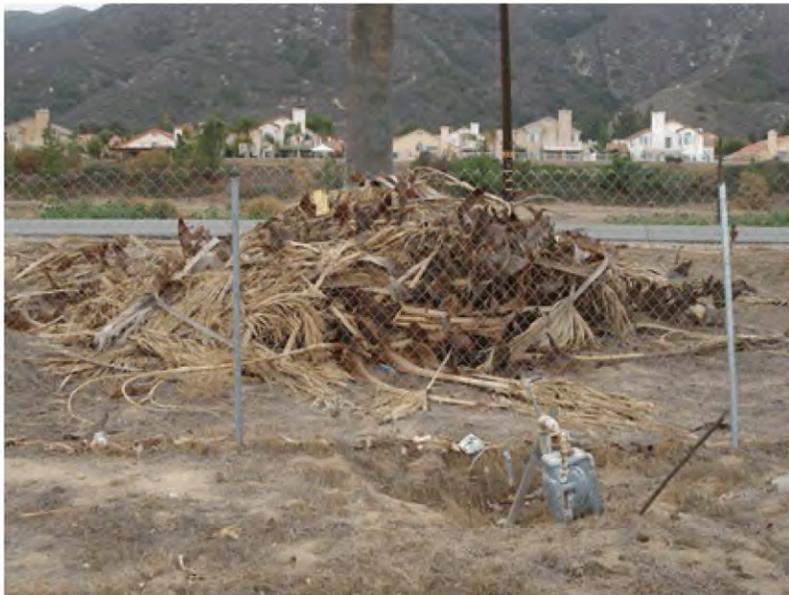
2. Northwest view looking towards Grand Avenue. Note palm tree debris, chain-link fence, and gas meter.

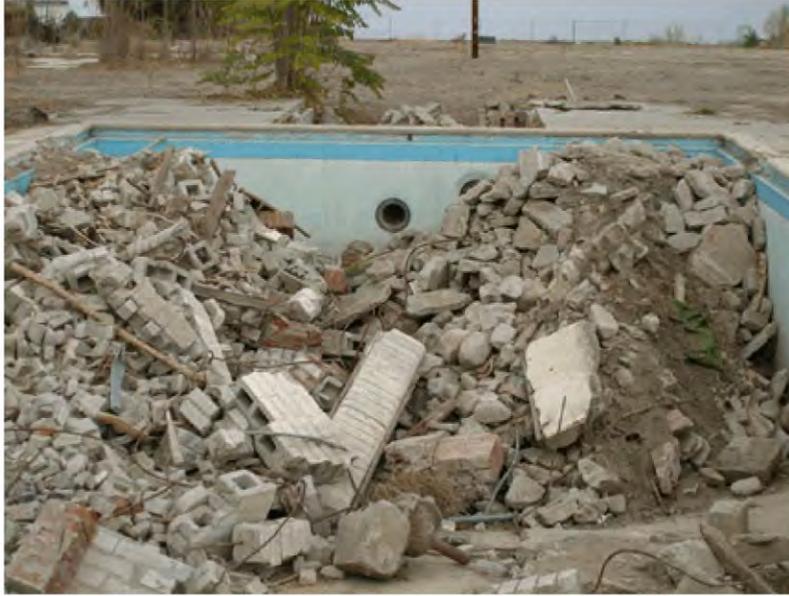
3. Northeast view of drained pool with demolition debris. Note concrete, rebar, and brick debris.

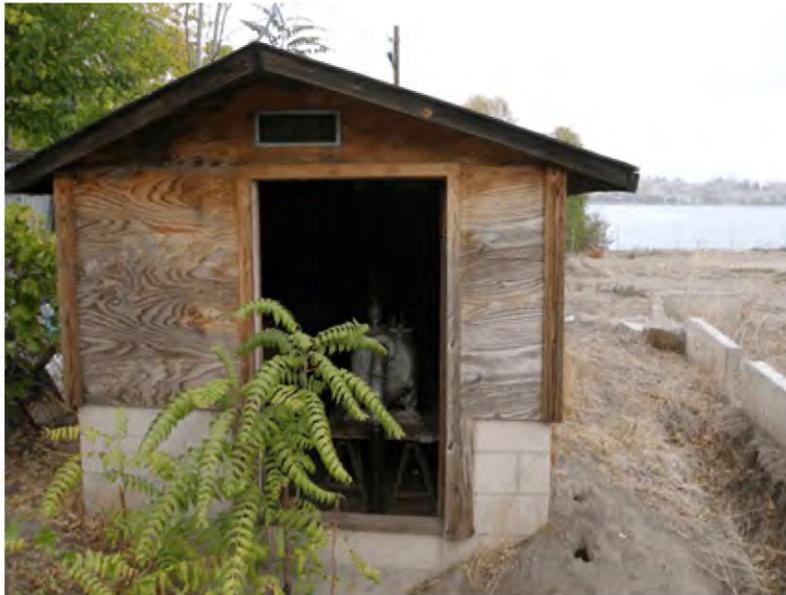
4. Northeast view of sewer pump station and concrete wall. Note sewer pump inside structure.

- Based on the historic property use, septic tanks (systems) may exist on the property. Although not considered a hazardous waste, any buried septic systems should be properly removed or abandoned following health department guidelines.
- All trash, debris, and waste materials should be disposed of offsite, in accordance with current local, state, and federal disposal regulations. Any materials containing petroleum residues encountered during property improvements should be

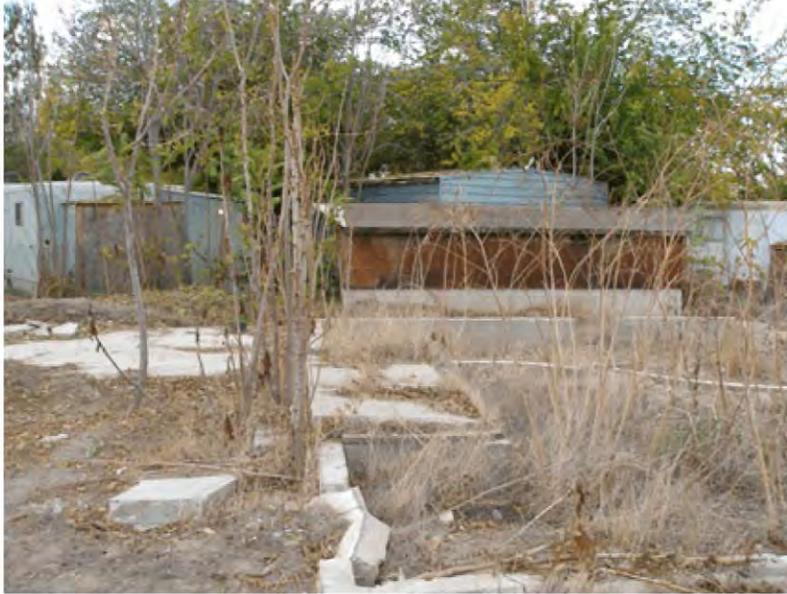
5. North view across property, showing concrete slabs, walls, sewer pump station, and mobile homes on adjacent property.

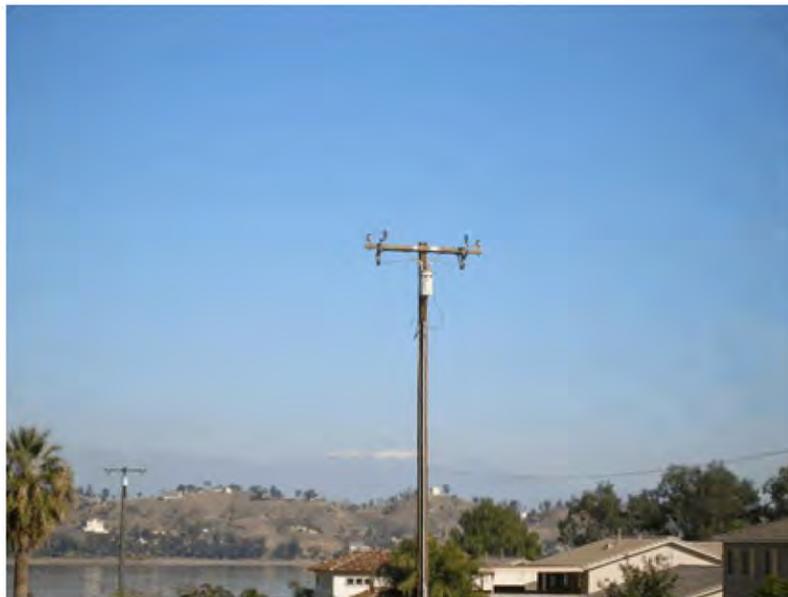
- **Potential Sources of Polychlorinated Biphenyls (PCBs)** - Overhead power lines or transformers were observed on the site. Overhead power lines with transformers are located along the County Drainage Channel (southeast portion of the site). Previous conversations with Southern California Edison (SCE) has indicated that the possibility of nearby PCB's leaking from their transformers is extremely unlikely, and the transformers are now probably filled with mineral oil. SCE has indicated that should the transformers leak, it would be their responsibility to perform cleanup. Accordingly, nearby transformers should not be of concern with respect to PCBs.

6. Northeast view across the property towards Lake Elsinore. Note power pole with transformers.
