**PHASE I ENVIRONMENTAL SITE ASSESSMENT
PROPOSED MULT-FAMILY RESIDENTIAL
DEVELOPMENT**

Riverside Drive, Southwest of Eisenhower
Drive
Lake Elsinore, California
for
Classic Pacific

January 3, 2006
Project No. 05E116-1

Subject: **Phase I Environmental Site Assessment**
Proposed Multi-Family Residential Development
Riverside Drive, southwest of Eisenhower Drive
Lake Elsinore, California

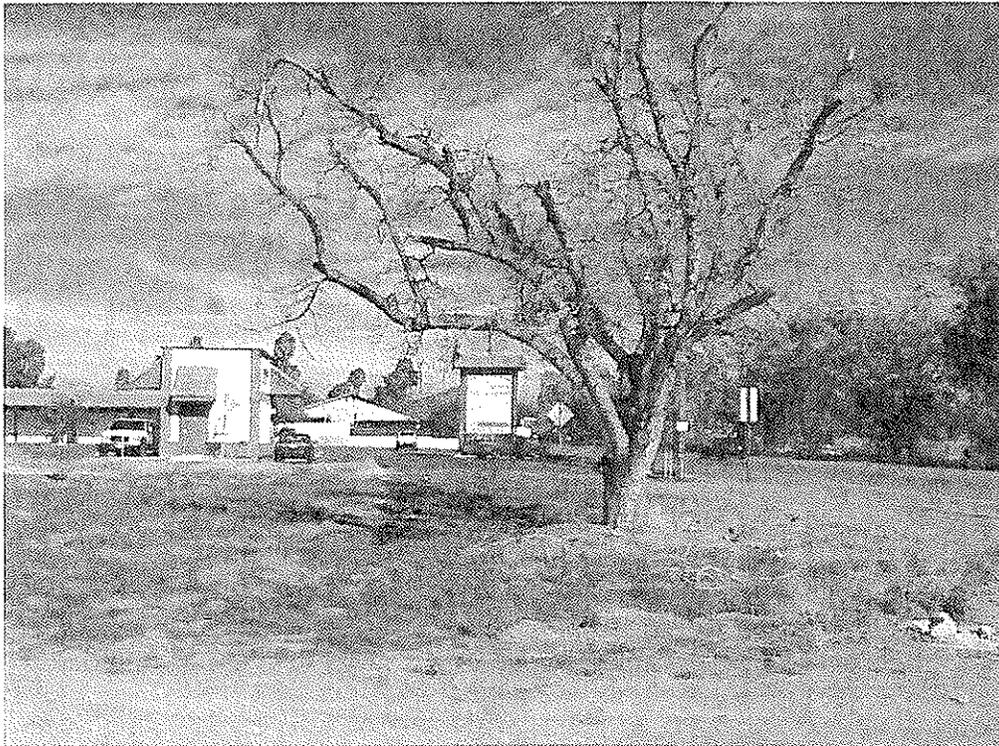
Photo 1: Overview of the subject site. Photo taken from the south corner of the site looking northeast. The Seers Plaza is visible in the background.

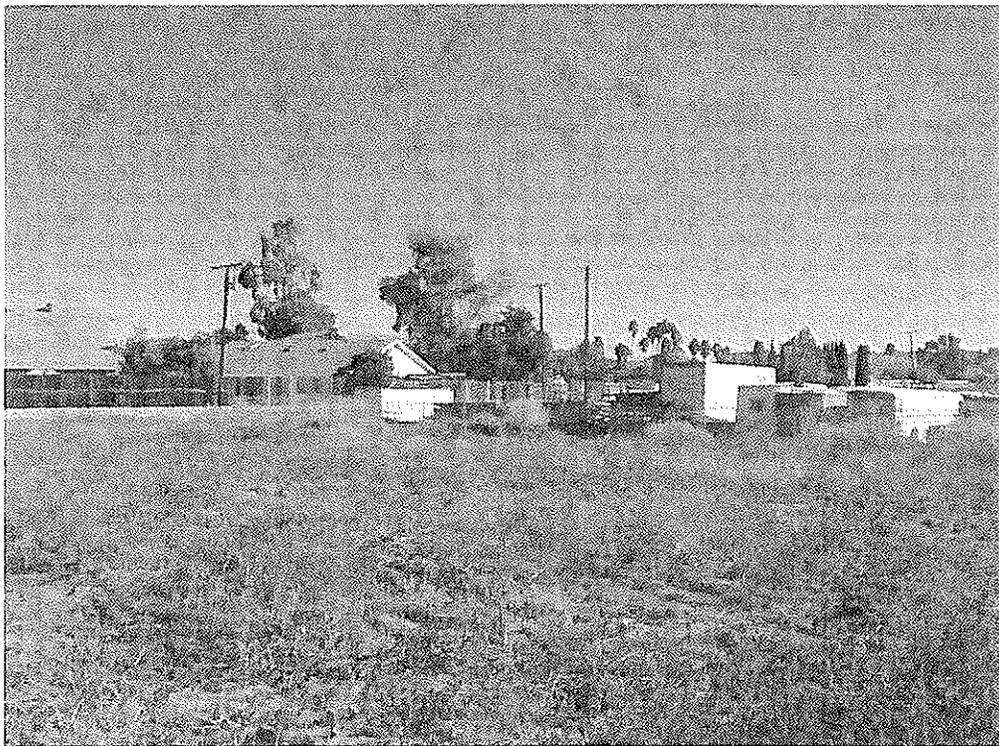
Photo 2: Overview of the subject site. Photo taken from the north-central area of the site looking north. The single family residences are visible in the background.

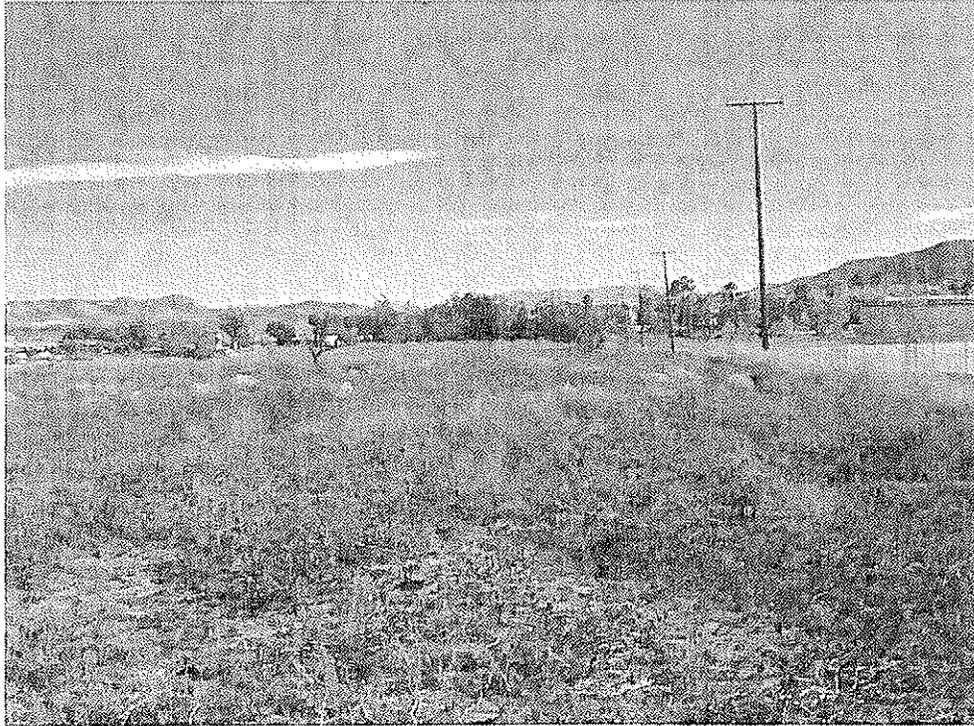
Photo 3: Overview of the subject site. Photo taken from west corner of the site looking southeast. Lake Elsinore is visible behind the trees in the background.

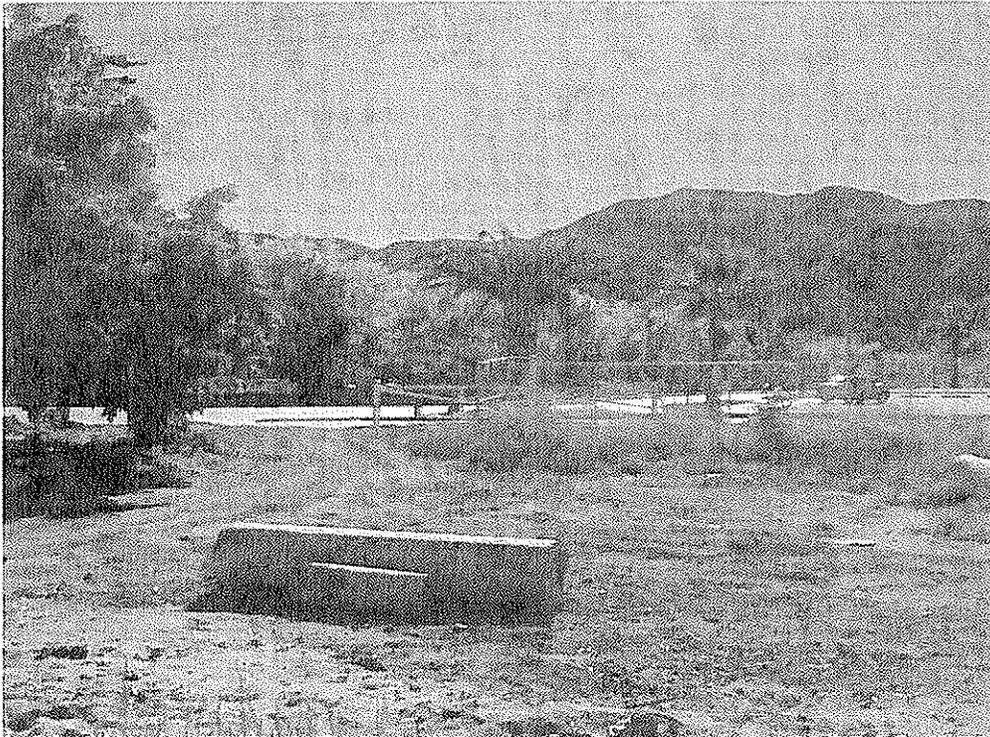
- Solid waste production and storage
 - Hazardous..... None Observed
 - Non-hazardous..... Observed
Household garbage was observed in the northern area of the site. Two (2) abandoned concrete pipes were observed on the ground surface in the southeastern area of the site. The pipes were approximately 12 feet and 5 feet in length, respectively.

Photo 4: Picture of the two abandoned concrete pipes. Photo taken from the southern area of the site looking southwest.

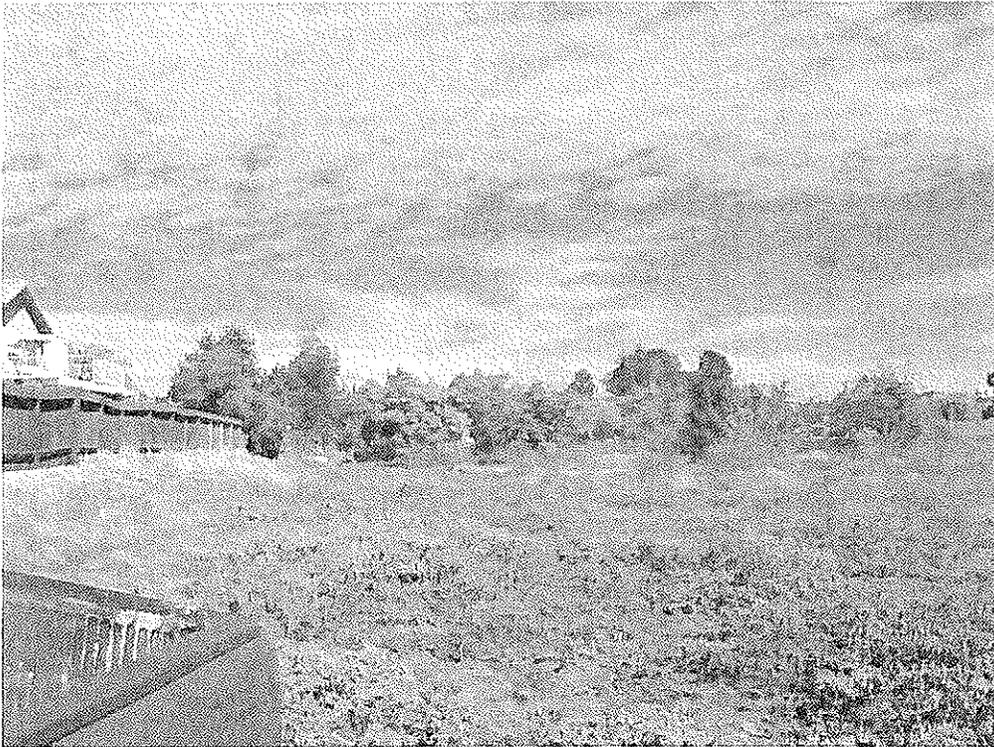
Photo 5: Overview of the subject site. Picture taken from west corner of the subject site looking northeast. The walnut orchards, located in the northern area of the subject site are visible in the background.

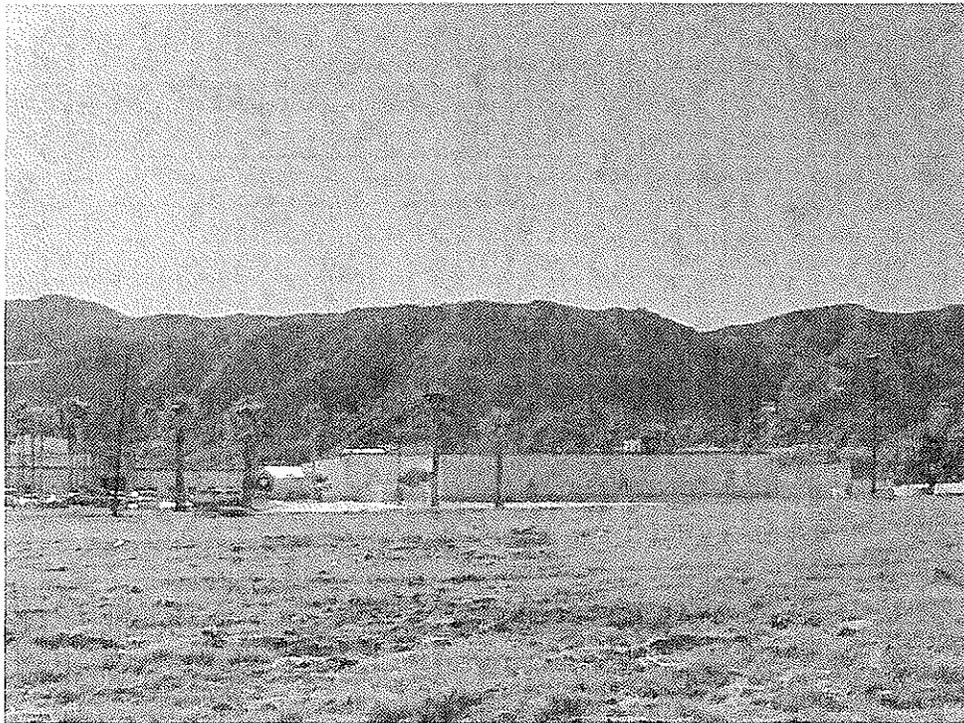
Photo 6: Overview of the subject site. Picture taken from the central area of the subject site looking southwest. Lakeside High School is visible in the background.
