**DISTRICT PRELIMINARY GEOTECHNICAL REPORT
TEMESCAL CANYON ROAD PROJECT
LAKE ELSINORE, CA**

Federal-Aid Project No. BRLO-5074 (015)

GDC Project No. IR-617
April 4, 2016

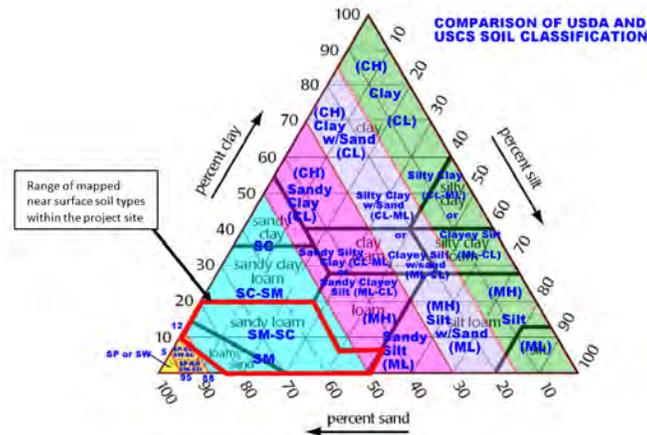
The chart below relates Unified Soil Classification System (USCS) classifications to the United States Department of Agriculture (USDA) textural classifications:

The soil types within the project site (Loamy Sand and Sandy Loam by USDA system) generally are Silty Sand (SM) and Clayey Sand (SC) by the USCS soil classification system, which is consistent with the Lake Street Bridge LOTB. Nearby soil groups include Clay Pits (likely Clay (CL) or CH) per USCS), Gravelly Loamy Sand (likely Silty and/or Clayey Sand with Gravel (SM and/or SC) per USCS), and Rocky Loam (sandy Clay and/or Silt with Gravel (CL and/or ML) per USCS). The following table presents minimum estimated infiltration rates and hydrologic soil group based on the textural triangle:

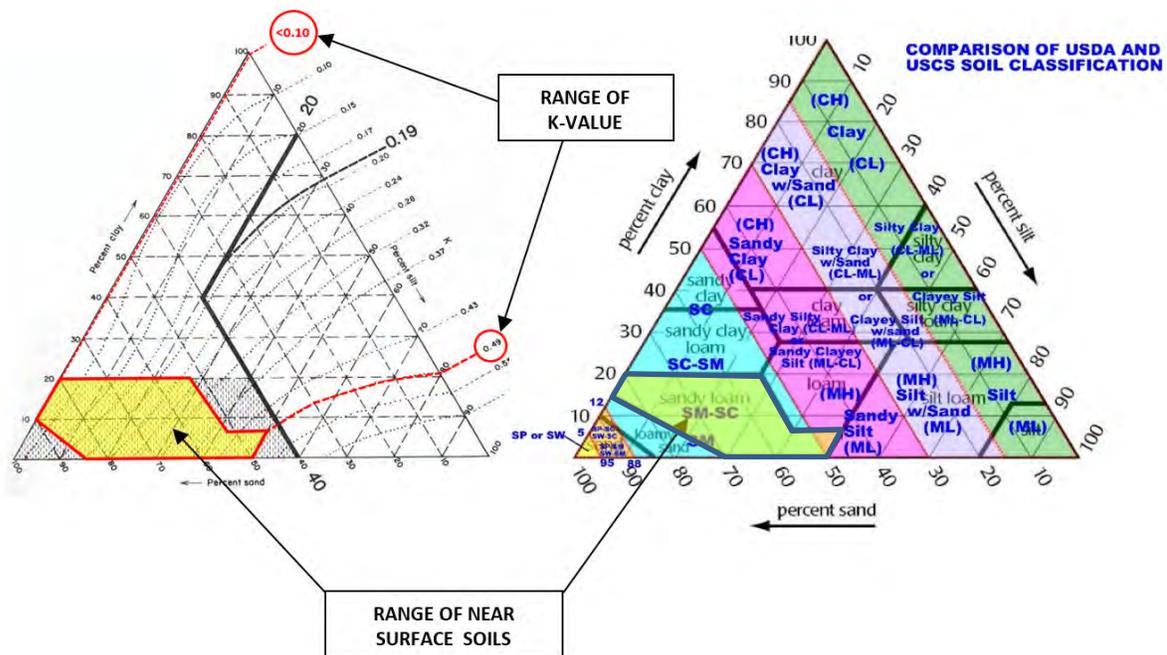
Soil erodibility assessment is required for a National Pollutant Discharge Elimination System (NPDES) permit where disturbance area is greater than 1 acre. The K-factor for use in the Revised Uniform Soil Loss Equation (RUSLE) was estimated by using the nomograph method based on particle size ranges for the types of near surface soils indicated in the Soil Survey Sheets (Figure 4B), which include loamy sand and sandy loam in accordance with USDA classification. No data on embankment are available, but they may be similar to the natural soils. The range of soil types and K-value are illustrated in the figure below:

The USDA agricultural classification sandy loam to loamy sand covers a fairly wide range of USCS soil types including Silty Sand (SM), Clayey Sand (SC), and Sandy Silt (ML), with percent sand ranging from 45 to 90, percent clay ranging from 0 to 20, and percent silt ranging from 0 to 50. The K-value has a wide range with values from < 0.1 to 0.49. In general, soils with higher silt content, lower clay content, and lower sand content have higher K values.

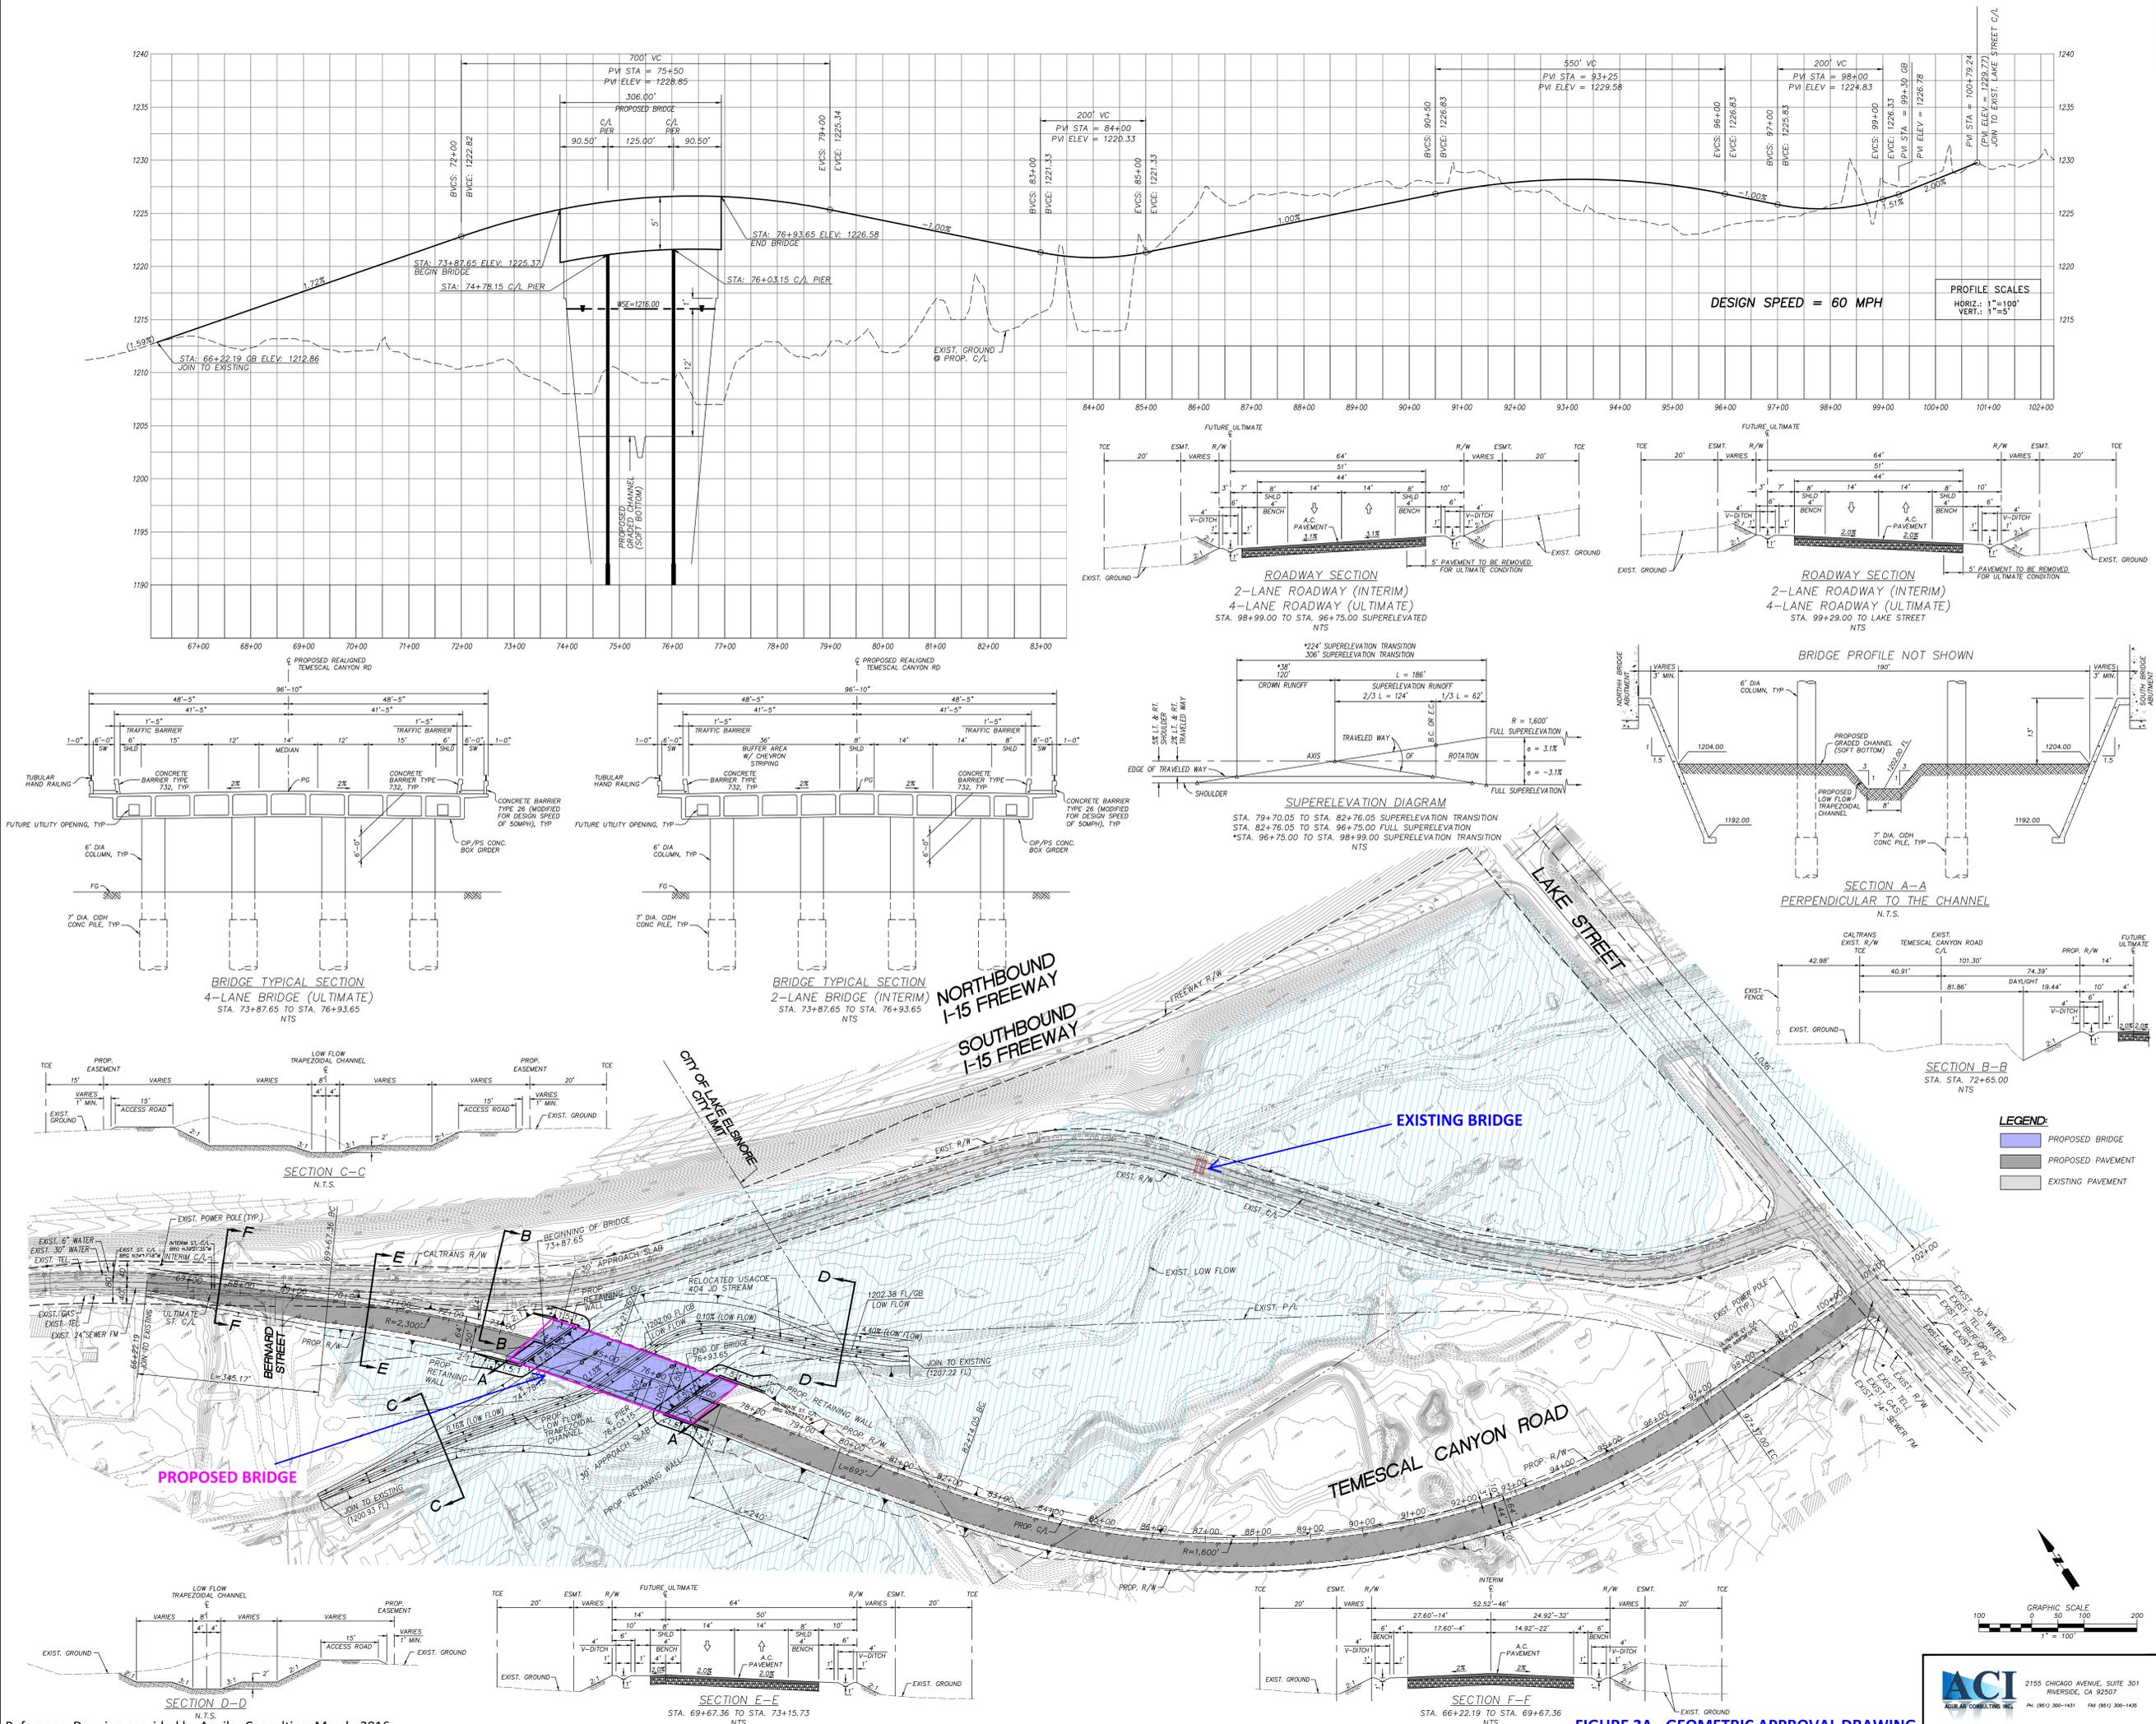
TEMESCAL CANYON ROAD GAD (OPTION 4)

2,300 AND 1,600-FOOT RADIUS, 2-LANE (INTERIM), 64' R/W (INTERIM), 4-LANE (ULTIMATE), 100' R/W (ULTIMATE)

Based on preliminary plans in Figure 2A (Section A-A), temporary construction excavations to about El. 1190 feet are proposed to construct foundation piles and slope paving / cutoff walls for scour protection within the channel. Based on existing data, it is uncertain exactly where the groundwater level might be at the time of construction. The groundwater level could be as high as the channel bed elevation (near El. 1200 feet), or could be at or below El. 1190 feet. The groundwater level is likely to vary seasonally and with distance from the Temescal Wash channel. If the groundwater is present at elevations above El. 1190 feet during construction then dewatering and/or cofferdams may be required for the temporary excavations. This is a major

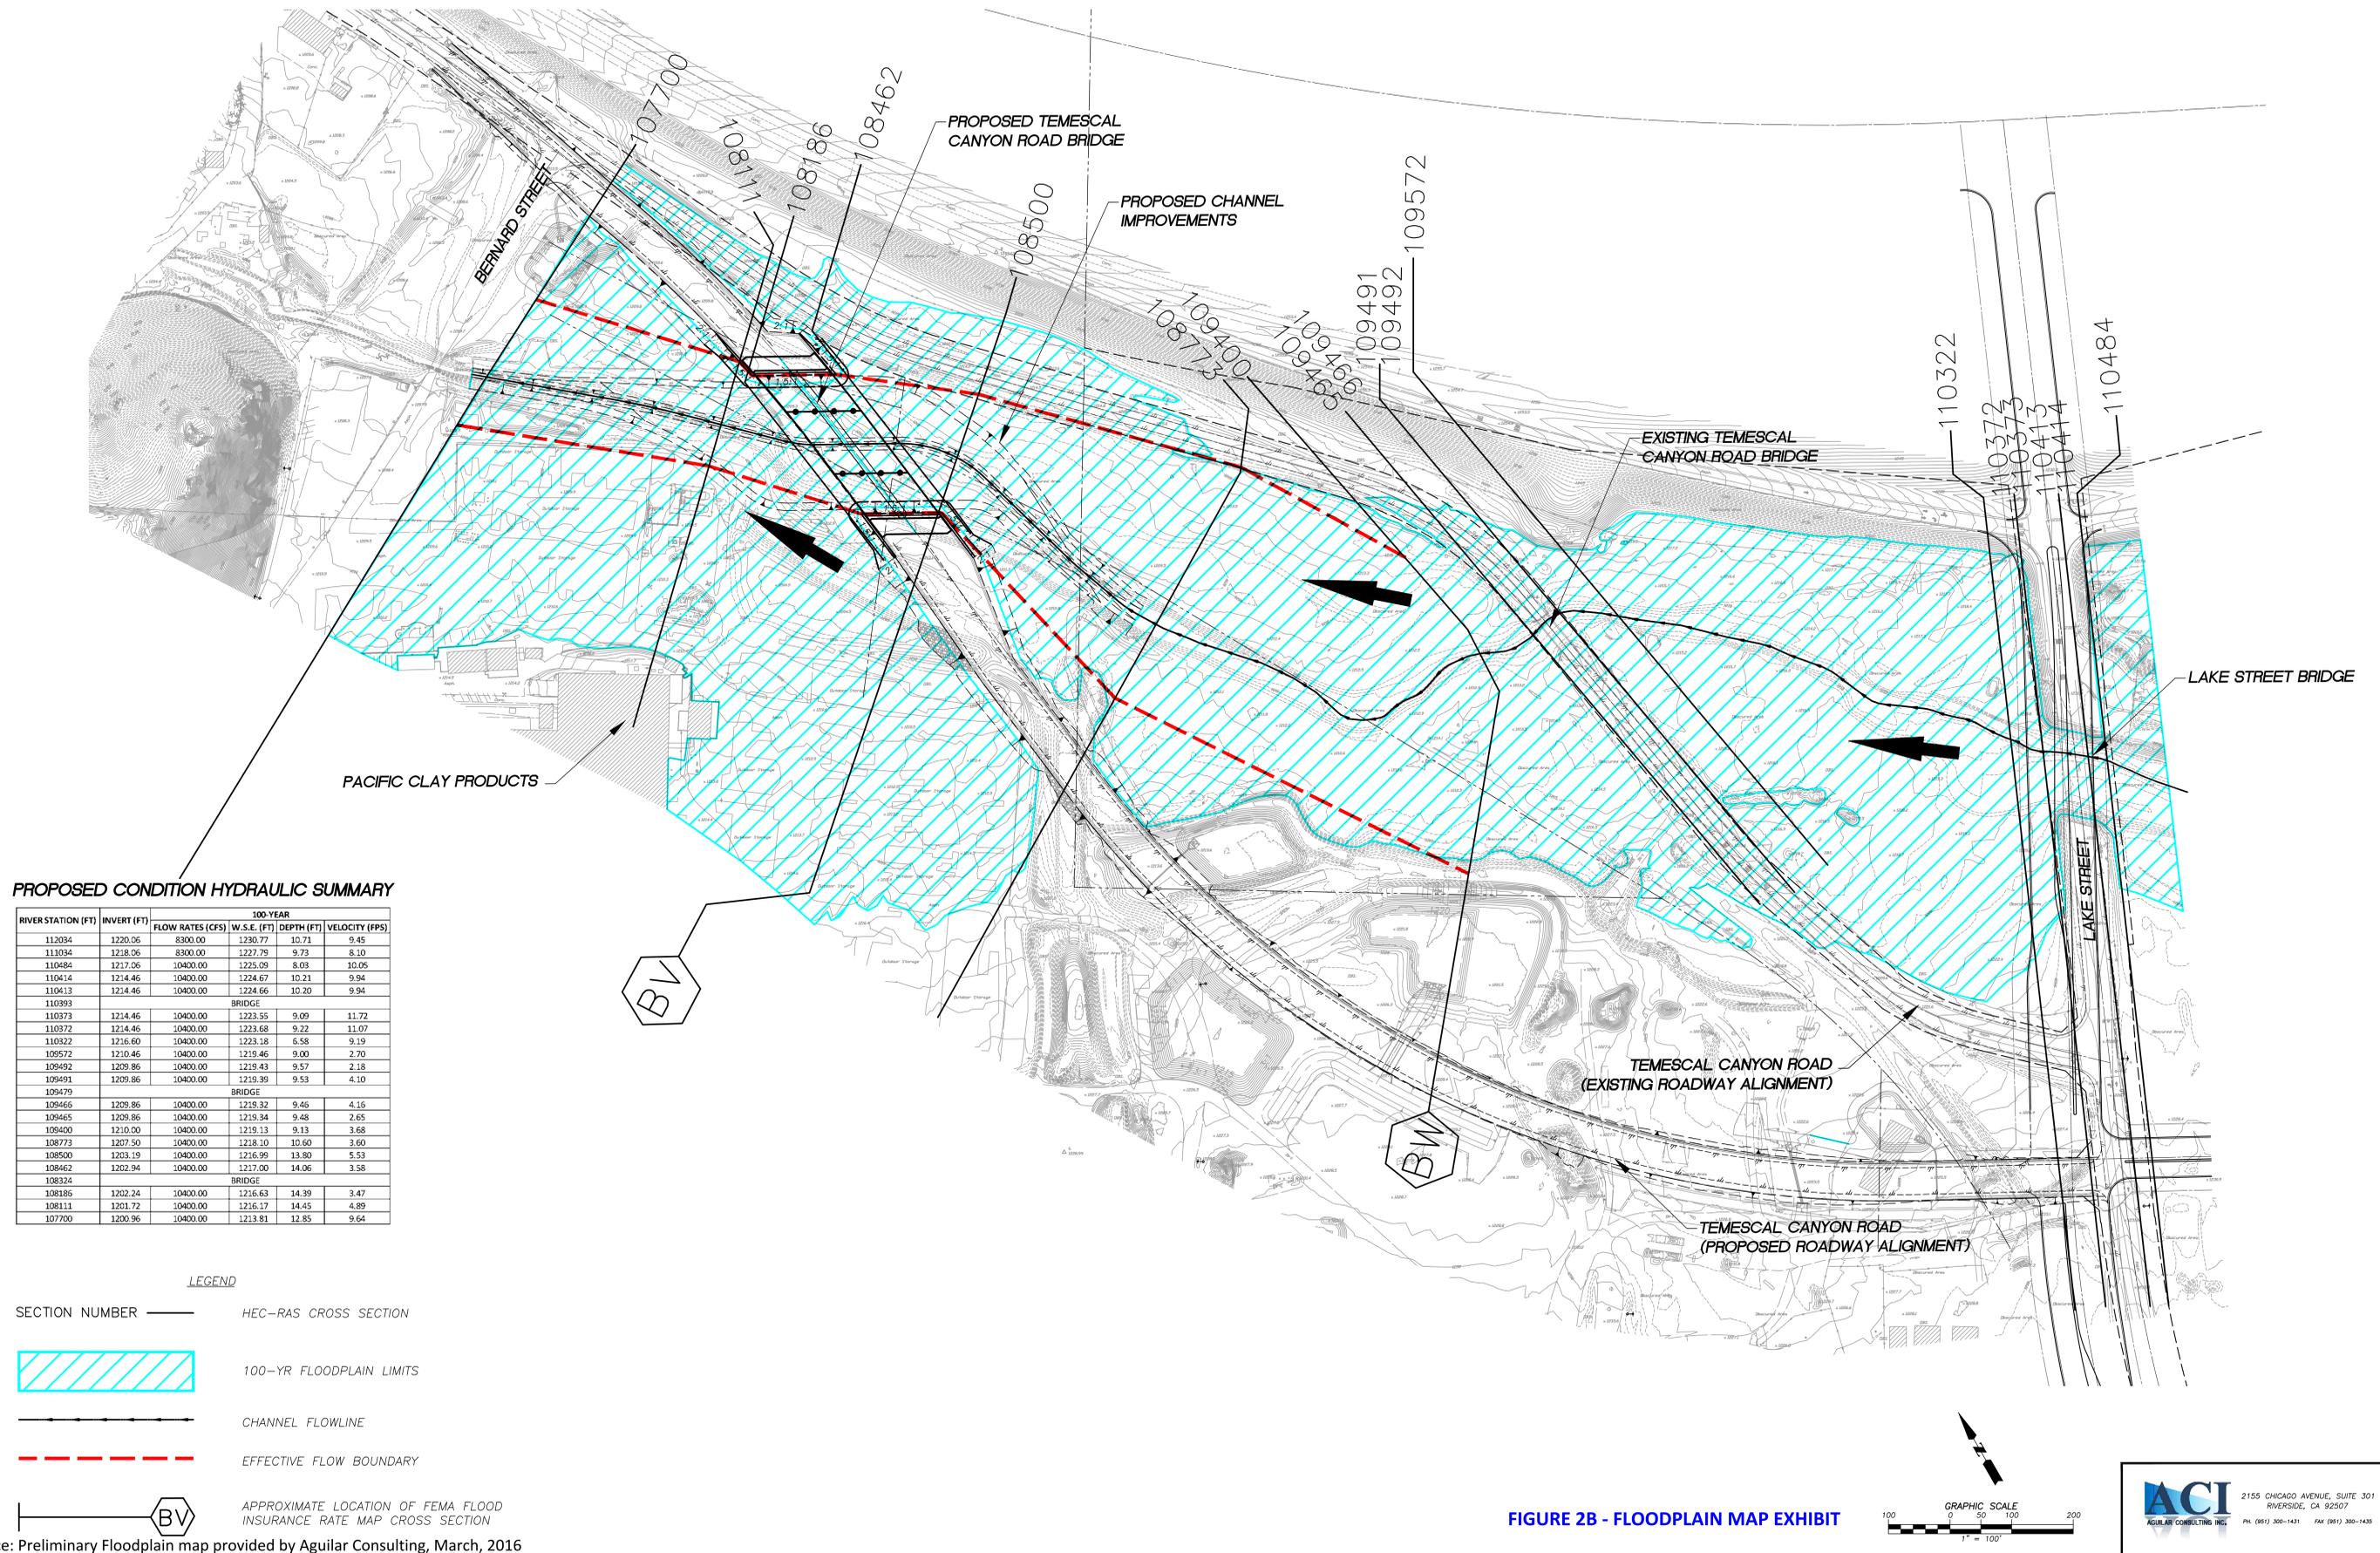
FIGURE 2B - FLOODPLAIN MAP EXHIBIT

EXHIBIT B: 100-YEAR FLOODPLAIN EXHIBIT FOR TEMESCAL WASH BASED ON PROPOSED CONDITION IN THE VICINITY OF THE TEMESCAL CANYON ROAD BRIDGE

A California Geological Survey (CGS) Seismic Hazard Zone Report or Map documenting historically highest groundwater has not yet been prepared for this site. The northern portion of the project site is located within the 100-year flood plain of Temescal Wash (Figure 6), and the proposed roadway realignment will be elevated on embankment and cross Temescal Wash on a bridge structure, as shown in Figures 2A and 2B. Where Lake Street crosses Temescal Wash, groundwater level was reported on the LOTB (Figure 4A) in 1974 at a depth of about 38 feet (Elevation 1182 feet) below the original grade. This may not be a stabilized groundwater level, due to presence of significant layers of clay above the reported groundwater level. Groundwater (or “wet” soil) was recorded at a depth of about 9 feet (El.1201 feet) in the monitoring well (MW-1) in 1999 installed at Pacific Clay Brick Products facility, which is close to the Temescal Wash channel bed elevation. Geomatrix also reported that during excavation for an underground storage tank (UST) where site elevation was near 1200 feet, groundwater seeped into the excavation and stabilized at a depth of 7 feet (El. 1193 feet). This indicates that permanent shallower groundwater table and/or perched groundwater is likely to be present at or slightly below the channel bed. Groundwater levels may be lower further from the creek. Groundwater level may vary during rainy seasons and it locally may be as high as the ground surface within and adjacent to flooded areas during flood conditions.

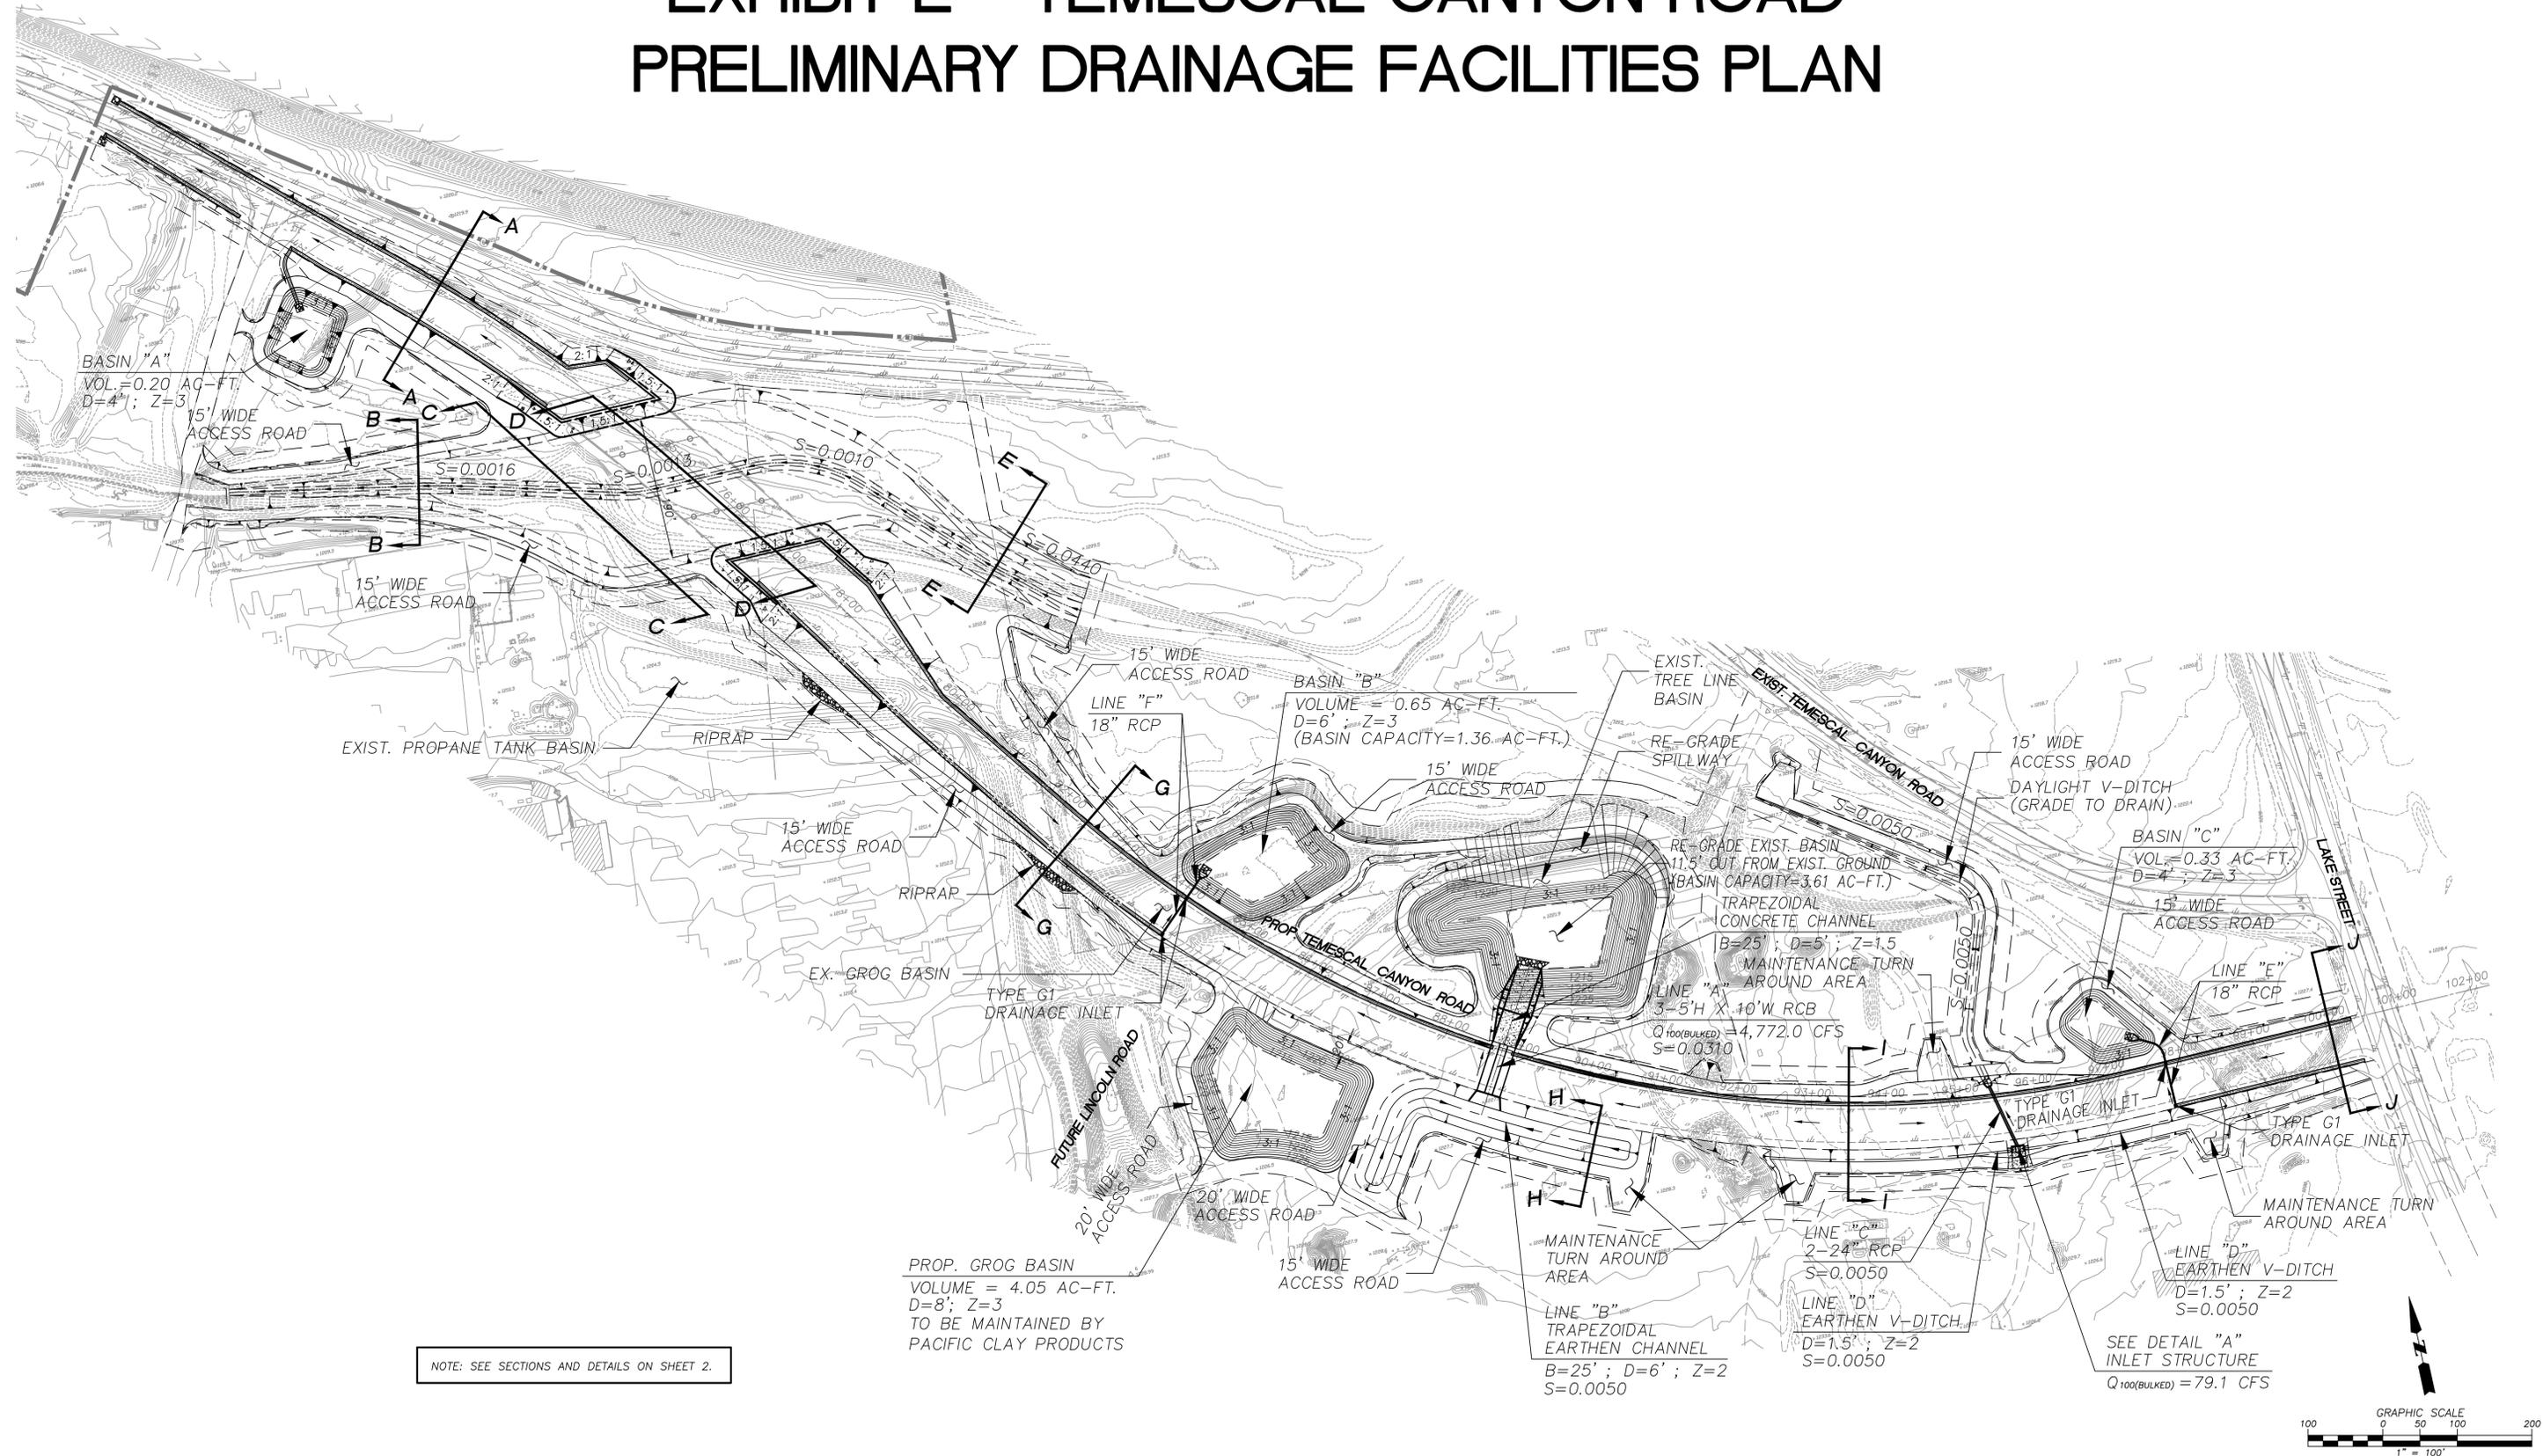
FIGURE 2C - PRELIMINARY CHANNEL AND DRAINAGE PLAN

EXHIBIT E - TEMESCAL CANYON ROAD PRELIMINARY DRAINAGE FACILITIES PLAN

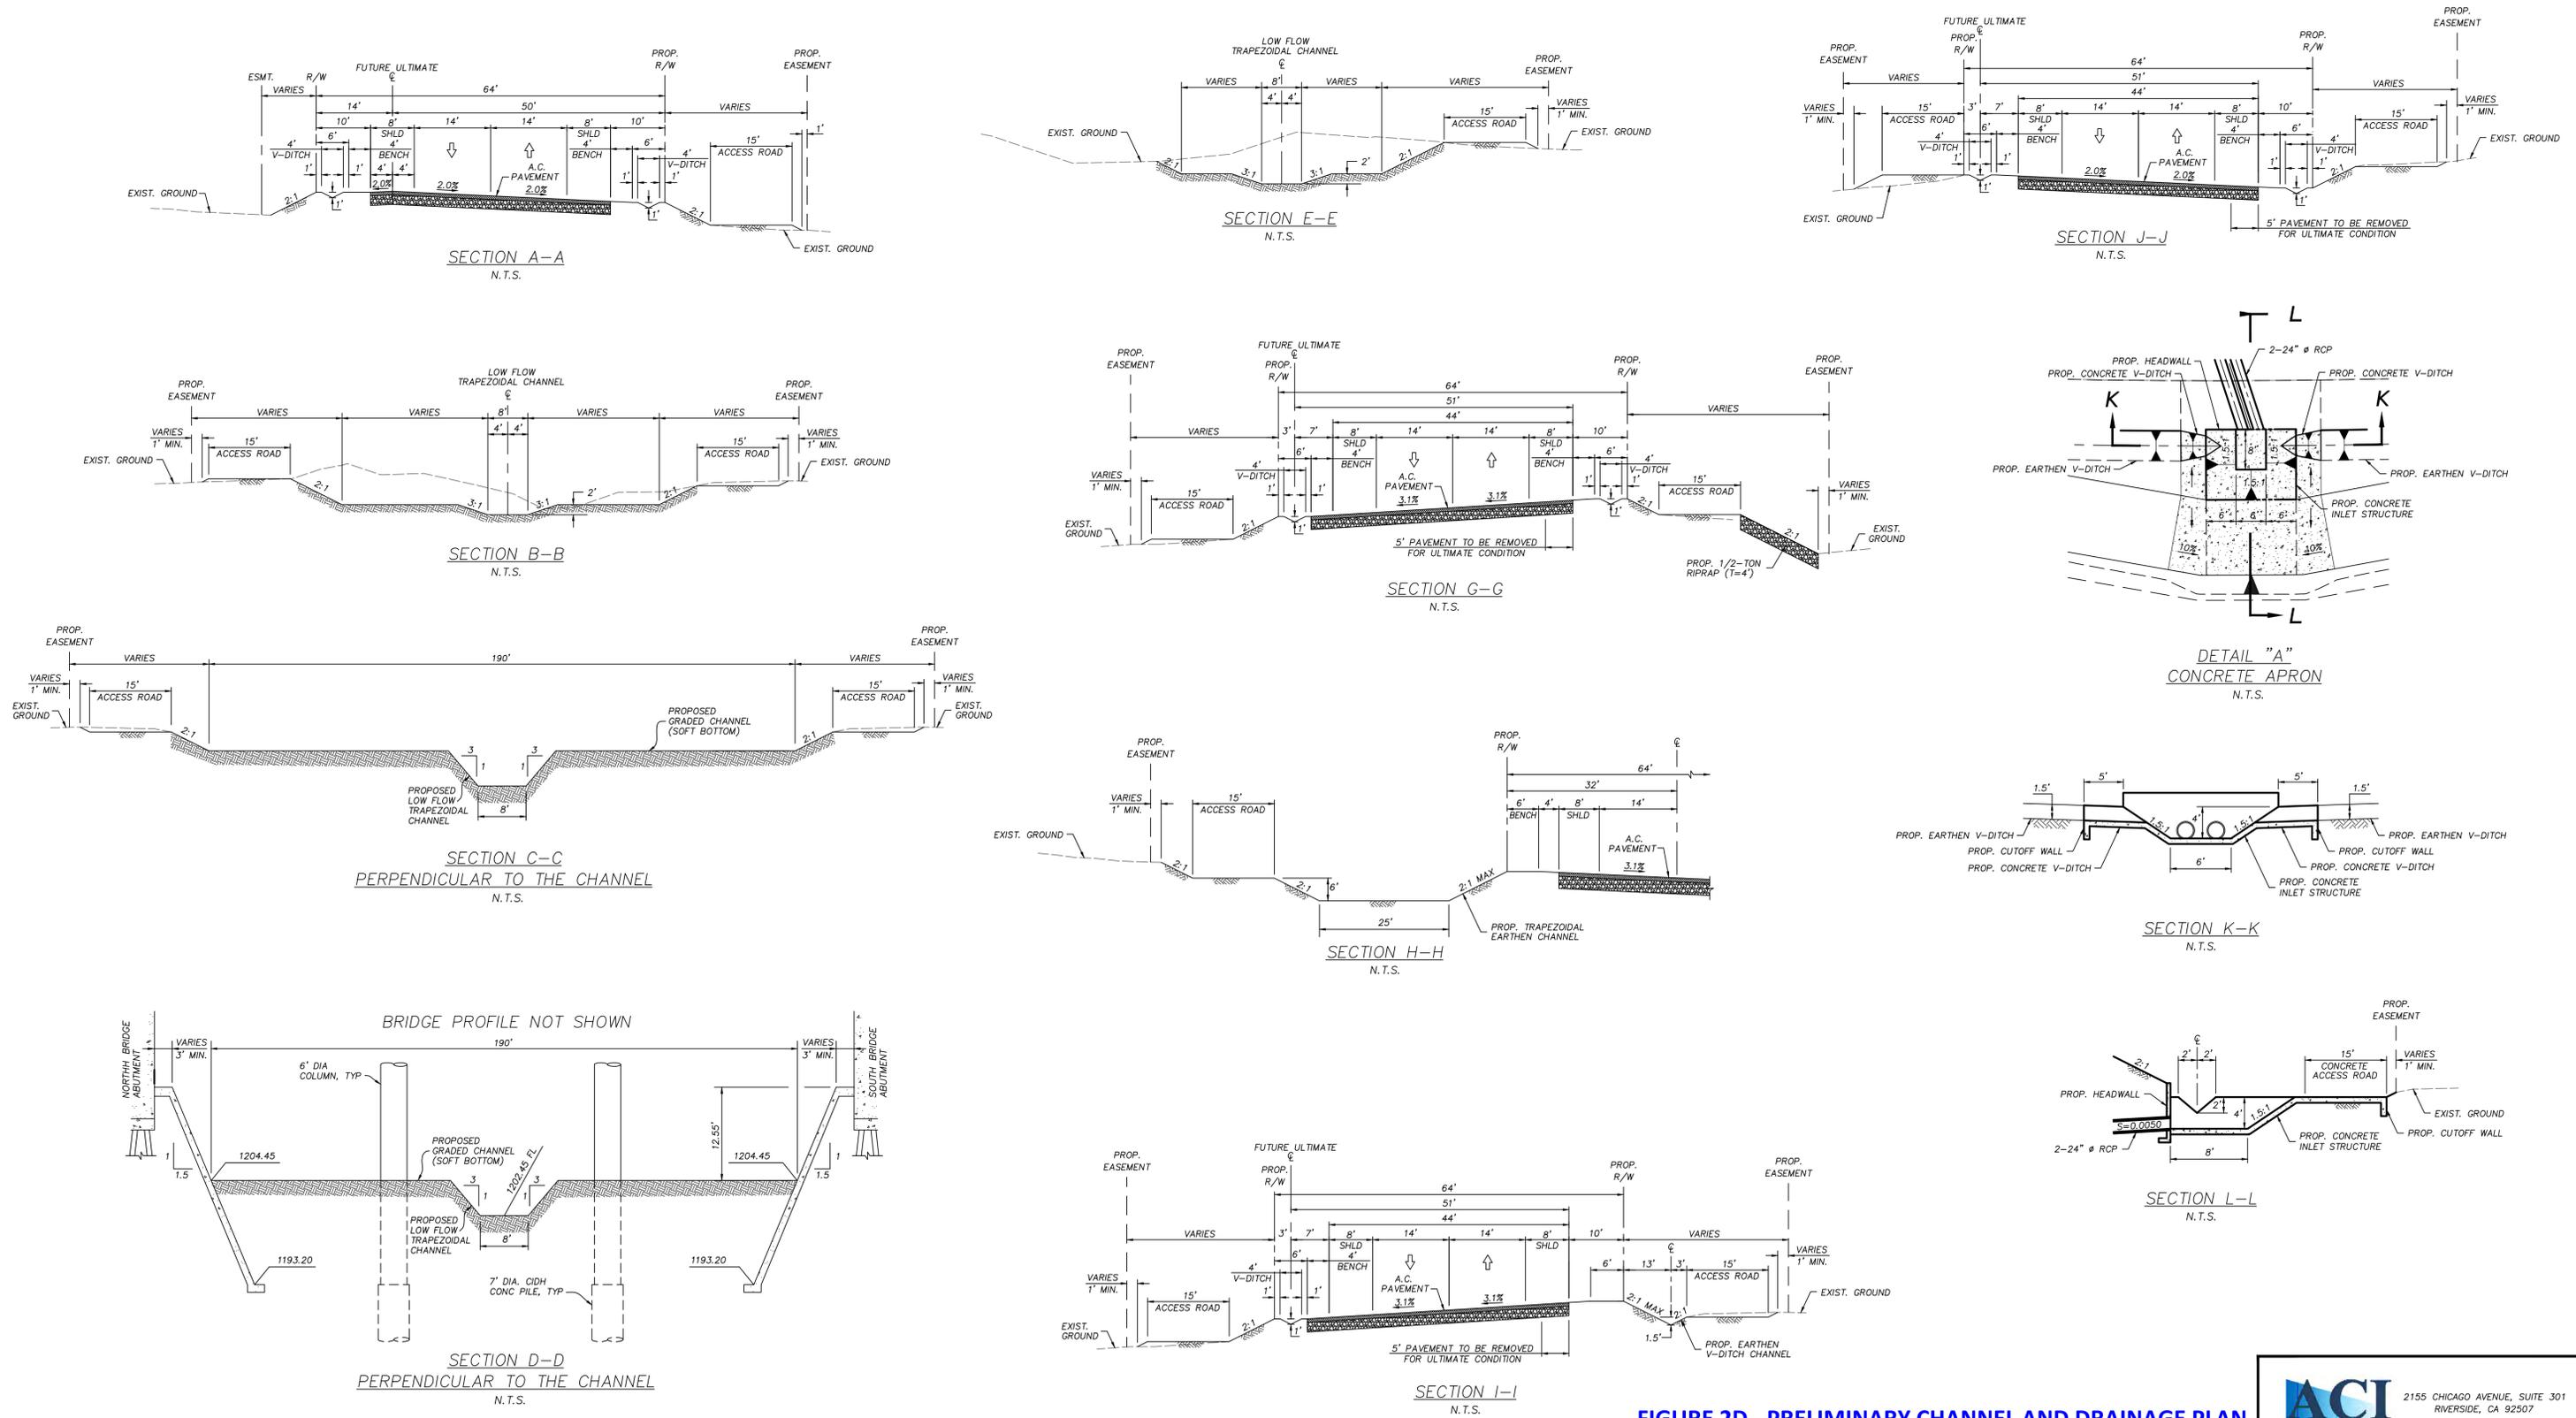
FIGURE 2D - PRELIMINARY CHANNEL AND DRAINAGE PLAN

EXHIBIT E - TEMESCAL CANYON ROAD PRELIMINARY DRAINAGE FACILITIES PLAN

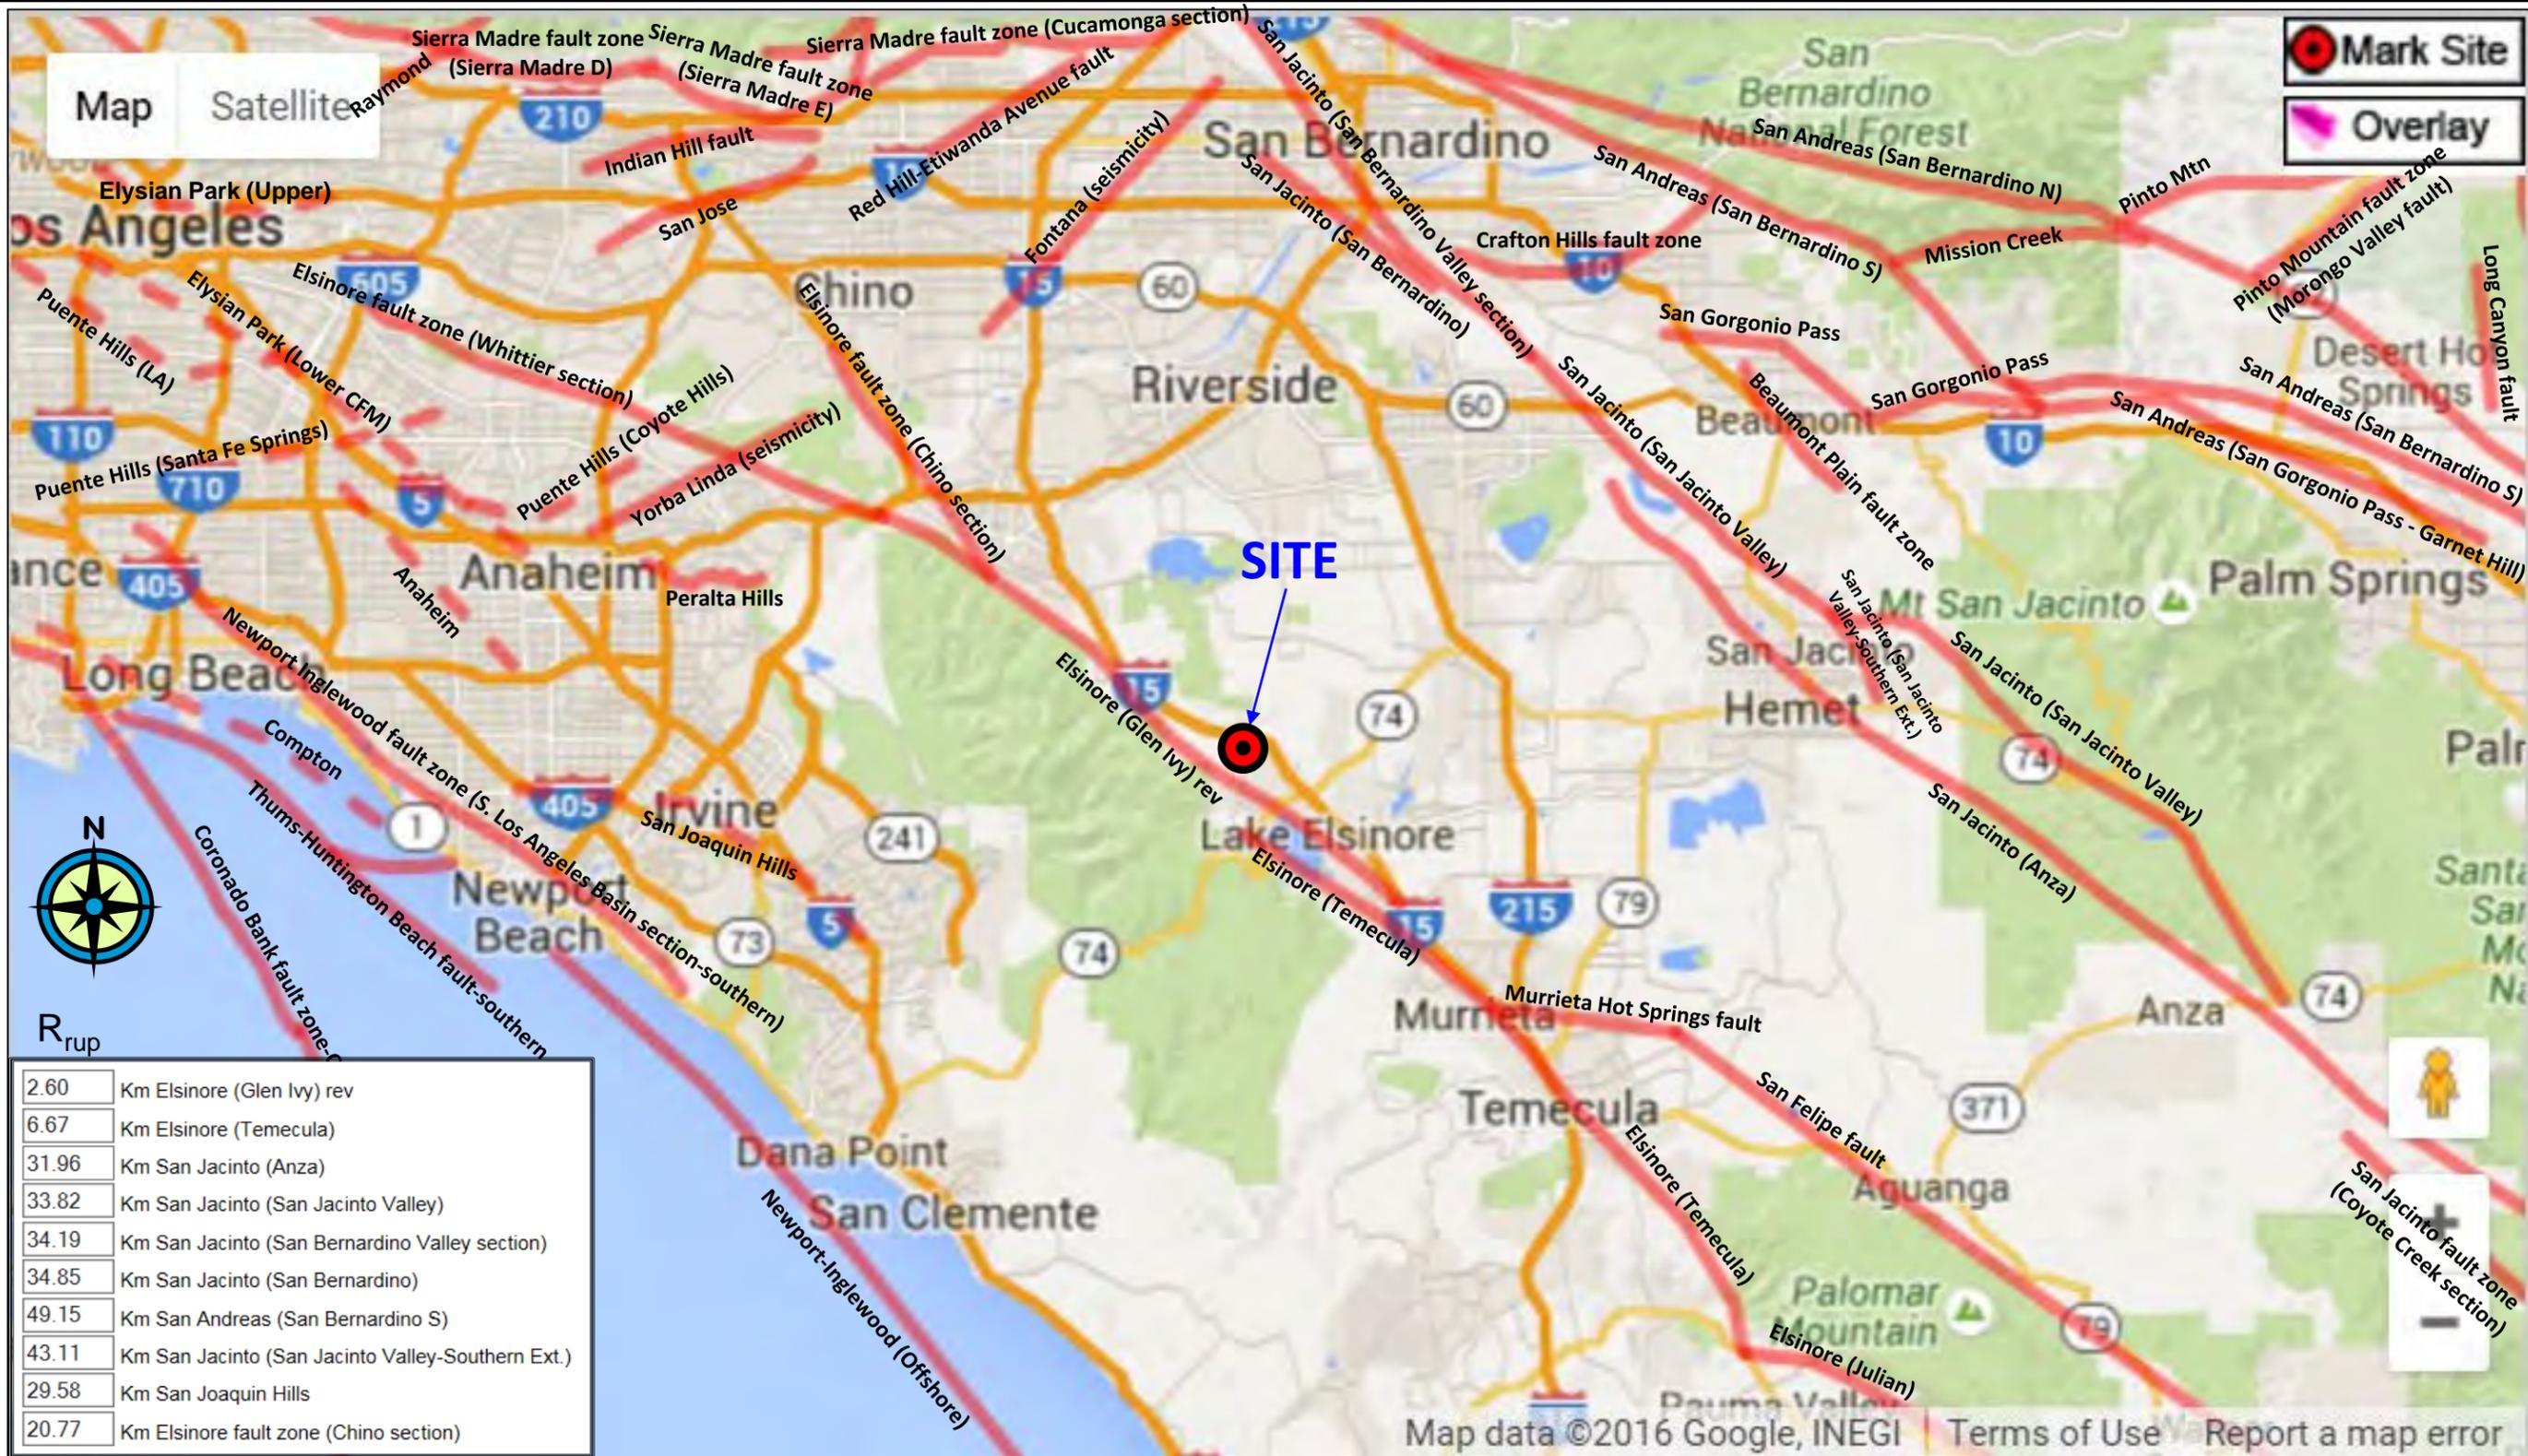
REGIONAL FAULT MAP

2.60	Km Elsinore (Glen Ivy) rev
6.67	Km Elsinore (Temecula)
31.96	Km San Jacinto (Anza)
33.82	Km San Jacinto (San Jacinto Valley)
34.19	Km San Jacinto (San Bernardino Valley section)
34.85	Km San Jacinto (San Bernardino)
49.15	Km San Andreas (San Bernardino S)
43.11	Km San Jacinto (San Jacinto Valley-Southern Ext.)
29.58	Km San Joaquin Hills
20.77	Km Elsinore fault zone (Chino section)

The site is in a seismically active area, and strong shaking should be expected in the life of the proposed improvement. Major active faults in the project area based on the latest Caltrans Fault Database are shown on the Regional Fault Map in Figure 5A, along with their site to fault rupture plane distances (R_{rup}) obtained from Caltrans Acceleration Response Spectra (ARS) Online tool. The fault data for the 10 nearest faults is summarized in Table 1. The closest major active fault is Elsinore (Glen Ivy) at a distance of about 2.6 km. Other major active faults having a major impact on site seismicity are the San Jacinto and San Andreas Fault Zones.
