PHASE I ENVIRONMENTAL SITE ASSESSMENT REPORT

Undeveloped Parcels

**APNs 373-210-037, 373-210-038, 373-210-039, 373-210-043, 373-
210-041, 363-150-006, 363-161-029, 363-161-030, 363-161-031,
and 365-280-022**

LAC Project Number 07-51645.1

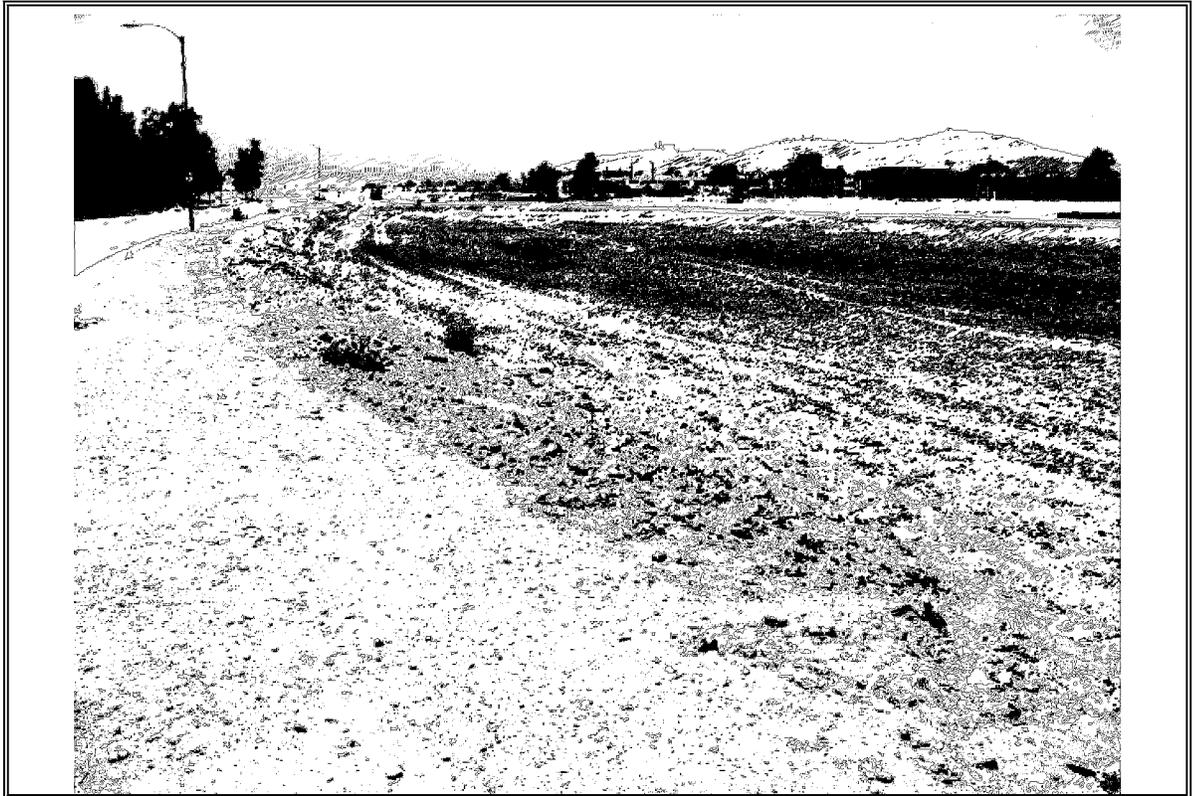
Photograph Number 1: Southern side of northern parcel.

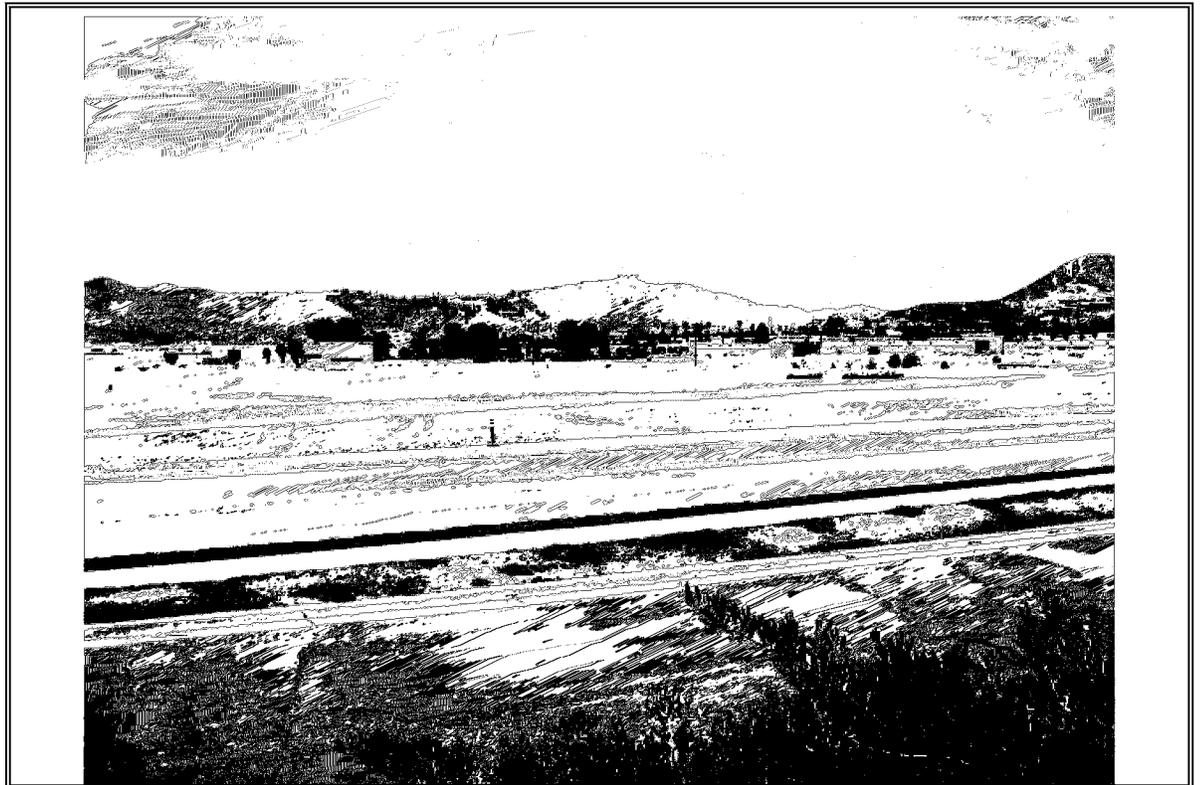
Photograph Number 7: Center of northern parcel.

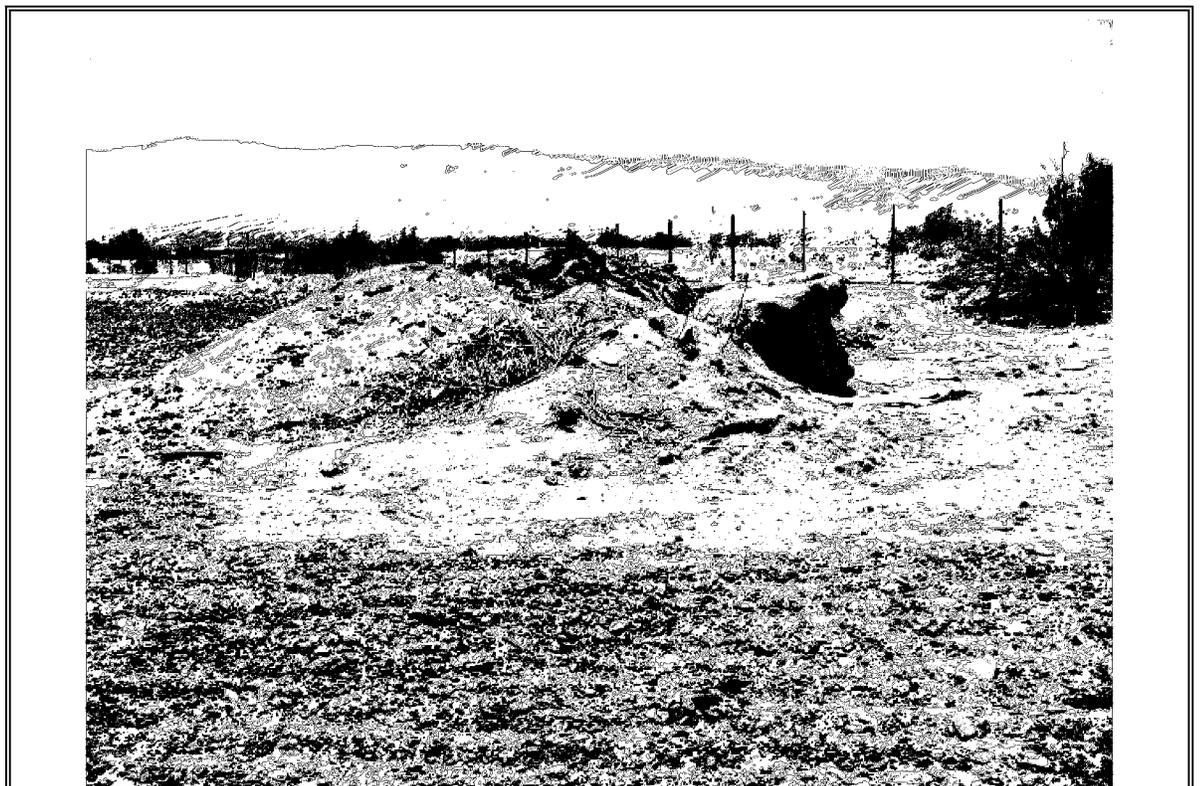
Photograph Number 8: Soils piles on northern parcel.

Approximately 50-60 piles of soil were observed on the southwest corner of the northern parcel and on the northern side of the southern parcel. No soil staining or odors were noted associated with the soil. The site contact, Tina Alexander, was not able to provide any information to LAC regarding the soil piles during the site visit. However, at LAC’s request, Ms. Alexander consulted others in her office familiar with the Property. According to Ms. Alexander, Mr. Steve Semingson stated that the soil piles on the Property came from the adjacent stadium site as a result of grading of the stadium site in approximately 1994. To the best of his knowledge, the soil was clean. The stadium site is not reported on any of the databases reviewed which report releases and contamination incidents, and no evidence of contamination at that site or the Property was identified. Additionally, historical aerial photographs show a similar site history for the stadium site as the Property, undeveloped land, until the stadium was built. There were no indications of dumping or other environmental concerns on the stadium site prior to its construction. Based on the available information, there is no reason to suspect that the soil piles on the Property are contaminated; therefore, no further action or investigation appears warranted at this time.

Approximately 50-60 piles of soil were observed on the southwest corner of the northern parcel and on the northern side of the southern parcel. No soil staining or odors were noted associated with the soil. However, the soil piles appear to be imported, rather than due to on-site grading activities.

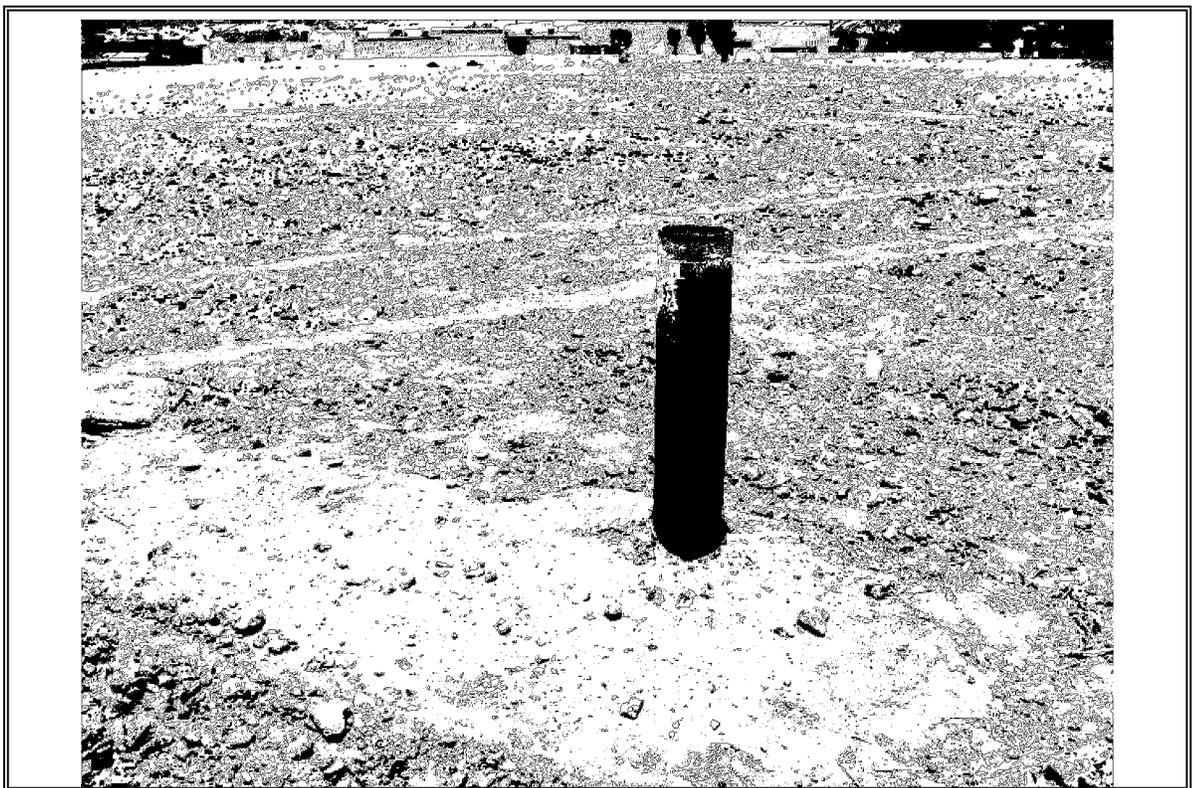
Photograph Number 10: Abandoned irrigation well on northern parcel.

One six-inch diameter, vertical steel pipe extends approximately three feet out of the ground and is located near the southern-central portion of the northern Property parcel. The pipe was filled and appeared to be a former irrigation well. This well should be abandoned in accordance with local and state regulations. No other significant surface features were noted on the Property at the time of the reconnaissance.

One six-inch diameter, vertical steel pipe extends approximately three feet out of the ground and is located near the southern-central portion of the northern parcel. The pipe was filled and appeared to be a former irrigation well. No other aboveground evidence of wells or cisterns was observed during the site reconnaissance.

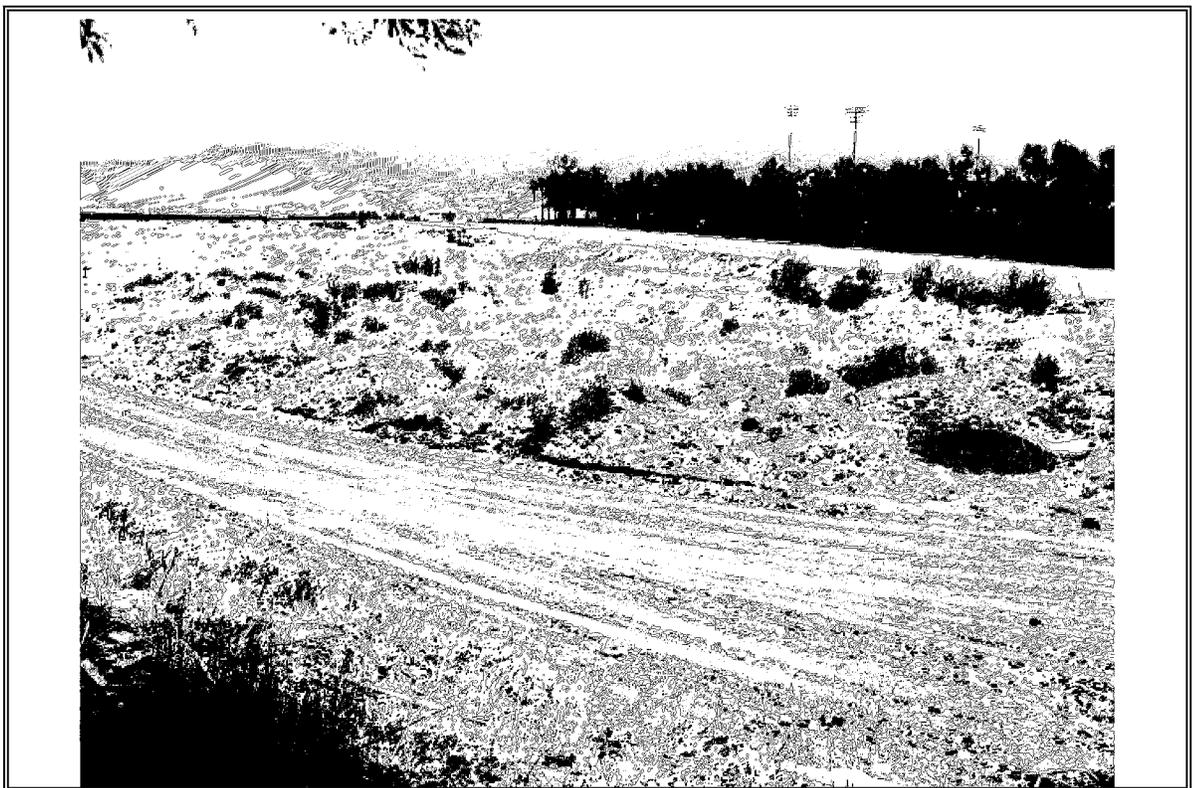
Photograph Number 16: Soils piles on north side of southern parcel.
