ELSINORE VALLEY CDC

SURVEY OF HISTORICAL STRUCTURES AND SITES
Lake Elsinore, California 1991

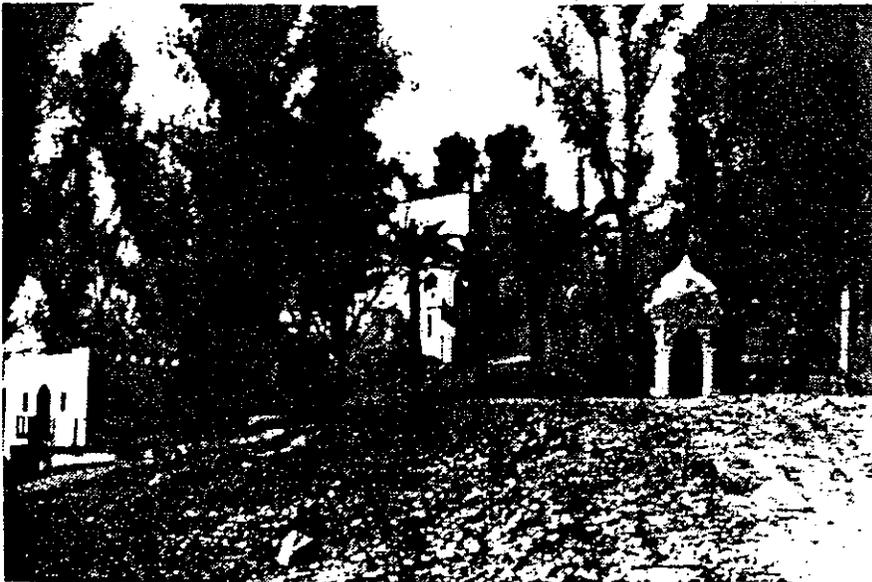
- 7a. Architectural style: Moorish
- 7b. Briefly describe the present *physical description* of the site or structure and describe any major alterations from its original condition:

8. Construction date:
 Estimated _____ Factual 19
9. Architect Edwin Dickman
of Elsinore
10. Builder Robert E. Lee
11. Approx. property size (in feet)
 Frontage _____ Depth _____
 or approx. acreage .93 ac
12. Date(s) of enclosed photograph(s)
July 24, 1990

13. Condition: Excellent ___ Good ___ Fair X Deteriorated ___ No longer in existence ___
14. Alterations: Unaltered
15. Surroundings: (Check more than one if necessary) Open land ___ Scattered buildings X Densely built-up ___
Residential X Industrial ___ Commercial ___ Other: ___
16. Threats to site: None known ___ Private development ___ Zoning ___ Vandalism ___
Public Works project ___ Other: Deterioration
17. Is the structure: On its original site? ✓ Moved? ___ Unknown? ___
18. Related features: Garage, wall

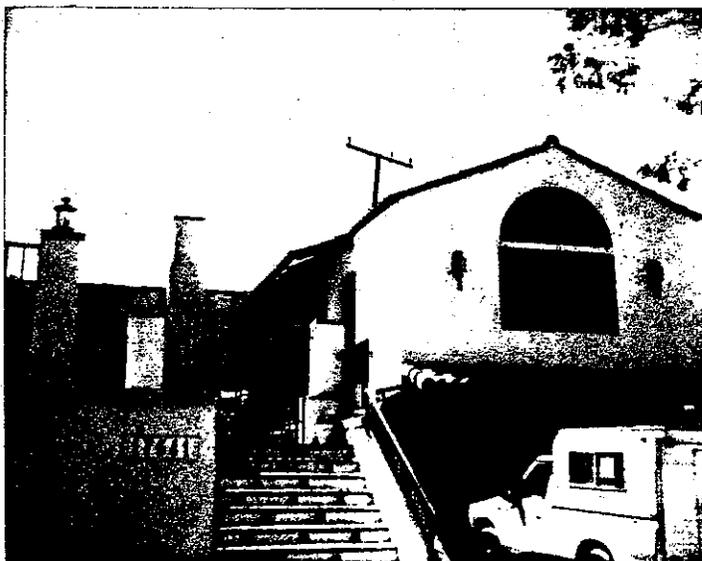
- 7a. Architectural style: Mediterranean/Spanish Revival
- 7b. Briefly describe the present *physical description* of the site or structure and describe any major alterations from its original condition:

- 8. Construction date:
Estimated _____ Factual 1927
- 9. Architect Unknown
- 10. Builder: Unknown
- 11. Approx. property size (in feet)
Frontage _____ Depth _____
or approx. acreage _____
- 12. Date(s) of enclosed photograph(s):
Sept 19, 1990

13. Condition: Excellent Good Fair Deteriorated No longer in existence
14. Alterations: Windows, re-stuccoed exterior, fencing.
15. Surroundings: (Check more than one if necessary) Open land Scattered buildings Densely built-up
Residential Industrial Commercial Other:
16. Threats to site: None known Private development Zoning Vandalism
Public Works project Other:
17. Is the structure: On its original site? Moved? Unknown?
18. Related features: Garage, old swimming pool

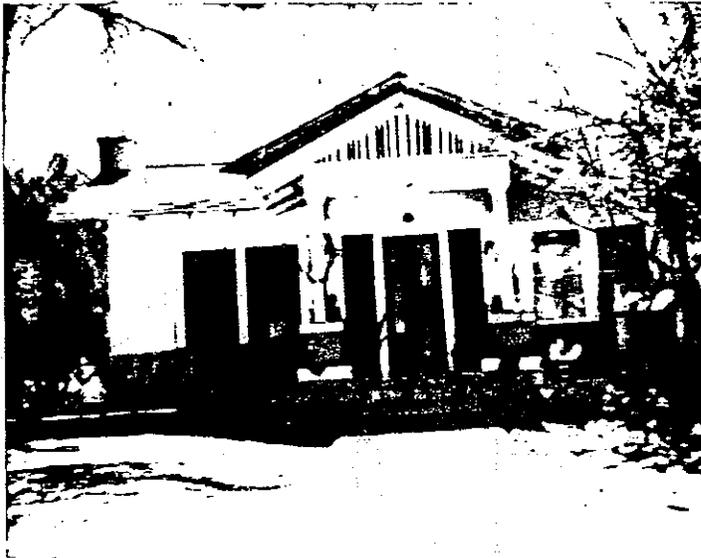
Square in plan with a wood shingle gable and hip roof, this two story vernacular brick house has a brick end chimney, exposed rafters, stucco siding over brick in the front and right side, brick siding on the left and rear, mullioned double-hung and casement windows, and a porch leading to the second story with square porch posts on brick piers and a vertical slat vent under the gable. Tall trees shade the house and a shed in also on the property.

13. Condition: Excellent ___ Good X Fair ___ Deteriorated ___ No longer in existence ___
14. Alterations: Minor. Second story stuccoed over
15. Surroundings: (Check more than one if necessary) Open land ___ Scattered buildings ___ Densely built-up X
Residential X Industrial ___ Commercial ___ Other: ___
16. Threats to site: None known X Private development ___ Zoning ___ Vandalism ___
Public Works project ___ Other: ___
17. Is the structure: On its original site? X Moved? ___ Unknown? ___
18. Related features: Shed

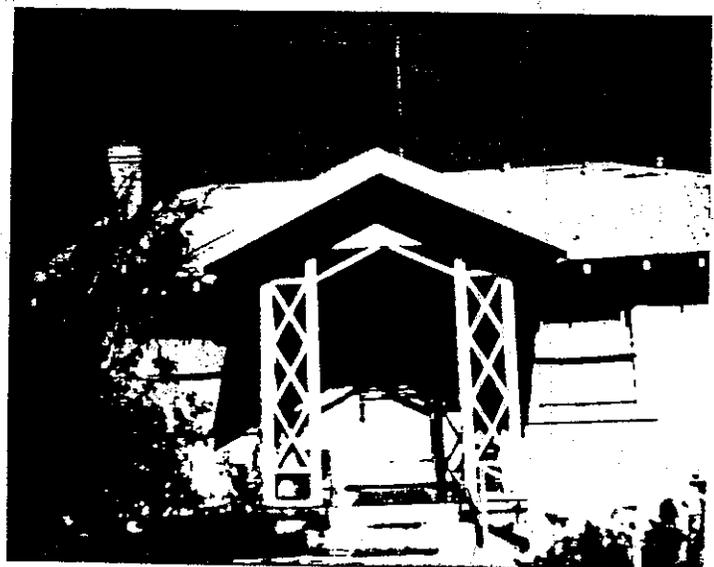
- 7a. Architectural style: Vernacular wood frame
- 7b. Briefly describe the present physical description of the site or structure and describe any major alterations from its original condition:

8. Construction date: _____ 19____
Estimated _____ Factual _____
9. Architect: Unknown
10. Builder: _____
Unknown
11. Approx. property size (in feet):
Frontage _____ Depth _____
or approx. acreage _____
12. Date(s) of enclosed photographs:
September 23, 1990

13. Condition: Excellent ___ Good Fair ___ Deteriorated ___ No longer in existence ___
14. Alterations: None
15. Surroundings: (Check more than one if necessary) Open land ___ Scattered buildings ___ Densely built-up
Residential Industrial ___ Commercial ___ Other: ___
16. Threats to site: None known Private development ___ Zoning ___ Vandalism ___
Public Works project ___ Other: ___
17. Is the structure: On its original site? Moved? ___ Unknown? ___
18. Related features: None

This 1923 house is a good example of a modest wood frame residence in Lake Elsinore. Its excellent unaltered condition makes it a valuable architectural resource

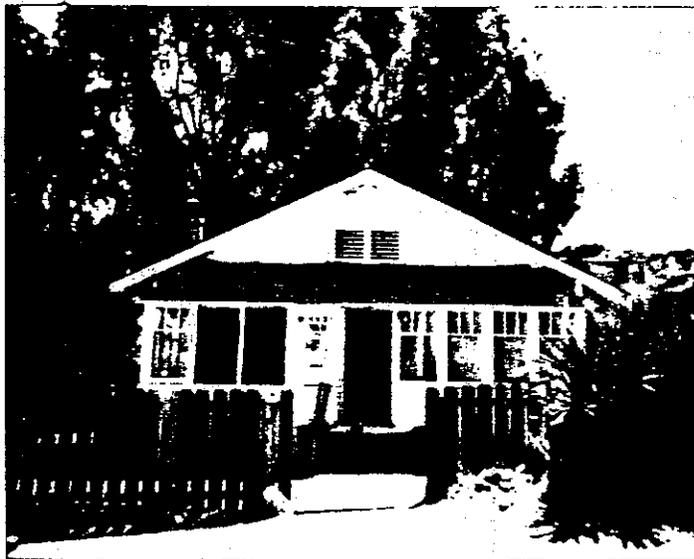
Rectangular in plan with a composition shingle gable roof, this bungalow has exposed carved rafters, a brick end chimney with stovepipe chimney pot, clapboard siding, mullioned windows, two adjacent horizontal-slat vents and cross and tie beams under the front-facing gable, and a hip roofed enclosed porch with a centered mullion-window door flanked by two bands of four mullioned windows each.

13. Condition: Excellent ___ Good XX Fair ___ Deteriorated ___ No longer in existence ___
14. Alterations: Addition of vertical fence in front.
15. Surroundings: (Check more than one if necessary) Open land ___ Scattered buildings ___ Densely built-up X
 Residential X Industrial ___ Commercial ___ Other: ___
16. Threats to site: None known X Private development ___ Zoning ___ Vandalism ___
 Public Works project ___ Other: ___
17. Is the structure: On its original site? X Moved? ___ Unknown? ___
18. Related features: None

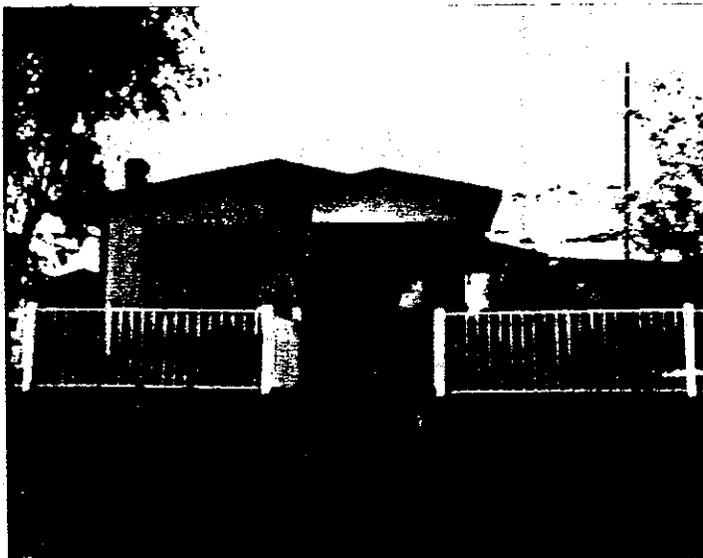
A double-gabled bungalow with shiplap siding and mullioned double-hung windows, the house at 30040 Illinois St. in Lake Elsinore has two trellises to one side of the porch and a pergola along the front of the house (roofed over). A stone-work and vertical wood slat wall compliments the house which has a garage with similar vent and architectural features.

13. Condition: Excellent ___ Good Fair ___ Deteriorated ___ No longer in existence ___
14. Alterations: None
15. Surroundings: (Check more than one if necessary) Open land ___ Scattered buildings ___ Densely built-up ___
Residential Industrial ___ Commercial ___ Other: ___
16. Threats to site: None known Private development ___ Zoning ___ Vandalism ___
Public Works project ___ Other: ___
17. Is the structure: On its original site? Moved? ___ Unknown? ___
18. Related features: Garage, wall

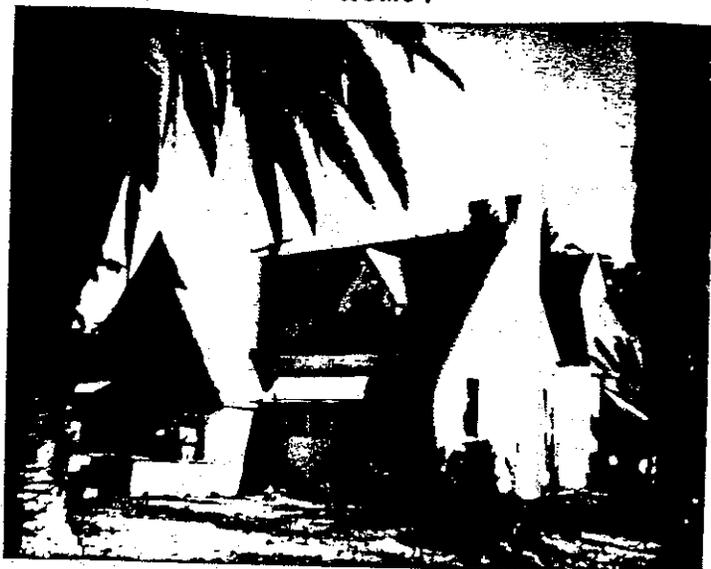
- 7a. Architectural style:
- 7b. Briefly describe the present physical description of the site or structure and describe any major alterations from its original condition:

- 8. Construction date: Estimated _____ Factual 1928
- 9. Architect Unknown
- 10. Builder: Unknown
- 11. Approx. property size (in feet):
Frontage _____ Depth _____
or approx. acreage _____
- 12. Date(s) of enclosed photograph(s)
Sept. 28, 1990

13. Condition: Excellent Good Fair Deteriorated No longer in existence
14. Alterations: Unaltered
15. Surroundings: (Check more than one if necessary) Open land Scattered buildings Densely built-up
Residential Industrial Commercial Other:
16. Threats to site: None known Private development Zoning Vandalism
Public Works project Other:
17. Is the structure: On its original site? Moved? Unknown?
18. Related features:

This home is one of many built in 1928 in a prosperous Lake Elsinore period. Its attempts to combine two period revival styles is commendable, and its relatively unaltered state and excellent condition make it an important community asset.

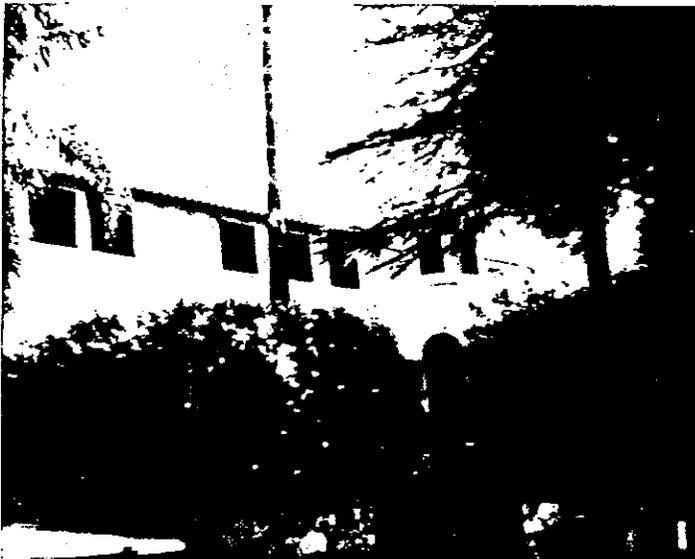
F-shaped in plan with a patio between the living room and the den extensions, this two-story Mediterranean/Spanish Revival style house has a Spanish tile hip and gable roof, stucco siding, mullioned rectangular and arched windows, a balcony on the left side, and a central tower where the front door is located. A rock retaining wall surrounds the property, and a short vertical slat fence between brick piers encloses the front yard. Tall trees shade this substantial house. A swimming pool is in the back yard.

13. Condition: Excellent Good _____ Fair _____ Deteriorated _____ No longer in existence _____
14. Alterations: _____
15. Surroundings: (Check more than one if necessary) Open land _____ Scattered buildings Densely built-up _____
Residential Industrial _____ Commercial _____ Other: _____
16. Threats to site: None known Private development _____ Zoning _____ Vandalism _____
Public Works project _____ Other: _____
17. Is the structure: On its original site? Moved? _____ Unknown? _____
18. Related features: Garage, wall

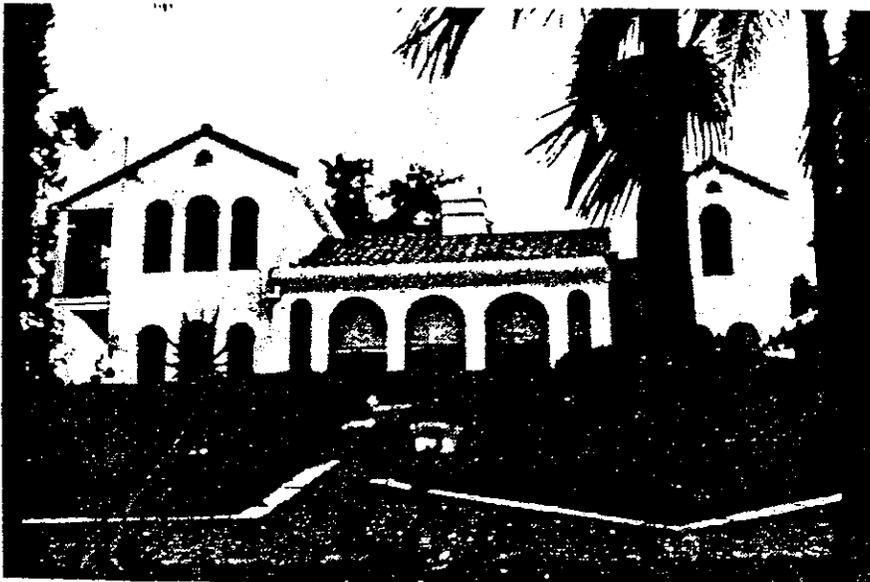
A Spanish-Mediterranean style structure with clay tile gable roof, this house is one of many such homes built in the 1920's and 1930's in Lake Elsinore. The arched windows with mullioned pattern and "fan" shaped mullioned treatment to conform to the arched shape at the top, are in harmony with the arched style of the front porch. This covered porch forms the front of the one-story midsection which connects two-story structures at each end. The larger end section also boasts an upper level deck of cantilever construction and is an integral part of the roofline. Landscaping of shrubbery and palm trees complement the house and complete the impression of historical value. In excellent condition, the stucco has been recently sand-blown and painted, however, the architectural historical integrity has been maintained.

13. Condition: Excellent Good _____ Fair _____ Deteriorated _____ No longer in existence _____
14. Alterations: None
15. Surroundings: (Check more than one if necessary) Open land _____ Scattered buildings _____ Densely built-up _____
Residential Industrial _____ Commercial _____ Other: _____
16. Threats to site: None known Private development _____ Zoning _____ Vandalism _____
Public Works project _____ Other: _____
17. Is the structure: On its original site? Moved? _____ Unknown? _____
18. Related features: None

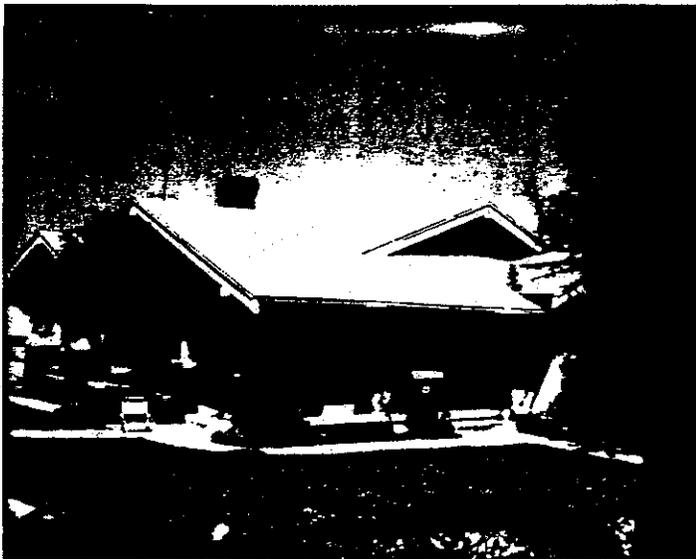
Rectangular in plan with a composition shingle gable roof, the bungalow at 257 Hill St. has a brick chimney with corbeled gable, a gablet with a vertical-slat vent, a front-facing gable with an identical vertical-slat vent, exposed pointed rafters, and clapboard siding. Two large front-facing square mullioned windows are flanked by mullioned sidelights of a similar pattern. An unusual feature of this bungalow is a very large veranda on the left side and half across the front which has battered porch piers with brick bases. The house sits close to the sidewalk and two large trees at the curb shade the house.

13. Condition: Excellent Good _____ Fair _____ Deteriorated _____ No longer in existence _____
14. Alterations: None
15. Surroundings: (Check more than one if necessary) Open land _____ Scattered buildings _____ Densely built-up _____
Residential Industrial _____ Commercial _____ Other: _____
16. Threats to site: None known Private development _____ Zoning _____ Vandalism _____
Public Works project _____ Other: _____
17. Is the structure: On its original site? Moved? _____ Unknown? _____
18. Related features: None

19. Briefly state historical and/or architectural importance (include dates, events, and persons associated with the site.)
This 1925 bungalow is unusual for its large veranda. Its excellent unaltered condition makes it a valuable architectural resource. It contains stained-glass windows, a built-in oak ice box, and was used as an auxiliary hospital during WW II.

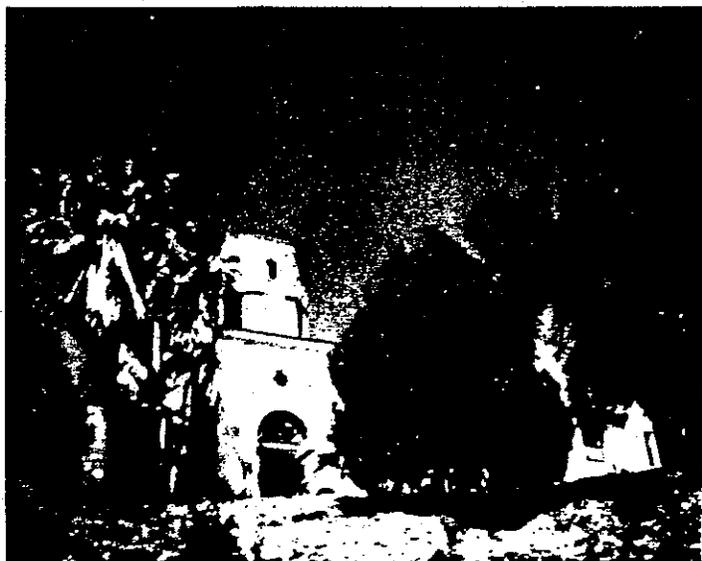
With a U-shaped floor plan surrounding a tiled courtyard, the three story Clevelin Country Club building has more than 20,000 square feet of floor space including a ballroom, two apartments, dining room, bar, eight sleeping rooms and many banquet and meeting rooms. Spanish tile is used on the hipped roof of the building and corner tower. Rehabilitation work in 1981 completely re-stuccoed the exterior walls which have both rectangular casement and arched windows in them. The tower had a cupola and flagpole which have not been replaced. Several tall palm trees, foliage and many stone wall terraces make up what was once a beautiful landscape plan. The building and grounds are in a state of disrepair at the time (1990) of this study.

13. Condition: Excellent ___ Good X Fair ___ Deteriorated ___ No longer in existence ___
14. Alterations: Minor, was rehabilitated, re-stuccoed
15. Surroundings: (Check more than one if necessary) Open land ___ Scattered buildings X Densely built-up ___
Residential X Industrial ___ Commercial ___ Other: ___
16. Threats to site: None known X Private development ___ Zoning ___ Vandalism ___
Public Works project ___ Other: ___
17. Is the structure: On its original site? X Moved? ___ Unknown? ___
18. Related features: Wall (rock), gazebo

19. Briefly state historical and/or architectural importance (include dates, events, and persons associated with the site.)
 The Clevelin Country Club was built to be the main drawing card for the Country Club Heights subdivision in the Clevelin hills on the north shore of Lake Elsinore. The Clevelin Realty Corporation bought over 700 "Genuine Marbelite Ornamental lights, planted over 50,000 trees and grew their own, and "every person who builds was promised over \$200 worth of excavating, foundation work or landscaping free of charge." Most lots sold for less than \$100 each and buyers also got two free club memberships. The Depression got the better of this development when most of the lots were on delinquent tax lists by 1936. In 1951, the clubhouse was re-opened and served during the fifties as the scene of many social events. In 1981 restoration work on the country club was being undertaken with the intention of opening a restaurant, several shops and eventually a gourmet restaurant on the lower front floor. This led to several owners over the years and plans to reopen and utilize this structure. At the time of this study (1990) it is vacant.

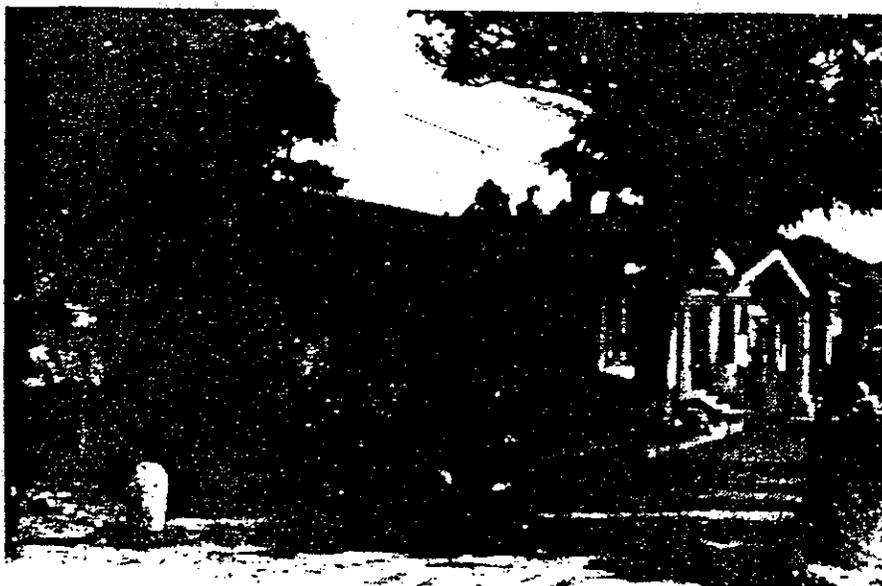
Rectangular in plan with uneven walls and short wings or room protrusions, the house at 34670 Orange St. is a Craftsman Bungalow with Classical Revival elements. There are two central brick chimneys with corbeled caps and stovepipe extensions. Composition shingles cover the roof which has very low-pitched gables with exposed rafters, purlins, and vertical-slat vents under them. Clapboard siding sheathes the walls which have bands of mullioned casement and double-hung windows. Turned posts are used in a pergola on the right side and Tuscan Order columns are used also as well as on the front porch. A vertical-slat balustrade crosses the front porch and latticework is used around the foundation. A similar-styled double garage and partially disassembled tankhouse are found in back and extensive rockwork landscapes the property, including a fishpond and posts flanking the driveway entrance.

13. Condition: Excellent Good Fair Deteriorated No longer in existence
14. Alterations: None
15. Surroundings: (Check more than one if necessary) Open land Scattered buildings Densely built-up
Residential Industrial Commercial Other:
16. Threats to site: None known Private development Zoning Vandalism
Public Works project Other:
17. Is the structure: On its original site? Moved? Unknown?
18. Related features: Garage

This 1925 Craftsman Bungalow with Clissical Revival elements is in excellent unaltered condition and an excellent example of this style of architecture in a rural setting. The decorative elements on the house and garage and the extensive rockwork in the yard and drive all give this house an aura of rural 1920's farm life in the Lake Elsinore Valley.

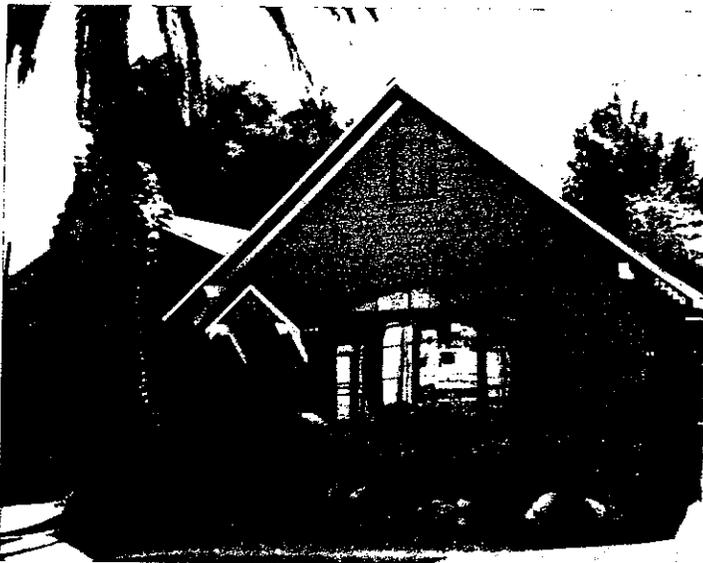
Rectangular in plan with composition gable roofs, the house at 32980 Garner Road appears to be two buildings joined together, one of stone, the other wood frame. The stone half to the left has a massive river rock chimney, stone walls set in concrete, and vertical slats under its front-facing gable. The wood frame right half has exposed rafters, clapboard siding, a rock base wall, a bracketed, gabled overdoor, and a large bay window with low arch over it. Tall trees shade this house set close to the street.

13. Condition: Excellent XX Good XX Fair Deteriorated No longer in existence
14. Alterations: None
15. Surroundings: (Check more than one if necessary) Open land Scattered buildings Densely built-up
Residential XX Industrial Commercial XX Other:
16. Threats to site: None known -X Private development Zoning Vandalism
Public Works project Other:
17. Is the structure: On its original site? X Moved? Unknown?
18. Related features: None

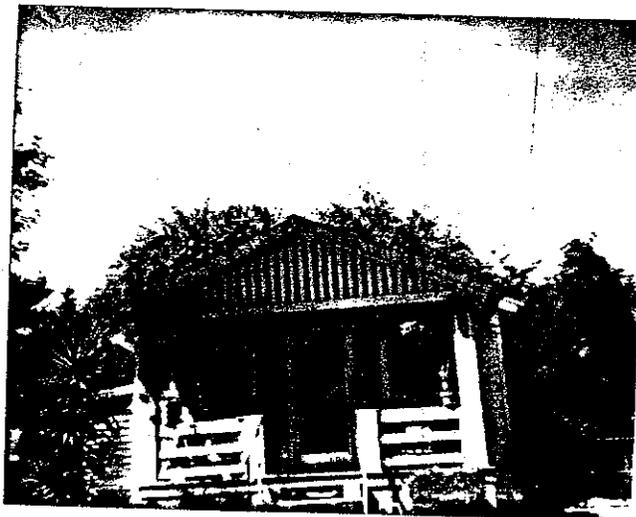
Rectangular in plan with a shed-roofed room to the left, the bungalow at 33225 Gillett has a composition shingle gable roof, clapboard siding, a central mullioned-window door flanked by two plate glass windows, and a porch with square porch posts, two balustrades flanking a central opening with short piers, a vertical slot pediment, and latticework flanking wood steps to the wood floor. The bungalow sits on a brick foundation and tall trees provide shade.

13. Condition: Excellent ___ Good XX Fair ___ Deteriorated ___ No longer in existence ___
14. Alterations: None
15. Surroundings: (Check more than one if necessary) Open land ___ Scattered buildings ___ Densely built-up ___
 Residential XX Industrial ___ Commercial ___ Other: ___
16. Threats to site: None known XX Private development ___ Zoning ___ Vandalism ___
 Public Works project ___ Other: ___
17. Is the structure: On its original site? XX Moved? ___ Unknown? ___
18. Related features: None

This is a good example of a bungalow and is unusual in that there is a vertical slat periment and latticework over the front door. It is a small home and needs care. The brick foundation noted in the 1982 inventory has now (1990) been replaced by a concrete block foundation. There is a gravel driveway leading from the street to the house.

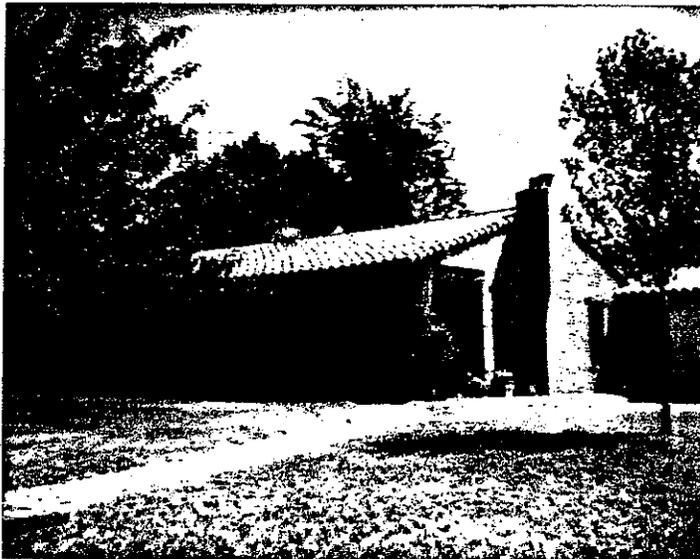
Square in plan with a Spanish tile gable roof, the vernacular brick house at 200 N. Scrivener St. has an end chimney with two short chimney pots, polychromatic brick walls, tall mullioned windows with wood window heads and sills, a porch across the front with square brick porch posts, and an attached double-door garage.

3. Condition: Excellent ___ Good XX Fair ___ Deteriorated ___ No longer in existence ___
4. Alterations: None
5. Surroundings: (Check more than one if necessary) Open land ___ Scattered buildings ___ Densely built-up ___
 Residential X Industrial ___ Commercial ___ Other: ___
6. Threats to site: None known X Private development ___ Zoning ___ Vandalism ___
 Public Works project ___ Other: ___
7. Is the structure: On its original site? XX Moved? ___ Unknown? ___
8. Related features: Garage

This is a good example of a vernacular brick house in a neighborhood of otherwise wood frame houses. The bricks used in the construction of this house are said to be from bricks produced at the local Alberhill brick yard. A new garage has been added to the house within the original style of construction to house two cars, in that the original garage was too small for modern automobiles. The home is in good condition and attractively landscaped with tall trees for shade.

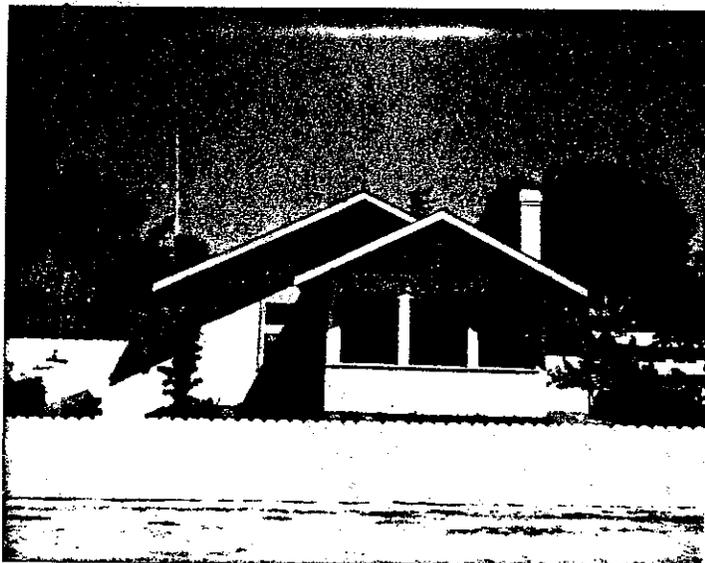
Rectangular in plan with a composition shingle roof, this house has a brick end chimney with corbeled cap, exposed rafters, newly-stuccoed siding, three bronze-glass windows to the front, latticework vents in the front facing gables, and a wood fence surrounding the property. A brick-raised flowerbed and tall trees landscape the parcel.

Condition: Excellent Good _____ Fair _____ Deteriorated _____ No longer in existence _____

This house has been recently remodeled and altered with a new stucco exterior replacing the original horizontal clapboard siding shown in the 1981-2 inventory. New windows have replaced the original mullioned double-hung windows and the prior screened-in porch is now an additional room. It is maintained in an excellent manner and demonstrates how a bungalow of the 1920's can be modernized and yet still retain its original appeal.

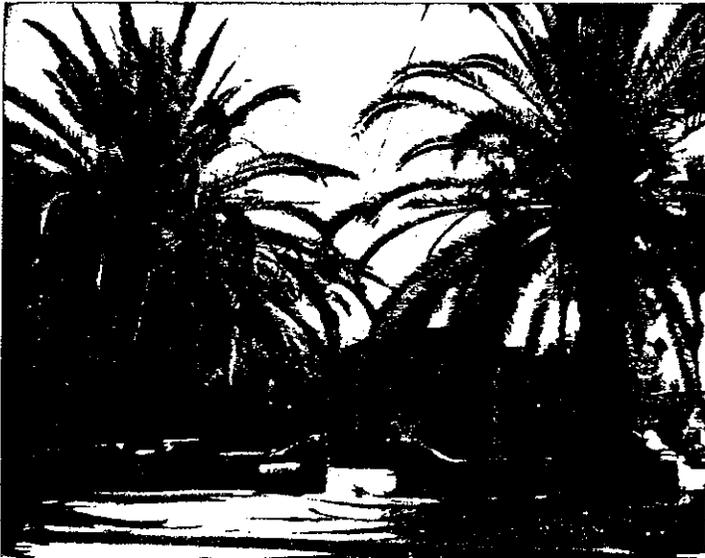
Rectangular in plan with composition shingle hipped gable roof, the house at 1036 Park Way has an end brick chimney with corbeled cap, clapboard siding, a centered mullioned-window door with double matching pattern mullioned windows on each side, and a hipped gable portico with horizontal slat vent and square porch posts. Two simple pergolas flank the portico and a rock wall fence and iron gate enclose the front yard. Two large palm trees and other trees shade the house set relatively close to the street.

1. Condition: Excellent ___ Good xx Fair ___ Deteriorated ___ No longer in existence ___
1. Alterations: None
2. Surroundings: (Check more than one if necessary) Open land ___ Scattered buildings ___ Densely built-up XX
 Residential XX Industrial ___ Commercial ___ Other: ___
3. Threats to site: None known X Private development ___ Zoning ___ Vandalism ___
 Public Works project ___ Other: ___
7. Is the structure: On its original site? X Moved? ___ Unknown? ___
8. Related features: Garage and wall

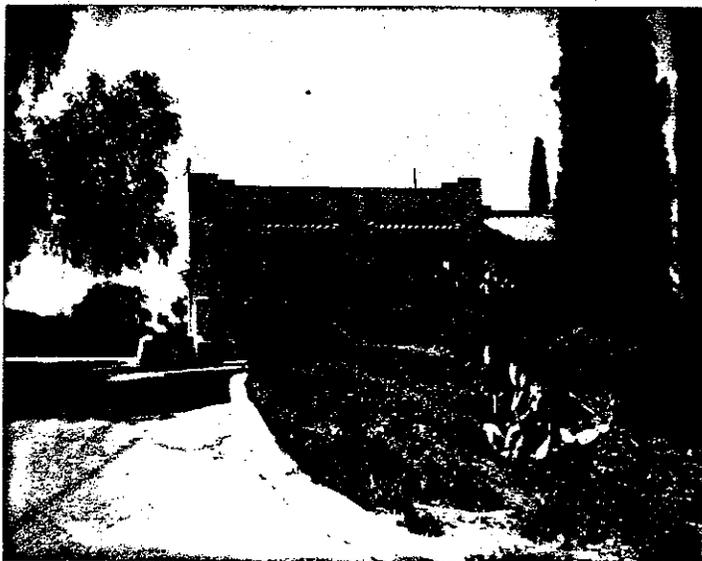
Rectangular in plan with a flat roof, the Mediterranean/Spanish style house at 250 Prospect has stucco siding, two Spanish-tiled hip-roofed awnings over casement windows, and a Spanish tiled hip-roofed porch with iron-rail posts and short balustrade. A long flight of stairs leads up to this house high on a hill. Three tall cypress bushes shade the house which also has a wagon wheel in front.

Condition: Excellent ___ Good X Fair ___ Deteriorated ___ No longer in existence ___

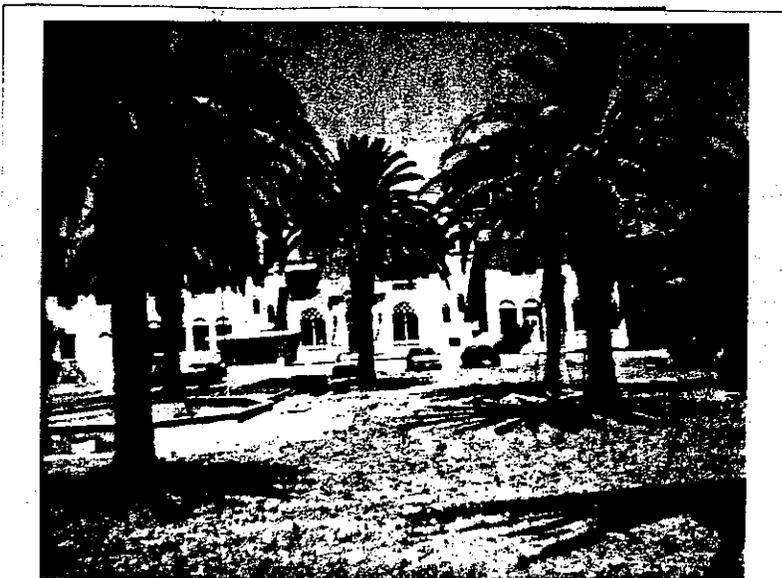
- 7a. Architectural style: Mediterranean/Spanish Rv. with Moorish & Italianate elements
- 7b. Briefly describe the present physical description of the site or structure and describe any major alterations from its original condition: With a floor plan in the shape of a narrow E and a Spanish tile hip roof, the two-story, stuccoed building at 15900 Grand Ave. has a Mediterranean/Spanish style with Moorish and Italianate elements. A centered double door under a semi-circular window in a recessed arched portal has a decorative terra cotta panel with five urns and a California bear on it. Two wrought iron lamps flank the portal as do two pairs of arched double-hung windows under larger arches with Moorish-style latticework. Similar windows are found on the sides of this protruding entry to the building. Two Moorish towers flank the main entry, each having arched windows with sidelights, Moorish-style latticework, and a decorative parapet capped by four large urns at the corners and eight small urns in-between. In the walls under these towers are three narrow arched windows in a candelabra arrangement. On each end of the building are wings with rectangular and arched windows and doorways under the center arches. An Italianate roofline with curvilinear brackets is found on these two wings. The only non-symmetrical aspects of the building are a second-story room over the left side of the main entrance and a screened-in patio over the right side and the main building itself. Moorish-style pilasters flank some of the windows.

13. Condition: Excellent ___ Good XX Fair ___ Deteriorated ___ No longer in existence ___

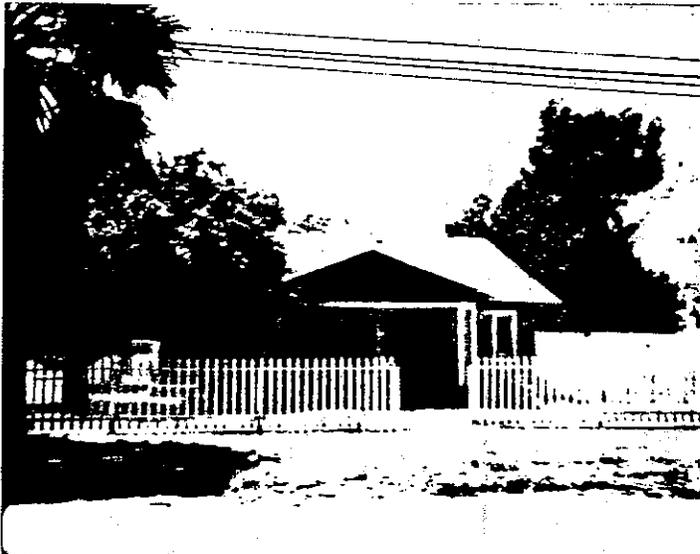
Rectangular in plan with a composition shingle gable roof, this bungalow has a brick end chimney with corbeled cap, exposed rafters, a horizontal slat vent in the front-facing gable, clapboard siding, a centered door flanked by mullioned windows, a porch with four porch posts, two on each side with lattice-work between them. Tall trees shade the house.

13. Condition: Excellent Good _____ Fair _____ Deteriorated _____ No longer in existence _____
14. Alterations: None
15. Surroundings: (Check more than one if necessary) Open land _____ Scattered buildings Densely built-up _____
Residential Industrial _____ Commercial Other: _____
16. Threats to site: None known Private development _____ Zoning _____ Vandalism _____
Public Works project _____ Other: _____
17. Is the structure: On its original site? Moved? _____ Unknown? _____
18. Related features: Garage

This 1924 bungalow is a good example of the style and its excellent unaltered condition makes it a valuable architectural resource.

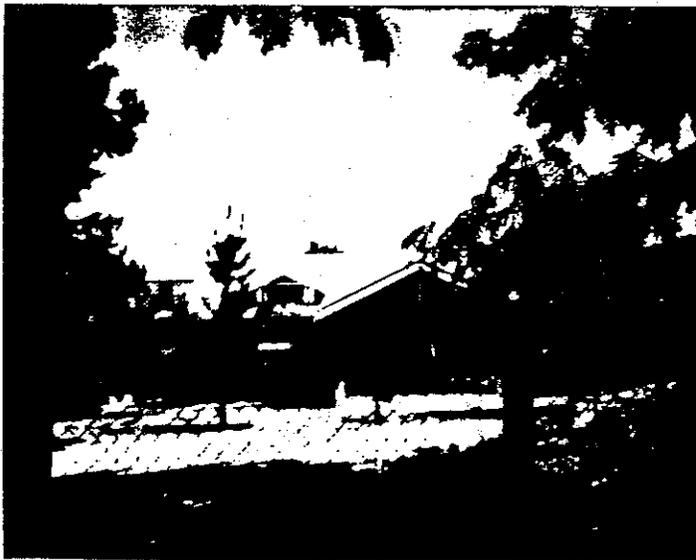
Rectangular in plan with a gabled square veranda added on the right front corner, this house has a composition shingle gable roof, exposed rafters, purlins, wood shingle siding, double-hung windows, and square porch posts at the three corners of the veranda. A latticework gazebo is also on the property.

13. Condition: Excellent Good Fair Deteriorated No longer in existence
14. Alterations: None
15. Surroundings: (Check more than one if necessary) Open land Scattered buildings Densely built-up
Residential Industrial Commercial Other: _____
16. Threats to site: None known Private development Zoning Vandalism
Public Works project Other: _____
17. Is the structure: On its original site? Moved? Unknown?
18. Related features: Fish pond

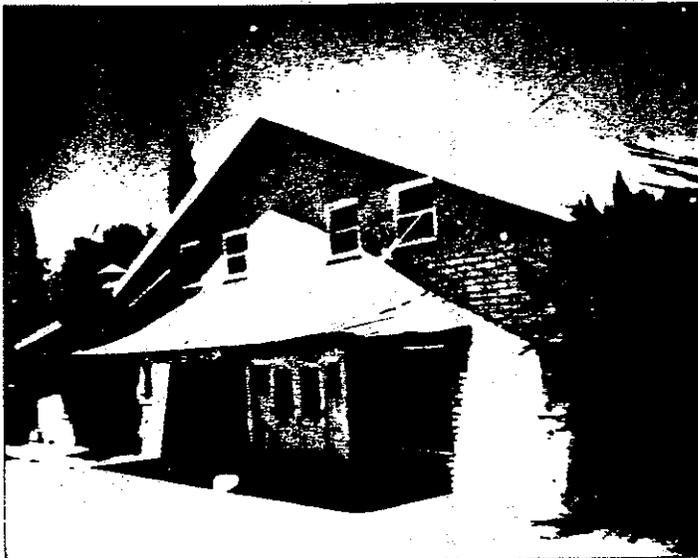
Rectangular in plan with a composition shingle roof, the brick community hall at 17470 Grand Avenue has stucco siding under its front-facing gable, brick walls on the first story, double-hung windows, a double door entrance under a hip roofed canopy suspended by cables, and a shed-roofed wing on the left side. The building sits close to the street (Grand Ave.) and has tall trees for shade to the right.

13. Condition: Excellent ___ Good Fair ___ Deteriorated ___ No longer in existence ___
14. Alterations: None
15. Surroundings: (Check more than one if necessary) Open land ___ Scattered buildings ___ Densely built-up ___
Residential Industrial ___ Commercial Other: ___
16. Threats to site: None known Private development ___ Zoning ___ Vandalism ___
Public Works project ___ Other: ___
17. Is the structure: On its original site? Moved? ___ Unknown? ___
18. Related features: None

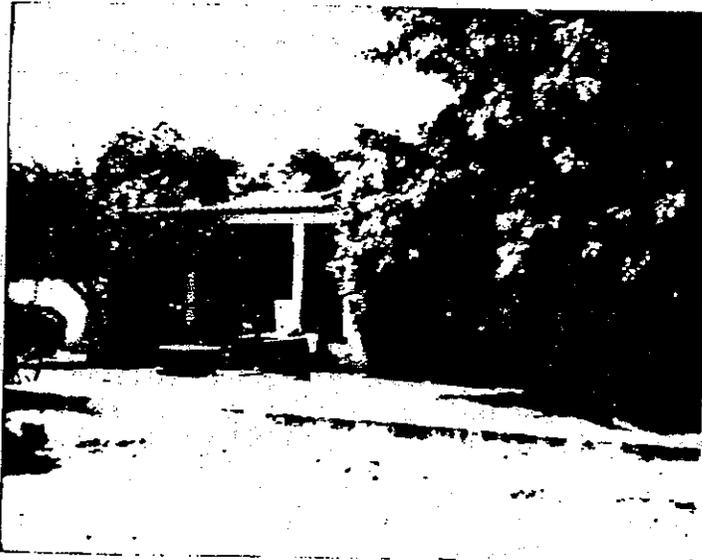
A one-story Mediterranean/Spanish Revival structure, this house is rectangular in plan with one wing having a gable tile roof with stucco siding. A simple porch with double rails is found at the front side of this house in a rural setting with a tankhouse, guest house, outhouse and wishing well.

13. Condition: Excellent Good Fair Deteriorated No longer in existence
14. Alterations: Unaltered
15. Surroundings: (Check more than one if necessary) Open land Scattered buildings Densely built-up
Residential Industrial Commercial Other: _____
16. Threats to site: None known Private development Zoning Vandalism
Public Works project Other: _____
17. Is the structure: On its original site? Moved? Unknown?
18. Related features: Outhouse, tankhouse

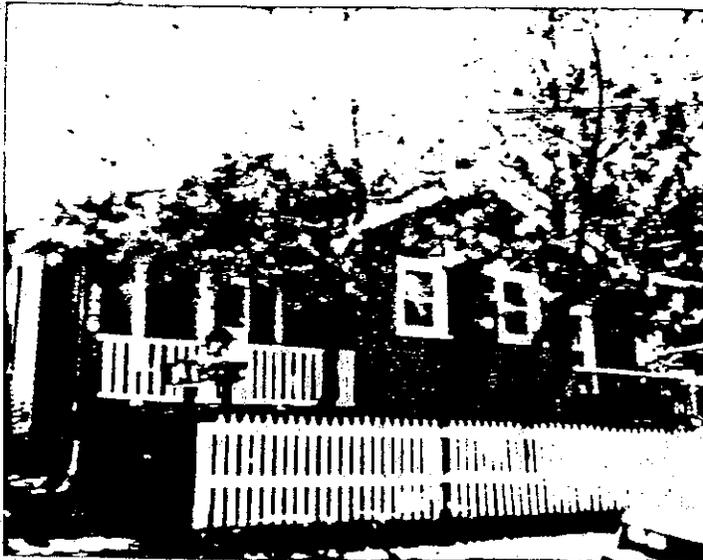
A symmetrical bungalow duplex with overhanging centered gables, this residence has vertical slat vents, mullioned double-hung windows, a balustrade on each side for each porch, and square porch posts.

13. Condition: Excellent ___ Good ___ Fair X Deteriorated ___ No longer in existence ___
14. Alterations: Unaltered
15. Surroundings: (Check more than one if necessary) Open land ___ Scattered buildings ___ Densely built-up X
Residential X Industrial ___ Commercial ___ Other: ___
16. Threats to site: None known X Private development ___ Zoning ___ Vandalism ___
Public Works project ___ Other: ___
17. Is the structure: On its original site? ✓ Moved? ___ Unknown? ___
18. Related features: None

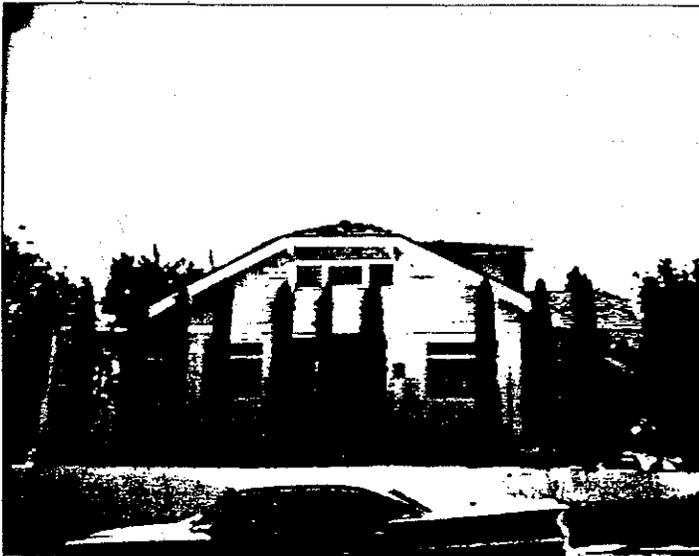
A one and one-half story hipped gable wood frame house, with shingle siding and shingle roof, this structure has extended eaves and a pergola to the right side.

13. Condition: Excellent ___ Good X Fair ___ Deteriorated ___ No longer in existence ___
14. Alterations: Minor Awnings added
15. Surroundings: (Check more than one if necessary) Open land ___ Scattered buildings ___ Densely built-up X
Residential X Industrial ___ Commercial ___ Other: ___
16. Threats to site: None known X Private development ___ Zoning ___ Vandalism ___
Public Works project ___ Other: ___
17. Is the structure: On its original site? ___ Moved? ___ Unknown? ___
18. Related features: Garage

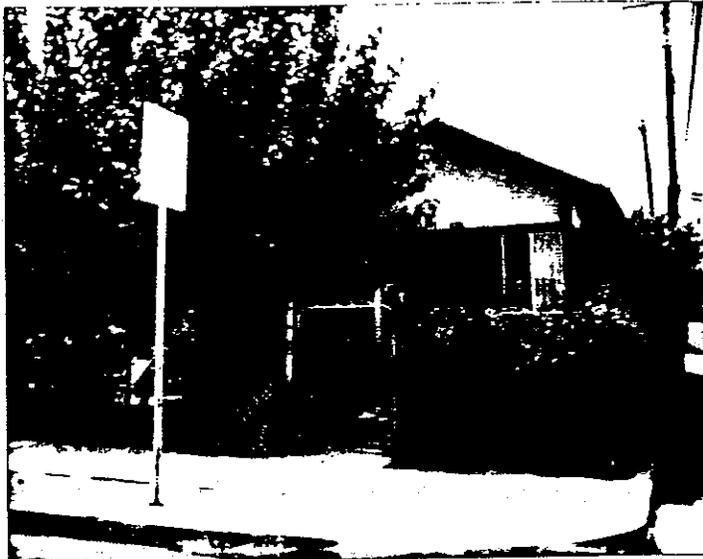
Rectangular in plan with an extended gable porch in front, this bungalow has shiplap siding, a lattice work vent under the main gable, mullioned windows and a screened-in porch with double-screened doors. A chainlink fence surrounds the property and a small brick planter is found in front of this fence. It is surrounded by shade trees.

- 13. Condition: Excellent Good Fair Deteriorated No longer in existence
- 14. Alterations: Minor - porch enclosed
- 15. Surroundings: (Check more than one if necessary) Open land Scattered buildings Densely built-up Residential Industrial Commercial Other:
- 16. Threats to site: None known Private development Zoning Vandalism Other:
- 17. Is the structure: On its original site? Moved? Unknown?
- 18. Related features: Fence

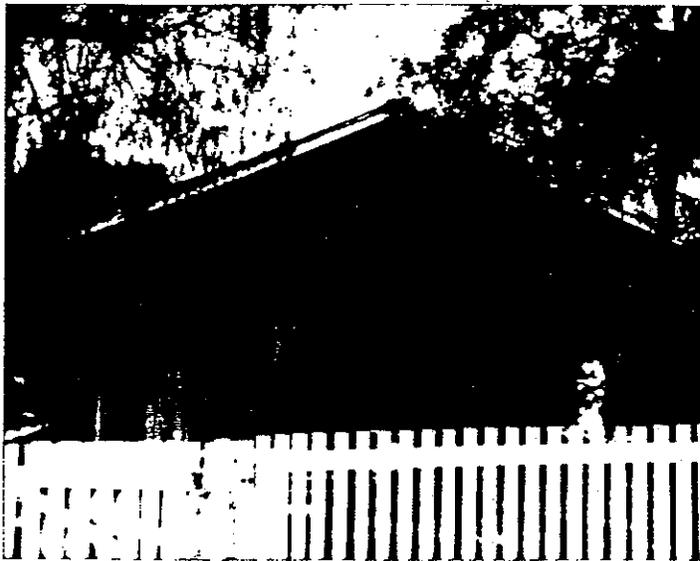
A single-story, single gabled structure, rectangular in plan, the bungalow duplex at 133 and 131 East Peck has recently had a renovation replacing clapboard siding with vertical redwood siding, a realignment of windows and other major changes from the 1981 historical structures survey. A porch to the front has been walled in and a front door installed in this space with light fixtures to either side. The original white picket fence is a holdover from the earlier appearance. Tall trees still shade the property and bungalow.

13. Condition: Excellent Good Fair Deteriorated No longer in existence
14. Alterations: Major, a complete renovation has been accomplished.
15. Surroundings: (Check more than one if necessary) Open land Scattered buildings Densely built-up
 Residential Industrial Commercial Other:
16. Threats to site: None known Private development Zoning Vandalism
 Public Works project Other:
17. Is the structure: On its original site? Moved? Unknown?
18. Related features: Fence.

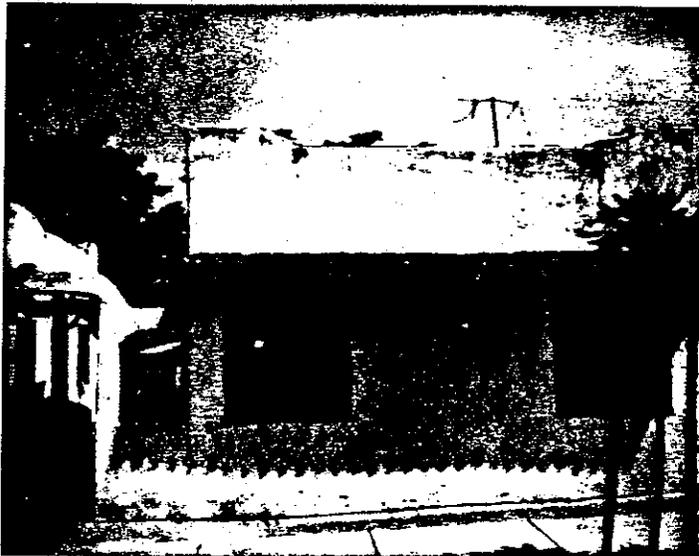
Rectangular in plan with composition gable roofs, the two apartment buildings at 133 and 137 E. Peck Street have stucco siding, double-hung windows, an arched entry between them, and a narrow Spanish tile awning across the front of each. These buildings are situated right at the sidewalk and have tall trees around them.

13. Condition: Excellent ___ Good X Fair ___ Deteriorated ___ No longer in existence ___
14. Alterations: Major: windoes replaced and building stuccoed.
15. Surroundings: (Check more than one if necessary) Open land ___ Scattered buildings ___ Densely built-up ___
Residential XX Industrial ___ Commercial ___ Other: ___
16. Threats to site: None known XX Private development ___ Zoning ___ Vandalism ___
Public Works project ___ Other: ___
17. Is the structure: On its original site? XX Moved? ___ Unknown? ___
18. Related features: None

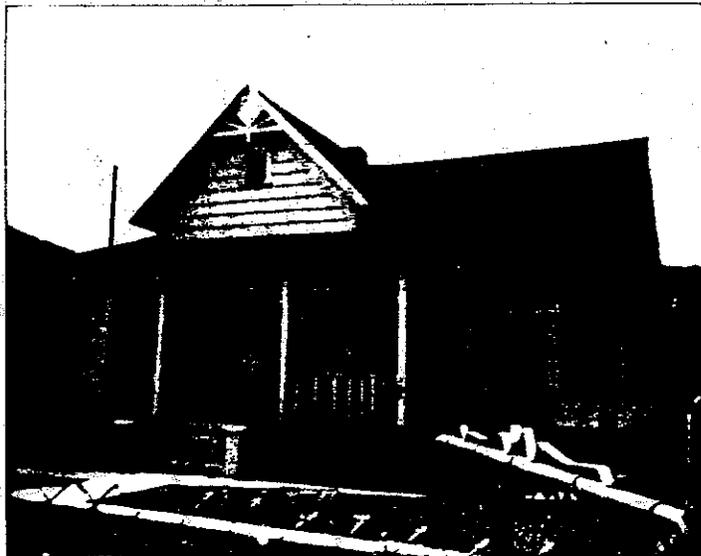
Rectangular in plan, this residence has a composition gable roof, horizontal shiplap siding, mullioned windows, and latticework above the front porch, with gabled lattice vent under the front gable. It has been recently (1990) painted and is well preserved. There are two cabins to the rear of the structure's main house.

13. Condition: Excellent ___ Good x Fair ___ Deteriorated ___ No longer in existence ___
14. Alterations: Major: windows changed, room added to original building
15. Surroundings: (Check more than one if necessary) Open land ___ Scattered buildings ___ Densely built-up ___
Residential x Industrial ___ Commercial ___ Other: ___
16. Threats to site: None known ___ x Private development ___ Zoning ___ Vandalism ___
Public Works project ___ Other: ___
17. Is the structure: On its original site? x Moved? ___ Unknown? ___
18. Related features: Two cabins in rear

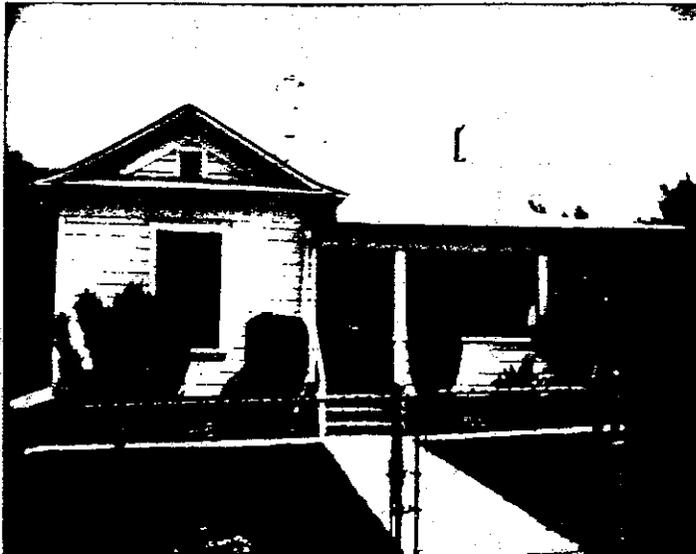
Rectangular in plan, this wood frame house has a composition roof that is hip, gablet and gable. Tongue-in-groove redwood siding sheathes the house and two brick chimneys have corbeled chimney caps and the single front gable has a pediment. The house has undergone considerable alterations since the 1981 survey.

13. Condition: Excellent ___ Good ___ Fair ___ Deteriorated ___ No longer in existence ___
14. Alterations: Extensive: porch removed and mullioned windows replaced; well kept & painted
15. Surroundings: (Check more than one if necessary) Open land ___ Scattered buildings ___ Densely built-up ___
 Residential Industrial ___ Commercial ___ Other: ___
16. Threats to site: None known Private development ___ Zoning ___ Vandalism ___
 Public Works project ___ Other: ___
17. Is the structure: On its original site? Moved? ___ Unknown? ___
18. Related features: None

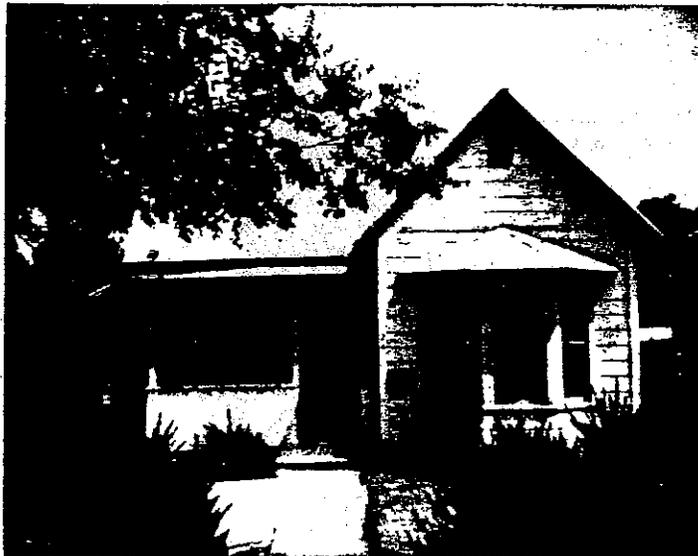
A single-story structure, L-shaped in plan, this house has a composition shingle gable roof, tongue-in-groove redwood siding, a bay window with its own hip roof and a shed roof porch with square posts and a short wall and low-pitched pediment-shaped window heads on the two tall side windows. A tall hedge transverses the front of the property at the sidewalk. A brick patio covers the front yard area and the house is newly painted.

13. Condition: Excellent ___ Good Fair ___ Deteriorated ___ No longer in existence ___
14. Alterations: Minor
15. Surroundings: (Check more than one if necessary) Open land ___ Scattered buildings ___ Densely built-up ___
Residential Industrial ___ Commercial ___ Other: ___
16. Threats to site: None known Private development ___ Zoning ___ Vandalism ___
Public Works project ___ Other: ___
17. Is the structure: On its original site? Moved? ___ Unknown? ___
18. Related features: None

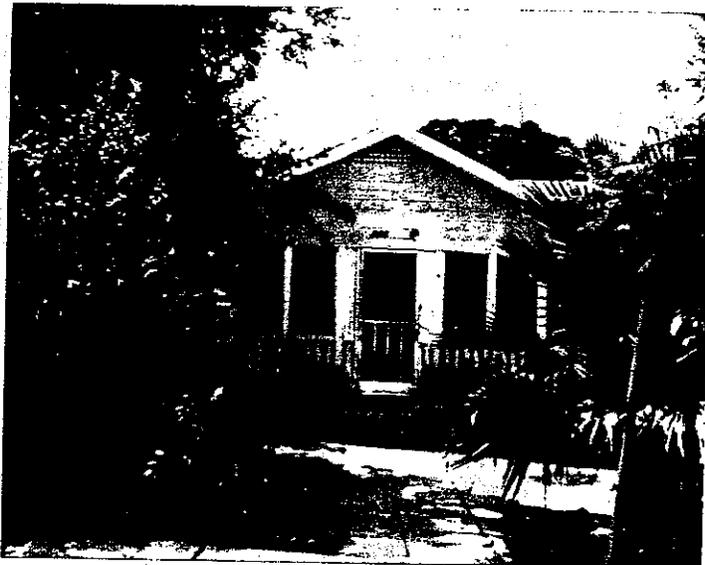
This bungalow is L-shaped in plan with a composition shingle gable roof, clapboard siding, with a lattice vent under the front gable, and an enclosed porch and some newer louvered windows. It is surrounded by trees and foliage.

13. Condition: Excellent ___ Good ___ Fair Deteriorated ___ No longer in existence ___
14. Alterations: Minor porch enclosed
15. Surroundings: (Check more than one if necessary) Open land ___ Scattered buildings ___ Densely built-up ___
Residential Industrial ___ Commercial ___ Other: ___
16. Threats to site: None known Private development ___ Zoning ___ Vandalism ___
Public Works project ___ Other: ___
17. Is the structure: On its original site? Moved? ___ Unknown? ___
18. Related features: Unusual sidewalk design
