ELSINORE VALLEY CDC

SURVEY OF HISTORICAL STRUCTURES AND SITES
Lake Elsinore, California 1991

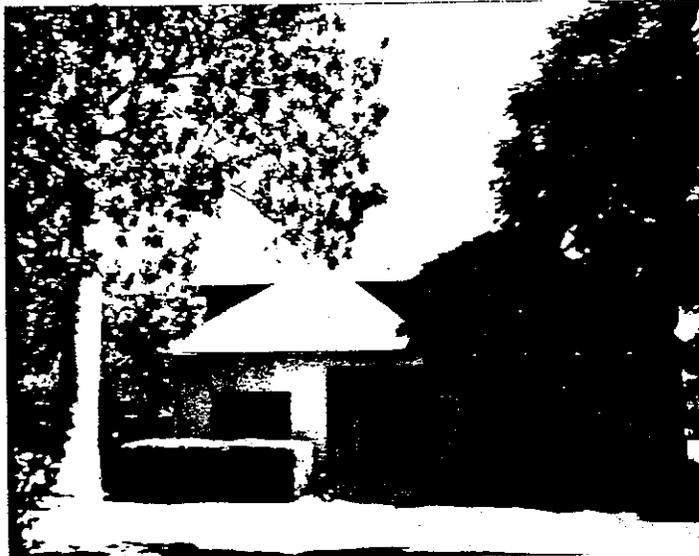
Rectangular in plan with a composition shingle hip and gablet roof, this two-story vernacular ranch house has exposed rafters, a balcony, wood shingles and board and batten siding, mullioned windows, and a porch with square porch posts. A wood shingled garage is in back and tall trees shade the house. It is in excellent condition and a fine example of this style of house. The trees are of exceptional girth and make an outstanding setting for this home.

13. Condition: Excellent _____ X Good _____ Fair _____ Deteriorated _____ No longer in existence _____
14. Alterations: None
15. Surroundings: (Check more than one if necessary) Open land _____ Scattered buildings _____ Densely built-up _____
Residential XX Industrial _____ Commercial _____ Other: _____
16. Threats to site: None known: X Private development _____ Zoning _____ Vandalism _____
Public Works project _____ Other: _____
17. Is the structure: On its original site? X Moved? _____ Unknown? _____
18. Related features: None

This 1912 house is a very good example of the vernacular ranch style house. Its excellent and unaltered condition make it a valuable architectural resource for the Lake Elsinore community.

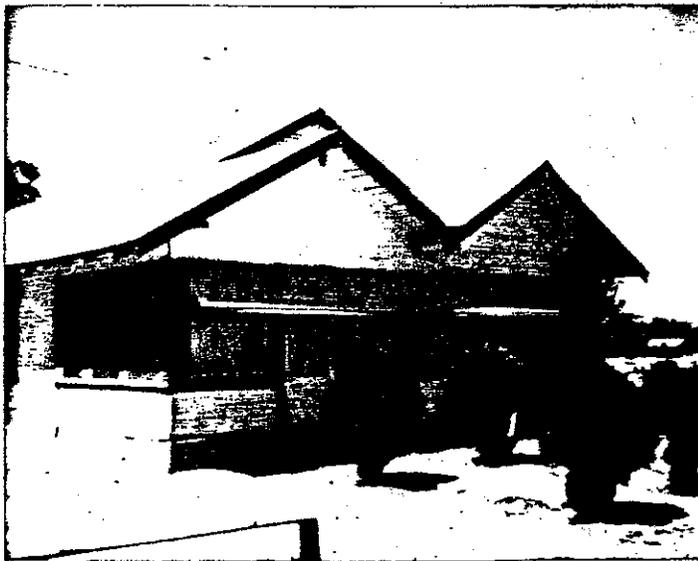
Square in plan with a composition gable roof, the bungalow at 32993 Machado St. has clapboard siding, double-hung windows, a latticework vent under the main front-facing gable, and an enclosed porch with a band of windows across the front under a metal awning. A door to the porch is under the left gable. Also on this ranch is another house, a shed, a barn, and a tankhouse.

13. Condition: Excellent ___ Good Fair ___ Deteriorz. ___ No longer in existence ___
14. Alterations: None
15. Surroundings: (Check more than one if necessary) Open land ___ Scattered buildings ___ Densely built-up ___
Residential Industrial ___ Commercial ___ Other: ___
16. Threats to site: None known ___ Private development ___ Zoning ___ Vandalism ___
Public Works project ___ Other: ___
17. Is the structure: On its original site? Moved? ___ Unknown? ___
18. Related features: Barn, shed, tankhouse

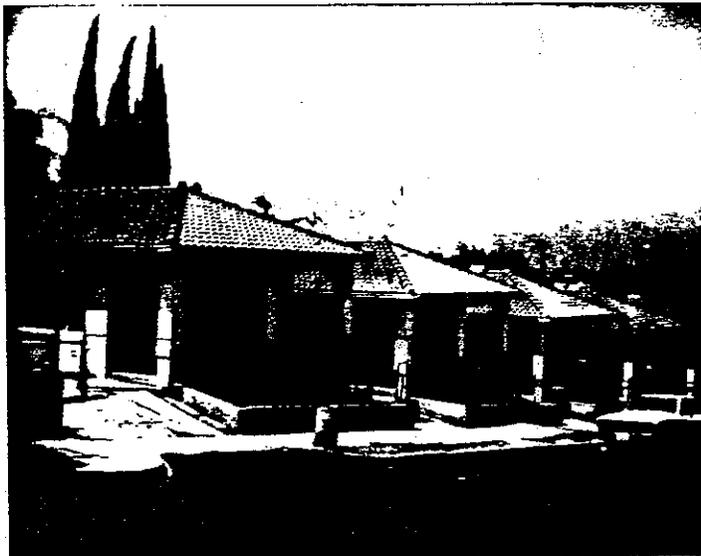
Brenneke Courts consists of ten rectangular-shaped bungalows with tile roofs giving them a Mediterranean/Spanish style. Each bungalow has a porch under its hip roof with square stuccoed porch posts and chimney with barrelled vault cap. The ten bungalows are arranged in two rows of five each, on a hillside, each about a half story below the next. The same style of architecture is used for the builder's house up the hill at 226 Franklin Street.

13. Condition: Excellent Good _____ Fair _____ Deteriorated _____ No longer in existence _____
14. Alterations: Minor. Air conditioners added
15. Surroundings: (Check more than one if necessary) Open land _____ Scattered buildings _____ Densely built-up
Residential Industrial _____ Commercial _____ Other: _____
16. Threats to site: None known Private development _____ Zoning _____ Vandalism _____
Public Works project _____ Other: _____
17. Is the structure: On its original site? Moved? _____ Unknown? _____
18. Related features: Fence

These ten identical bungalows are in excellent condition and basically unaltered except for the addition of air conditioners in windows. They are together an excellent example of a bungalow court in the Mediterranean/Spanish style.

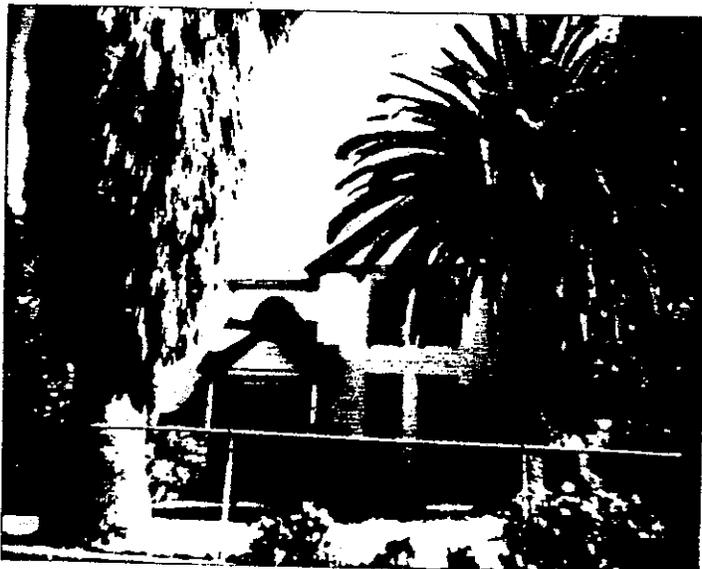
L-shaped in plan, this two story Victorian house has a composition shingle gable roof, clapboard siding and tall double-hung windows. The front-facing gable has a cornice with dentils. The porch has a shed roof with projecting gables, small studs supporting the base of the gable, and Tuscan Order columns for porch posts. A semi-circular sunburst with a square window in it sits at the top of the porch's shed roof in a second-story wall. The structure is well-preserved.

13. Condition: Excellent Good _____ Fair _____ Deteriorated _____ No longer in existence _____
14. Alterations: Bedroom and bath downstairs.
15. Surroundings: (Check more than one if necessary) Open land _____ Scattered buildings _____ Densely built up _____
Residential Industrial _____ Commercial _____ Other: _____
16. Threats to site: None known Private development _____ Zoning _____ Vandalism _____
Public Works project _____ Other: _____
17. Is the structure: On its original site? Moved? _____ Unknown? _____
18. Related features: Shed and fence.

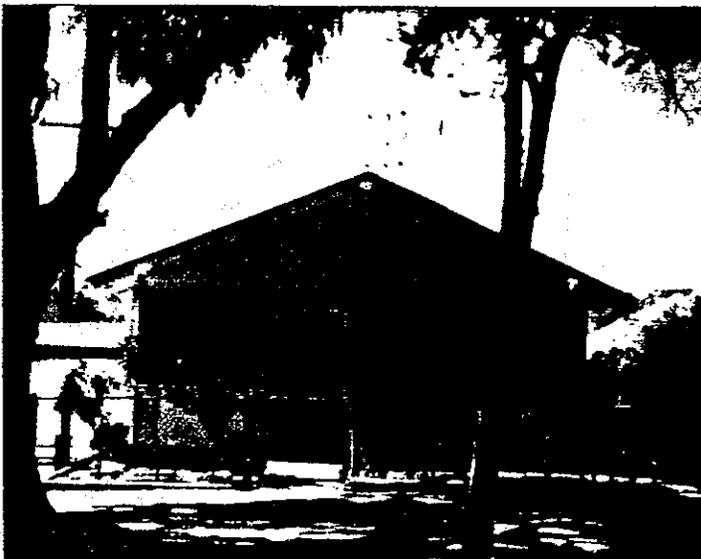
Rectangular in plan, the bungalow at 508 W. Heald has a composition gable roof, clapboard siding, mullioned windows, a vertical slat vent at the apex of the front-facing gable, and a screened-in porch. A garage in the rear, tall trees, and a chain link fence are also on the property.

13. Condition: Excellent ___ Good X Fair ___ Deteriorated ___ No longer in existence ___
14. Alterations: none
15. Surroundings: (Check more than one if necessary) Open land ___ Scattered buildings ___ Densely built-up ___
Residential X Industrial ___ Commercial ___ Other: ___
16. Threats to site: None known X Private development ___ Zoning ___ Vandalism ___
Public Works project ___ Other: ___
17. Is the structure: On its original site? X Moved? ___ Unknown? ___
18. Related features: Garage

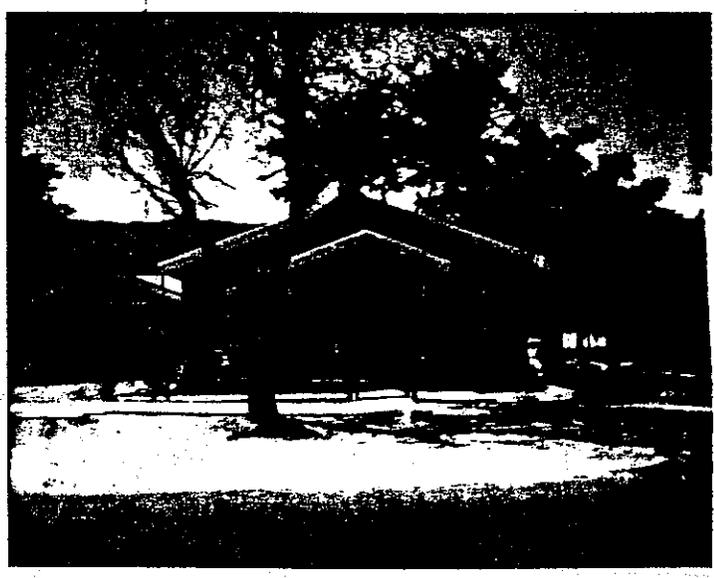
Square in plan, the bungalow at 512 W. Heald has a composition gable roof, exposed rafters, clapboard siding, double-hung windows, and a gabled porch with square porch posts. A garage in the rear, tall trees and a chain link fence are also on the property.

13. Condition: Excellent ___ Good ___ Fair X Deteriorated ___ No longer in existence ___
14. Alterations: None
15. Surroundings: (Check more than one if necessary) Open land ___ Scattered buildings ___ Densely built-up ___
Residential X Industrial ___ Commercial ___ Other: ___
16. Threats to site: None known X Private development ___ Zoning ___ Vandalism ___
Public Works project ___ Other: ___
17. Is the structure: On its original site? X Moved? ___ Unknown? ___
18. Related features: Garage

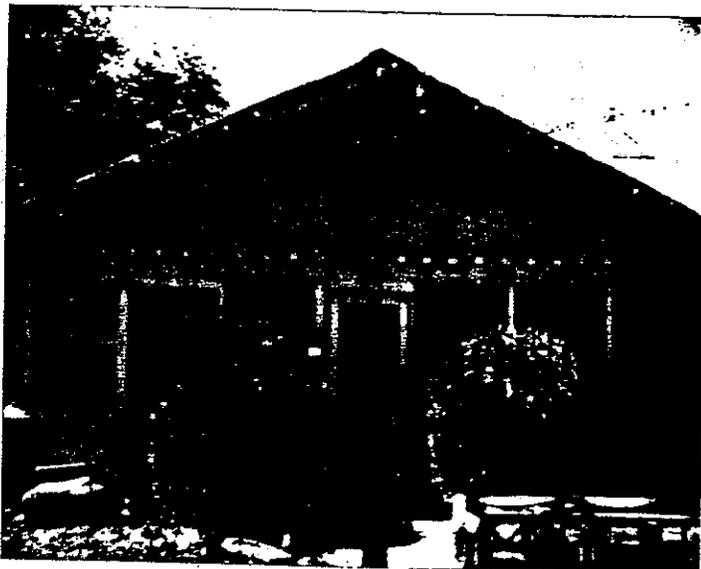
Square in plan, the bungalow at 704 W. Heald has a composition gable roof, exposed rafters, clapboard siding, mullioned windows, a vent at the apex of the front-facing gable and dentils along its base, a cross beam and king post over the vent, and an enclosed porch with battered porch posts. A garage and shed in the rear, tall trees, and a white picket fence are also on the property.

13. Condition: Excellent ___ Good ___ Fair Deteriorated ___ No longer in existence ___
14. Alterations: None
15. Surroundings: (Check more than one if necessary) Open land ___ Scattered buildings ___ Densely built-up ___
Residential Industrial ___ Commercial ___ Other: ___
16. Threats to site: None known Private development ___ Zoning ___ Vandalism ___
Public Works project ___ Other: ___
17. Is the structure: On its original site? Moved? ___ Unknown? ___
18. Related features: None other than garage and shed

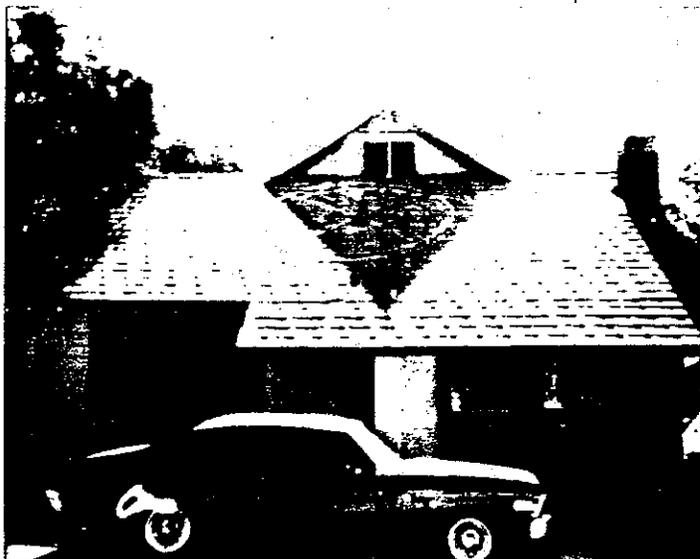
Rectangular in plan, this wood frame house has a composition gablet roof with brick chimney, clapboard siding, exposed rafters, double-hung windows, and wood steps leading to a centered door. Tall shade trees surround this house.

13. Condition: Excellent _____ Good Fair _____ Deteriorated _____ No longer in existence _____
14. Alterations: Minor windows changed
15. Surroundings: (Check more than one if necessary) Open land _____ Scattered buildings _____ Densely built-up _____
Residential Industrial _____ Commercial _____ Other: _____
16. Threats to site: None known Private development _____ Zoning _____ Vandalism _____
Public Works project _____ Other: _____
17. Is the structure: On its original site? Moved? _____ Unknown? _____
18. Related features: None

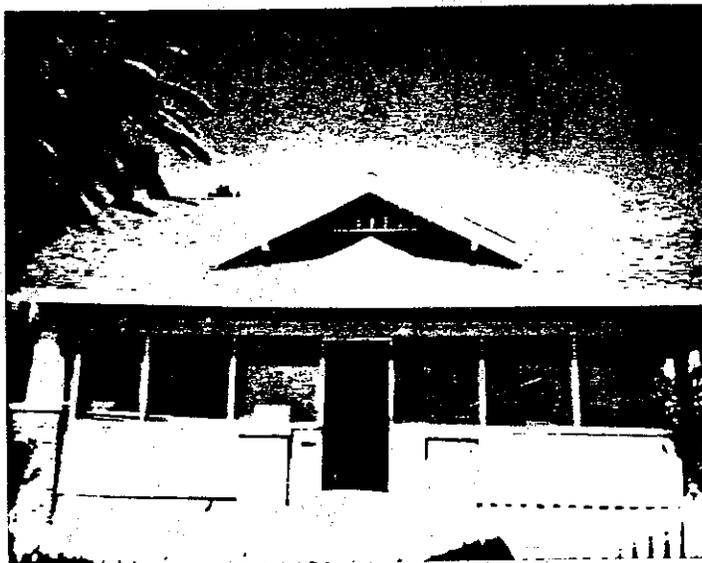
Rectangular in plan, this wood frame house has a wood shingle gable roof, dormer gable vent, clapboard siding, a mullioned window front door with mullioned sidelights, and a screened-in porch. Tall trees and dense foliage surround the house.

13. Condition: Excellent ___ Good ~~xx~~ Fair ___ Deteriorated ___ No longer in existence ___
14. Alterations: Minor - porch enclosed
15. Surroundings: (Check more than one if necessary) Open land ___ Scattered buildings ___ Densely built-up ___
Residential xx Industrial ___ Commercial ___ Other: ___
16. Threats to site: None known ___ X Private development ___ Zoning ___ Vandalism ___
Public Works project ___ Other: ___
17. Is the structure: On its original site? xx Moved? ___ Unknown? ___
18. Related features: Garage

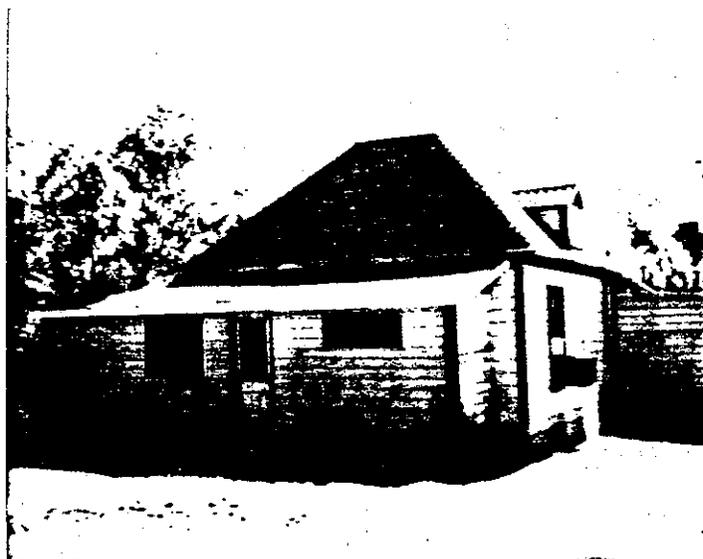
Square in plan with a composition shingle hip roof, this house has shiplap siding, tall double-hung windows and a newly-added framed in former porch. This addition to the original 1895 home has carried out the shiplap siding theme and has two windows to the right of the door and a larger window of the casement style to the left. Tall trees surround this hipped roof cottage. A side window with an air conditioner has been added to the rear. Other than that, the architectural integrity of the house remains intact.

13. Condition: Excellent ___ Good XX Fair ___ Deteriorated ___ No longer in existence ___
14. Alterations: Minor: enclosed porch and air conditioner added.
15. Surroundings: (Check more than one if necessary) Open land ___ Scattered buildings ___ Densely built-up ___
Residential XX Industrial ___ Commercial ___ Other: ___
16. Threats to site: None known XX Private development ___ Zoning ___ Vandalism ___
Public Works project ___ Other: ___
17. Is the structure: On its original site? XX Moved? ___ Unknown? ___
18. Related features: None

This house is a good example of the hipped roof cottage style of architecture popular around the turn of the century. The roof has recently been replaced and steel grating has been installed on the windows as the owner attempts to maintain the value of the property.

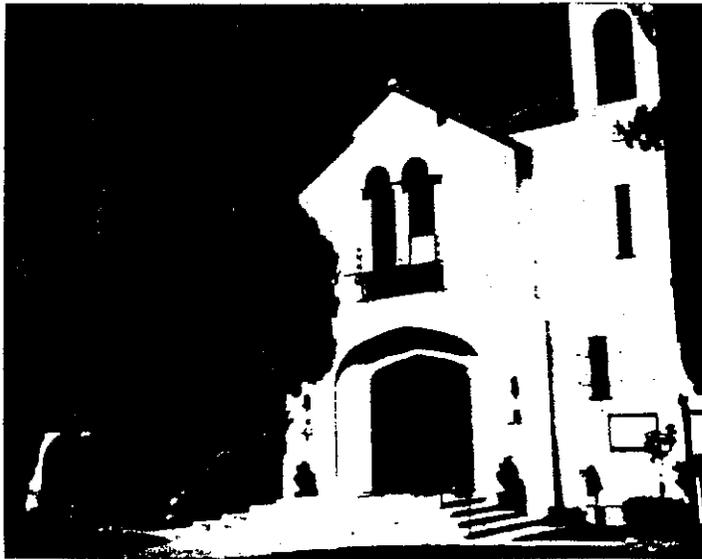
Rectangular in plan, Mediterranean/Spanish Revival in style, this church has a Spanish tile gable roof, stucco siding, steeple bell tower with arched openings and a Spanish tile hip roof with a cross at the apex, tall narrow stained glass windows in the tower, arched-opening stained glass windows with a small balcony, a double-door entry under a Tudor arch, an archway off to the left, and an announcement sign with a Swan's neck pediment. Cement steps fan out from the front doors and tall trees landscape the property.

13. Condition: Excellent Good _____ Fair _____ Deteriorated _____ No longer in existence _____
14. Alterations: Major. Original small chapel has been greatly enlarged.
15. Surroundings: (Check more than one if necessary) Open land _____ Scattered buildings _____ Densely built-up
Residential Industrial _____ Commercial _____ Other: _____
16. Threats to site: None known Private development _____ Zoning _____ Vandalism _____
Public Works project _____ Other: _____
17. Is the structure: On its original site? _____ Moved? Unknown? _____
18. Related features: Class rooms

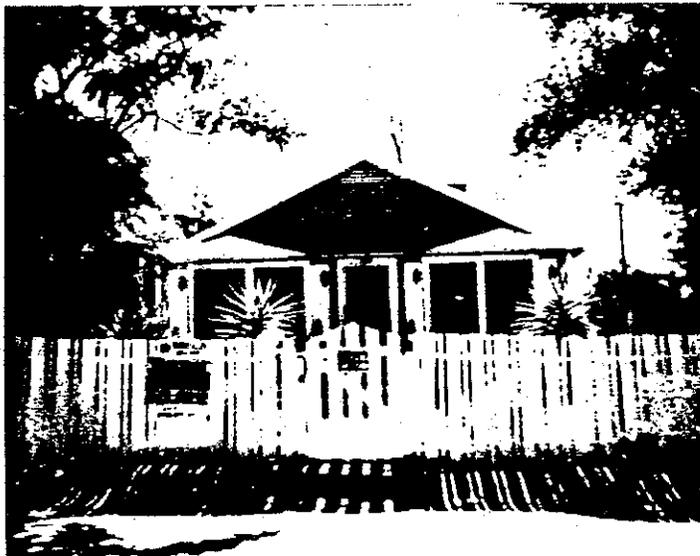
Square in plan, this bungalow has a composition shingle gable roof with lattice-work vent, a hip roofer front that abuts this front gable, clapboard siding, paired double-hung windows on either side of a center door, and four shutters flank these windows. Tall trees and a white picket fence surround the bungalow.

13. Condition: Excellent _____ Good Fair _____ Deteriorated _____ No longer in existence _____
14. Alterations: None
15. Surroundings: (Check more than one if necessary) Open land _____ Scattered buildings _____ Densely built-up _____
Residential Industrial _____ Commercial _____ Other: _____
16. Threats to site: None known Private development _____ Zoning _____ Vandalism _____
Public Works project _____ Other: _____
17. Is the structure: On its original site? Moved? _____ Unknown? _____
18. Related features: Fence

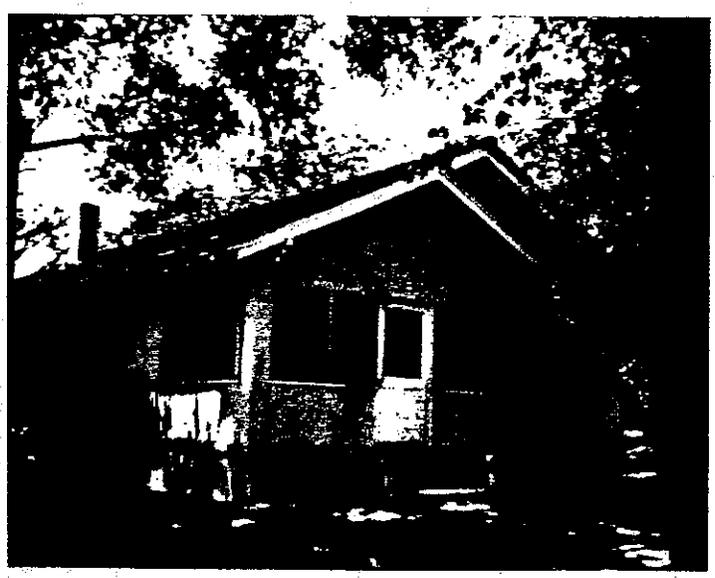
Rectangular in plan, this bungalow has a composition, overlapping double-gable roof, stucco siding, vents at each gable apex, newer aluminum frame louvered windows, and concrete porch steps. Tall trees shade this attractive and well-maintained home.

13. Condition: Excellent Good Fair Deteriorated No longer in existence
14. Alterations: Minor: louvered windows added
15. Surroundings: (Check more than one if necessary) Open land Scattered buildings Densely built-up
Residential Industrial Commercial Other:
16. Threats to site: None known Private development Zoning Vandalism
Public Works project Other:
17. Is the structure: On its original site? Moved? Unknown?
18. Related features: None

This residence is a part of the Lake Elsinore historic downtown area. The owner is a member of a long-time Lake Elsinore family and has kept the house in very good condition.

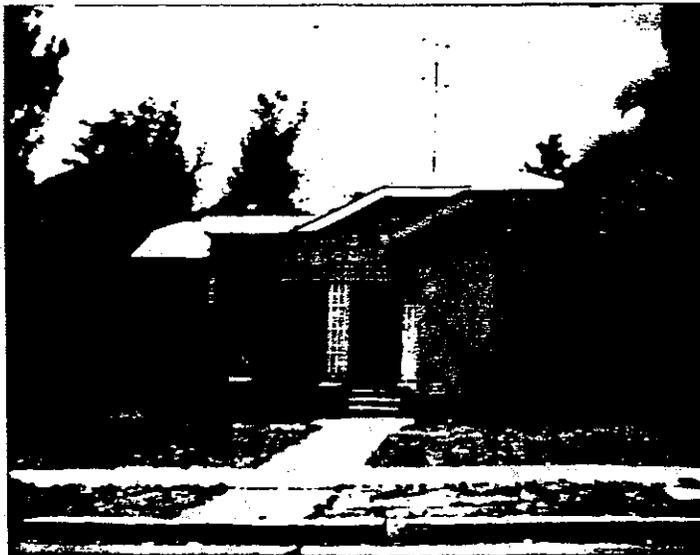
L-shaped in plan, this wood frame house has a composition shingle hipped gable roof, clapboard siding on the walls and two porch posts, trellises on these posts and horizontally over them, and a brick chimney with corbeled cap and chimney pot.

13. Condition: Excellent ___ Good ~~xxx~~ Fair ___ Deteriorated ___ No longer in existence ___
14. Alterations: Minor - new composition roof
15. Surroundings: (Check more than one if necessary) Open land ___ Scattered buildings ___ Densely built-up ___
 Residential ~~xxx~~ Industrial ___ Commercial ___ Other: ___
16. Threats to site: None known ~~xxx~~ Private development ___ Zoning ___ Vandalism ___
 Public Works project ___ Other: ___
17. Is the structure: On its original site? ~~xxx~~ Moved? ___ Unknown? ___
18. Related features: None

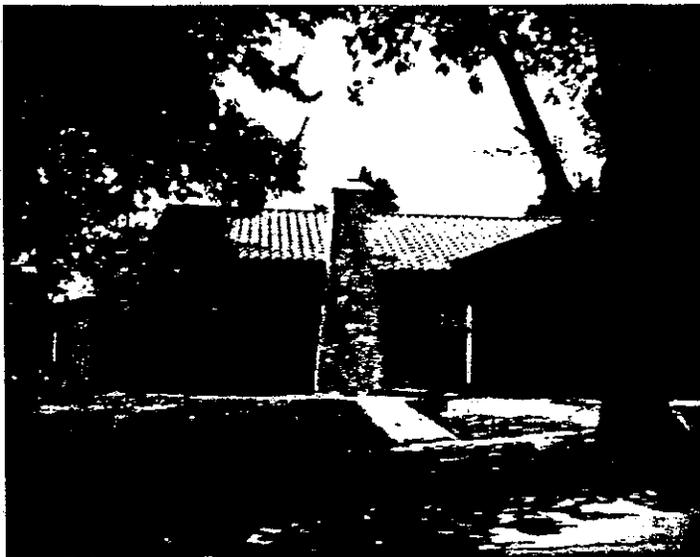
Rectangular in plan with a recessed entry and battered chimney, this house has a Spanish tile gable roof, casement windows, stucco siding, and a small overdoor over a low brick porch. Tall trees surround the house which is well landscaped and maintained. A chain link fence encloses the back yard.

13. Condition: Excellent Good Fair Deteriorated No longer in existence
14. Alterations: None
15. Surroundings: (Check more than one if necessary) Open land Scattered buildings Densely built-up
Residential Industrial Commercial Other:
16. Threats to site: None known Private development Zoning Vandalism
Public Works project Other:
17. Is the structure: On its original site? Moved? Unknown?
18. Related features: None

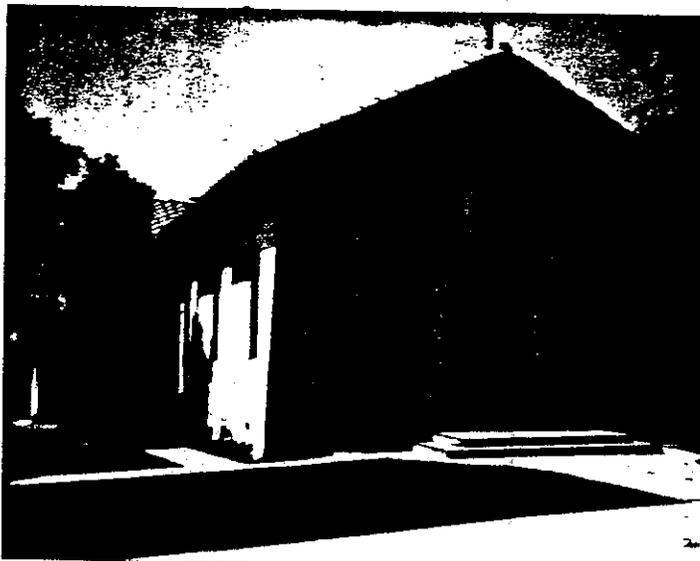
Cross-shaped in plan with side naves, this church has a Spanish tile gabled roof, stucco siding, arched stain-glass windows, plain battered wall buttresses, (5 on each side), a circular window in front with an arched double-door entry with two lanterns flanking it and a pedimented announcement board to the right. Other buildings in the church complex include church offices and classrooms. Tall trees are part of the landscaping.

13. Condition: Excellent ___ Good X Fair ___ Deteriorated ___ No longer in existence ___
14. Alterations: None
15. Surroundings: (Check more than one if necessary) Open land ___ Scattered buildings ___ Densely built-up X
Residential X Industrial ___ Commercial X Other: _____
16. Threats to site: None known X Private development ___ Zoning ___ Vandalism ___
Public Works project ___ Other: _____
17. Is the structure: On its original site? X Moved? ___ Unknown? ___
18. Related features: Class Rooms

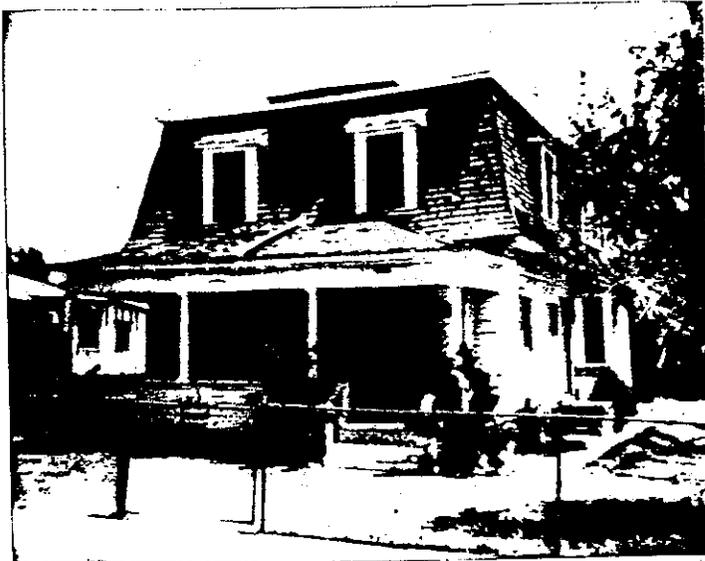
Rectangular in plan with a shingle mansard roof with domer windows, this Colonial Revival house has a porch with four Tuscan columns and hip roof, clapboard siding, double-hung windows and a side bay window.

13. Condition: Excellent ___ Good XX Fair ___ Deteriorated ___ No longer in existence ___
14. Alterations: Minor.
15. Surroundings: (Check more than one if necessary) Open land ___ Scattered buildings ___ Densely built-up ___
Residential XX Industrial ___ Commercial ___ Other: ___
16. Threats to site: None known X Private development ___ Zoning ___ Vandalism ___
Public Works project ___ Other: ___
17. Is the structure: On its original site? XX Moved? ___ Unknown? ___
18. Related features: None

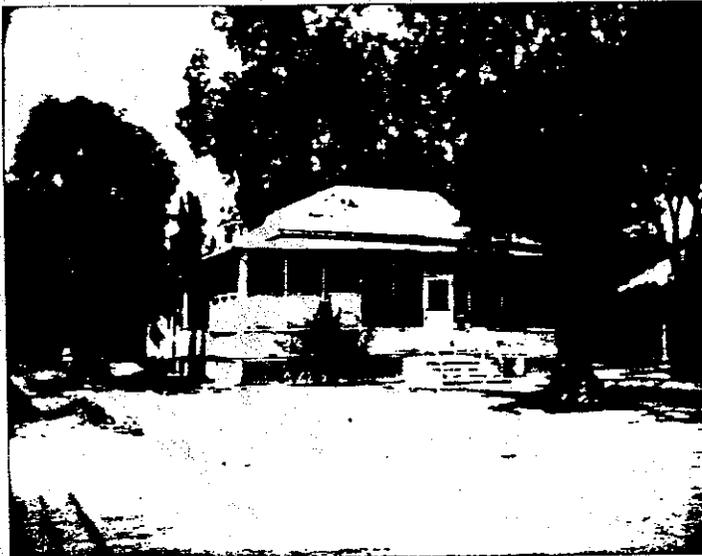
Square in plan, this house has a half-hipped composition roof, clapboard siding, and a screened-in porch with lattice-work around the base.

13. Condition: Excellent ___ Good ___ Fair X Deteriorated ___ No longer in existence ___
14. Alterations: Minor, porch enclosed
15. Surroundings: (Check more than one if necessary) Open land ___ Scattered buildings ___ Densely built-up ___
Residential XX Industrial ___ Commercial ___ Other: ___
16. Threats to site: None known X Private development ___ Zoning ___ Vandalism ___
Public Works project ___ Other: ___
17. Is the structure: On its original site? XX Moved? ___ Unknown? ___
18. Related features: Fence, wall decoration

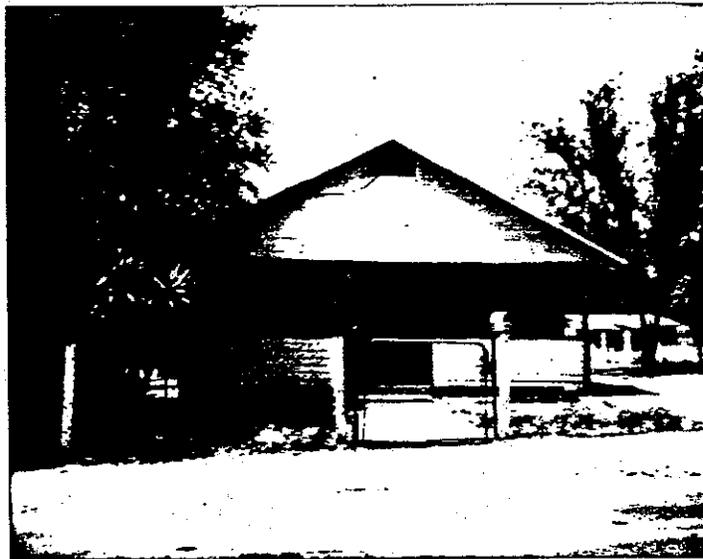
Rectangular in plan, this bungalow has a composition roof, exposed rafters, clapboard siding and a partially enclosed porch across the entire front under the single gable with a vent at its apex. A chain link fence surrounds the property.

13. Condition: Excellent _____ Good X Fair _____ Deteriorated _____ No longer in existence _____
14. Alterations: Minor; porch doorway gate added.
15. Surroundings: (Check more than one if necessary) Open land _____ Scattered buildings _____ Densely built-up X
Residential X Industrial _____ Commercial _____ Other: _____
16. Threats to site: None known X Private development _____ Zoning _____ Vandalism _____
Public Works project _____ Other: _____
17. Is the structure: On its original site? X Moved? _____ Unknown? _____
18. Related features: Fence

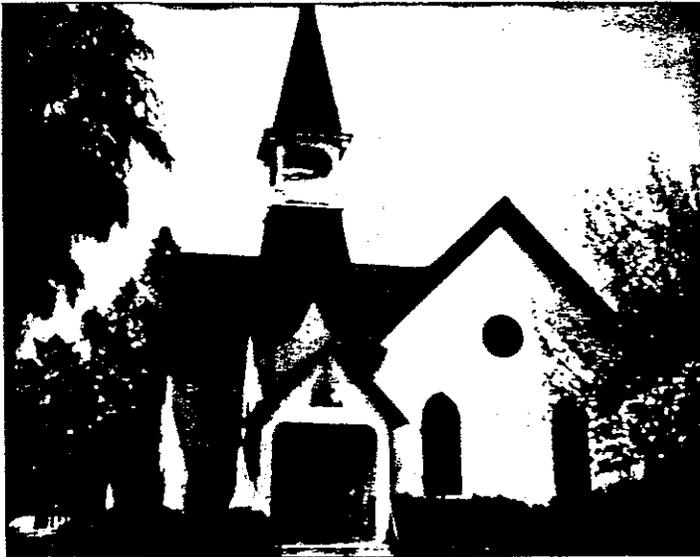
This 100 year old structure is rectangular in plan, Gothic Revival in style, has a composition shingle gable roof, tall steeple bell tower with a hip roof and finial, lancet stained glass windows, rose windows, and a double-door entrance. Tall palms and other trees landscape the property. The church office and the "Lord's Clothes Closet" occupy the adjacent structure at 105½ North Lindsay Street.

13. Condition: Excellent ___ Good Fair ___ Deteriorated ___ No longer in existence ___
14. Alterations: Minor
15. Surroundings: (Check more than one if necessary) Open land ___ Scattered buildings ___ Densely built-up
 Residential Industrial ___ Commercial Other: ___
16. Threats to site: None known ___ Private development ___ Zoning Vandalism ___
 Public Works project ___ Other: ___
17. Is the structure: On its original site? Moved? ___ Unknown? ___
18. Related features: None - Church office to the right.

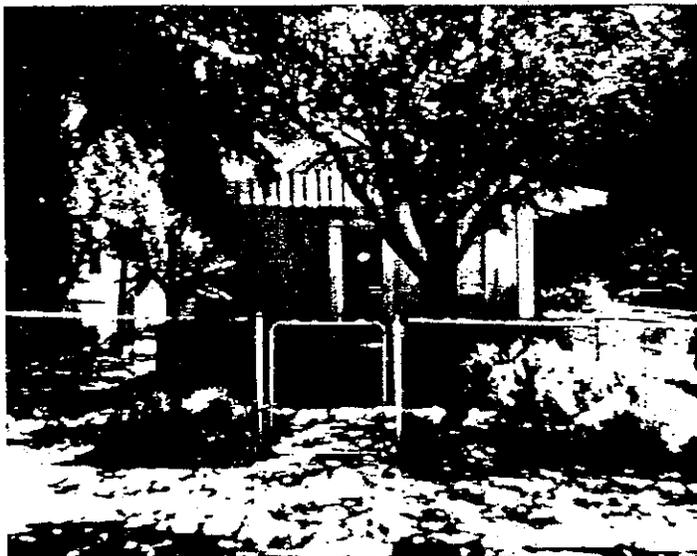
Rectangular in plan, this home has a low-pitched composition gable roof, exposed rafters, vertical slats across the front over the porch, square porch posts, board and batten siding, and a short brick wall around the wooden-floored porch. Tall trees surround this modest home.

13. Condition: Excellent _____ Good _____ Fair Deteriorated _____ No longer in existence _____
14. Alterations: Minor - brick wall added to porch
15. Surroundings: (Check more than one if necessary) Open land _____ Scattered buildings _____ Densely built-up _____
Residential Industrial _____ Commercial _____ Other: _____
16. Threats to site: None known Private development _____ Zoning _____ Vandalism _____
Public Works project _____ Other: _____
17. Is the structure: On its original site? Moved? _____ Unknown? _____
18. Related features: none

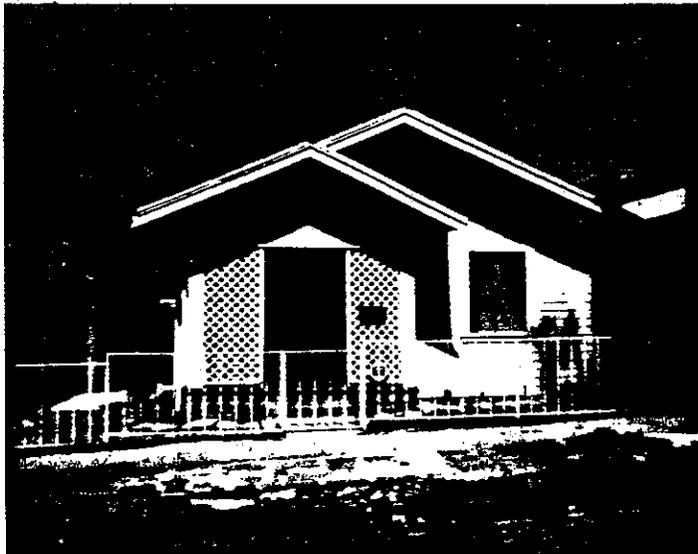
Rectangular in plan with an extended gable porch with square porch columns, this bungalow has a composition shingle gable roof, exposed rafters, clapboard siding, double-hung windows and a mullioned window front door flanked by sidelights. Tall trees and a fence surround the bungalow and the three others on this parcel (105, 105½, 101 and 103 N. Poe Street.)

13. Condition: Excellent ___ Good Fair ___ Deteriorated ___ No longer in existence ___
14. Alterations: None
15. Surroundings: (Check more than one if necessary) Open land Scattered buildings Densely built-up ___
Residential ___ Industrial ___ Commercial ___ Other: ___
16. Threats to site: None known Private development ___ Zoning ___ Vandalism ___
Public Works project ___ Other: ___
17. Is the structure: On its original site? Moved? ___ Unknown? ___
18. Related features: Minor: shed and fencing.

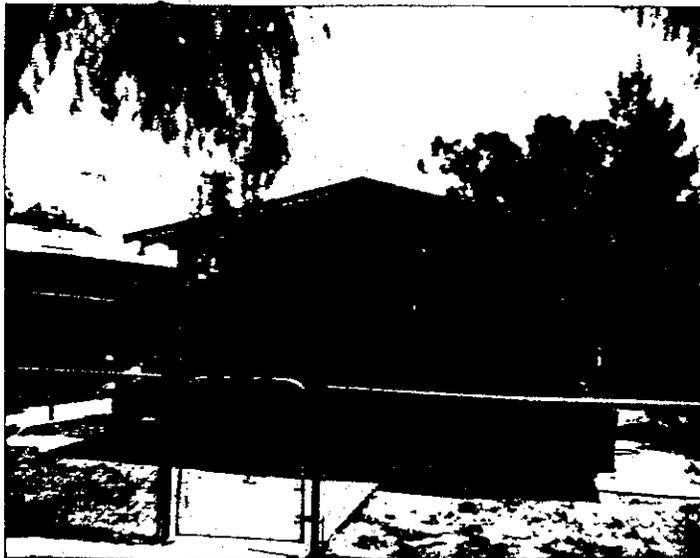
Rectangular in plan, this house is of wood frame construction, has a low-pitched composition roof, exposed rafters, vertical slats across the front over the porch, square porch posts, board and batten siding, and a short brick wall around the porch which has a wooden floor. Tall trees are found on thr property.

13. Condition: Excellent ___ Good ___ Fair Deteriorated ___ No longer in existence ___
14. Alterations: Minor
15. Surroundings: (Check more than one if necessary) Open land ___ Scattered buildings ___ Densely built-up ___
Residential Industrial ___ Commercial ___ Other: ___
16. Threats to site: None known Private development ___ Zoning ___ Vandalism ___
Public Works project ___ Other: ___
17. Is the structure: On its original site? Moved? ___ Unknown? ___
18. Related features: None

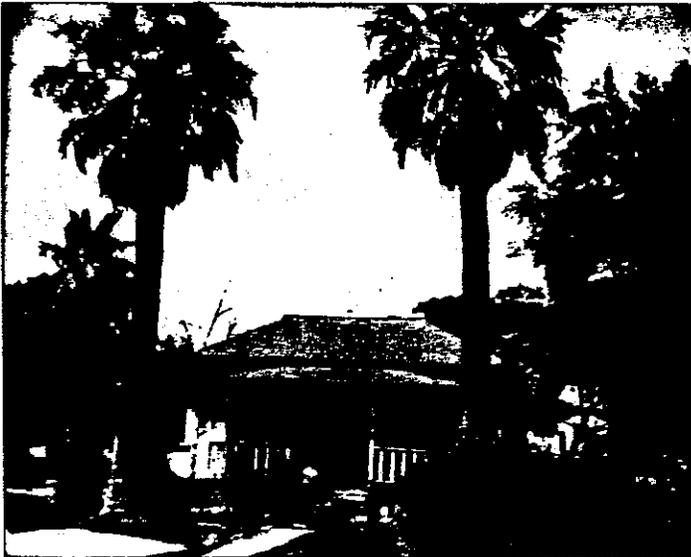
Square in plan, this house has a half-hipped composition shingle roof, hipped roof porch with four square posts and a balustrade on each side of center concrete steps. It has clapboard siding which sheathes the walls except for the front section under the porch roof which has varied width shingle siding, and two large windows which flank a narrow doorway. Two very large palm trees flank the front porch as well. The house has not been maintained and is in poor exterior condition.

13. Condition: Excellent ___ Good ___ Fair ___ Deteriorated No longer in existence ___
14. Alterations: Unaltered
15. Surroundings: (Check more than one if necessary) Open land ___ Scattered buildings ___ Densely built-up ___
Residential Industrial ___ Commercial ___ Other: ___
16. Threats to site: None known Private development ___ Zoning ___ Vandalism ___
Public Works project ___ Other: ___
17. Is the structure: On its original site? Moved? ___ Unknown? ___
18. Related features: Garage

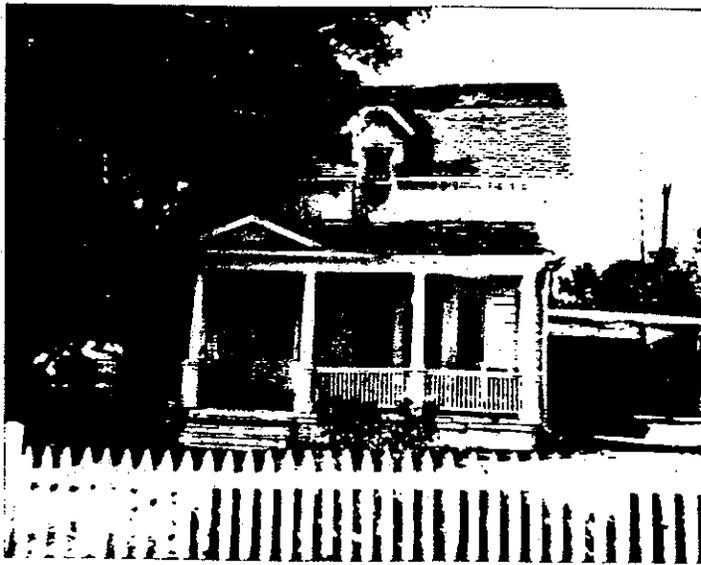
Rectangular in plan, the one-and-one-half story house at 115 North Langstaff has Classical Revival elements in its Doric porch columns, its pediment over the steps to the porch and front door, and its large cornice for the shed porch roof. The main roof is gambrel, facing sideways, with a side-wall dormer with a hipped gable roof centered over the porch roof. Clapboard siding is used on the first story, large wood shingles are used on the top half-story side wall, and smaller riven shingles are used on the roof. The porch has a balustrade and a bay window with tall double-hung windows. Very tall trees shade this house in the afternoon, and a white picket fence surrounds the property.

13. Condition: Excellent Good _____ Fair _____ Deteriorated _____ No longer in existence _____
14. Alterations: Unaltered
15. Surroundings: (Check more than one if necessary) Open land _____ Scattered buildings _____ Densely built-up _____
Residential Industrial _____ Commercial _____ Other: _____
16. Threats to site: None known Private development _____ Zoning _____ Vandalism _____
Public Works project _____ Other: _____
17. Is the structure: On its original site? Moved? _____ Unknown? _____
18. Related features: Shed, fence, and carport

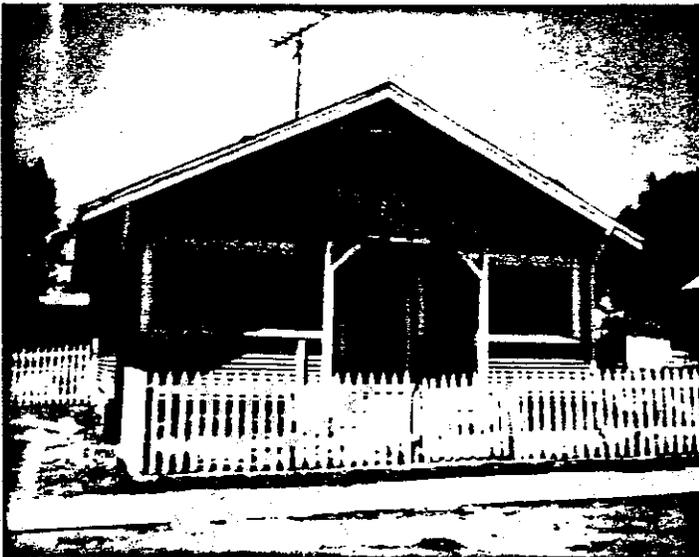
Square in plan, this bungalow has a composition gable roof, shiplap siding, a center door flanked by two Prairie-style bands of windows, two small vents and two purlins under the eaves, and an added conditioner on the right side.

13. Condition: Excellent ___ Good XX Fair ___ Deteriorated ___ No longer in existence ___
14. Alterations: Minor
15. Surroundings: (Check more than one if necessary) Open land ___ Scattered buildings ___ Densely built-up ___
 Residential X Industrial ___ Commercial ___ Other: ___
16. Threats to site: None known X Private development ___ Zoning ___ Vandalism ___
 Public Works project ___ Other: ___
17. Is the structure: On its original site? X Moved? ___ Unknown? ___
18. Related features: None

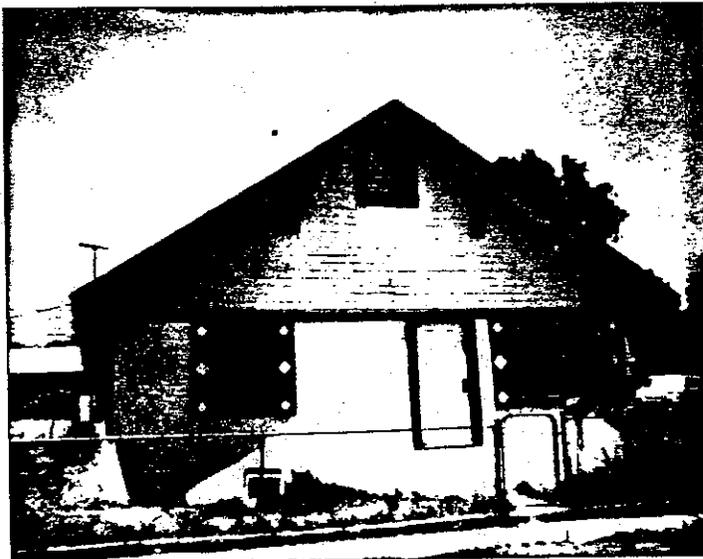
Rectangular in plan, this bungalow has a composition shingle gable roof, exposed rafters, double-hung windows in a bay window, two bands of windows, and purlins under the front gable which has a vent at its apex. Clapboard siding sheathes the house and concrete steps lead to the narrow front door.

13. Condition: Excellent ___ Good Fair ___ Deteriorated ___ No longer in existence ___
14. Alterations: Minor
15. Surroundings: (Check more than one if necessary) Open land ___ Scattered buildings ___ Densely built-up ___
Residential Industrial ___ Commercial ___ Other: ___
16. Threats to site: None known Private development ___ Zoning ___ Vandalism ___
Public Works project ___ Other: ___
17. Is the structure: On its original site? Moved? ___ Unknown? ___
18. Related features: Carport

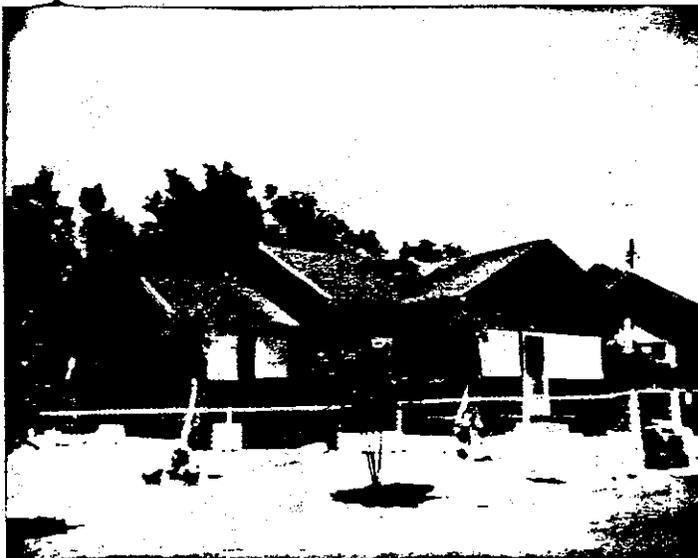
Rectangular in plan with an enclosed porch projecting to the front, this wood frame house has a composition shingle gable roof with central brick chimney, shiplap siding, double-hung windows, and a mullioned window-door (painted over) on the porch. Several of the windows are also painted over surrounding the house giving the structure a walled-in appearance. A lattice-work vent and purlins are found under the eaves at the front-facing gable.

13. Condition: Excellent ___ Good X Fair ___ Deteriorated ___ No longer in existence ___
14. Alterations: Minor - porch enclosed
15. Surroundings: (Check more than one if necessary) Open land ___ Scattered buildings ___ Densely built-up ___
Residential XX Industrial ___ Commercial ___ Other: ___
16. Threats to site: None known xxx Private development ___ Zoning ___ Vandalism ___
Public Works project ___ Other: ___
17. Is the structure: On its original site? xxx Moved? ___ Unknown? ___
18. Related features: Shed and fence.

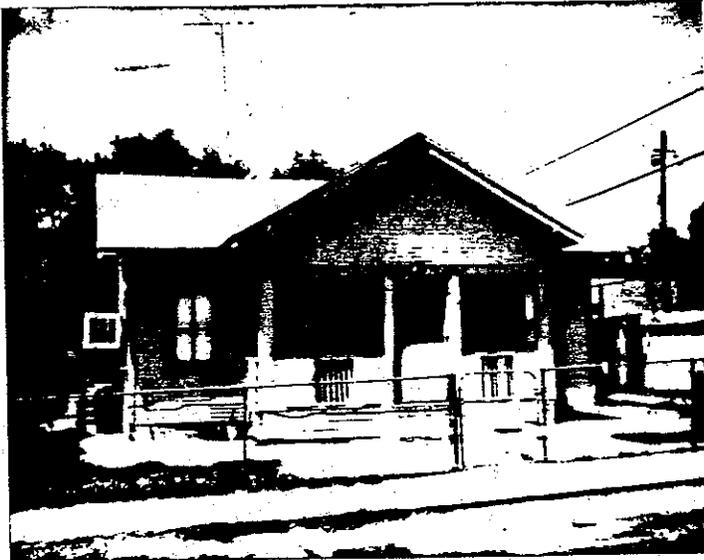
Rectangular in plan with an enclosed porch projecting to the front, this wood frame house has a composition gable roof, shiplap siding, double-hung windows, and vertical slat vents in the porch wall enclosure. A lattice-work vent and purlins are found under the eaves of the front facing gable.

13. Condition: Excellent ___ Good Fair ___ Deteriorated ___ No longer in existence ___
14. Alterations: Unaltered
15. Surroundings: (Check more than one if necessary) Open land ___ Scattered buildings ___ Densely built-up ___
 Residential Industrial ___ Commercial ___ Other: ___
16. Threats to site: None known Private development ___ Zoning ___ Vandalism ___
 Public Works project ___ Other: ___
17. Is the structure: On its original site? Moved? ___ Unknown? ___
18. Related features: Fence

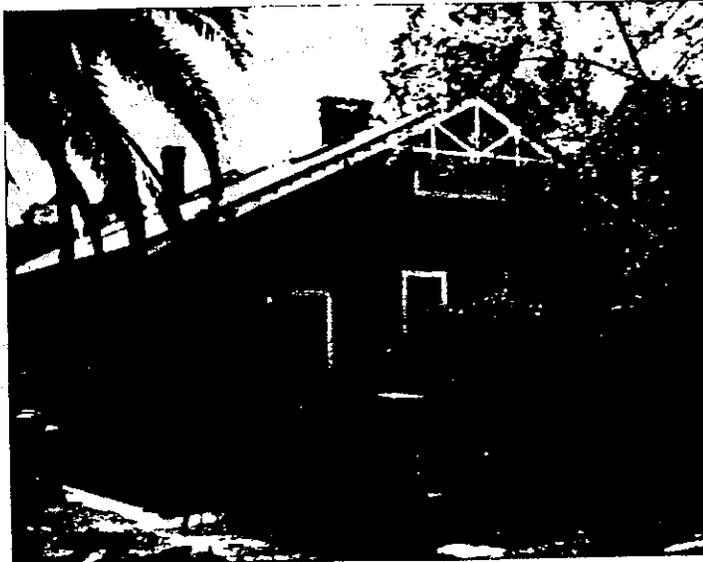
Square in plan, the single story bungalow at 214 N. Riley St. has a composition shingle gable roof, clapboard siding, tall mullioned windows, and a vent at the apex of the single front-facing gable. A corner porch with balustrade and turned porch posts faced to the side of the bungalow; more than the front. The interior has been extensively rehabilitated to its original hardwood floors, wood paneling, and other original decorative elements, with only the kitchen showing some modernization.

13. Condition: Excellent Good
14. Alterations: Unaltered
15. Surroundings: (Check more than one if necessary) Open land Scattered buildings Densely built-up
 Residential X Industrial Commercial Other:
16. Threats to site: None known X Private development Zoning Vandalism
 Public Works project Other:
17. Is the structure: On its original site? X Moved? Unknown?
18. Related features: none

This bungalow is in excellent condition and is a part of the Lake Elsinore historic downtown area.

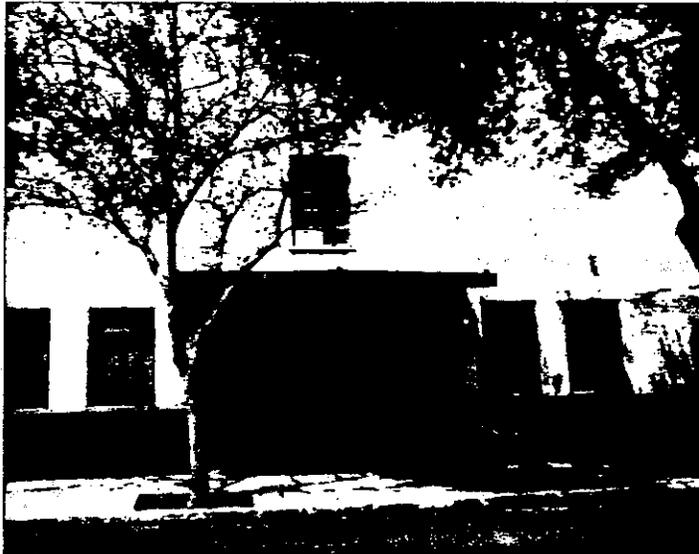
A single story structure, rectangular in plan, this building has housed several religious groups over the years. It has a composition shingle gable roof, stucco siding with mullioned windows, a false front, and semi-circular flat roofed portico over the front entrance.

13. Condition: Excellent _____ Good _____ Fair Deteriorated _____ No longer in existence _____
14. Alterations: None
15. Surroundings: (Check more than one if necessary) Open land _____ Scattered buildings _____ Densely built-up _____
Residential Industrial _____ Commercial Other: _____
16. Threats to site: None known Private development _____ Zoning _____ Vandalism _____
Public Works project _____ Other: _____
17. Is the structure: On its original site? Moved? _____ Unknown? _____
18. Related features: None

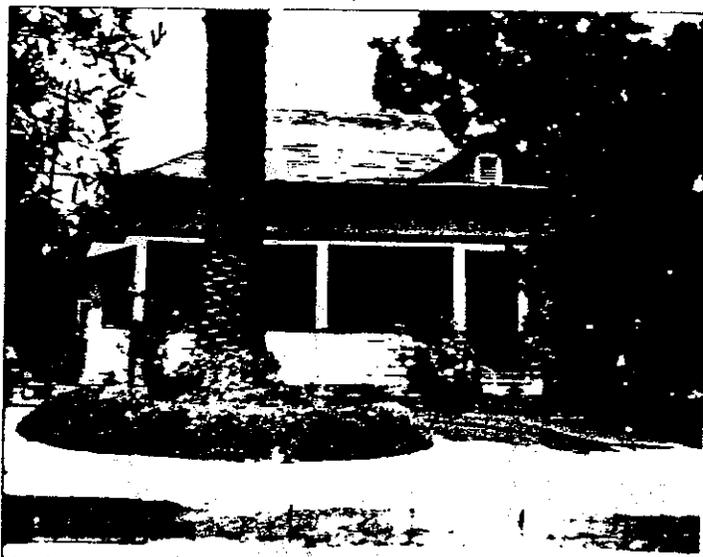
Rectangular in plan, this wood frame house has a composition shingle gablet roof, shingle and clapboard siding, mullioned windows and a porch across the entire front with five square porch posts. A gable dormer vent stands over the doorway entry to the porch. A large palm tree is placed in the center of the front yard, and a large shade tree stands at the right side of the house. A granite stone curb is found in front of the house.

13. Condition: Excellent ___ Good Fair ___ Deteriorated ___ No longer in existence ___
14. Alterations: Minor
15. Surroundings: (Check more than one if necessary) Open land ___ Scattered buildings ___ Densely built-up ___
Residential Industrial ___ Commercial ___ Other: ___
16. Threats to site: None known Private development ___ Zoning ___ Vandalism ___
Public Works project ___ Other: ___
17. Is the structure: On its original site? Moved? ___ Unknown? ___
18. Related features: None

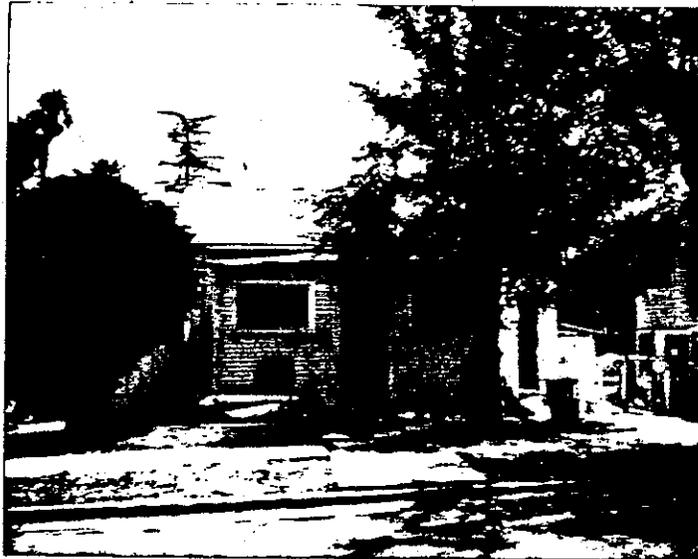
Irregular in plan, this wood frame house has a composition shingle gable roof, board and batten siding, and mullioned double-hung windows. The back of the house has a shed-roof addition, also in board and batten, with a low door. The front of the house has a hipped roof addition, with clapboard siding and metal awning over its four windows. Tall trees are in the property.

13. Condition: Excellent ___ Good XX Fair ___ Deteriorated ___ No longer in existence ___
14. Alterations: Major: additions to both front and back as well as side
15. Surroundings: (Check more than one if necessary) Open land ___ Scattered buildings ___ Densely built-up ___
Residential X Industrial ___ Commercial ___ Other: ___
16. Threats to site: None known X Private development ___ Zoning ___ Vandalism ___
Public Works project ___ Other: ___
17. Is the structure: On its original site? X Moved? ___ Unknown? ___
18. Related features: None

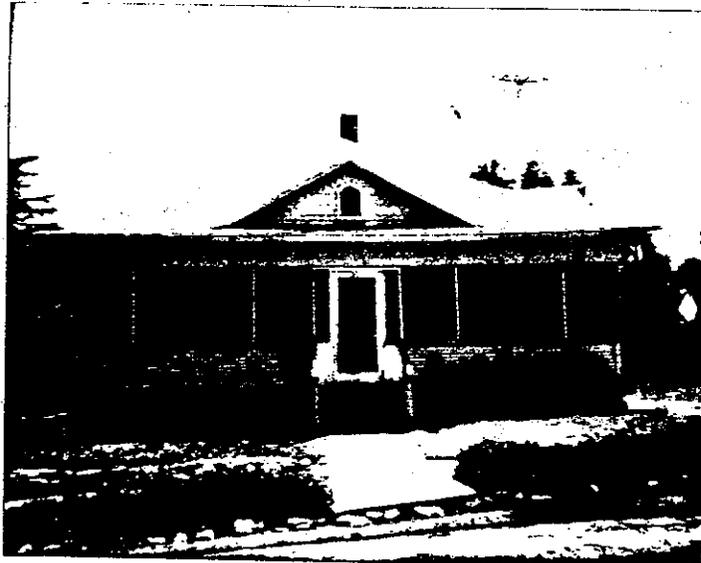
Square in plan with a basement opening to the rear, this one-story wood-frame house has a composition hip roof with dormer gable vents facing each side (fish-scale shingles on the front-facing one), central brick chimney, clapboard siding, mullioned windows, a screened-in porch with short wall and 6 Tuscan Order porch columns, as well as windows for light. A cement walkway leads to a centered screen door. A rock and cement retaining wall helps level the front yard of this house on a hill. The Henning family has occupied this home since 1943.

13. Condition: Excellent ___ Good X Fair ___ Deteriorated ___ No longer in existence ___
14. Alterations: Minor: porch enclosed, painted and landscaped.
15. Surroundings: (Check more than one if necessary) Open land ___ Scattered buildings ___ Densely built-up ___
Residential X Industrial ___ Commercial ___ Other: ___
16. Threats to site: None known X Private development ___ Zoning ___ Vandalism ___
Public Works project ___ Other: ___
17. Is the structure: On its original site? X Moved? ___ Unknown? ___
18. Related features: None
