ELSINORE VALLEY CDC

SURVEY OF HISTORICAL STRUCTURES AND SITES
Lake Elsinore, California 1991

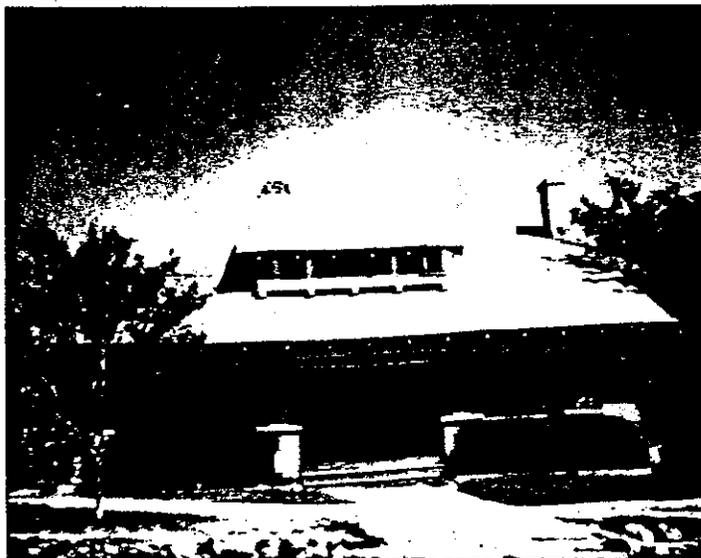
Rectangular in plan, this one-and-a-half story wood frame house has a composition shingle gable roof with an end brick corbeled top chimney and shed dormer windows with planter box, exposed rafters, purlins on the side gables, clapboard siding, mullioned windows, and a porch the length of the front with square porch columns, and two ballustrades. A chain link fence encloses a garden to the left of the house and tall trees grow on both sides. The home has been restored, both inside and out, and is a compliment to the owners as the structure was condemned when purchased by them.

13. Condition: Excellent Good Fair Deteriorated No longer in existence
4. Alterations: None
15. Surroundings: (Check more than one if necessary) Open land Scattered buildings Densely built-up
Residential Industrial Commercial Other: _____
16. Threats to site: None known Private development Zoning Vandalism
Public Works project Other: _____
17. Is the structure: On its original site? Moved? Unknown?
18. Related features: Garage

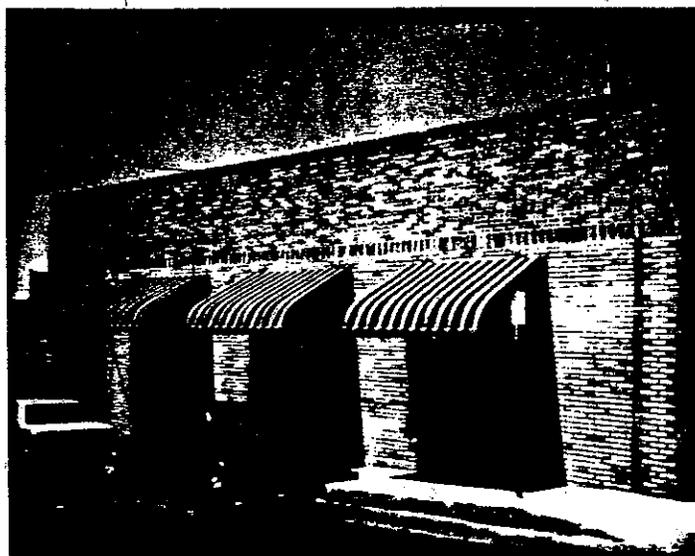
Rectangular in plan with a flat roof, this brick commercial building has a doorway at the left front corner, three large windows with iron railings and attractive awnings above facing Graham Avenue. It has brick dentils around the top of the building and has been recently (1990) restored by the owner.

13. Condition: Excellent Good _____ Fair _____ Deteriorated _____ No longer in existence _____
14. Alterations: Considerable: new window treatment, awnings, interior
15. Surroundings: (Check more than one if necessary) Open land _____ Scattered buildings _____ Densely built-up _____
Residential Industrial _____ Commercial Other: _____
16. Threats to site: None known Private development _____ Zoning _____ Vandalism _____
Public Works project _____ Other: _____
17. Is the structure: On its original site? Moved? _____ Unknown? _____
18. Related features: None

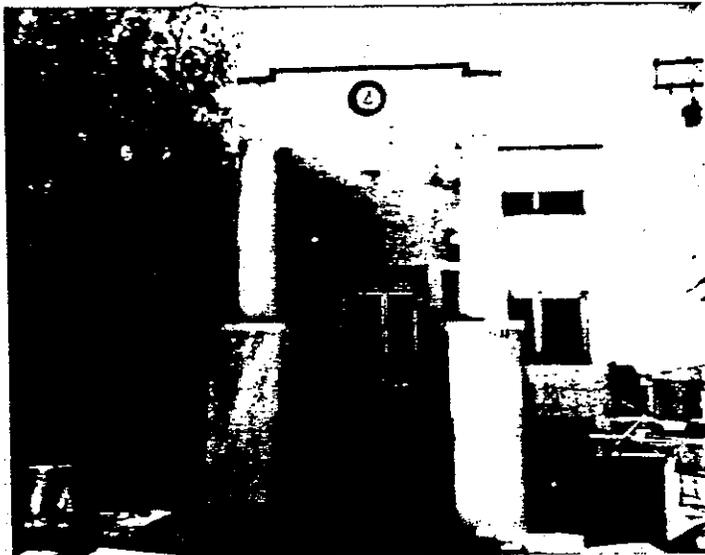
Rectangular in plan with a flat roof, the building at 120 E. Graham Ave. has a stucco facade with double-hung windows, a large portico with battered Tuscan order columns and square column supports, a double-door entry of glass with transom and sidelights, and low-to-the-ground windows for a half-sunken basement.

13. Condition: Excellent ___ Good X Fair ___ Deteriorated ___ No longer in existence ___
14. Alterations: None
15. Surroundings: (Check more than one if necessary) Open land ___ Scattered buildings ___ Densely built-up X
Residential ___ Industrial ___ Commercial ___ Other: _____
16. Threats to site: None known ___ Private development ___ Zoning ___ Vandalism X
Public Works project ___ Other: _____
17. Is the structure: On its original site? X Moved? ___ Unknown? ___
18. Related features: None

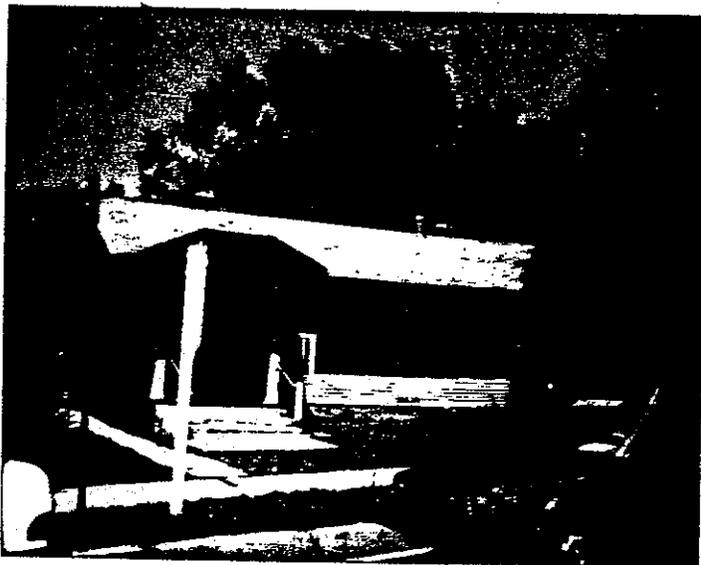
- 7a. Architectural style:
7b. Briefly describe the present physical description of the site or structure and describe any major alterations from its original condition:
U-shaped in plan with a composition-shingle roof, this bungalow duplex has shiplap siding with some plate glass and some double-hung windows and two small porches with square porch posts, exposed rafters and brick floors.

13. Condition: Excellent ___ Good^X ___ Fair ___ Deteriorated ___ No longer in existence ___
14. Alterations: Minor
15. Surroundings: (Check more than one if necessary) Open land ___ Scattered buildings ___ Densely built-up ___
Residential X Industrial ___ Commercial X Other: ___
16. Threats to site: None known X Private development ___ Zoning ___ Vandalism ___
Public Works project ___ Other: ___
17. Is the structure: On its original site? X Moved? ___ Unknown? ___
18. Related features: None

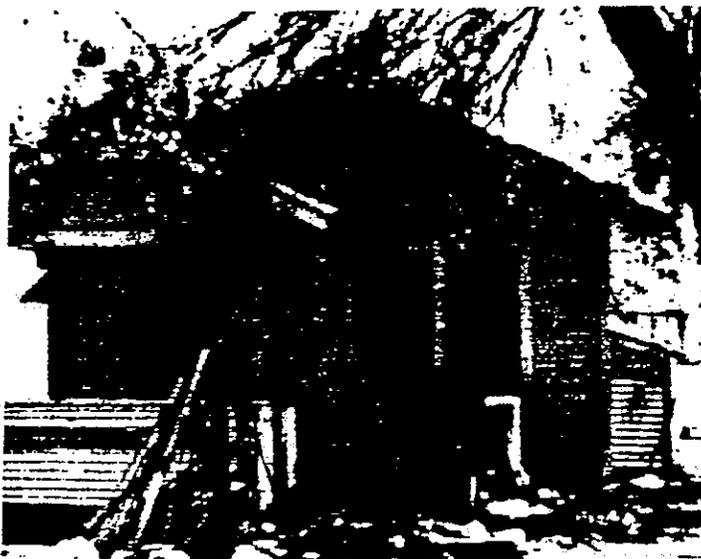
Rectangular in plan, with a composition shingle gable roof, this bungalow has vertical slat vents under both front-facing gables, shiplap siding with two plate glass windows, and a porch with square porch posts, exposed rafters and a short wall encompassing two sides.

13. Condition: Excellent ___ Good ___ Fair ^{XX} Deteriorated ___ No longer in existence ___
14. Alterations: Unaltered
15. Surroundings: (Check more than one if necessary) Open land ___ Scattered buildings ___ Densely built-up ___
Residential X Industrial ___ Commercial X Other: _____
16. Threats to site: None known XX Private development ___ Zoning ___ Vandalism ___
Public Works project ___ Other: _____
17. Is the structure: On its original site? XX Moved? ___ Unknown? ___
18. Related features: None

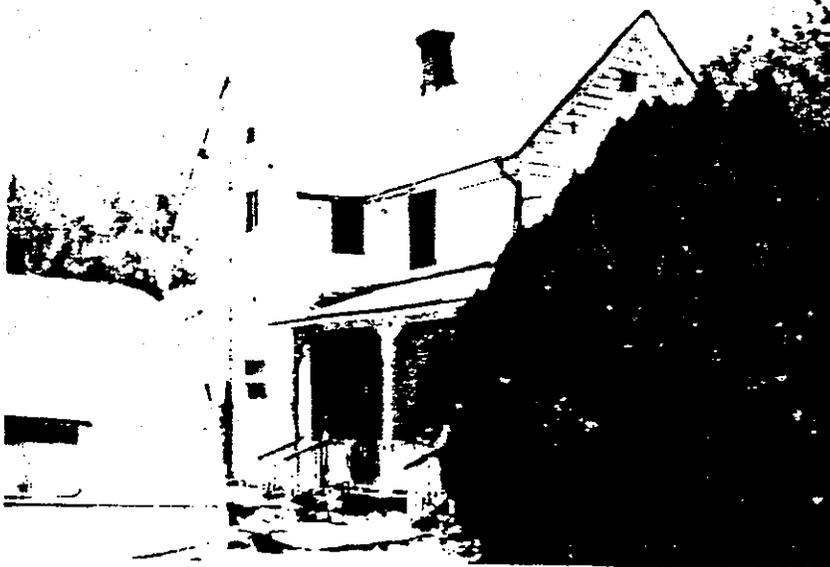
A two-story structure, L-shaped in plan, this house has a composition shingle gable roof with central brick chimney, clapboard siding, three turned porch posts with knobs, fan-like brackets, tall double-hung windows, and small vents under each gable. A shed roof has been added to the porch which had a flat roof which served as a balcony; a second story door is now blocked by this roof. Tall trees and foliage surround three sides of this Victorian style house. It is located on two adjacent lots.

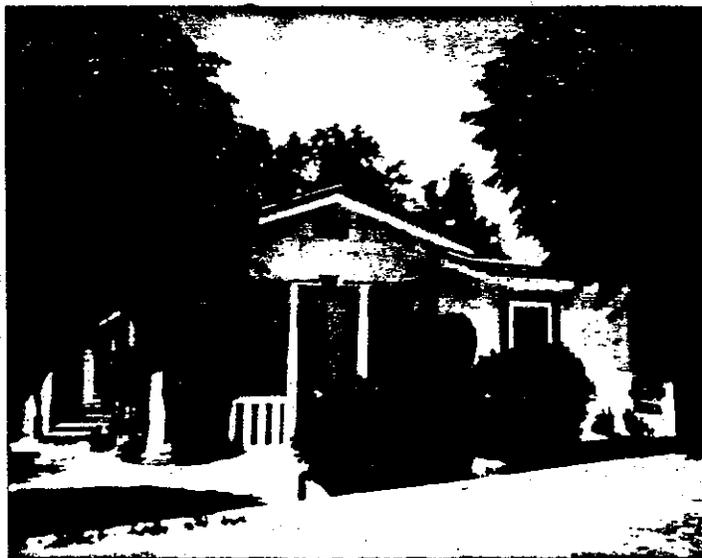
Irregular in plan with gable and shed roofs, this house has asbestos shingle siding, a centered door flanked by two double-hung windows, room extensions on both sides, and a porch with square porch posts and short slat balustrades.

The front yard is concrete with tall trees flanking the parcel. The house has been recently painted in a red and white manner (White walls and red detailing around the windows, trim and door).

13. Condition: Excellent XX Good _____ Fair _____ Deteriorated _____ No longer in existence _____
14. Alterations: None noted.
15. Surroundings: (Check more than one if necessary) Open land _____ Scattered buildings _____ Densely built-up _____
Residential X Industrial _____ Commercial _____ Other: _____
16. Threats to site: None known _____ X Private development _____ Zoning _____ Vandalism _____
Public Works project _____ Other: _____
17. Is the structure: On its original site? X Moved? _____ Unknown? _____
18. Related features: None except for garage

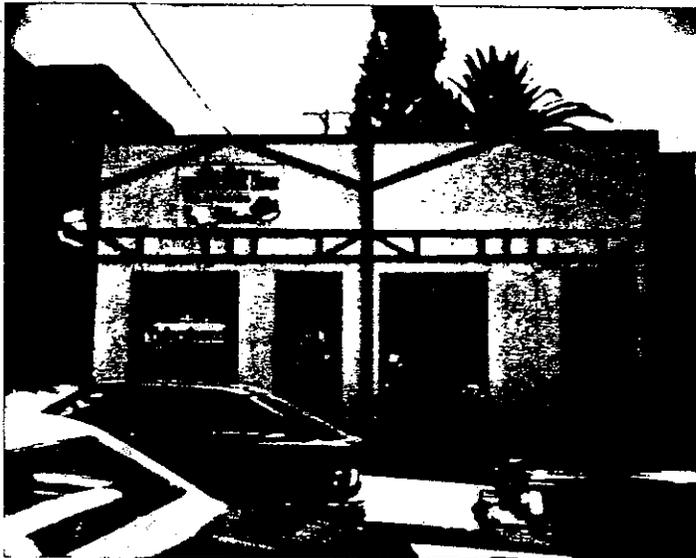
Rectangular in plan with a flat roof and parapet, the brick building has a stucco facade with wooden trim in geometric designs over the windows and entrances. From left to right, there is a square plate glass window with two small transom windows above it, a glass windowed door with a small transom window above it, a second square plate glass window like the first, and a second door with a window and a small transom over it. A sign over the window to the left identifies the business establishment located there (1990).

13. Condition: Excellent ___ Good Fair ___ Deteriorated ___ No longer in existence ___
14. Alterations: None except for wooden geometric designs above.
15. Surroundings: (Check more than one if necessary) Open land ___ Scattered buildings ___ Densely built-up ___
Residential ___ Industrial ___ Commercial Other: _____
16. Threats to site: None known Private development ___ Zoning ___ Vandalism ___
Public Works project ___ Other: _____
17. Is the structure: On its original site? Moved? ___ Unknown? ___
18. Related features: None

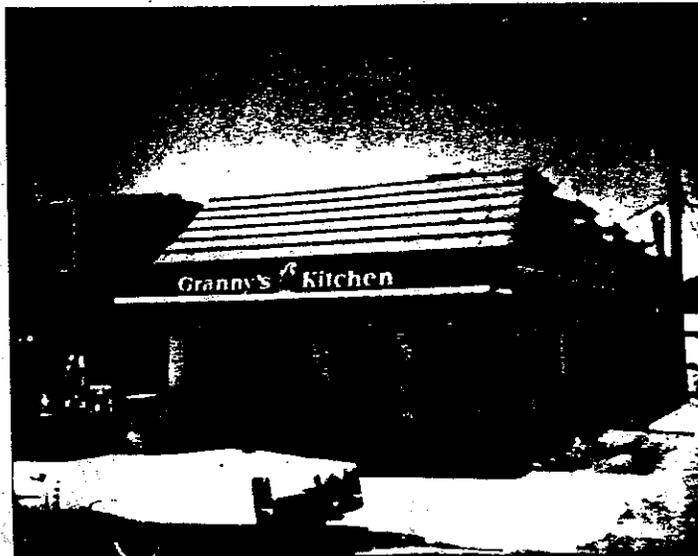
Rectangular in plan with a flat roof and shingle shed roof awning, this building has stucco siding, two plate glass windows flanking a glass door, side windows with vents added to some of them, and a sign on the overhead awning identifying this business establishment.

13. Condition: Excellent ___ Good ^{XX} Fair ___ Deteriorated ___ No longer in existence ___
14. Alterations: Minor, awning added
15. Surroundings: (Check more than one if necessary) Open land ___ Scattered buildings ___ Densely built-up ___
 Residential ___ Industrial ___ Commercial ^{XX} Other: ___
16. Threats to site: None known Private development ___ Zoning ___ Vandalism ___
 Public Works project ___ Other: ___
17. Is the structure: On its original site? Moved? ___ Unknown? ___
18. Related features: None

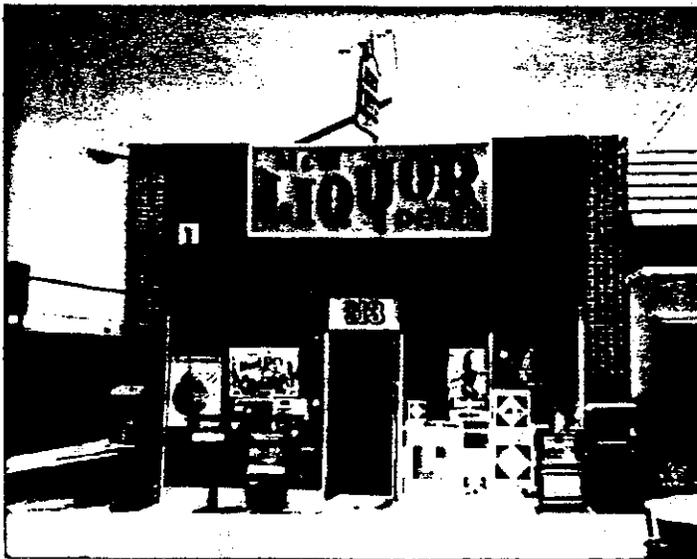
Rectangular in plan, this building has a flat roof, brick side walls, two plate glass windows flanking the center glass door, added wood paneling over the windows and door, and a large sign identifying the "M & M LIQUOR DELI" over the front of the structure. A telephone (public) and several news racks are on the street to the front. Two bricked pillars flank the building.

13. Condition: Excellent ___ Good X Fair ___ Deteriorated ___ No longer in existence ___
14. Alterations: Major: front glass doors and wood trim
15. Surroundings: (Check more than one if necessary) Open land ___ Scattered buildings ___ Densely built-up ___
Residential ___ Industrial ___ Commercial XX Other: ___
16. Threats to site: None known ___ X Private development ___ Zoning ___ Vandalism ___
Public Works project ___ Other: ___
17. Is the structure: On its original site? X Moved? ___ Unknown? ___
18. Related features: None

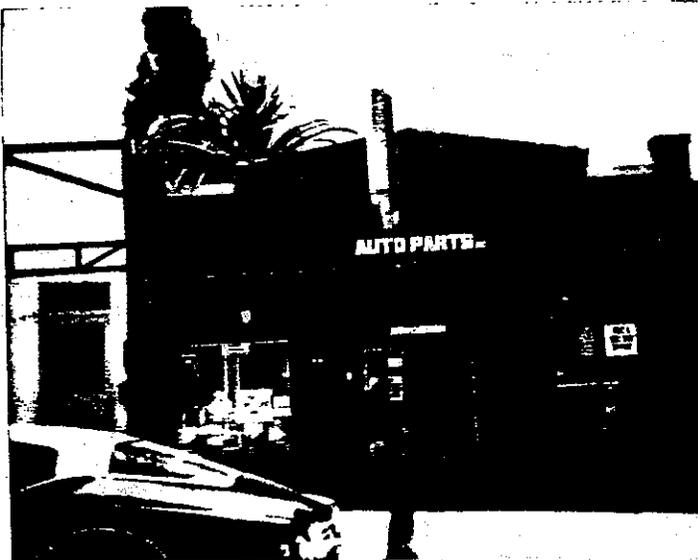
Rectangular on plan with a flat roof, this brick building has a false front gable with shoulders, stucco over brick with two vents, a painted-over horizontal row of vertical glass panes, double mullioned window doors flanked by four plate glass windows, two parallel to the store facade and two diagonal to it, and a fluorescent sign identifying the business located there.

13. Condition: Excellent ___ Good XX Fair ___ Deteriorated ___ No longer in existence ___
14. Alterations: None
15. Surroundings: (Check more than one if necessary) Open land ___ Scattered buildings ___ Densely built-up ___
Residential ___ Industrial ___ Commercial XX Other: ___
16. Threats to site: None known XXX Private development ___ Zoning ___ Vandalism ___
Public Works project ___ Other: ___
17. Is the structure: On its original site? XX Moved? ___ Unknown? ___
18. Related features: None

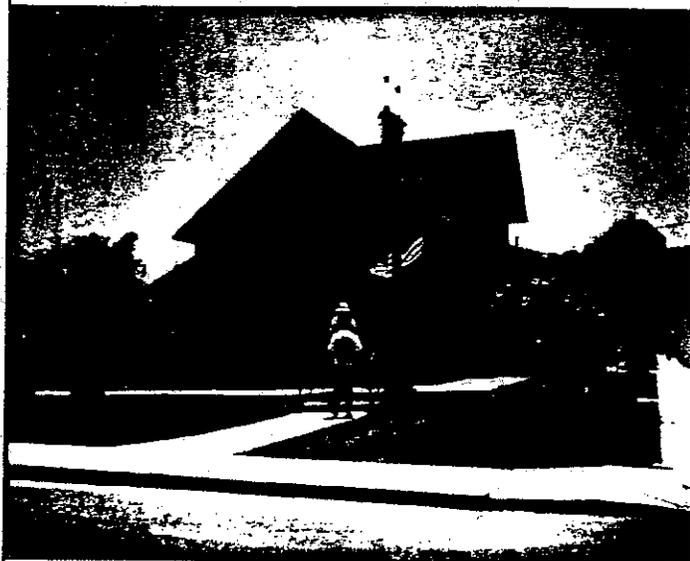
T-shaped in plan, this building at 132 West Graham Ave. has a composition shingle-gable roof, clapboard siding and some diamond-pattern siding (1981) a rectangular vent in each end gable and a triangular one in the side gable facing the tracks, purlins this side gable, a hip-roofed bay window with mullioned windows, and a chimney with corbeled cap. An end circular porch shown in an 1899 picture is missing today. The entire building was rebuilt by the City of Lake Elsinore in 1988 with air-conditioning, new toilet facilities and other amenity updates. A handcar of early vintage has been placed on a portion of the original railroad track to the east of the structure. It was built in 1896 by Dickey and Charles Merrifield. It is on a site measuring 120' in frontage with 135' in depth. The photos below were taken on July 30, 1990.

13. Condition: Excellent Good Fair Deteriorated No longer in existence
14. Alterations: Numerous in 1988.
15. Surroundings: (Check more than one if necessary) Open land Scattered buildings Densely built-up
Residential Industrial Commercial Other:
16. Threats to site: None known Private development Zoning Vandalism
Public Works project Other:
17. Is the structure: On its original site? Moved? Unknown?
18. Related features: none

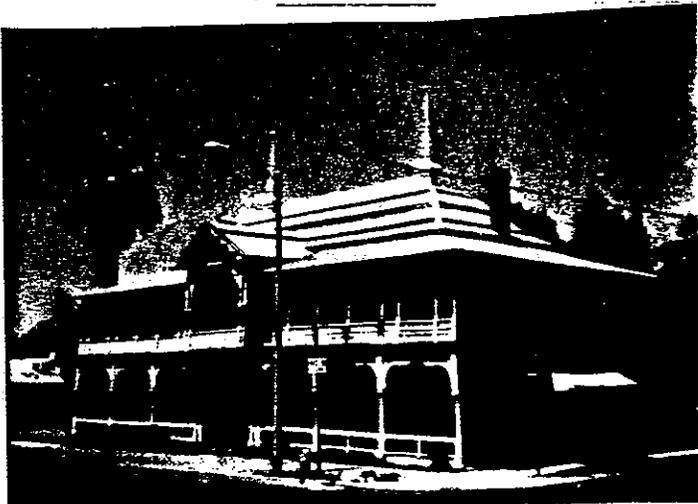
7b. Briefly describe the present *physical description* of the site or structure and describe any major alterations from its original condition: Shaped like a capital "J" with the front facade being the top of the "J", the "Chimes", as it is known today, is two stories high with verandas on both stories across the front and both sides. The hip roof is curvilinear near the top and at a lower-pitched plane near the bottom. Roof cresting runs along the top of the hip with very tall finials at each end. Completing the symmetrical roof arrangement are two brick chimneys with corbeled caps. The walls are sheathed with vertical redwood siding, interspersed with very tall mullioned double-hung windows. Each window has a clear center pane surrounded by stained glass cut in three-inch squares. Each story has a centered double door with the same stained-glass mullioned windows. Seven arches are on the first floor, each having bracket-shaped brackets. The second story has smaller semi-circular arches. A two-tiered portico with gabled roof is centered over both doorways.

Turned posts support the arches on both stories; while the first story has a simple railing between these posts, the second story has a very elaborate balustrade between them.

13. Condition: Excellent ___ Good XX Fair ___ Deteriorated ___ No longer in existence ___
14. Alterations: None
15. Surroundings: (Check more than one if necessary) Open land ___ Scattered buildings ___ Densely built-up ___
Residential ___ Industrial ___ Commercial X Other: ___
16. Threats to site: None known X Private development ___ Zoning ___ Vandalism ___
Public Works project ___ Other: ___
17. Is the structure: On its original site? yes Moved? ___ Unknown? ___
18. Related features: None

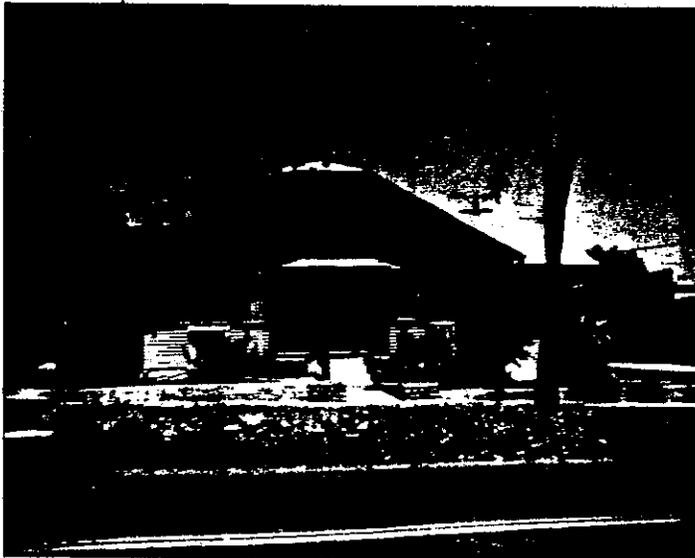
T-Shaped in plan with a composition shingle, hipped gable roof, this bungalow duplex has exposed rafters, a central brick chimney, clapboard siding double-hung and new aluminum frame windows, two doors centered under three vents at the apex of the hipped gable, and cement steps leading to these doors. A wing with hipped gable extends to the right on this corner lot and a short brick retaining wall helps to level the front yard.

13. Condition: Excellent ___ Good ___ ^XFair ___ Deteriorated ___ No longer in existence ___
14. Alterations: Minor: windows changed
15. Surroundings: (Check more than one if necessary) Open land ___ Scattered buildings ___ Densely built-up ___
 Residential ^{XX} Industrial ___ Commercial ^{XX} Other: _____
16. Threats to site: None known ___ ^XPrivate development ___ Zoning ___ Vandalism ___
 Public Works project ___ Other: _____
17. Is the structure: On its original site? ^X Moved? ___ Unknown? ___
18. Related features: None

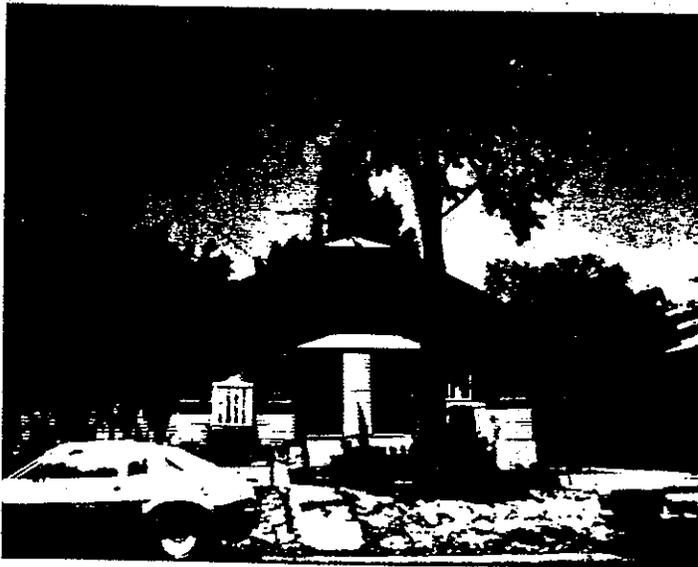
Rectangular in plan with a composition shingle hipped gable roof, the bungalow duplex at 403 W. Graham Ave. has exposed rafters, a central brick chimney, clapboardsiding, double-hung and newer aluminum frame windows, two doors centered under three vents at the apex of the hipped gable, and cement steps leading to these doors. A patio awning is at the right side of the house and a short brick retaining wall helps level the front yard.

13. Condition: Excellent ___ Good ___ Fair ___ Deteriorated ___ No longer in existence ___
14. Alterations: Minor
15. Surroundings: (Check more than one if necessary) Open land ___ Scattered buildings ___ Densely built-up ___
Residential Industrial ___ Commercial ___ Other: ___
16. Threats to site: None known ___ Private development ___ Zoning ___ Vandalism ___
Public Works project ___ Other: ___
17. Is the structure: On its original site? Moved? ___ Unknown? ___
18. Related features: Garage, wall

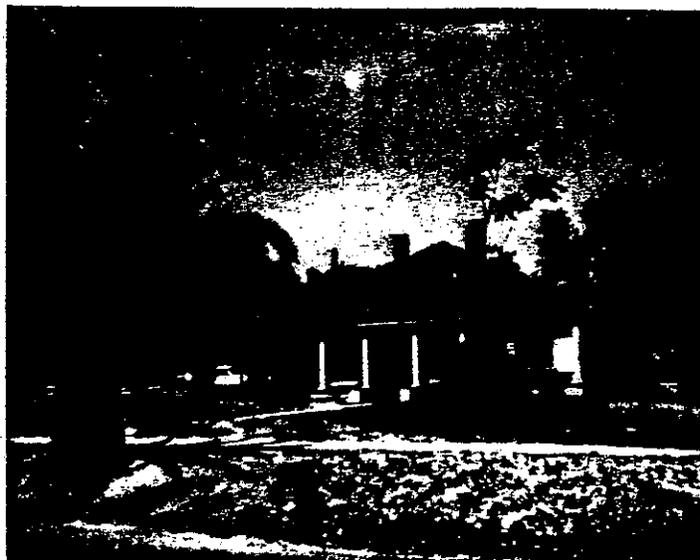
Square in plan, this vernacular brick house has a hipped roof with two corbel capped brick chimneys on either side of the hip apex, composition shingle roofing, walls constructed of terra cotta tile made originally as conduits for telephone lines, and an encircling veranda that has been enclosed on the right side with a wood-frame, brick base, room addition. Colonial Revival elements are present in the six Tuscan columns symmetrically placed along the front veranda and the center door flanked symmetrically by two large double-hung windows. Large bushes and tall trees are found in the yard and a very old garage is in the back.

13. Condition: Excellent ___ Good XX Fair ___ Deteriorated ___ No longer in existence ___
14. Alterations: Unaltered
15. Surroundings: (Check more than one if necessary) Open land ___ Scattered buildings ___ Densely built-up ___
 Residential X Industrial ___ Commercial X Other: _____
16. Threats to site: None known X Private development ___ Zoning ___ Vandalism ___
 Public Works project ___ Other: _____
17. Is the structure: On its original site? X Moved? ___ Unknown? ___
18. Related features: None

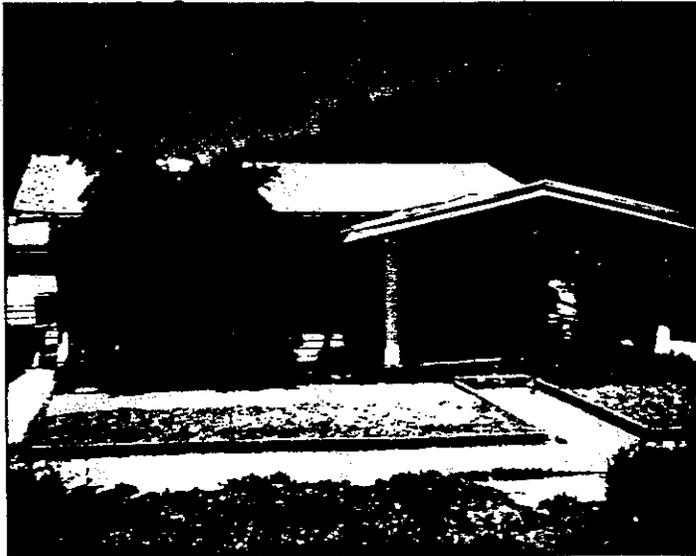
Rectangular in plan with an extended gabled entry and a low-pitched gable veranda with square porch columns, this bungalow has a low-pitched, composition shingled roof, exposed rafters, clapboard siding, double-hung windows, and two entrances. On a corner lot, the house seems to face both streets. Tall trees, low brick retaining walls, and a wood fence in the back make up the surroundings. The house is recently painted and well-maintained.

13. Condition: Excellent ___ Good ___ X Fair ___ Deteriorated ___ No longer in existence ___
14. Alterations. None
15. Surroundings: (Check more than one if necessary) Open land ___ Scattered buildings ___ Densely built-up ___
Residential ___ Industrial ___ Commercial XX Other: ___
16. Threats to site: None known ___ X Private development ___ Zoning ___ Vandalism ___
Public Works project ___ Other: ___
17. Is the structure: On its original site? X ___ Moved? ___ Unknown? ___
18. Related features: None

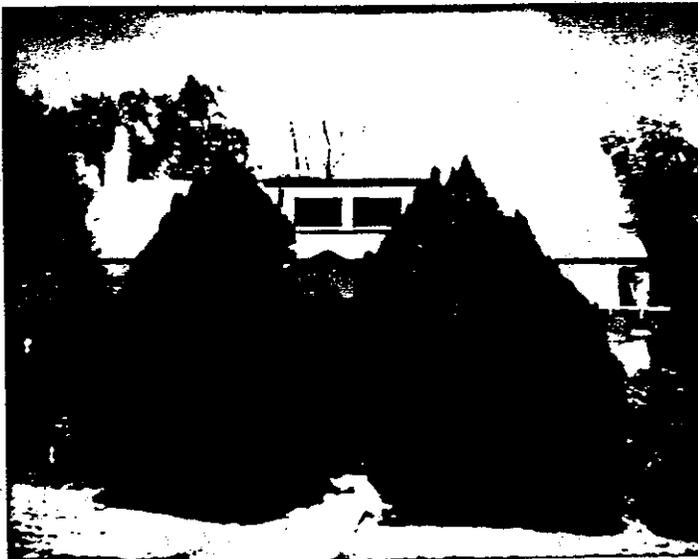
Rectangular in plan with a composition gable roof, the one-and-a-half story house at 505 W. Graham Ave. has a shed dormer window, clapboard siding with double-hung and mullioned windows, a plain cornice with short brackets, and a gabled porch with square pilasters and arch. Tall trees surround this house.

13. Condition: Excellent ___ Good Fair ___ Deteriorated ___ No longer in existence ___
14. Alterations: No major ones.
15. Surroundings: (Check more than one if necessary) Open land ___ Scattered buildings ___ Densely built-up ___
Residential Industrial ___ Commercial Other: ___
16. Threats to site: None known Private development ___ Zoning ___ Vandalism ___
Public Works project ___ Other: ___
17. Is the structure: On its original site? ___ Moved? ___ Unknown? ___
18. Related features: None

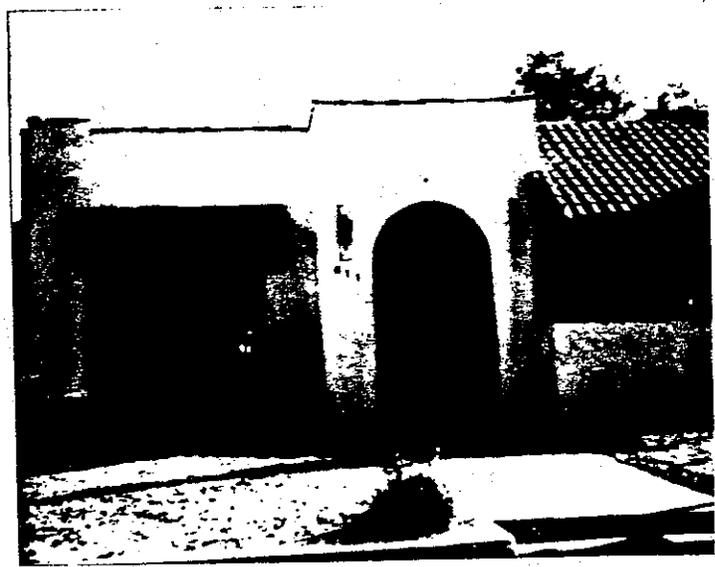
This house is rectangular in plan and has a flat roof with parapets surrounding it, stucco siding, a mullioned window door enclosed by an arched entryway, four tall eight-paned casement windows under a tile awning on the left and the same side by side windows on the felt, but covered by a tile shed roof over a screened in porch area.

13. Condition: Excellent ___ Good xx Fair ___ Deteriorated ___ No longer in existence ___
14. Alterations: Unaltered
15. Surroundings: (Check more than one if necessary) Open land ___ Scattered buildings ___ Densely built-up ___
Residential ___ X Industrial ___ Commercial x Other: ___
16. Threats to site: None known xx Private development ___ Zoning ___ Vandalism ___
Public Works project ___ Other: ___
17. Is the structure: On its original site? xx Moved? ___ Unknown? ___
18. Related features: None

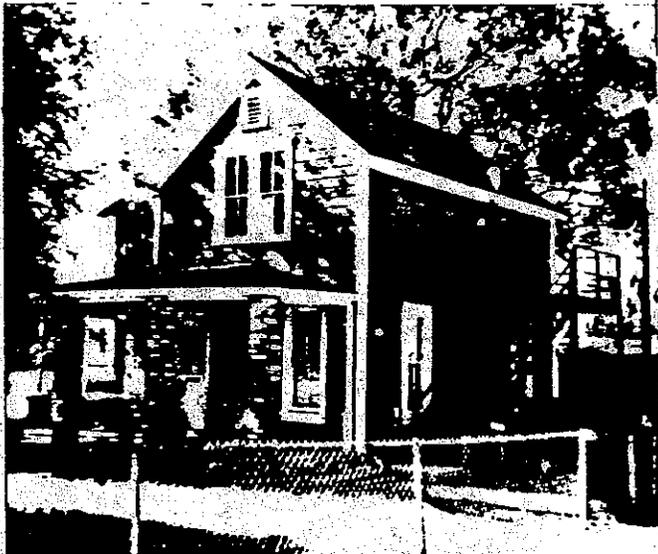
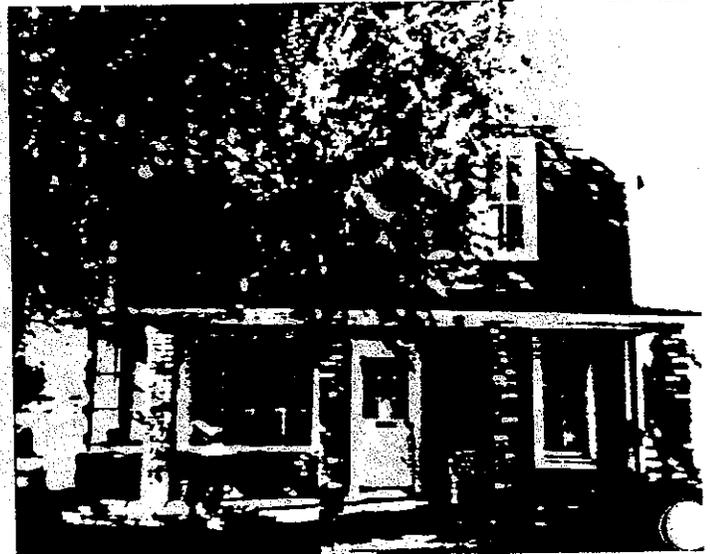
Rectangular in plan, the former L-shaped, two-story, vernacular ranch house at 700 W. Graham Ave. has a composition shingle gable roof on the main house and a composition hip roof on the porch addition with its used fireplace, brick, porch columns, tongue-in-groove siding (possibly redwood), large mullioned double-hung windows with lintel-type window heads, a center door with drip board similar to the window heads, and a staircase addition to the right for second story access. A vent with horizontal slats is found at the apex of the front-facing gable. Set well back from the street, this house has tall trees surrounding it and a large windowed addition to the left.

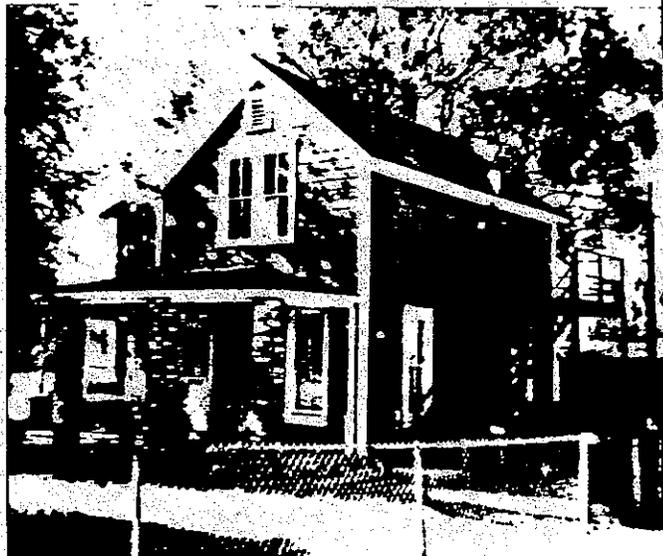
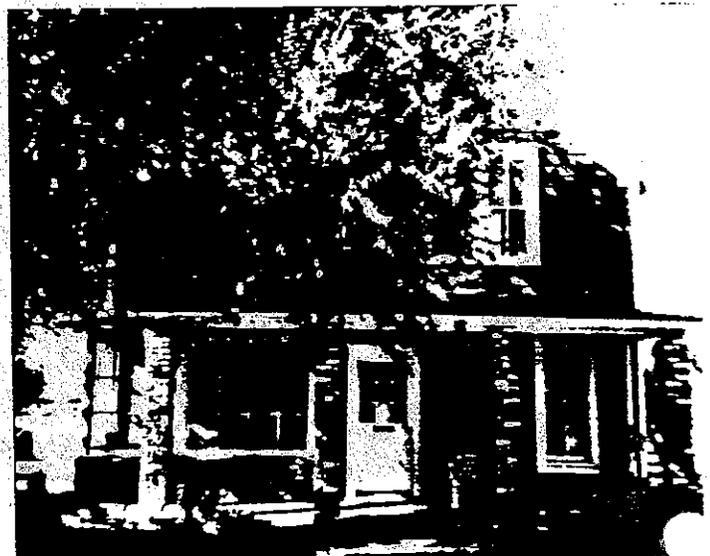
Rectangular in plan, the former L-shaped, two-story, vernacular ranch house at 700 W. Graham Ave. has a composition shingle gable roof on the main house and a composition hip roof on the porch addition with its used fireplace, brick, porch columns, tongue-in-groove siding (possibly redwood), large mullioned double-hung windows with lintel-type window heads, a center door with drip board similar to the window heads, and a staircase addition to the right for second story access. A vent with horizontal slats is found at the apex of the front-facing gable. Set well back from the street, this house has tall trees surrounding it and a large windowed addition to the left.

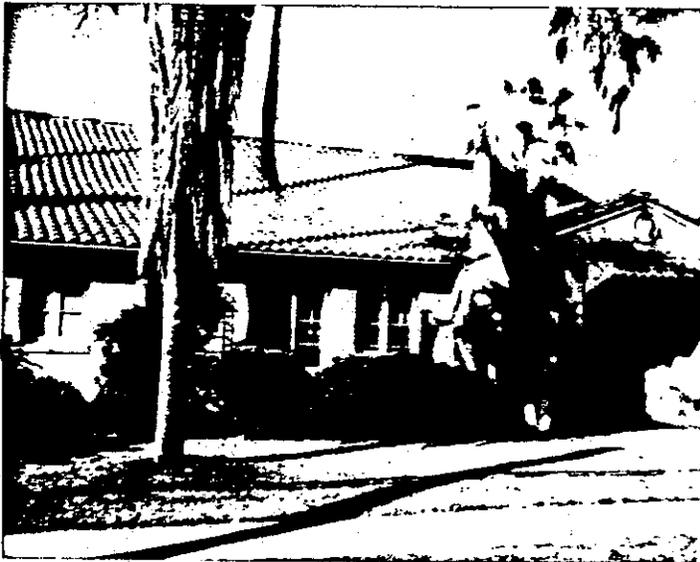
Rectangular in plan, Mediterranean/Spanish in style, the Elsinore Women's Clubhouse at 710 W. Graham Ave. has a gable Spanish tile roof, stucco siding, mullioned rectangular and arched windows, and a stuccoed chimney to the left of the front portico. The interior has hardwood floors, a large meeting room with stage, and a large kitchen for banquets. Tall palm trees surround the building.

13. Condition: Excellent Good Fair Deteriorated No longer in existence
14. Alterations: None
15. Surroundings: (Check more than one if necessary) Open land Scattered buildings Densely built-up
Residential Industrial Commercial Other: _____
16. Threats to site: None known Private development Zoning Vandalism
Public Works project Other: _____
17. Is the structure: On its original site? Moved? Unknown?
18. Related features: None

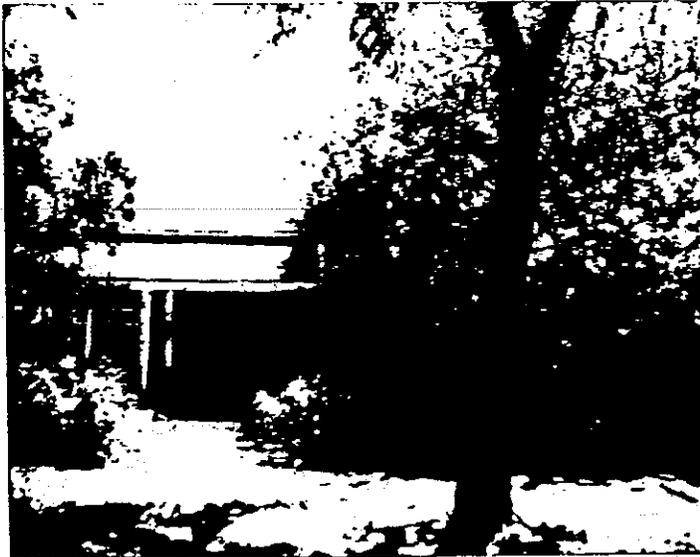
L-shaped in plan, the house at 800 W. Graham Ave. has a composition shingle gable roof, tongue-in-groove siding, double-hung windows, and a hip roofed veranda. A garage sits behind the house which is surrounded by tall trees.

13. Condition: Excellent ___ Good XX Fair ___ Deteriorated ___ No longer in existence ___
14. Alterations: Minor
15. Surroundings: (Check more than one if necessary) Open land ___ Scattered buildings ___ Densely built-up ___
Residential XX Industrial ___ Commercial ___ Other: ___
16. Threats to site: None known X Private development ___ Zoning ___ Vandalism ___
Public Works project ___ Other: ___
17. Is the structure: On its original site? X Moved? ___ Unknown? ___
18. Related features: None - Garage

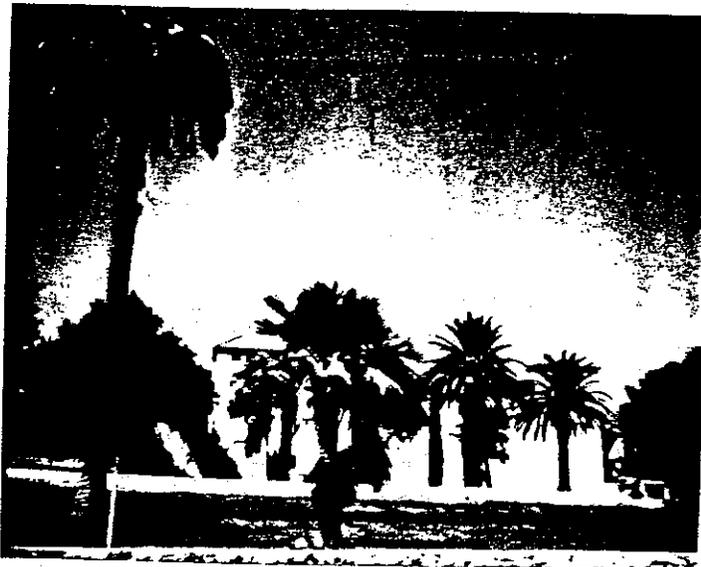
A two-story Mediterranean/Spanish Revival structure, this school building has a tile hip roof with end towers, arched windows, and stuccoed walls. Most of the large windows have been closed up in an extensive remodeling done in the early 1960's when this former senior high school was converted to a junior high school as the new high school was constructed on Canyon Drive at the southern end of the lake. Interior alterations are extensive since classrooms were made out of what once was a gymnasium and other spaces were converted for similar use.

13. Condition: Excellent ___ Good X Fair ___ Deteriorated ___ No longer in existence ___
14. Alterations: Major. Front windows concrete over. Much inside changed.
15. Surroundings: (Check more than one if necessary) Open land ___ Scattered buildings ___ Densely built-up X
 Residential X Industrial ___ Commercial X Other: _____
16. Threats to site: None known ___ Private development ___ Zoning ___ Vandalism ___
 Public Works project X Other: _____
17. Is the structure: On its original site? X Moved? ___ Unknown? ___
18. Related features: Wall

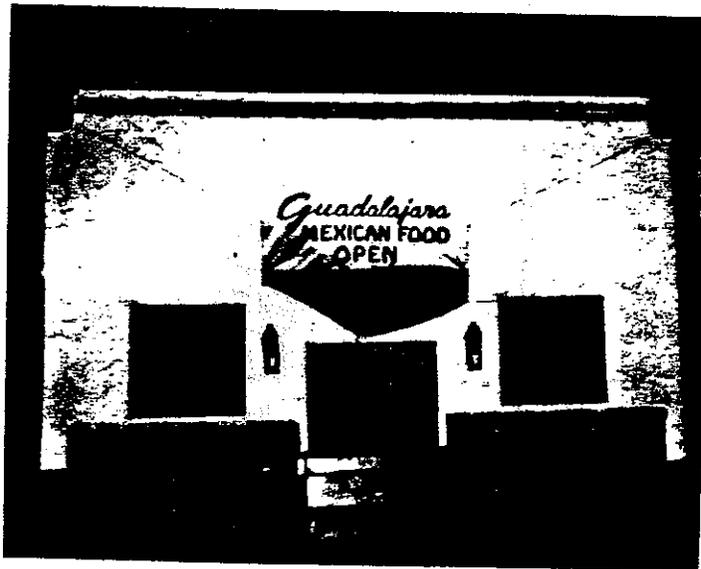
Rectangular in plan, this building is made up of two previous units, 195 and 107 North Main St. It has a new stucco facade with a double door entrance flanked by two multipaned windows. It was completely rehabilitated in 1989-90 as a part of the Lake Elsinore Redevelopment Agency plans for downtown upgrading. The wondows are above rectangles of brickwork.

13. Condition: Excellent _____ Good _____ Fair _____ Deteriorated _____ No longer in existence _____
14. Alterations: _____ Major new facia and interior improvements _____
15. Surroundings: (Check more than one if necessary) Open land _____ Scattered buildings _____ Densely built-up _____
 Residential _____ Industrial _____ Commercial Other: _____
16. Threats to site: None known Private development _____ Zoning _____ Vandalism _____
 Public Works project _____ Other: _____
17. Is the structure: On its original site? Moved? _____ Unknown? _____
18. Related features: _____ none _____

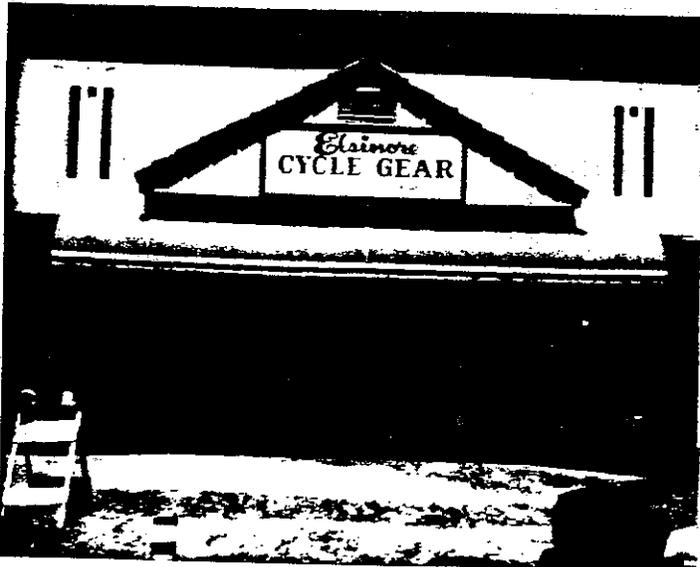
Rectangular in plan with a flat roof and brick walls flanking the centered door, this building is located adjacent to a small City-owned park at the intersection of Graham Avenue and Main St. A stucco facade is above the lower portion of the front of the structure with a tiled over hang above a sign designating the business occupant. This was remodeled in 1989-90 during the City Redevelopment Agency's Downtown upgrading. A green awning now covers the front of the building in line with the theme of downtown Lake Elsinore.

13. Condition: Excellent Good _____ Fair _____ Deteriorated _____ No longer in existence _____
14. Alterations: Numerous to the front
15. Surroundings: (Check more than one if necessary) Open land _____ Scattered buildings _____ Densely built-up _____
Residential _____ Industrial _____ Commercial Other: _____
16. Threats to site: None known _____ Private development _____ Zoning _____ Vandalism _____
Public Works project _____ Other: _____
17. Is the structure: On its original site? Moved? _____ Unknown? _____
18. Related features: None

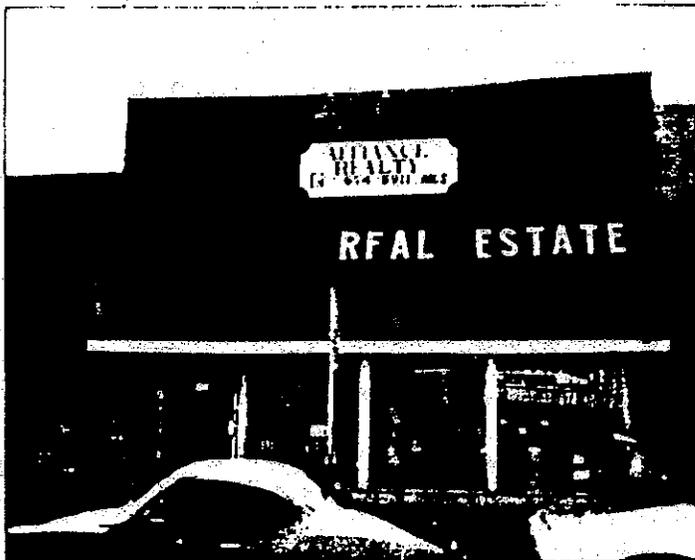
Rectangular in plan with a flat roof, this bldg. is really part of a single building including its neighbor at 102 S. Main. With a new wood shingle facade and new plate glass windows, only the structural frame of this building has retained its original architectural integrity.

13. Condition: Excellent Good Fair Deteriorated No longer in existence
14. Alterations: minor - windows changed
15. Surroundings: (Check more than one if necessary) Open land Scattered buildings Densely built-up Residential Industrial Commercial Other:
16. Threats to site: None known Private development Zoning Vandalism Other:
17. Is the structure: On its original site? Moved? Unknown?
18. Related features: none
- SIGNIFICANCE
19. Briefly state historical and/or architectural importance (include dates, events, and persons associated with the site). This bldg. is a part of the LE downtown historic area. It served as the Hib Stuart Furniture store until 1960 and became the real estate office of Jerry Harmatz in 1963.

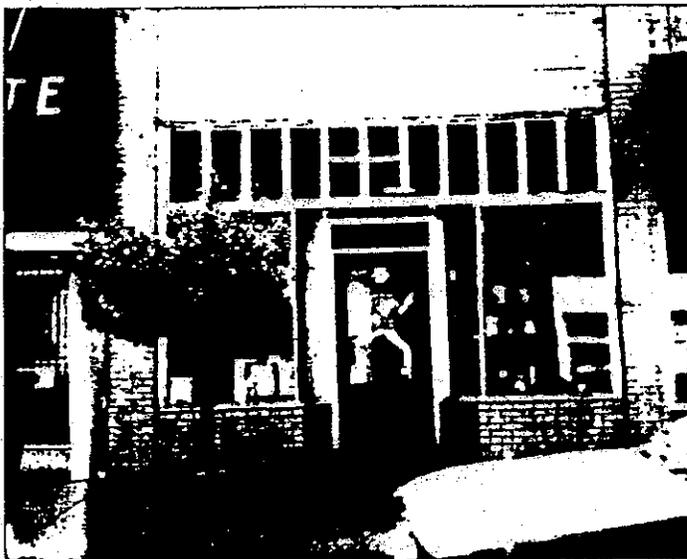
Rectangular in plan with a flat roof, this bldg. is really the left third of a single brick building that includes 110 and 112 S. Main Street. This section has a painted brick facade with a single windowed door entry, four plate glass windows over short brick walls and a horizontal row of vertical panes of opaque glass.

13. Condition: Excellent Good Fair Deteriorated No longer in existence
14. Alterations: Major - new front added
15. Surroundings: (Check more than one if necessary) Open land Scattered buildings Densely built-up Residential Industrial Commercial Other:
16. Threats to site: None known Private development Zoning Vandalism Other:
17. Is the structure: On its original site? Moved? Unknown?
18. Related features: None
- SIGNIFICANCE
19. Briefly state historical and/or architectural importance (include dates, events, and persons associated with the site).
- This bldg. is a part of the LE downtown historical area. It has been used for a wide range of commercial ventures over the years including a dress shop and souvenir store.

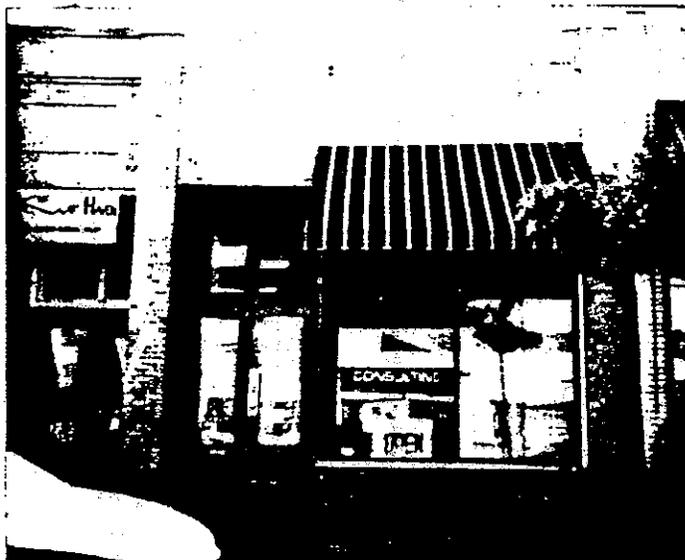
Rectangular in plan with a flat roof, this bldg. is the right third of a single brick bldg that includes 110, and 108 S. Main St. This section has a painted brick facade, a double-door entry and transom windows. It also has a mullioned plate glass window and a newly (1990) added blue striped awning.

13. Condition: Excellent ___ Good ^{XX} Fair ___ Deteriorated ___ No longer in existence ___
14. Alterations: awnings and brick facade painted
15. Surroundings: (Check more than one if necessary) Open land ___ Scattered buildings ___ Densely built-up ___
 Residential ___ Industrial ___ Commercial X Other: ___
16. Threats to site: None known X Private development ___ Zoning ___ Vandalism ___
 Public Works project ___ Other: ___
17. Is the structure: On its original site? X Moved? ___ Unknown? ___
18. Related features: none

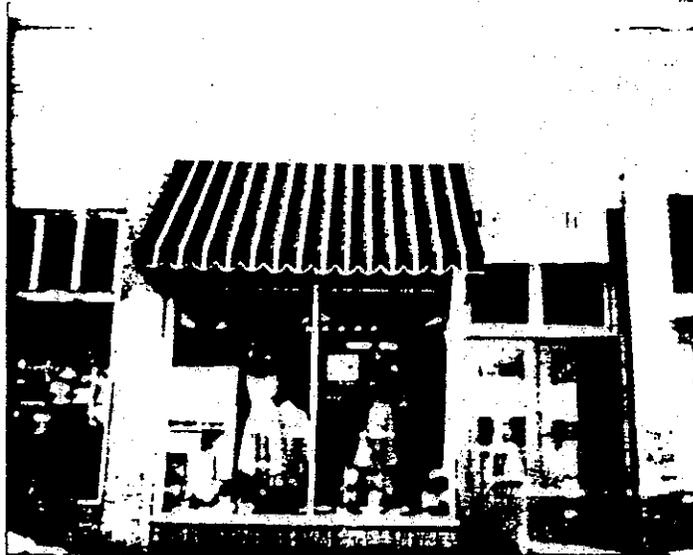
Rectangular in plan with a flat roof, the bldg. is really the middle third of a single brick bldg that includes 108 and 112 S. Main St. This section has a painted brick facade, a double-door entry with two painted-over transoms, and three plate glass windows over a short ceramic-tiled wall.

13. Condition: Excellent ___ Good ___ Fair ___ Deteriorated ___ No longer in existence ___
14. Alterations: Remodeled inside and a new awning over windows.
15. Surroundings: (Check more than one if necessary) Open land ___ Scattered buildings ___ Densely built-up ___
Residential ___ Industrial ___ Commercial ___ Other: ___
16. Threats to site: None known ___ Private development ___ Zoning ___ Vandalism ___
Public Works project ___ Other: ___
17. Is the structure: On its original site? ___ Moved? ___ Unknown? ___
18. Related features: none

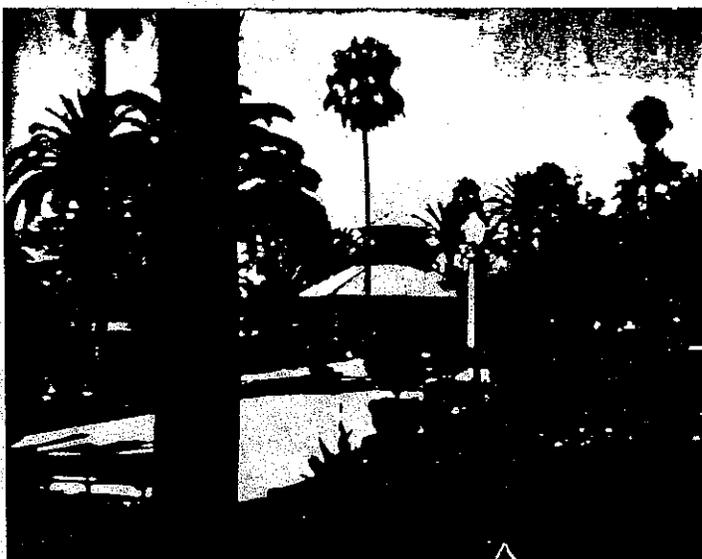
Consisting of two parcels, .77 acres and .61 acres for a total of 1.38 acres of land, City Park has a bandstand, a masonry barbeque stove, concrete brick-shingled roofed restrooms, corrugated metal gable-roofed picnic table shelters and several picnic tables. A rock retaining wall surrounds the park which has the usual landscaping consisting of tall trees, shrubs and grass. On the second parcel, a Mexican restaurant has been constructed under an arrangement with the City for park landscaping care.

13. Condition: Excellent Good _____ Fair _____ Deteriorated _____ No longer in existence _____
14. Alterations: addition of Mexican restaurant facility in 1985.
15. Surroundings: (Check more than one if necessary) Open land _____ Scattered buildings _____ Densely built-up _____
Residential Industrial _____ Commercial _____ Other: _____
16. Threats to site: None known Private development _____ Zoning _____ Vandalism _____
Public Works project _____ Other: _____
17. Is the structure: On its original site? Moved? _____ Unknown? _____
18. Related features: Horseshoe pits, childrens play area, parking

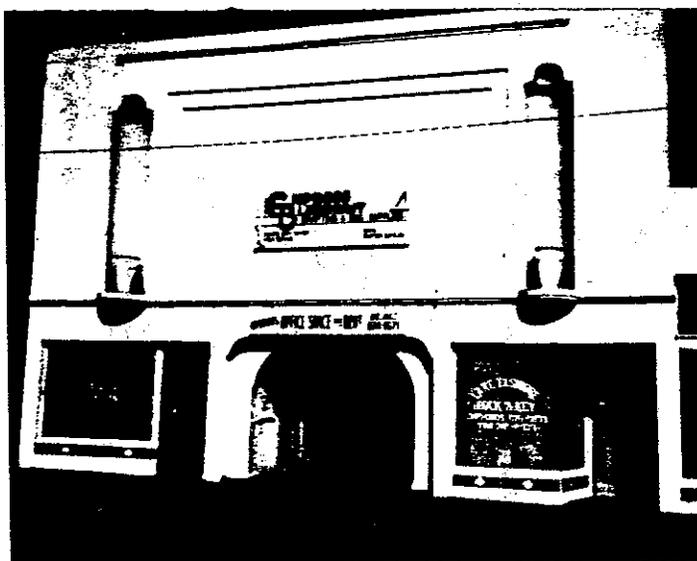
Rectangular in plan with flat roof, the theater at 117 S. Main St. has a stucco facade with Art Deco features including a large recessed rectangular surface with diagonal pattern flanked by two semi-cylindrical recessed areas with a large cement urn in each one. At street level, there is a boarded-up entryway flanked by two small shops; the one on the left having a glass-windowed door and large plate glass window or short ceramic tiled wall, and the one on the right having been remodeled into additional floor space for the camera shop next door (also on this parcel). The interior is in need of extensive rehabilitation.

In 1989-90, the building underwent remodeling and many improvements were made to both the interior and exterior while preserving the historic aspects of the original Art Deco style of design.

13. Condition: Excellent Good Fair Deteriorated No longer in existence
14. Alterations: extensive - interior primarily
15. Surroundings: (Check more than one if necessary) Open land Scattered buildings Densely built-up
Residential Industrial Commercial Other:
16. Threats to site: None known Private development Zoning Vandalism
Public Works project Other:
17. Is the structure: On its original site? Moved? Unknown?
18. Related features: none
