ELSINORE VALLEY CDC

SURVEY OF HISTORICAL STRUCTURES AND SITES
Lake Elsinore, California 1991

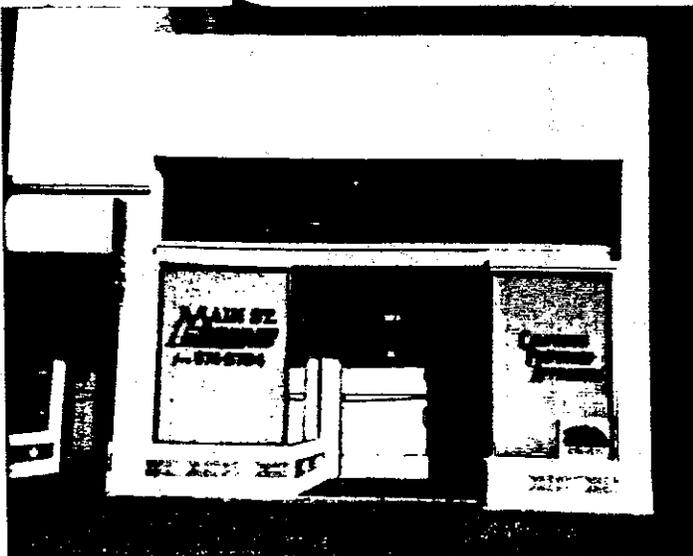
Rectangular in plan with a flat roof, the building at 113 S. Main St. has a stucco facade with a three-by-sixteen-foot band of glass bricks, centered glass-windowed double door entry flanked by plate glass windows over a short ceramic-tile brick wall. A corbeled cornice separates the glass bricks and plate-glass windows and two transom lights of glass bricks are symmetrically placed in the band of glass bricks. A painted sign of billboard dimensions across the stucco facade identifies this business establishment.

(1990) The entire original structure burned and was rebuilt following this in a style compatible with the adjacent 117 structure. In 1989, the complex was completely remodeled and updated.

13. Condition: Excellent _____ Good Fair _____ Deteriorated _____ No longer in existence _____
14. Alterations: Rebuilt following fire
15. Surroundings: (Check more than one if necessary) Open land _____ Scattered buildings _____ Densely built-up _____
Residential _____ Industrial _____ Commercial Other: _____
16. Threats to site: None known Private development _____ Zoning _____ Vandalism _____
Public Works project _____ Other: _____
17. Is the structure: On its original site? Moved? _____ Unknown? _____
18. Related features: none

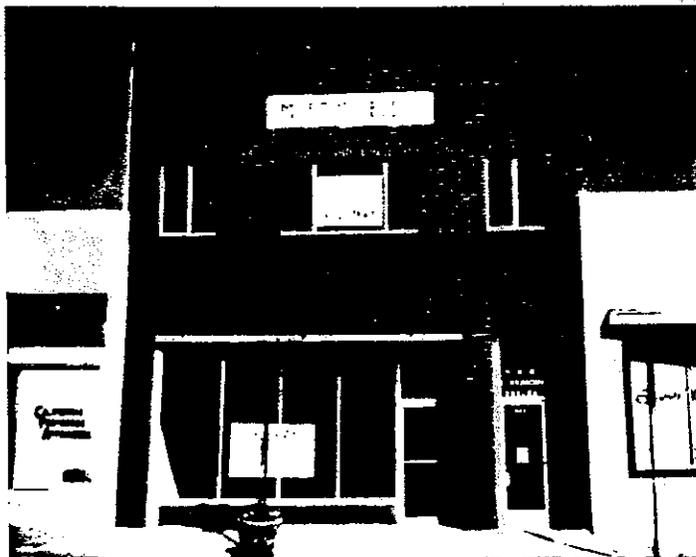
Rectangular in plan with a flat roof, the two story building at 109 South Main has a brick facade with corbeled corner posts at the top, a corbeled cornice at the top, a rectangular brick pattern with "Morton Bldg." on the top, three newer aluminum frame windows, a glass door entry to the shop below with plate glass windows over a short brick wall, and a doorway to the right of this leading to a stairway to the second story apartments. Signs currently advertise the fact that the building is unoccupied and offered for lease.

13. Condition: Excellent ___ Good Fair ___ Deteriorated ___ No longer in existence ___
14. Alterations: Minor additions to wood front and signs.
15. Surroundings: (Check more than one if necessary) Open land ___ Scattered buildings ___ Densely built-up ___
Residential ___ Industrial ___ Commercial Other: ___
16. Threats to site: None known Private development ___ Zoning ___ Vandalism ___
Public Works project ___ Other: ___
17. Is the structure: On its original site? yes Moved? ___ Unknown? ___
18. Related features: None

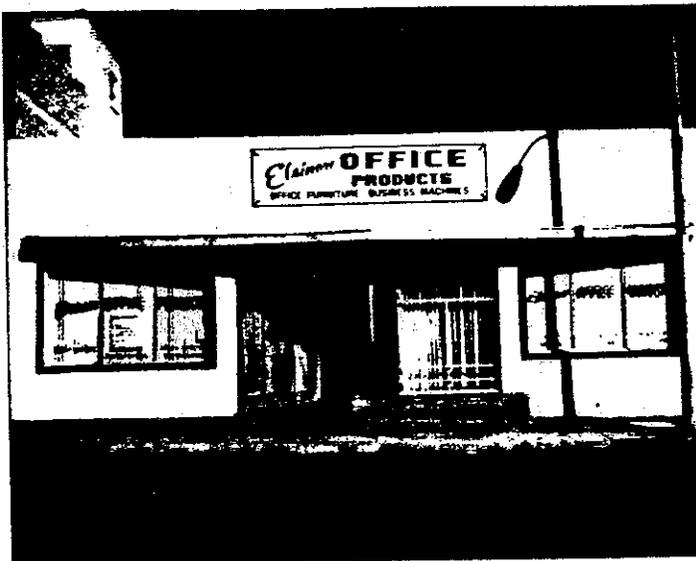
Rectangular in plan with a flat roof, this building has a plain stucco facade with a recessed glass door entry flanked by plate glass windows and two larger windows on each side.

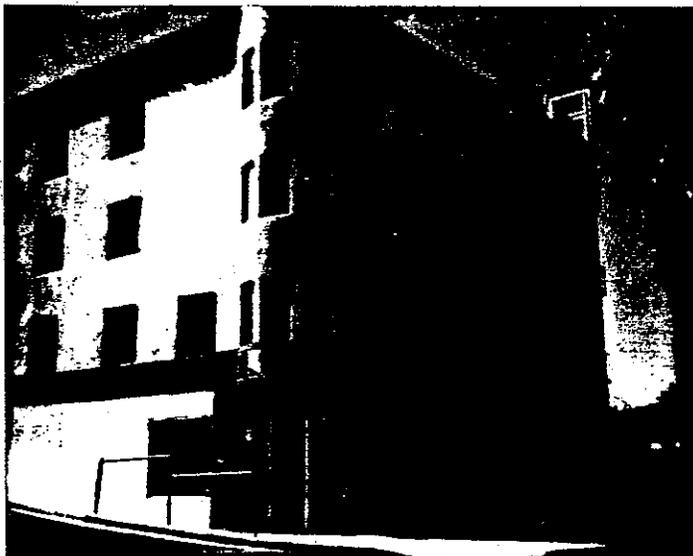
Rectangular in plan, the four story Ambassador Hotel has a flat roof with a Spanish-tiled parapet, stucco siding with newer aluminum frame windows, a corner-facing front door with a corner tower above it capped by a conical roof, and a metal-frame fire escape to the right. The interior contains the vault once used when this building was a bank. It was originally a two-story building constructed by Franklin Heald in 1887 with the bank occupying the corner space of the ground floor and the adjoining space used as a meeting hall. In 1946, two additional stories were added, making it the tallest building in Lake Elsinore and the only structure with an elevator.

13. Condition: Excellent ___ Good Fair ___ Deteriorated ___ No longer in existence ___
14. Alterations: minor - metal awnings
15. Surroundings: (Check more than one if necessary) Open land ___ Scattered buildings ___ Densely built-up ___
Residential ___ Industrial Commercial ___ Other: ___
16. Threats to site: None known Private development ___ Zoning ___ Vandalism ___
Public Works project ___ Other: ___
17. Is the structure: On its original site? Moved? ___ Unknown? ___
18. Related features: none

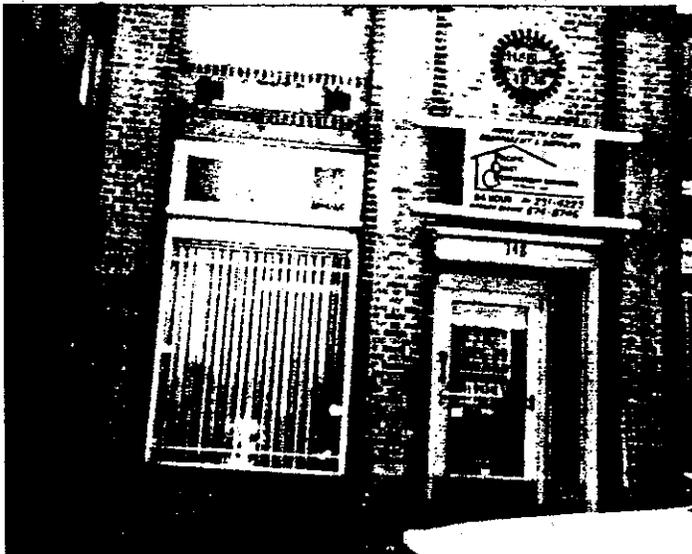
Rectangular in plan with a flat roof, the brick building at 148 S. Main St. has a Flemish brick bond facade with four brick pilasters, edged with darker brick. A recessed doorway is flanked by two boarded-up former windows. Three transom windows with four panes each are placed over the doorway and large window spaces. A circle of darker brick decorates the middle of the section over the doorway and is flanked by two canales each in the side wall sections. A corner parking lot is situated to the right and a newer stucco building to the left.

13. Condition: Excellent ___ Good Fair ___ Deteriorated ___ No longer in existence ___
14. Alterations: None
15. Surroundings: (Check more than one if necessary) Open land ___ Scattered buildings ___ Densely built-up ___
Residential ___ Industrial ___ Commercial Other: ___
16. Threats to site: None known Private development ___ Zoning ___ Vandalism ___
Public Works project ___ Other: ___
17. Is the structure: On its original site? Moved? ___ Unknown? ___
18. Related features: _____

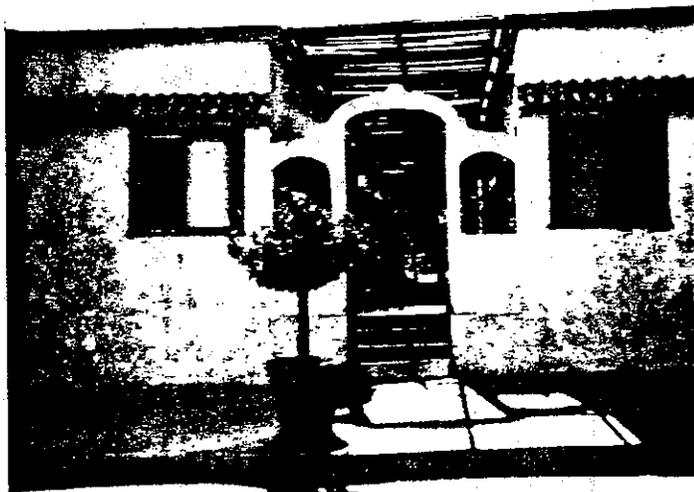
An apartment complex, the two identical buildings, 138 and 140 S. Main Street have composition shingle hip roofs, stucco siding, aluminum frame single-pane and louvered windows and single-door entrances with a shed-roof overdoor. Five arched openings with iron grillwork, three gates and two openings, are symmetrically placed across the front of these rectangular shaped buildings.

There is no noticed change from the 1981 survey.

13. Condition: Excellent ___ Good X Fair ___ Deteriorated ___ No longer in existence ___
14. Alterations: Major, added stucco and new paint
15. Surroundings: (Check more than one if necessary) Open land ___ Scattered buildings ___ Densely built-up ___
Residential ___ Industrial ___ Commercial X Other: ___
16. Threats to site: None known X Private development ___ Zoning ___ Vandalism ___
Public Works project ___ Other: ___
17. Is the structure: On its original site? X Moved? ___ Unknown? ___
18. Related features: none

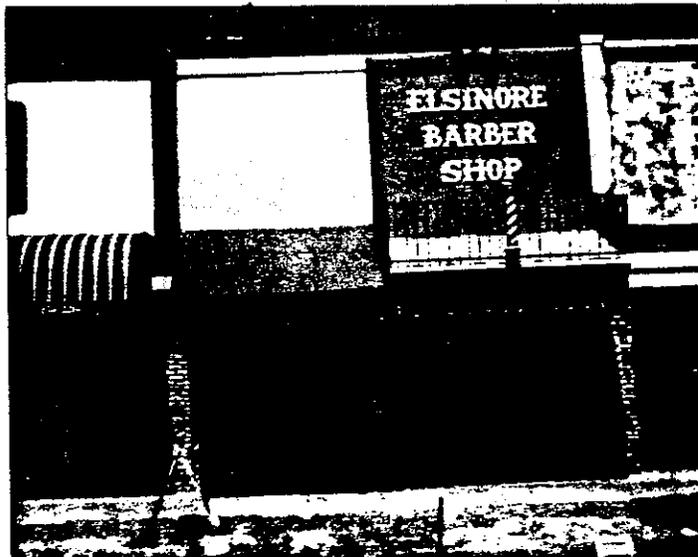
Rectangular in plan with a flat roof, the building at 115 North Main Street has a brick facade (added in 1989-90) with a composition shed-roofed awning with an iron grillwork balustrade. A left-of-center door provided the entrance with a large plate glass window to the right. A barber pole with a globe sits in the middle outside in front of a newly-stuccoed facade. There is a raised letter sign identifying the building as "Elsinore Barber Shop." A newly installed fabric awning is over the front of the unit as a part of the 1920's theme adopted for Main Street under the Redevelopment plan.

13. Condition: Excellent ___ Good X Fair ___ Deteriorated ___ No longer in existence ___
14. Alterations: Major
15. Surroundings: (Check more than one if necessary) Open land ___ Scattered buildings ___ Densely built-up ___
Residential ___ Industrial ___ Commercial X Other: ___
16. Threats to site: None known X Private development ___ Zoning ___ Vandalism ___
Public Works project ___ Other: ___
17. Is the structure: On its original site? X Moved? ___ Unknown? ___
18. Related features: None

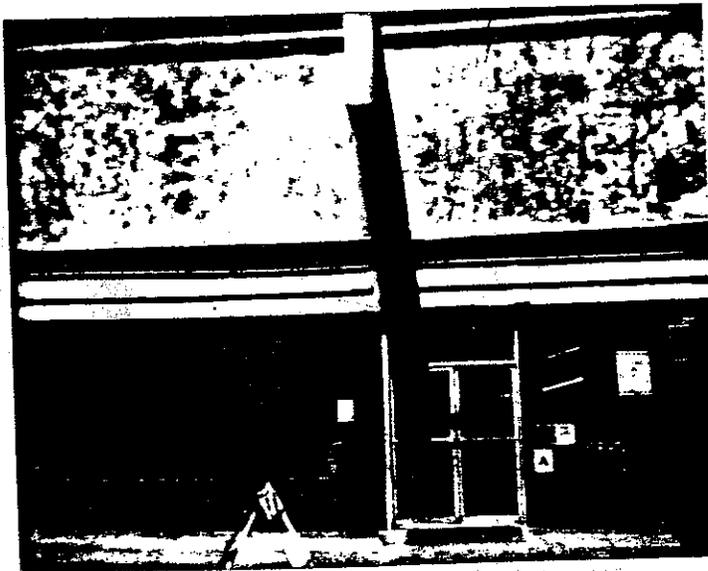
Rectangular with a flat roof, the building has a plain stucco front, plate glass doors and windows across the front, and an overhang sign identifying the business. It has been rehabilitated as a part of the Lake Elsinore Downtown Redevelopment Project in 1989-90, as the City of Lake Elsinore has conducted a major upgrading of this historic area.

13. Condition: Excellent ___ Good XX Fair ___ Deteriorated ___ No longer in existence ___
14. Alterations: Major - false wood front, rehab facade
15. Surroundings: (Check more than one if necessary) Open land ___ Scattered buildings ___ Densely built-up ___
Residential ___ Industrial ___ Commercial XX Other: ___
16. Threats to site: None known X Private development ___ Zoning ___ Vandalism ___
Public Works project ___ Other: ___
17. Is the structure: On its original site? XX Moved? ___ Unknown? ___
18. Related features: None

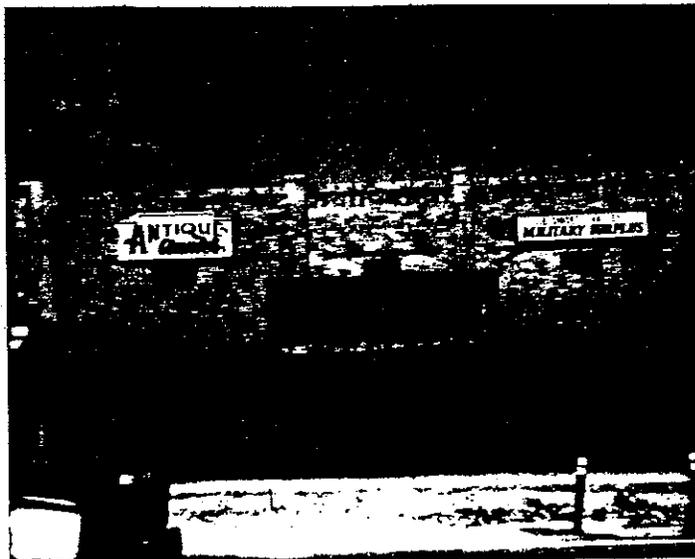
Rectangular in plan with a flat roof, the brick building at 133 N. Main St. has a corbeled cornice across the top, divided by four pilasters with corbeled caps, three rectangular indentations have lattice-like brick vents. A wood-shingled awning shades the plate glass windows over short brick walls. Board-and-batten siding has been added to the entry which has two single doors approximately six feet apart. An unpainted wood marquee has been added over the entrance with a flourescent sign identifying this business as Ace Hardware.

1990: The sign described above is no longer there and has been replaced by two signs: "Antique Annies" to the left (133A) and "Elsinore Valley Military Surplus" to the right (133B). The former surplus store is closed.

13. Condition: Excellent ___ Good ___ Fair ___ Deteriorated ___ No longer in existence ___
14. Alterations: Minimal.
15. Surroundings: (Check more than one if necessary) Open land ___ Scattered buildings ___ Densely built-up ___
Residential ___ Industrial ___ Commercial XX Other: _____
16. Threats to site: None known XX Private development ___ Zoning ___ Vandalism ___
Public Works project ___ Other: _____
17. Is the structure: On its original site? XX Moved? ___ Unknown? ___
18. Related features: None

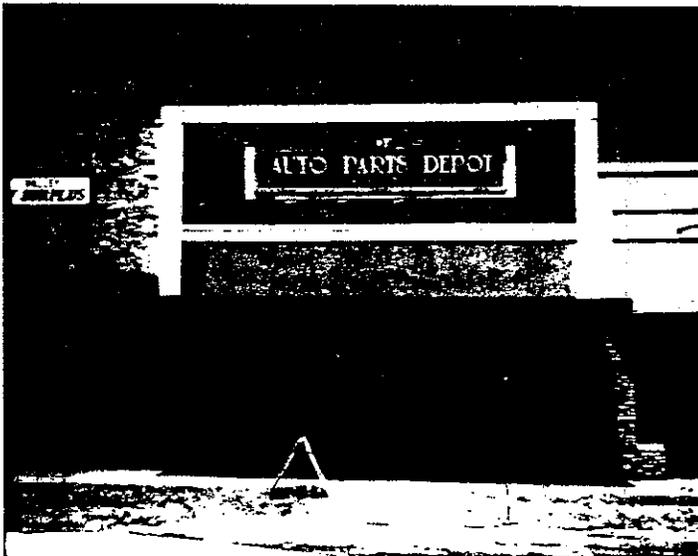
Rectangular in plan with a flat roof, the brick building at 137 N. Main St. has a polychromatic brick and stucco facade. White glazed bricks in a pattern form a border around the building (two sides and the top) and are also used for a belt course dividing the darker polychromatic bricks from the stucco facade. A flat canopy extends out over a large recessed entry with a glass double-door entry flanked by plate glass windows for window displays. A fluorescent sign similar to the one next door identifies this building as the Lake Elsinore Department Store.

1990: The building has been painted and new windows have been added as the Lake Elsinore Downtown Business area has been the beneficiary of the City's Redevelopment Agency's efforts to upgrade the area and street.

13. Condition: Excellent ___ Good Fair ___ Deteriorated ___ No longer in existence ___
14. Alterations: Major, new windows and rehab.
15. Surroundings: (Check more than one if necessary) Open land ___ Scattered buildings ___ Densely built-up ___
Residential ___ Industrial ___ Commercial Other: ___
16. Threats to site: None known Private development ___ Zoning ___ Vandalism ___
Public Works project ___ Other: ___
17. Is the structure: On its original site? Moved? ___ Unknown? ___
18. Related features: None

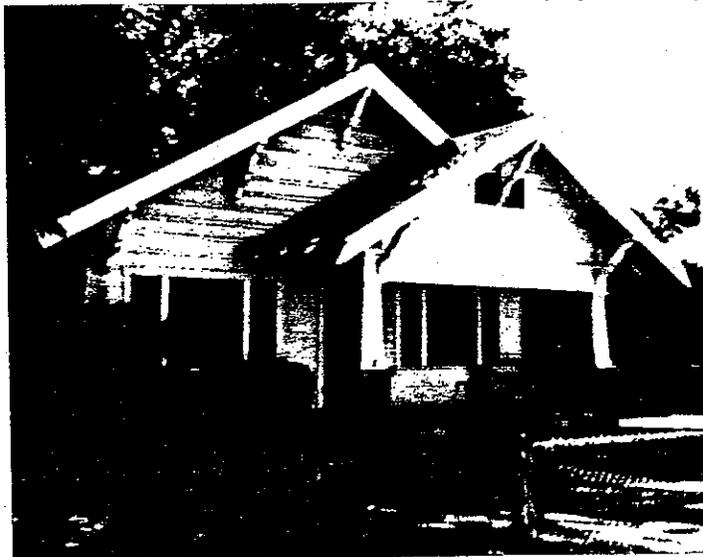
This Craftsman bungalow at 307 N. Main St. has a gabled roof and gabled porch with three brick pier supports and two battered wood piers on each side. Siding is tongue-in-groove with wide and narrow horizontal slats. Purlins have curvilinear edges and the eave rafters are pointed and extended. Mullioned windows have a decorative diamond pattern to them. Tall trees shade one side of this Craftsman bungalow.

13. Condition: Excellent ___ Good XX Fair ___ Deteriorated ___ No longer in existence ___
14. Alterations: few
15. Surroundings: (Check more than one if necessary) Open land ___ Scattered buildings ___ Densely built-up ___
 Residential X Industrial ___ Commercial X Other: ___
16. Threats to site: None known ___ Private development ___ Zoning ___ Vandalism ___
 Public Works project ___ Other: ___
17. Is the structure: On its original site? X Moved? ___ Unknown? ___
18. Related features: None

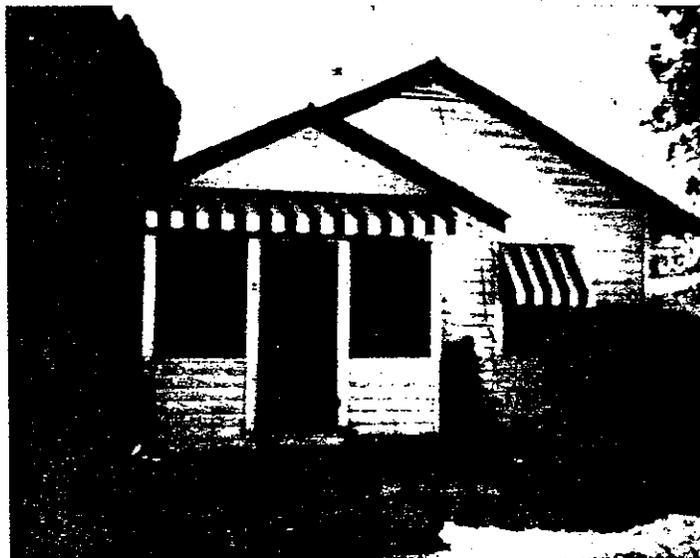
The bungalow court at 313-315 N. Main St. seven bungalows, square in plan, with one rectangular building with three connected units in it. Each bungalow has a gable roof (some with original fish-scale shingles), clapboard siding, double-hung windows, and an enclosed porch with screen door. Metal striped awnings have been added over each window and porch doorway. These buildings, all painted white with red trim, form a U-shaped court with cement sidewalks and many tall trees.

- 13. Condition: Excellent _____ Good _____ Fair _____ Deteriorated _____ No longer in existence _____
- 14. Alterations: None
- 15. Surroundings: (Check more than one if necessary) Open land _____ Scattered buildings _____ Densely built-up _____
Residential Industrial _____ Commercial Other: _____
- 16. Threats to site: None known Private development _____ Zoning _____ Vandalism _____
Public Works project _____ Other: _____
- 17. Is the structure: On its original site? Moved? _____ Unknown? _____
- 18. Related features: None

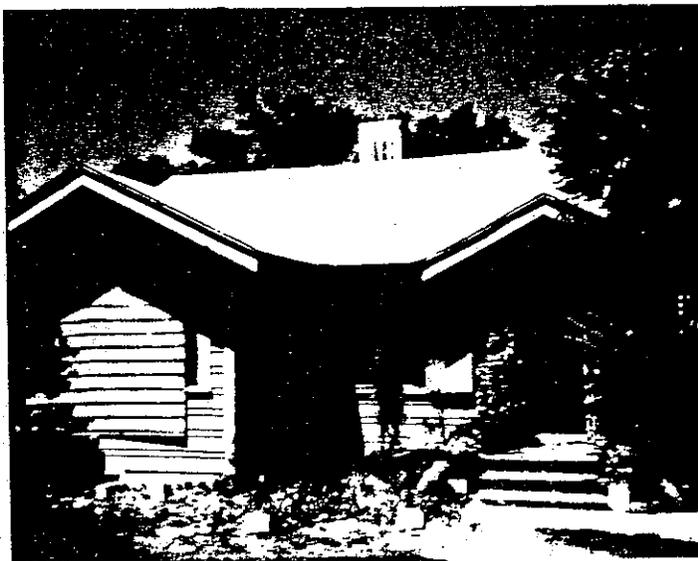
L-shaped in plan, the bungalow at 411 N. Main St. has a composition shingle gable roof with brick chimney with corbeled cap and an evaporative cooler. Tongue-in-groove siding with alternating wide and narrow horizontal boards sheathes the walls which have mullioned windows. A semi-elliptical overdoor is supported by curvilinear brackets. A vent is found at the apex of the front-facing gable and distinctive shutters flank the window next to the front door. A latticework arch connects this bungalow with its "flipside" twin next door.

13. Condition: Excellent ___ Good ___ Fair Deteriorated ___ No longer in existence ___
14. Alterations: Major: stucco surface and new front doors
15. Surroundings: (Check more than one if necessary) Open land ___ Scattered buildings ___ Densely built-up ___
Residential ___ Industrial ___ Commercial Other: ___
16. Threats to site: None known ___ Private development Zoning ___ Vandalism ___
Public Works project ___ Other: ___
17. Is the structure: On its original site? Moved? ___ Unknown? ___
18. Related features: Fencing

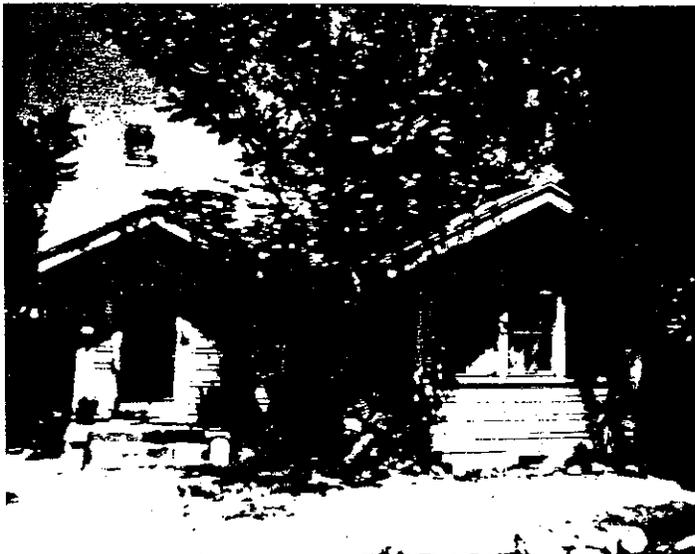
L-shaped in plan, the bungalow at 413 N. Main St. has a composition shingle gable roof with brick chimney with corbeled cap. Tongue-in-groove siding with alternating wide and narrow horizontal boards sheathes the walls which have mullioned windows. A semi-elliptical overdoor is supported by curvilinear brackets. A vent is found at the apex of the front-facing gable and distinctive shutters flank the window next to the front door. A latticework arch connects this bungalow with its "flipside" twin next door.

13. Condition: Excellent ___ Good ___ Fair X Deteriorated ___ No longer in existence ___
14. Alterations: Minor
15. Surroundings: (Check more than one if necessary) Open land ___ Scattered buildings ___ Densely built-up ___
 Residential X Industrial ___ Commercial X Other: ___
16. Threats to site: None known XX Private development ___ Zoning ___ Vandalism ___
 Public Works project ___ Other: ___
17. Is the structure: On its original site? X Moved? ___ Unknown? ___
18. Related features: None

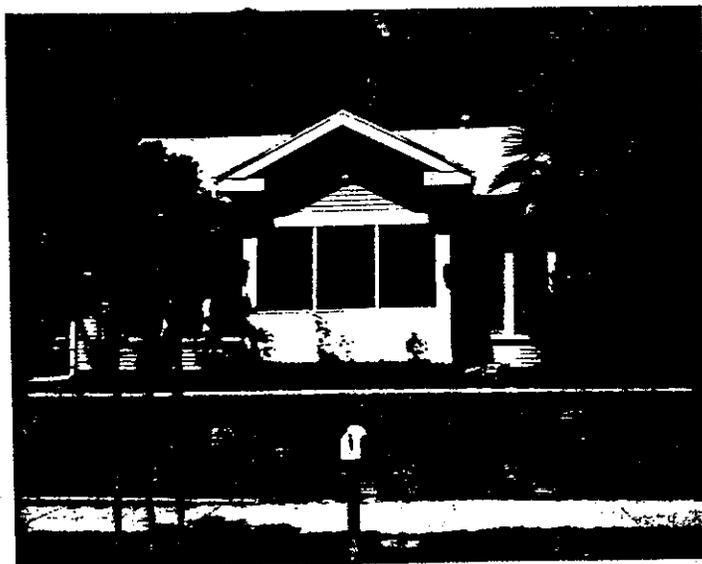
Rectangular in plan with a composition gable roof, the Colonial Revival house at 509 N. Main has clapboard siding, mullioned windows, three on each side of a centered door that has mullioned sidelights. A screened-in porch has a pediment with returns, and dentils under the sides and across the base, and square porch posts. A tile brick retaining wall at the sidewalk accents this house situated above street level.

13. Condition: Excellent _____ Good Fair _____ Deteriorated _____ No longer in existence _____
14. Alterations: unaltered
15. Surroundings: (Check more than one if necessary) Open land _____ Scattered buildings _____ Densely built-up _____
Residential Industrial _____ Commercial _____ Other: _____
16. Threats to site: None known Private development _____ Zoning _____ Vandalism _____
Public Works project _____ Other: _____
17. Is the structure: On its original site? Moved? _____ Unknown? _____
18. Related features: none

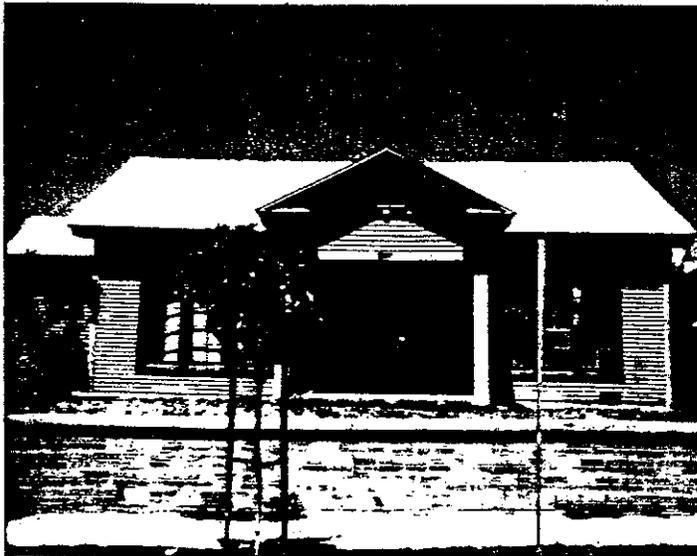
Rectangular in plan with a composition single-gable roof, this house has clapboard siding, mullioned windows, three on each side of a centered door that has mullioned sidelights. A porch with square porch posts has a pediment with returns and dentils under the sides and across the base. A tile brick retaining wall at the sidewalk accents this house situated above street level.

13. Condition: Excellent ___ Good ___ Fair ___ Deteriorated ___ No longer in existence ___
14. Alterations: minor - closed in porch
15. Surroundings: (Check more than one if necessary) Open land ___ Scattered buildings ___ Densely built-up ___
Residential ___ Industrial ___ Commercial ___ Other: ___
16. Threats to site: None known Private development ___ Zoning ___ Vandalism ___
Public Works project ___ Other: ___
17. Is the structure: On its original site? Moved? ___ Unknown? ___
18. Related features: Shed to rear

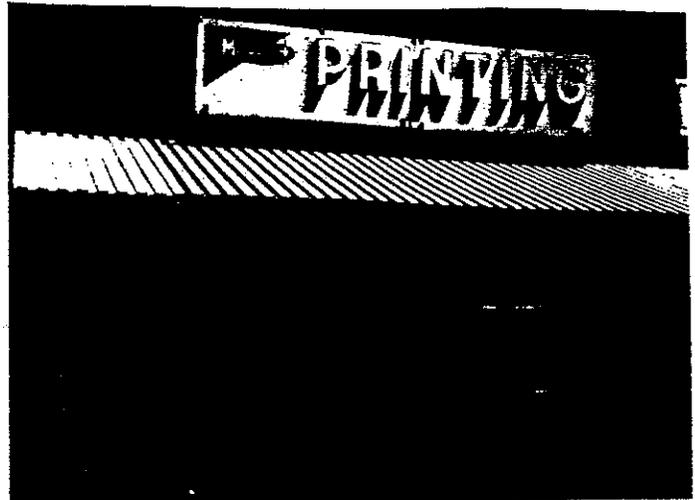
138 N. Main

- 7a. Architectural style: Commercial
- 7b. Briefly describe the present physical description of the site or structure and describe any major alterations from its original condition: Built 1926; architect & Builder unknown; 100' x 150'; Photos 7/5/90

13. Condition: Excellent ___ Good ___ X Fair ___ Deteriorated ___ No longer in existence ___
14. Alterations: Minor
15. Surroundings: (Check more than one if necessary) Open land ___ Scattered buildings ___ Densely built-up ___
Residential ___ Industrial ___ Commercial XX Other: ___
16. Threats to site: None known ___ Private development ___ Zoning ___ Vandalism ___
Public Works project ___ Other: ___
17. Is the structure: On its original site? XX Moved? ___ Unknown? ___
18. Related features: None
