**UPDATE PHASE I ENVIRONMENTAL SITE ASSESSMENT  
15712 GRAND AVENUE (APN 381-030-005)  
LAKE ELSINORE, RIVERSIDE COUNTY, CALIFORNIA 92530**

**W.O. E6318-SC**

**FEBRUARY 14, 2012**

**Subject:** Update Phase I Environmental Site Assessment, 15712 Grand Avenue  
(APN 381-030-005), Lake Elsinore, Riverside County, California 92530

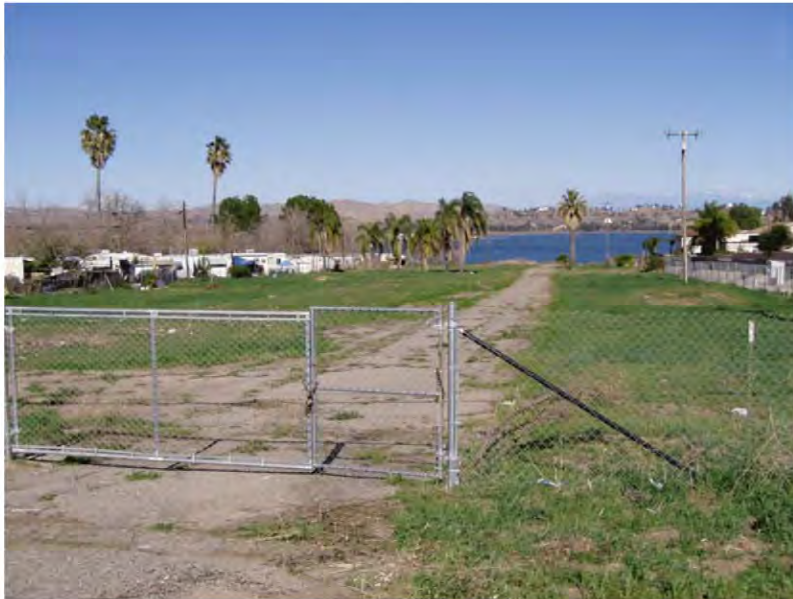
1. Southwest portion of site (exterior) looking northeast, near Grand Avenue. Note chain-link fence to limit site access and power lines on southeast side of project. Note transformers on power poles. Also note removal of previous motel slabs onsite.

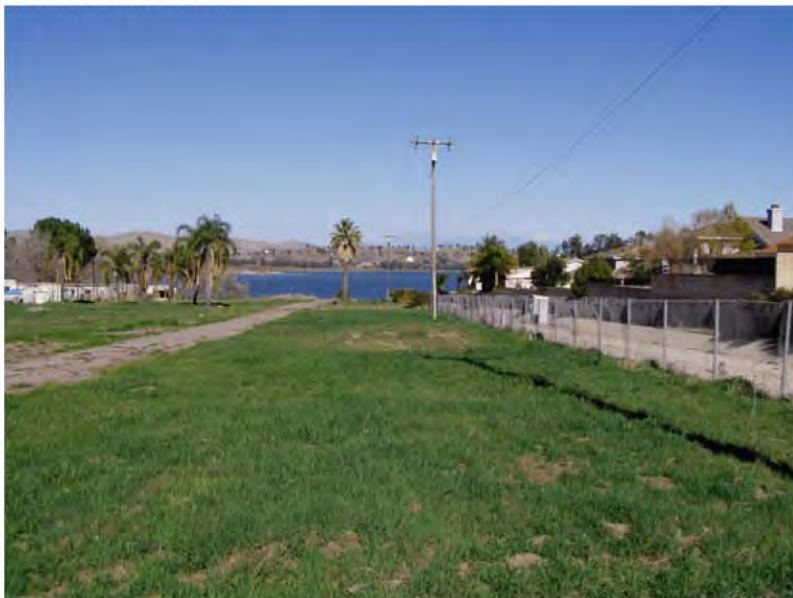
2. Southeast portion of site (interior) looking northeast. Note flood control channel on southeast boundary of project site.

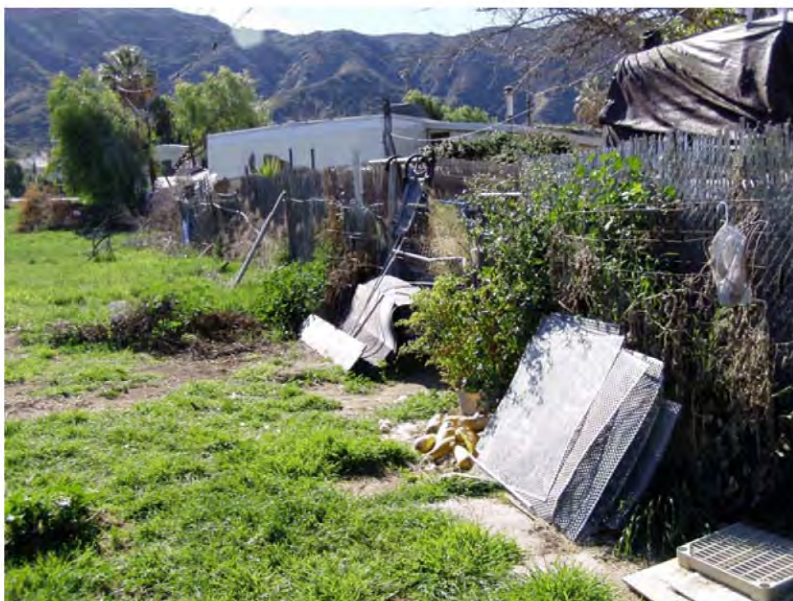
3. Northwest-central portion of site (interior) looking west. Note landscape and garden debris from adjoining mobile home park.

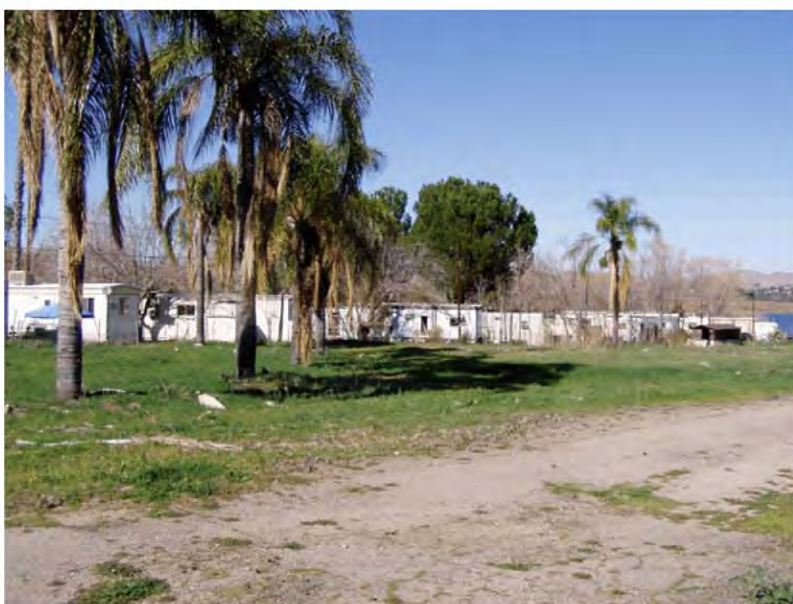
4. Central portion of site (interior) looking northwest. Note removal of previous swimming pool structure located in general area.

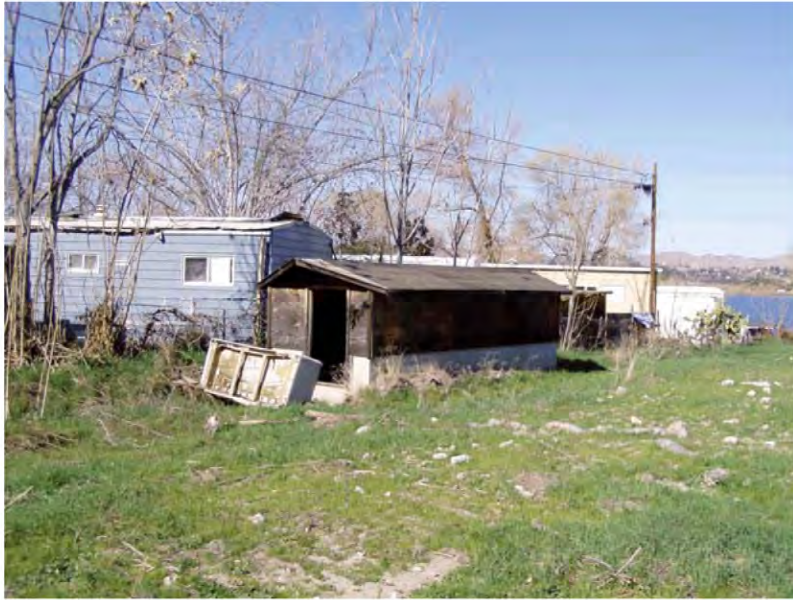
- **Asbestos** - Evaluation of the presence of asbestos onsite is beyond the scope of this current study; however, there are structures (old sewer lift station) located onsite which have the potential to for asbestos containing materials (ACM). As such, GSI recommends that an asbestos survey should be performed on the materials by a licensed asbestos contractor prior to demolition, removal, and disposal.

5. Northwest portion of site looking north. Note old sewer pump house onsite.

- Based upon the relative age of the structures onsite, there is the potential for construction materials to contain asbestos (ACM), GSI recommends that an asbestos survey should be performed on the materials by a licensed asbestos contractor prior to demolition, removal, and disposal. A lead paint assessment could also be performed at that time, since the dock has been previously painted.

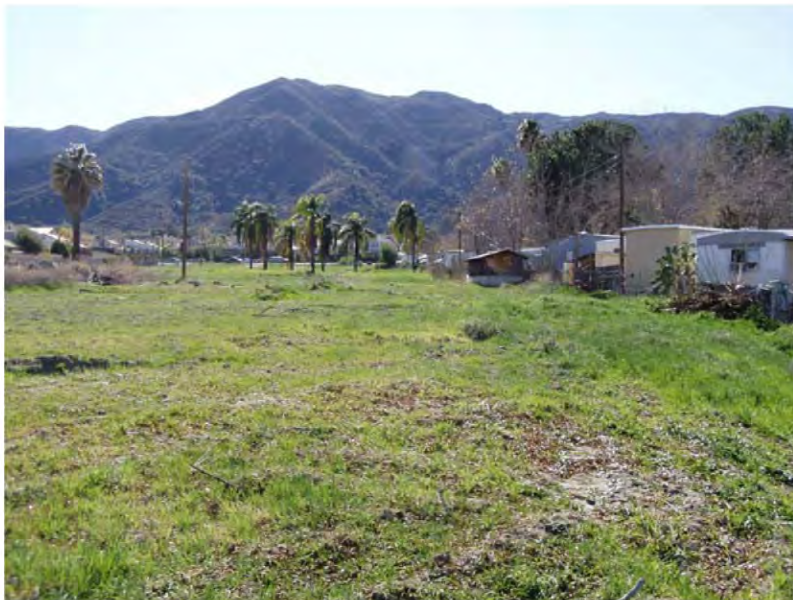
6. Northeast portion of site near Lake Elsinore looking southwest. Note adjoining mobile home park to the northwest.

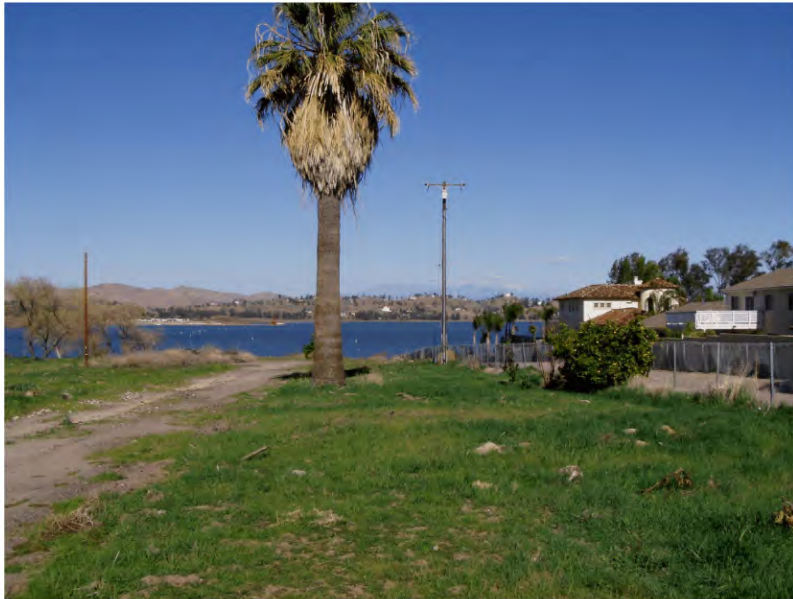
- **Electromagnetic Evaluation** - As discussed above, power lines were noted onsite, located on the southern margin of the property. An evaluation of electric and magnetic fields (EMF) onsite is beyond this current scope of work. Based upon a public information booklet by a southern California power company, the magnetic field from transmission lines get weaker with distance. Magnetic fields are reported to vary from 1 to 300 milliGauss (mG) at the edge of a right-of-way. For comparison purposes, magnetic fields range from 0.1 mG to 8 mG on microwave ovens or televisions at a distance of 39 inches. Although there is some speculation that EMFs represent a risk to human health, medical and scientific research has yet to determine exposure levels related to health risks. Studies (to date) have been inconclusive as to the possible dangers from EMFs. Additional information is available from Southern California Edison (SCE), the United States Environmental Protection Agency, The National Academy of Sciences or the American Medical Association.

7. Southeast-central portion of the site looking northeast. Note Lake Elsinore in background. Also note power lines on southeast side of project. Note transformer on power pole.

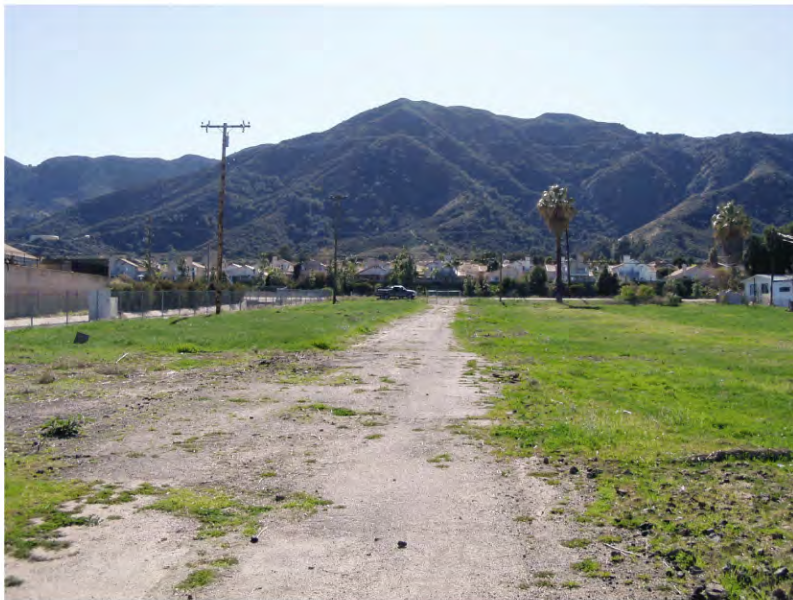
8. Central portion of site (interior) looking southwest. Note removal of previous motel slabs and other construction debris onsite.
