# APPENDIX H

## Hydrology Studies

# Project Specific Water Quality Management Plan

**Project Title:** Lake Elsinore, CA Retail Store

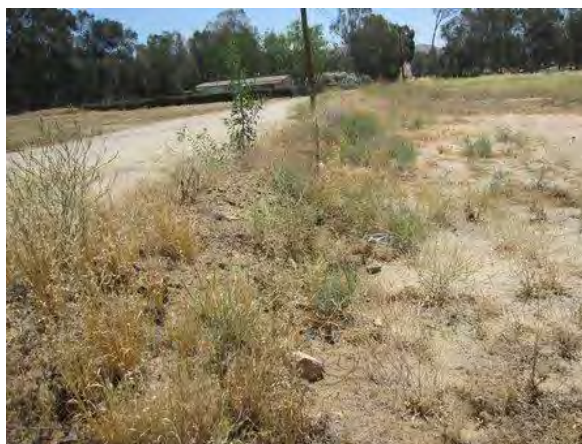
Photograph 2. View of mounded fill on-Site along Cambern Avenue (looking southeast).

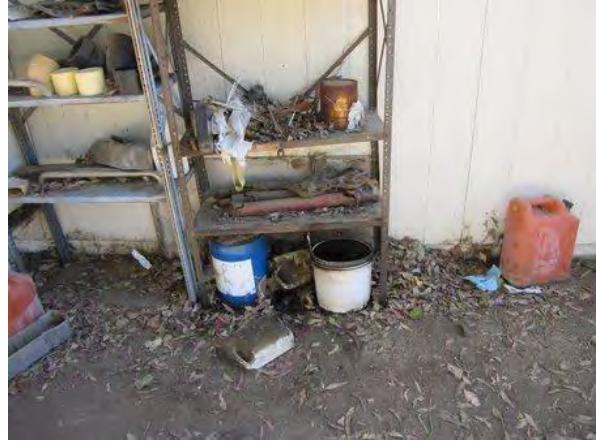
Photograph 10. View of used oil bucket on side of garage at 29421 3<sup>rd</sup> Street.

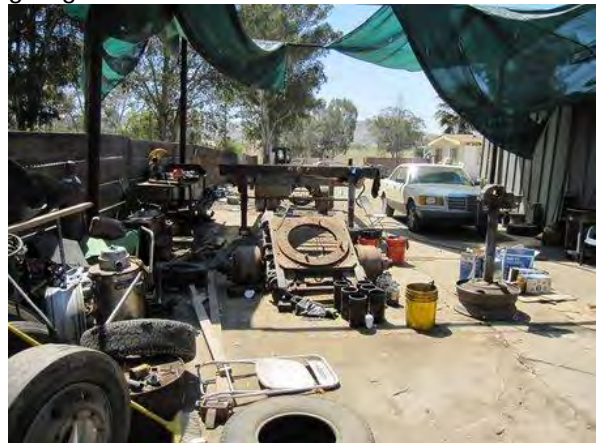
Photograph 12. View of awning covered vehicle maintenance area at 29445 3<sup>rd</sup> Street (looking southeast).

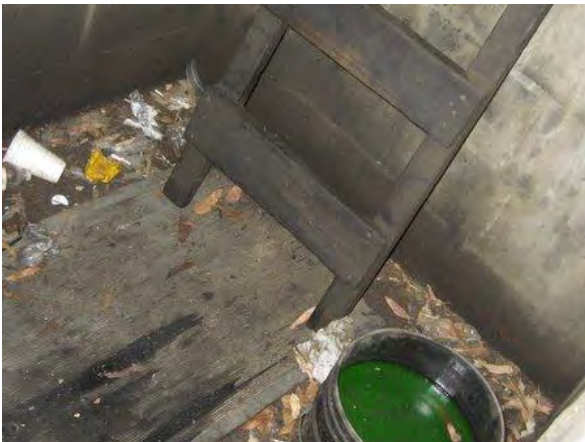
Photograph 13. Base of auto maintenance pit at 29445 3<sup>rd</sup> Street. Pit is located below the car shown in Photograph 12.

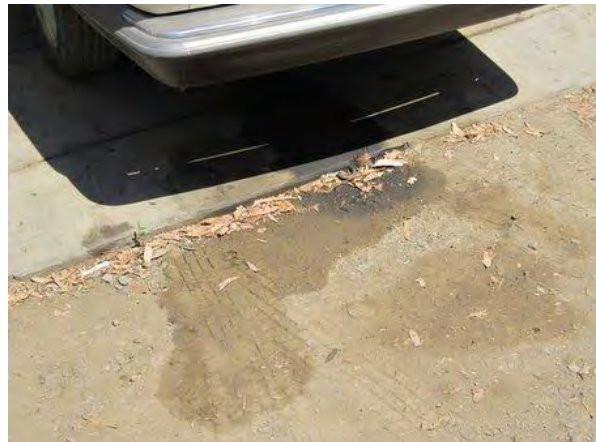
Photograph 14. Oil staining on soil and concrete pad at 29445 3<sup>rd</sup> Street.

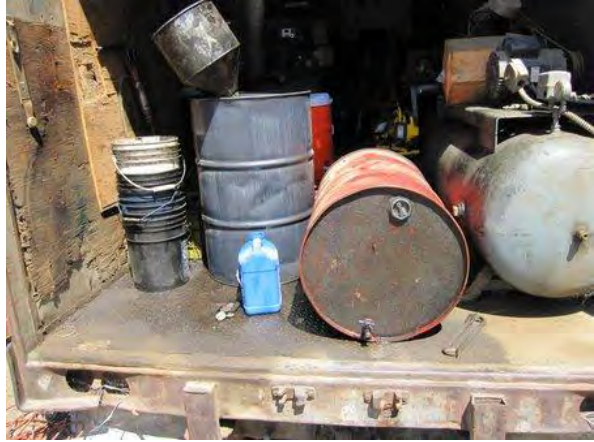
Photograph 16. Oil drums and spilled oil on floor of trailer at 29445 3<sup>rd</sup> Street.

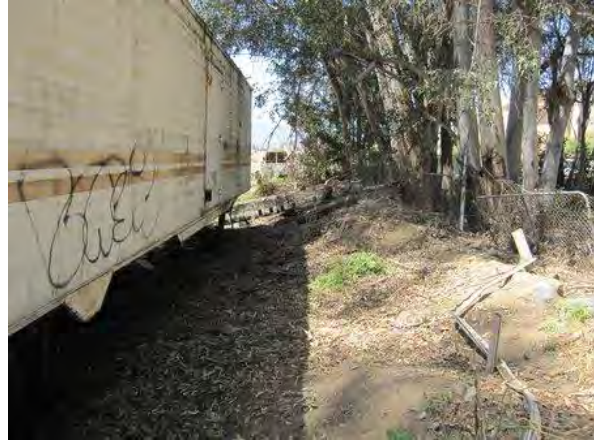
Photograph 22. View of semi-truck trailer and mounded fill soil along northwest border of 29467 3<sup>rd</sup> Street (looking southwest).
