Phase One Environmental Site Assessment,  
APNS 377-190-002, 377-190-003,  
377-190-004, Collier Avenue

**PHASE ONE ENVIRONMENTAL SITE ASSESSMENT**  
**APNS 377-190-002, 377-190-003, 377-190-004 COLLIER AVENUE**  
**LAKE ELSINORE, CALIFORNIA 92530**

**October 28, 2024**

**S & S Job #OC24012**

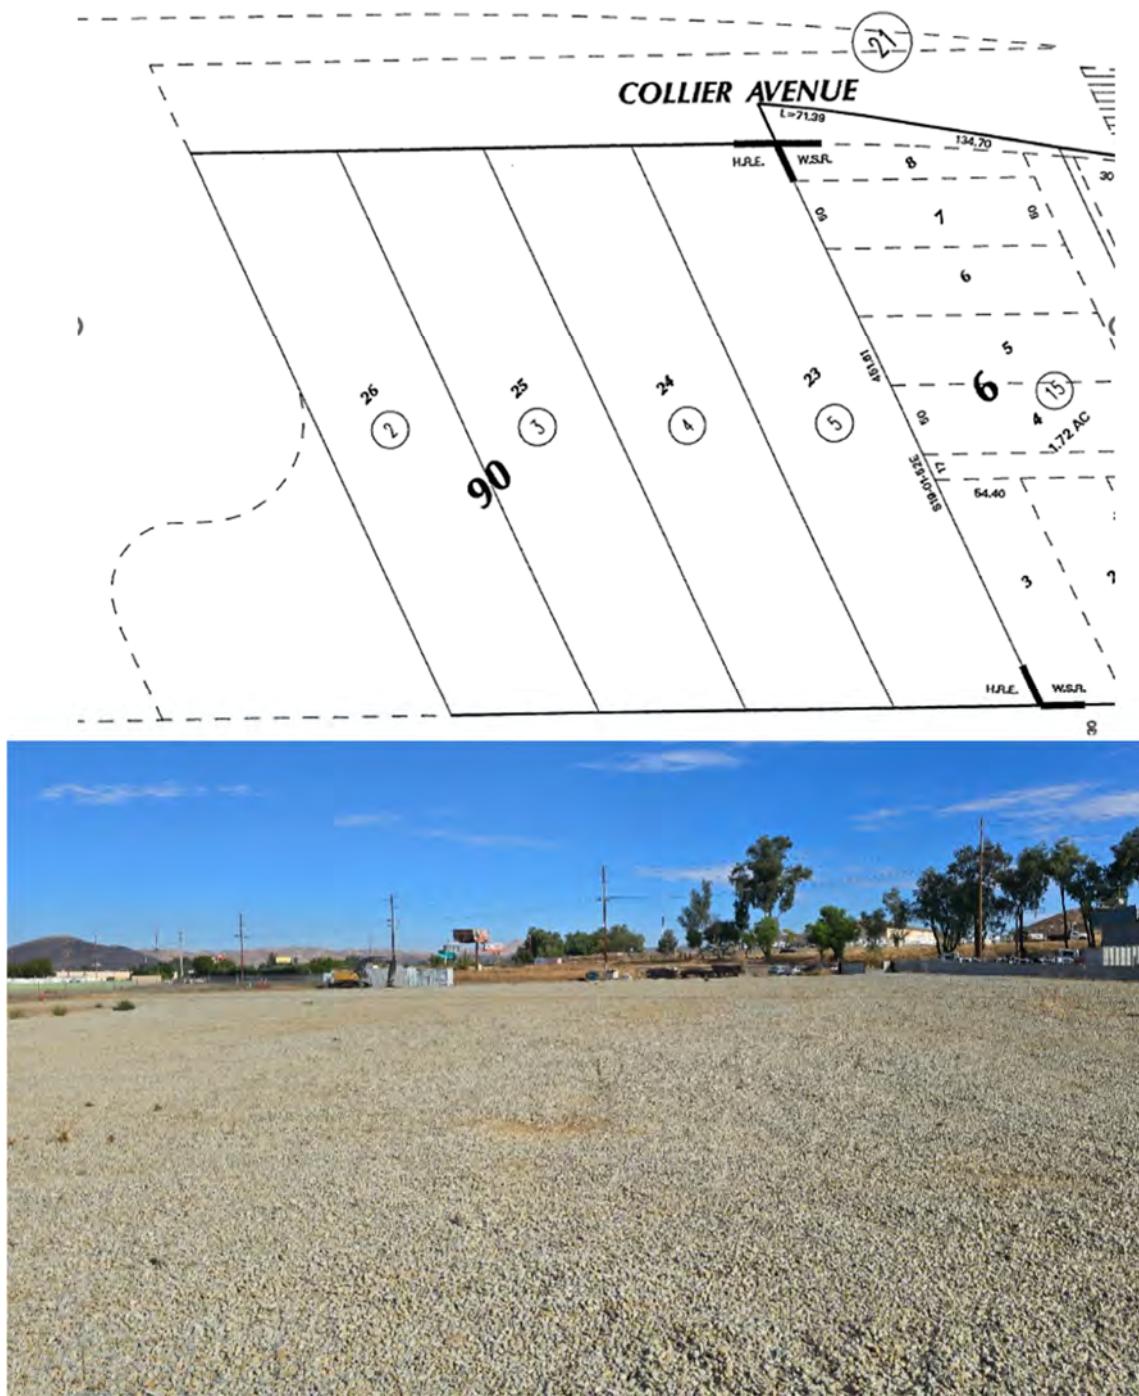
**TOP: APN Map Parcels 377-190-002, 377-190-003, 377-190-004**

**BOTTOM: View Across Subject Property SW to NE**

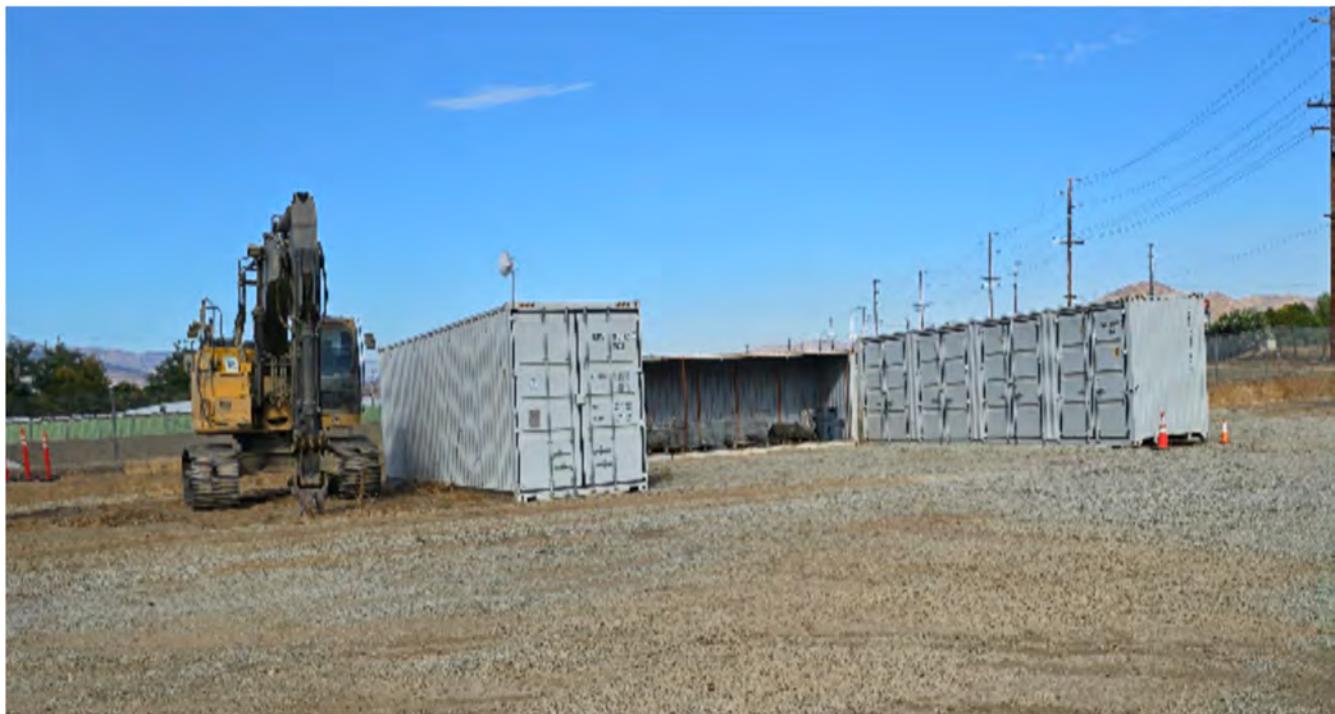
**Construction Equipment and Container Storage**

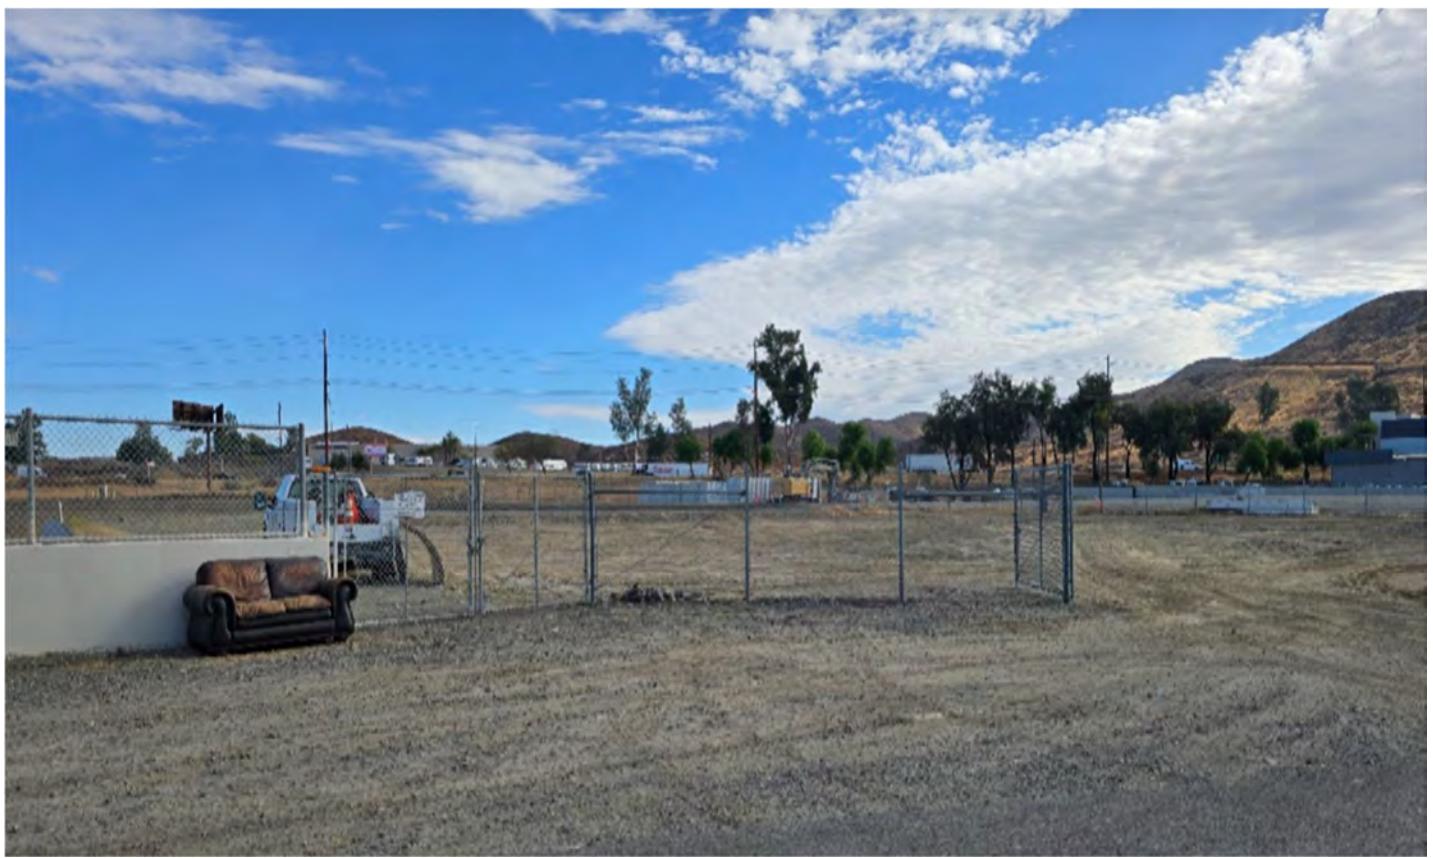
**North Flood Control**

North is a Flood Control/Stormwater Retention Basin operated by the Riverside County Flood Control and Water Conservation. Next is Rightway Site Services Inc. at 653 W. Minthorn Street, which had a former underground tank leak closed in 1989.

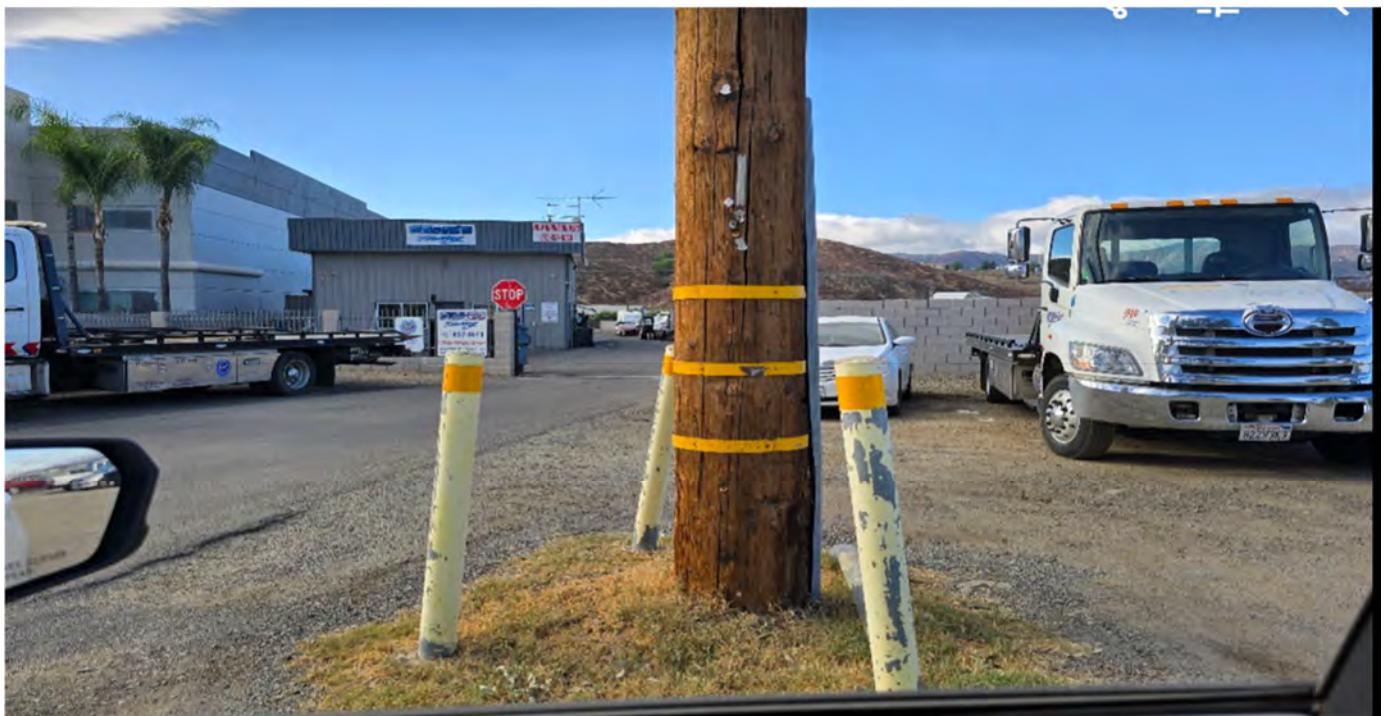
**South Towing Services**

South is Brothers Towing and Steve's Towing then Aggregate Crushing. That site was the Laidlaw site which had an underground tank leak that closed in 1989.
