Systemic Safety Analysis Report

CITY OF LAKE ELSINORE

RE: Systemic Safety Analysis Report Program (SSARP)

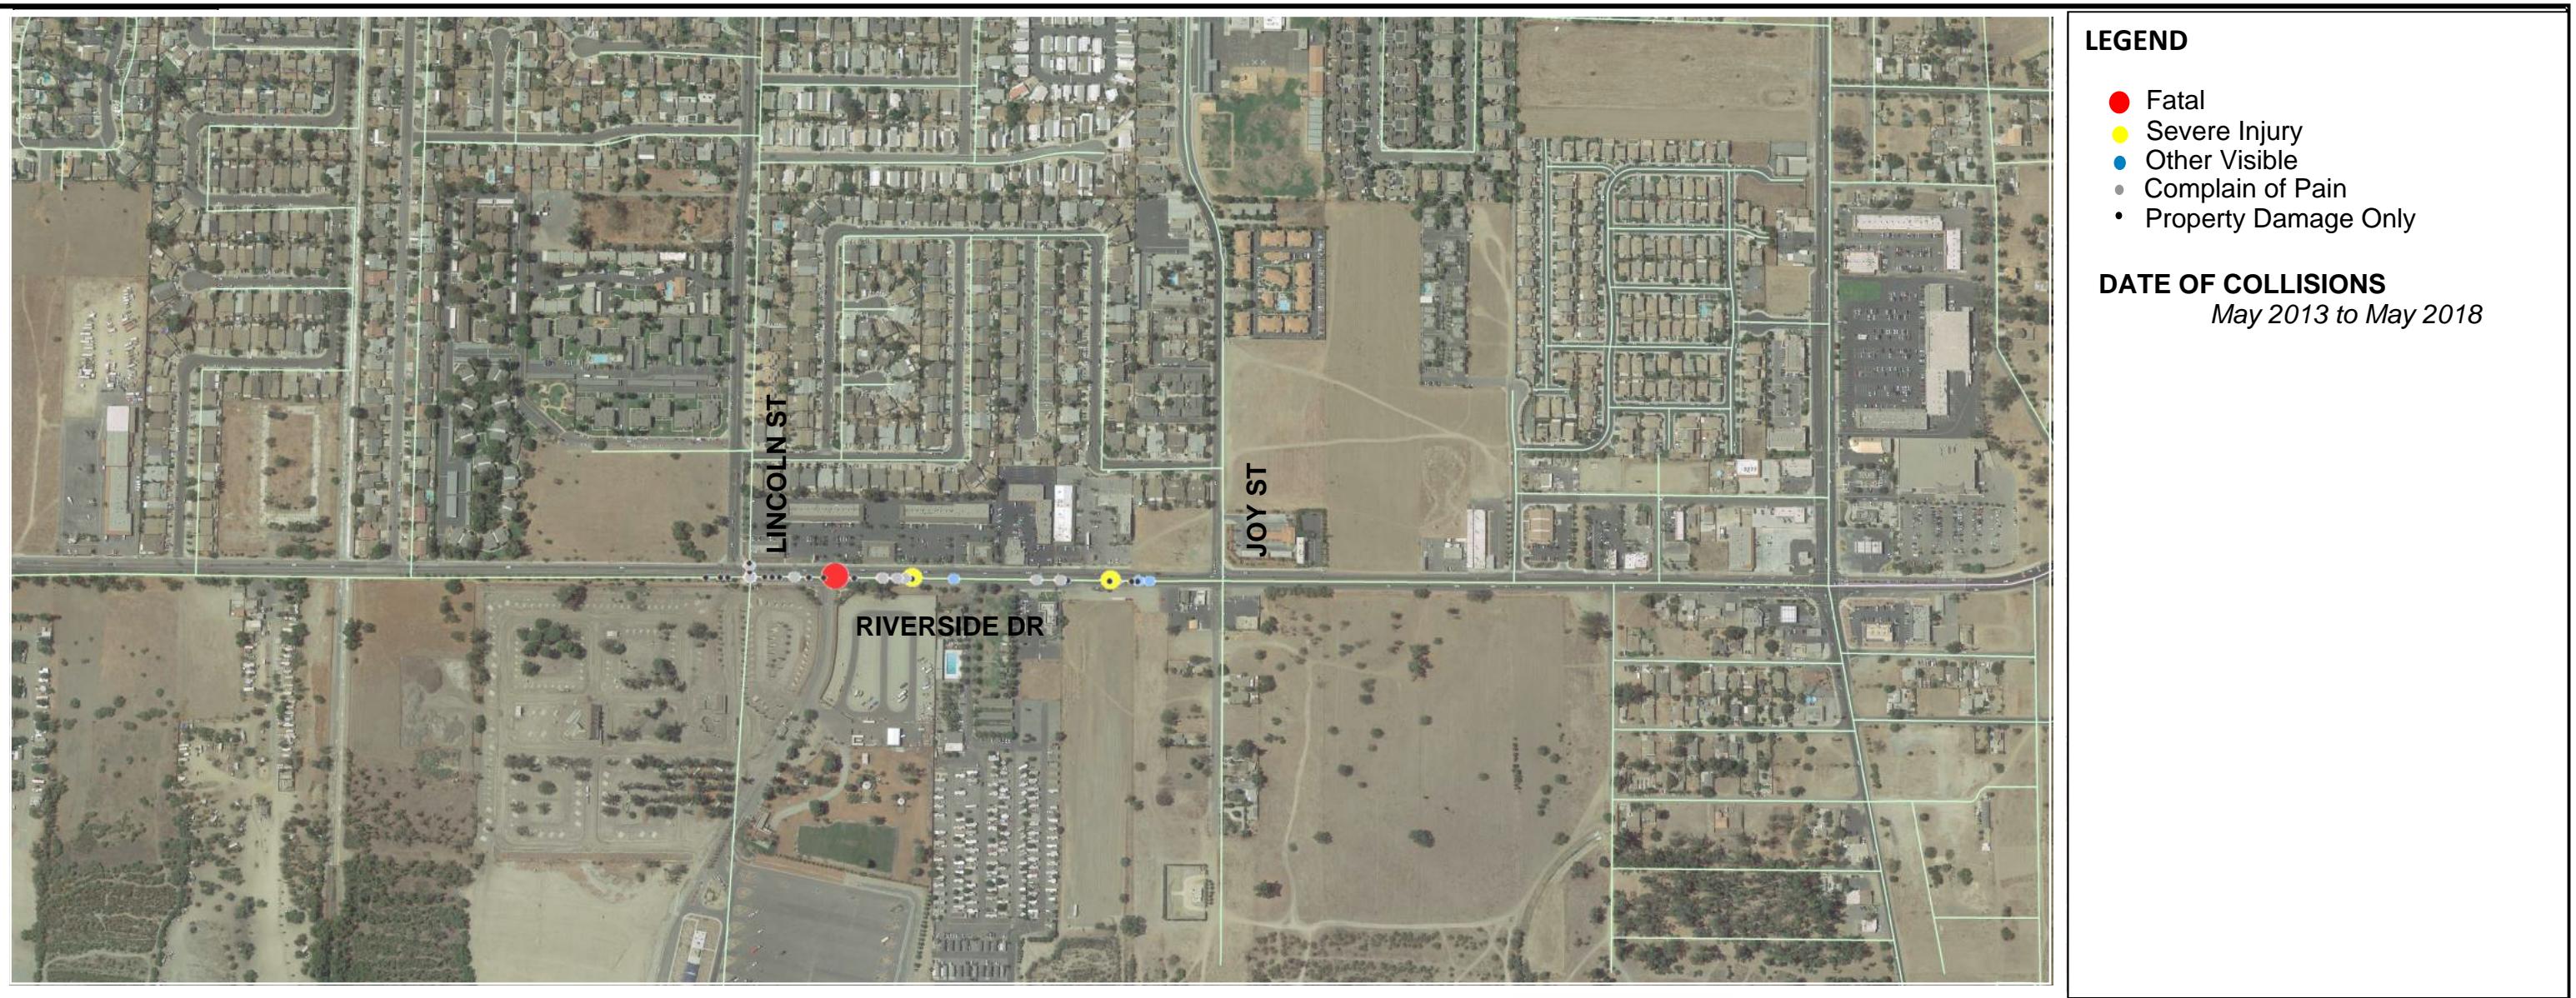
1. RIVERSIDE DR FROM LINCOLN ST TO JOY ST

- Riverside Drive from Lincoln Street to Joy Street is a two lane roadway.
- The roadway segment is surrounded by vacant land, retail and houses.
- Riverside Drive is identified as Urban Arterial (120'ROW) in the City of Lake Elsinore General Plan Circulation Element.
- The length of the segment is 0.30 Miles.
- The rate of collision of the segment is 187.09.
- This segment of Riverside Drive provides connectivity to I-215.

- Unsafe Speed (33) and Pedestrian Violation (4) are the major causes of collisions on this segment of Riverside Drive.
- Most of the collision types on this segments were Rear End (39) or Broadside (9) collisions.

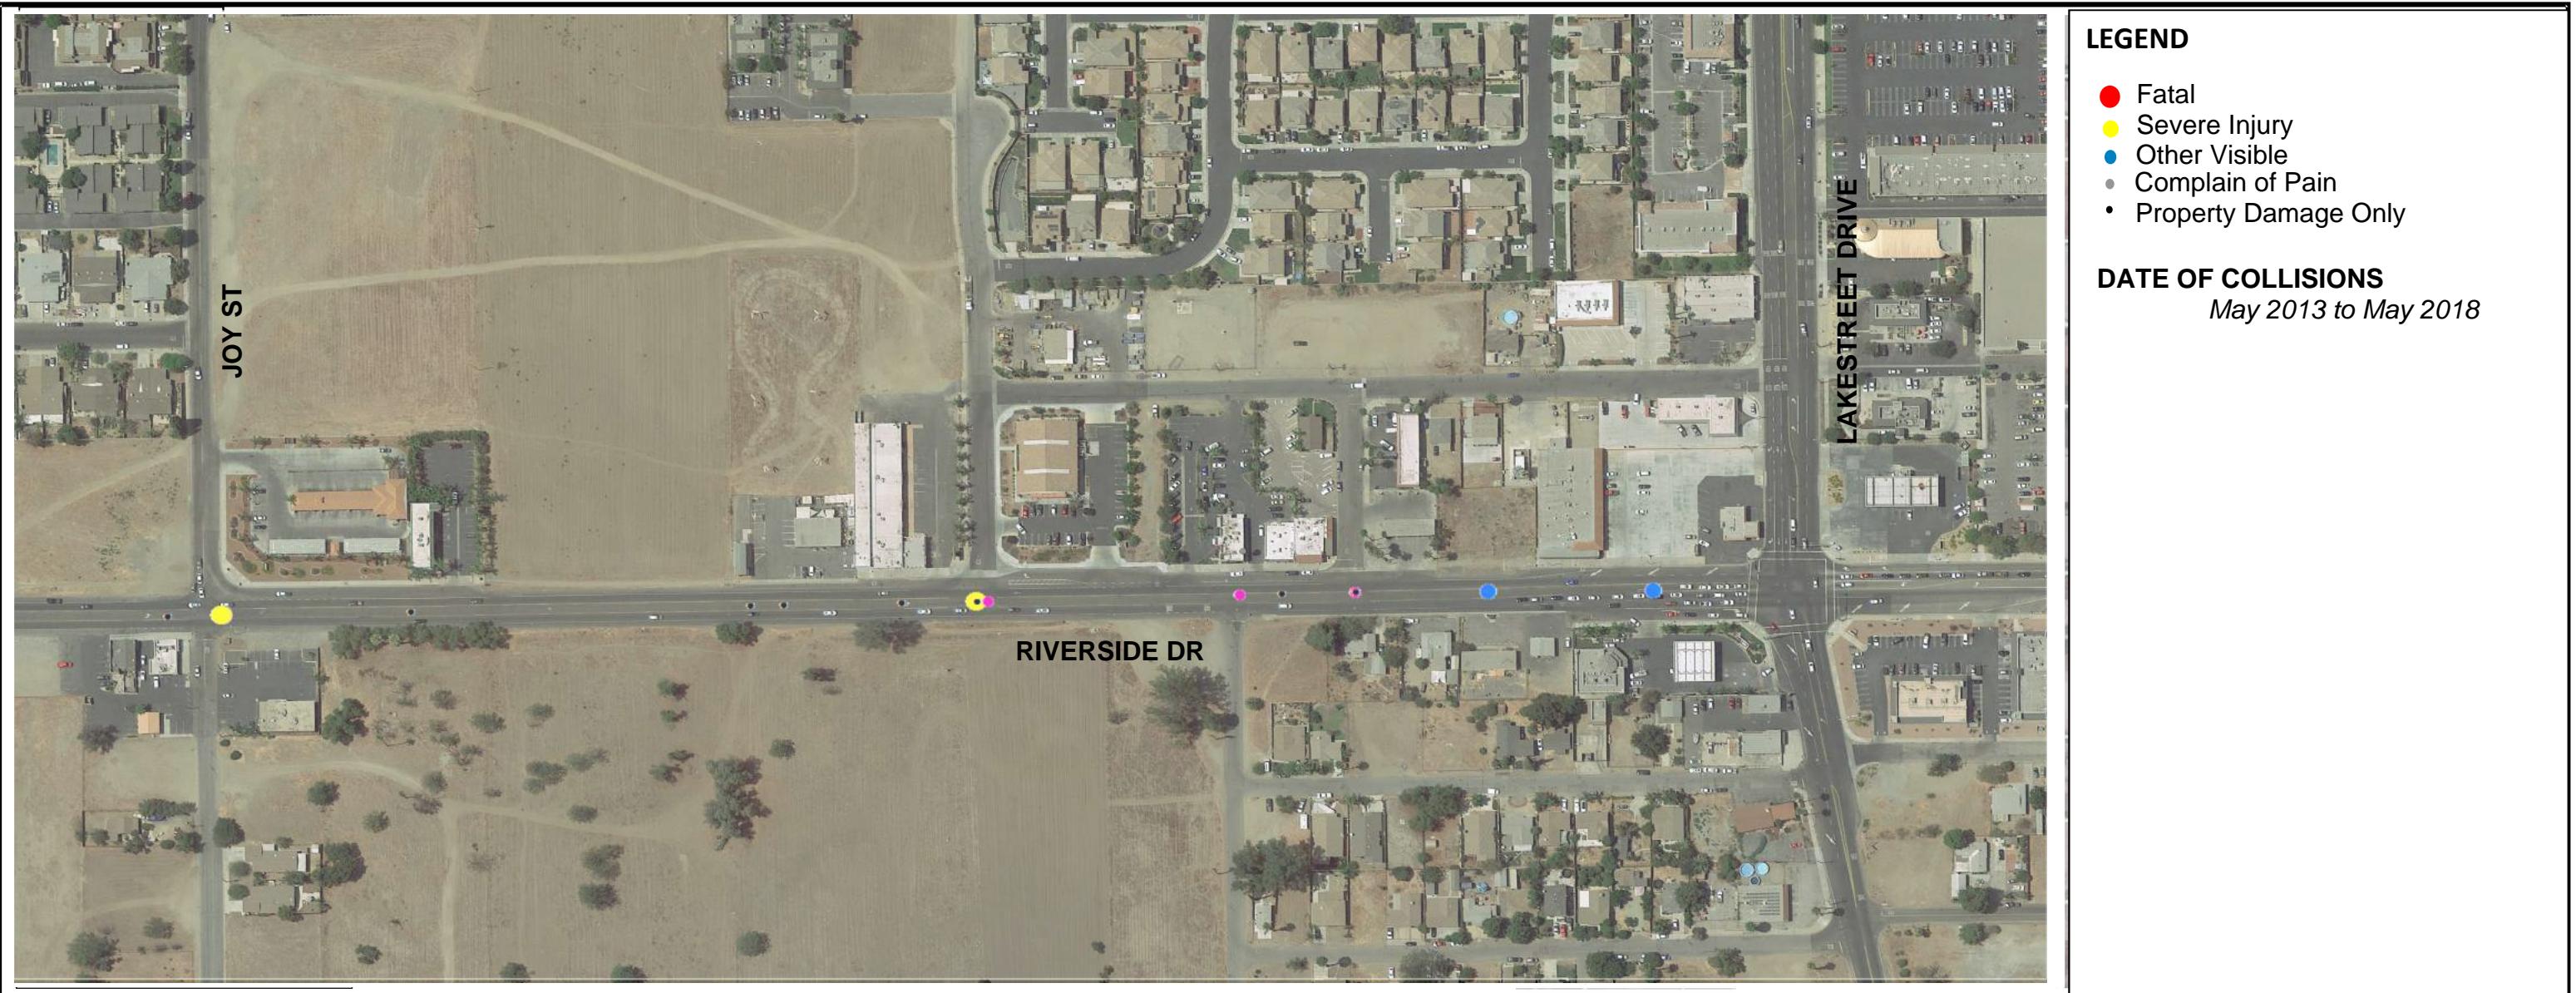
2. RIVERSIDE DR FROM JOY STREET TO LAKESHORE DRIVE

- Riverside Drive from Joy Street to Lakeshore Drive is a two lane roadway.
- The roadway segment is surrounded by vacant land, retail and houses.
- Riverside Drive is identified as Urban Arterial (120'ROW) in the City of Lake Elsinore General Plan Circulation Element.
- The length of the segment is 0.40 Miles.
- The rate of collision of the segment is 70.

- Unsafe Speed (9) and Driving Under influence (4) are the major causes of collisions on this segment of Riverside Drive.
- Most of the collision types on this segments were Rear End (11) or Broadside (8) collisions.

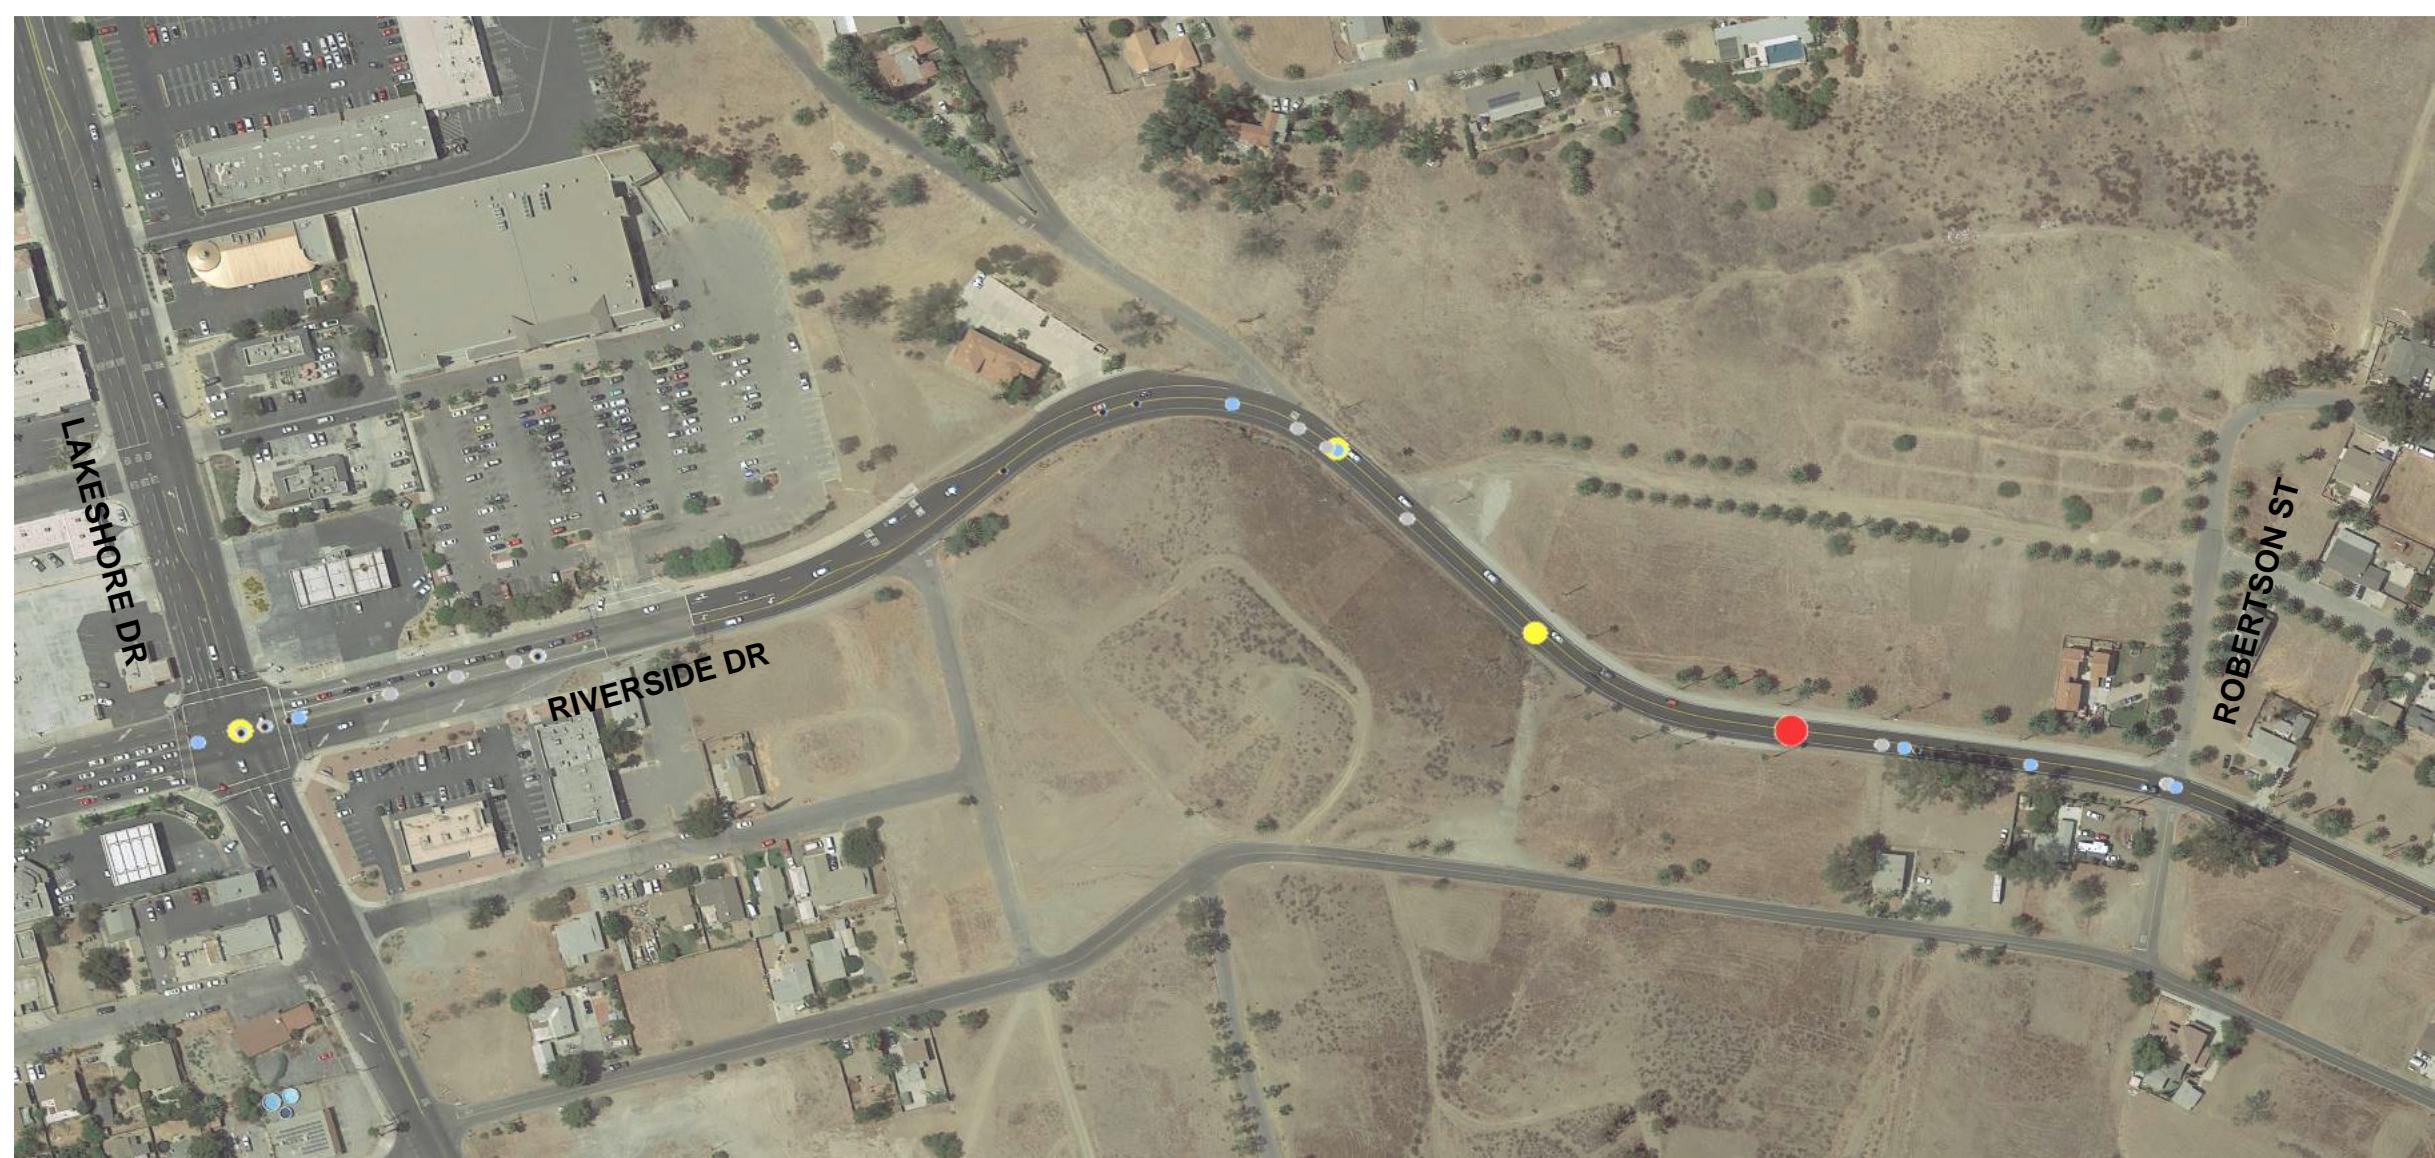
3. RIVERSIDE DR FROM LAKESHORE DR TO ROBERTSON STREET

- Unsafe Speed (20) and Driving Under Influence (12) are the major causes of collisions on this segment of Riverside Drive.
- Most of the collision types on this segments were Rear End (27) or Sideswipe (10) collisions.

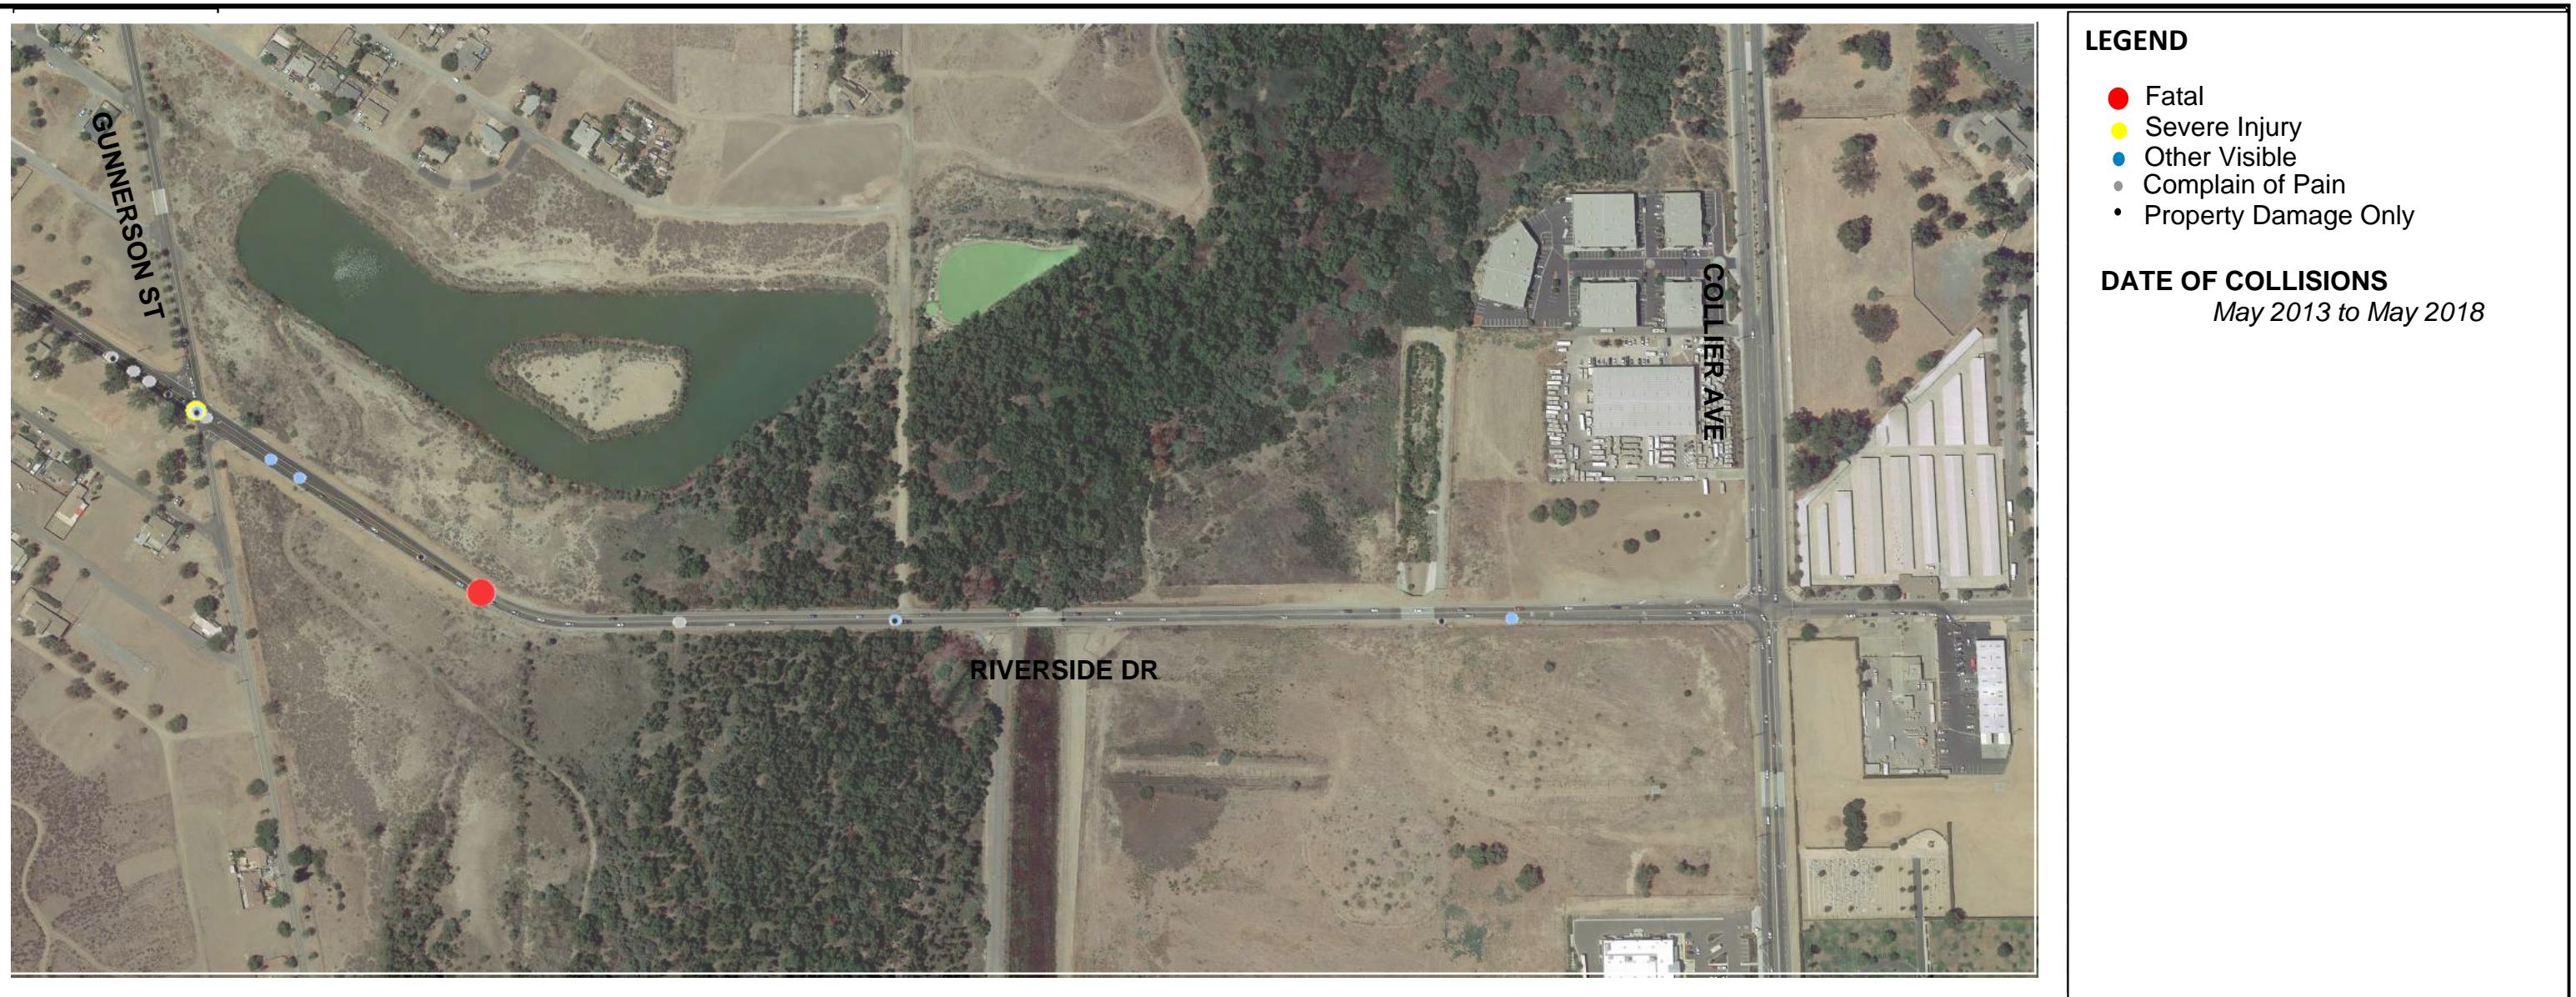
4. RIVERSIDE DR FROM GUNNERSON ST TO COLLIER AVENUE

- Riverside Drive from Gunnerson Street to Collier is a two lane roadway.
- The roadway segment is surrounded by vacant land, retail and houses.
- Riverside Drive is identified as Urban Arterial (120'ROW) in the City of Lake Elsinore General Plan Circulation Element.
- The length of the segment is 0.66 Miles.
- The collision per mile rate of the segment is 44.

- Unsafe Speed (10) and Driving Under influence (4) are the major causes of collisions on this segment of Riverside Drive.
- Most of the collision types on this segment were Rear End (11) or Head-On (6) collisions.

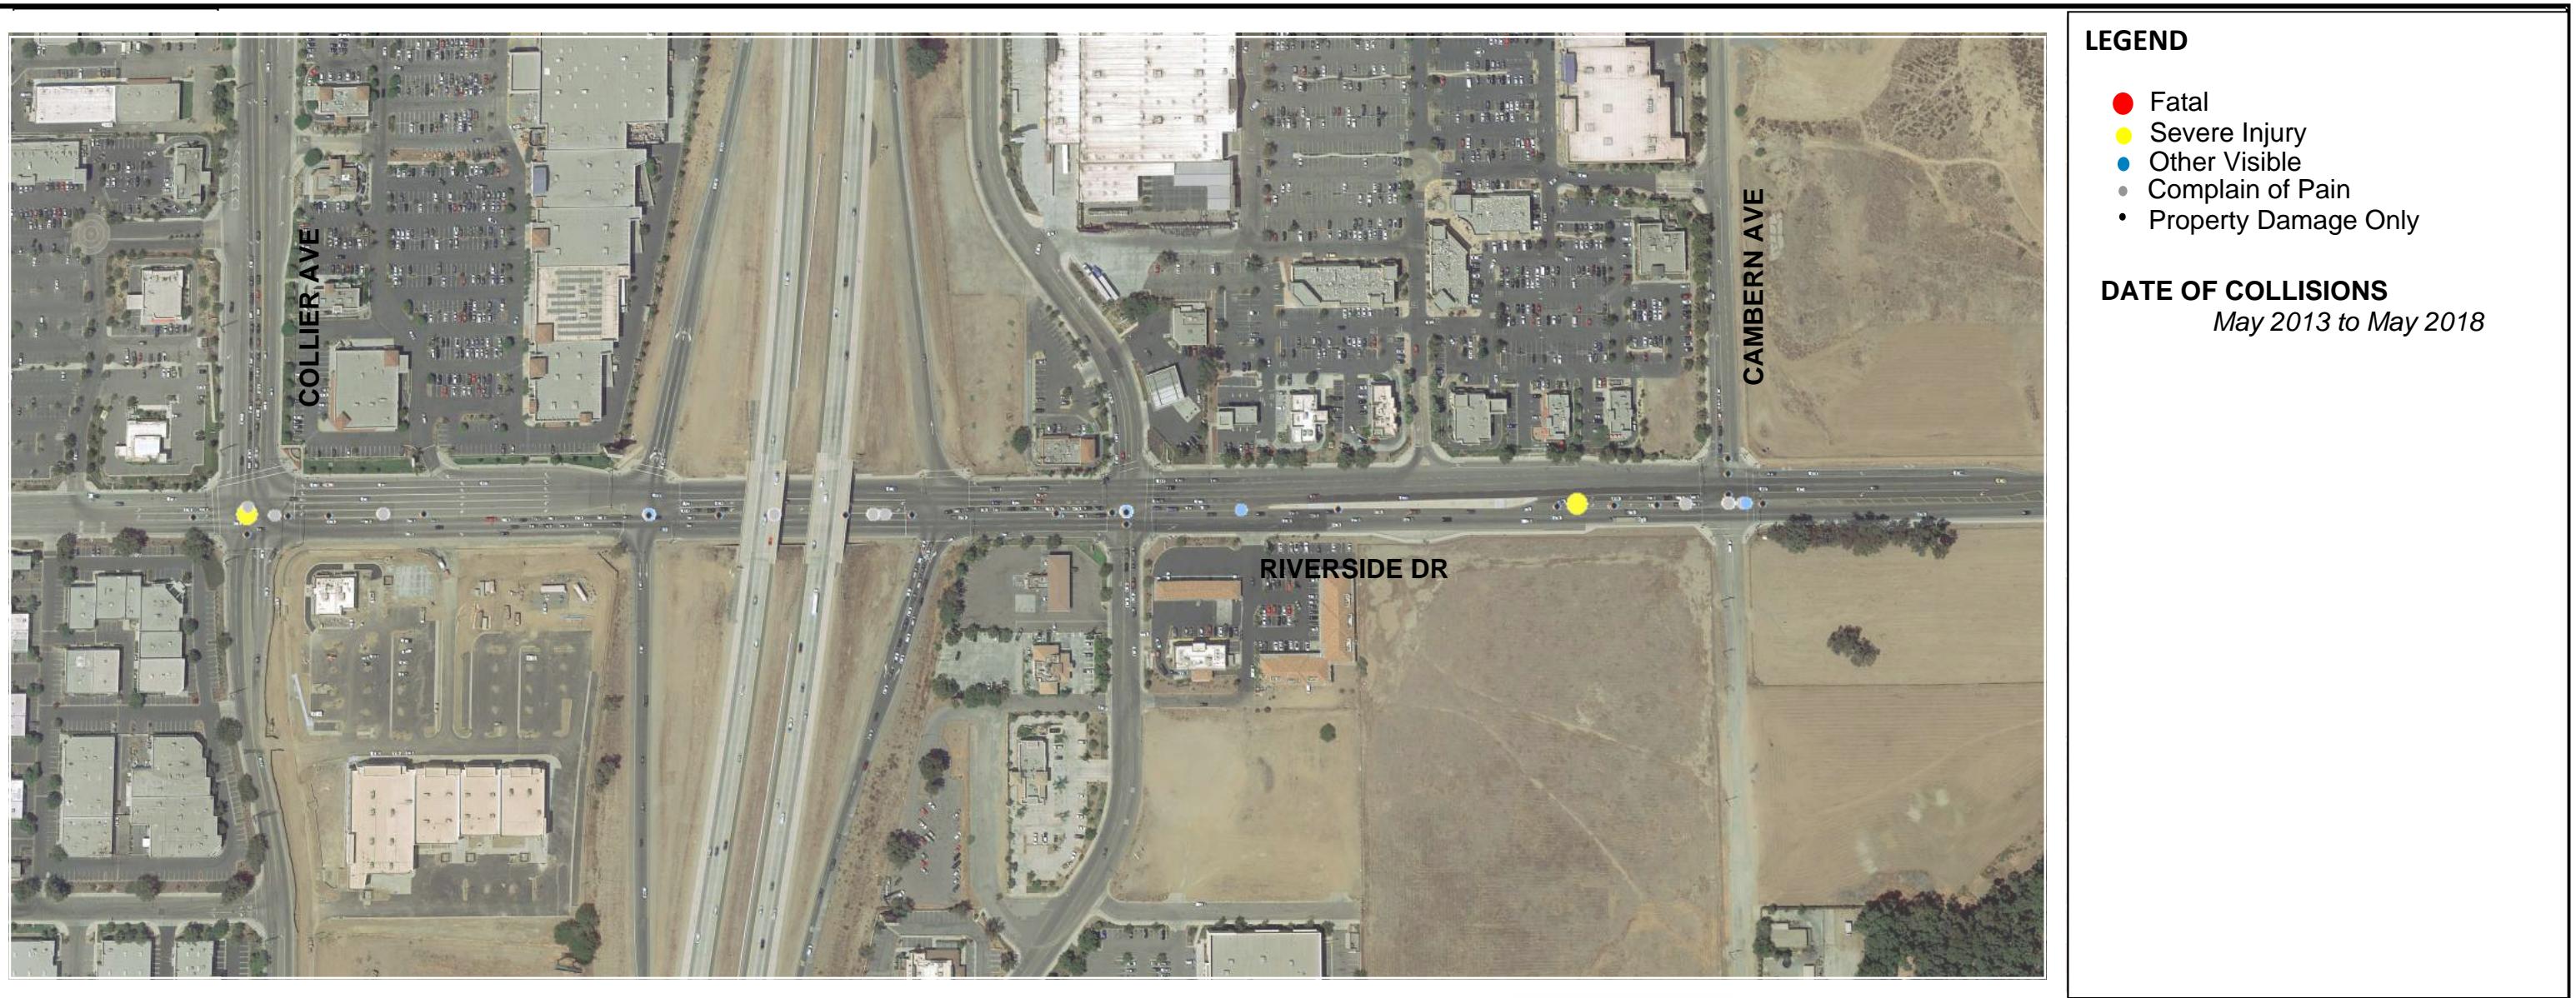
6. RIVERSIDE DR FROM COLLIER AVENUE TO CAMBERN AVENUE

- Riverside Drive from Collier Avenue to Central Avenue is a six lane roadway.
- The roadway segment is surrounded by vacant land, retail and houses.
- Riverside Drive is identified as Augmented Urban Arterial (120'ROW) in the City of Lake Elsinore General Plan Circulation Element.
- The length of the segment is 0.50 Miles.
- The collisions per mile rate of the segment is 238.

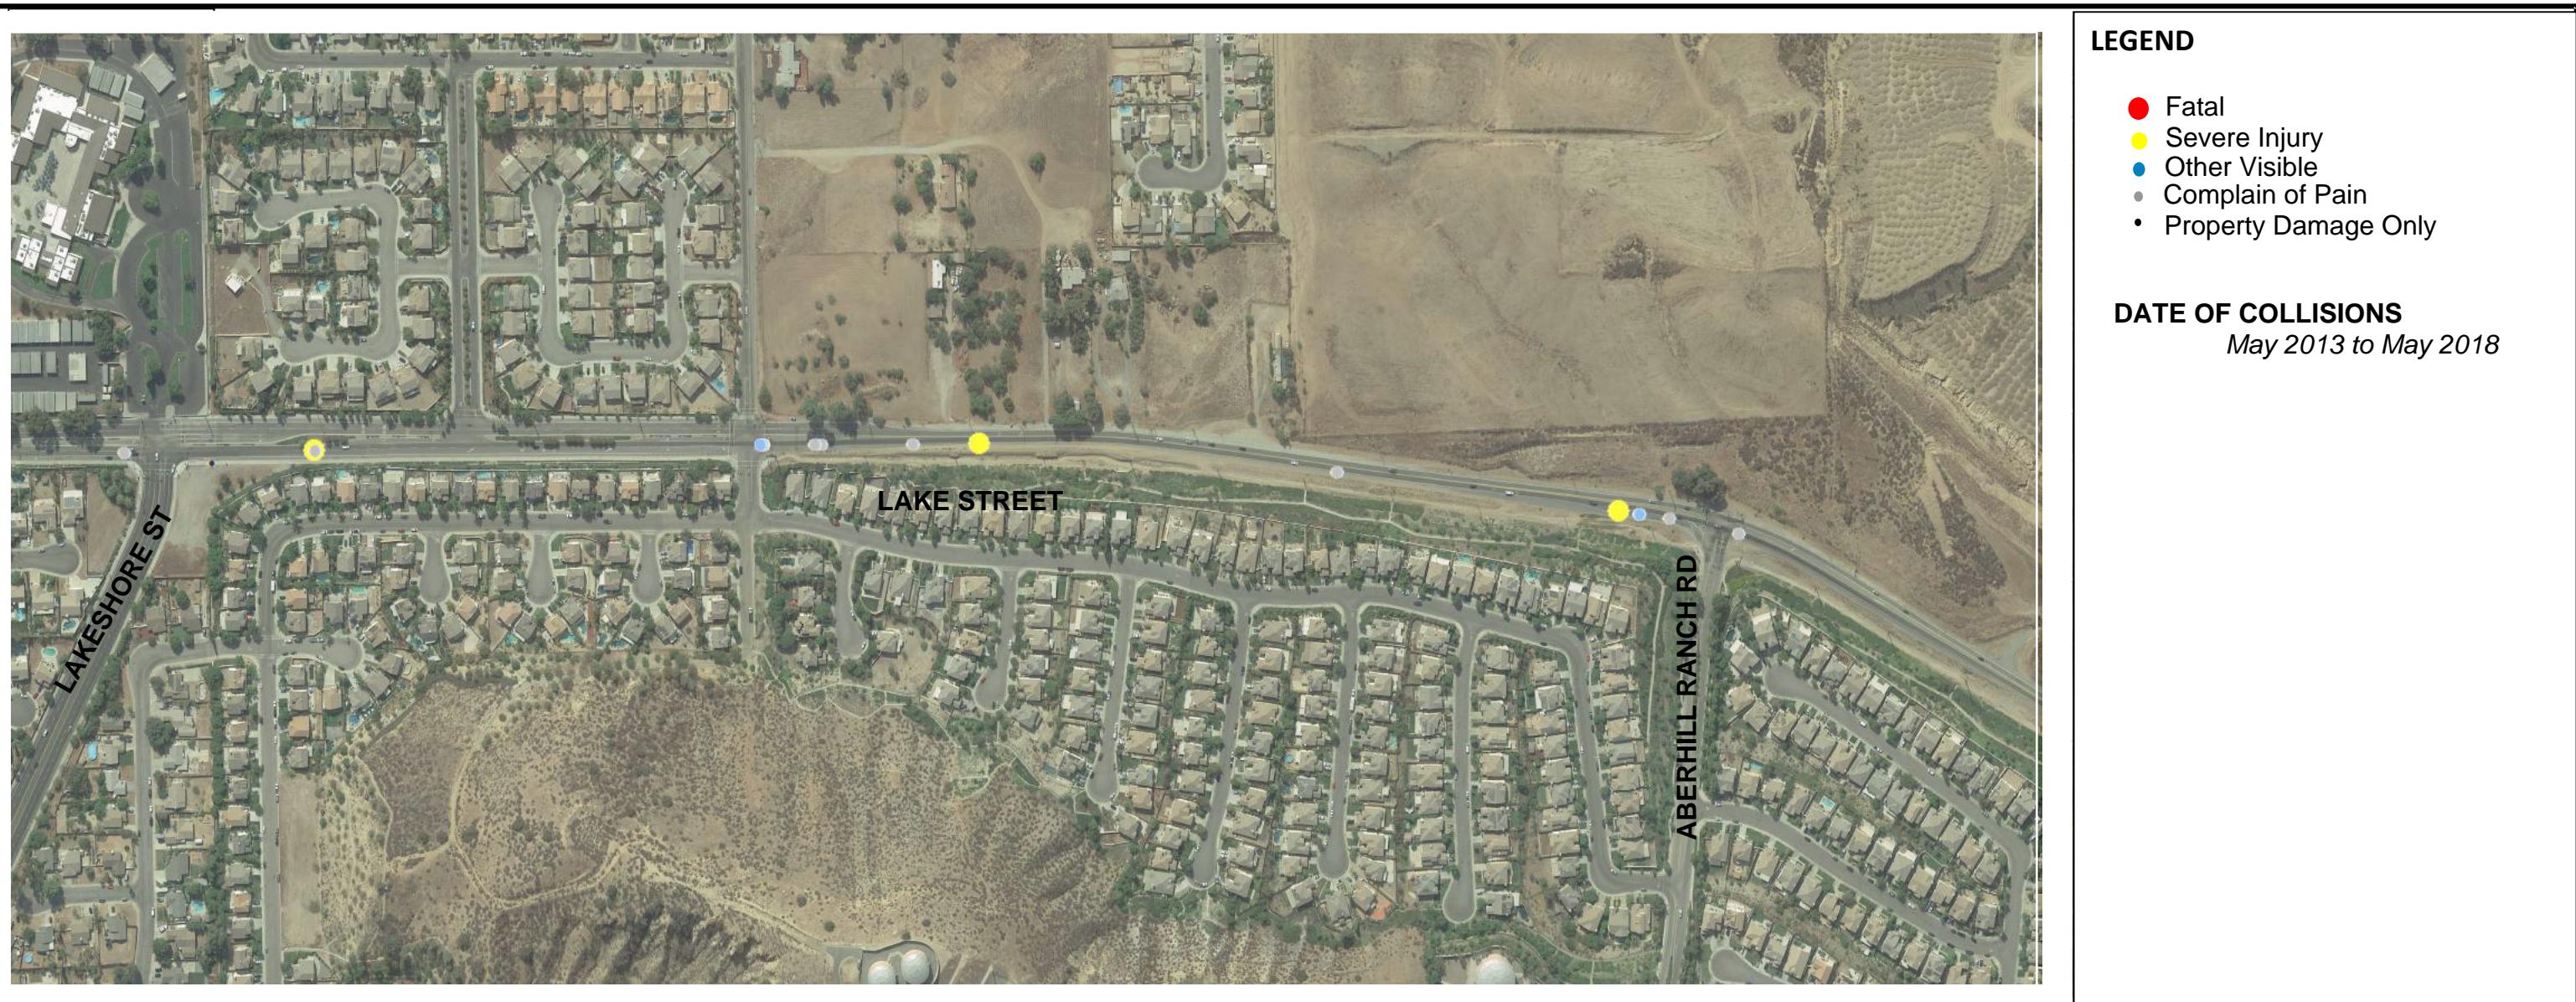
7. LAKE STREET FROM ALBERHILL RANCH ROAD TO LAKESHORE STREET

- Lake Street from Alberhill Ranch Road to Lakeshore Street is a two lane roadway.
- The roadway segment is surrounded by vacant land and residential houses.
- Lake Street is identified as Urban Arterial (120'ROW) in the City of Lake Elsinore General Plan Circulation Element.
- The length of the segment is 0.70 Miles.
- The Collision per mile rate of the segment is 57.

- Improper Turning (11) and Traffic Signal and Signs (7) are the major causes of collisions on this segment of Lake Street.
- Most of the collision types on this segments were Rear End (10) or Broadside (10) collisions.

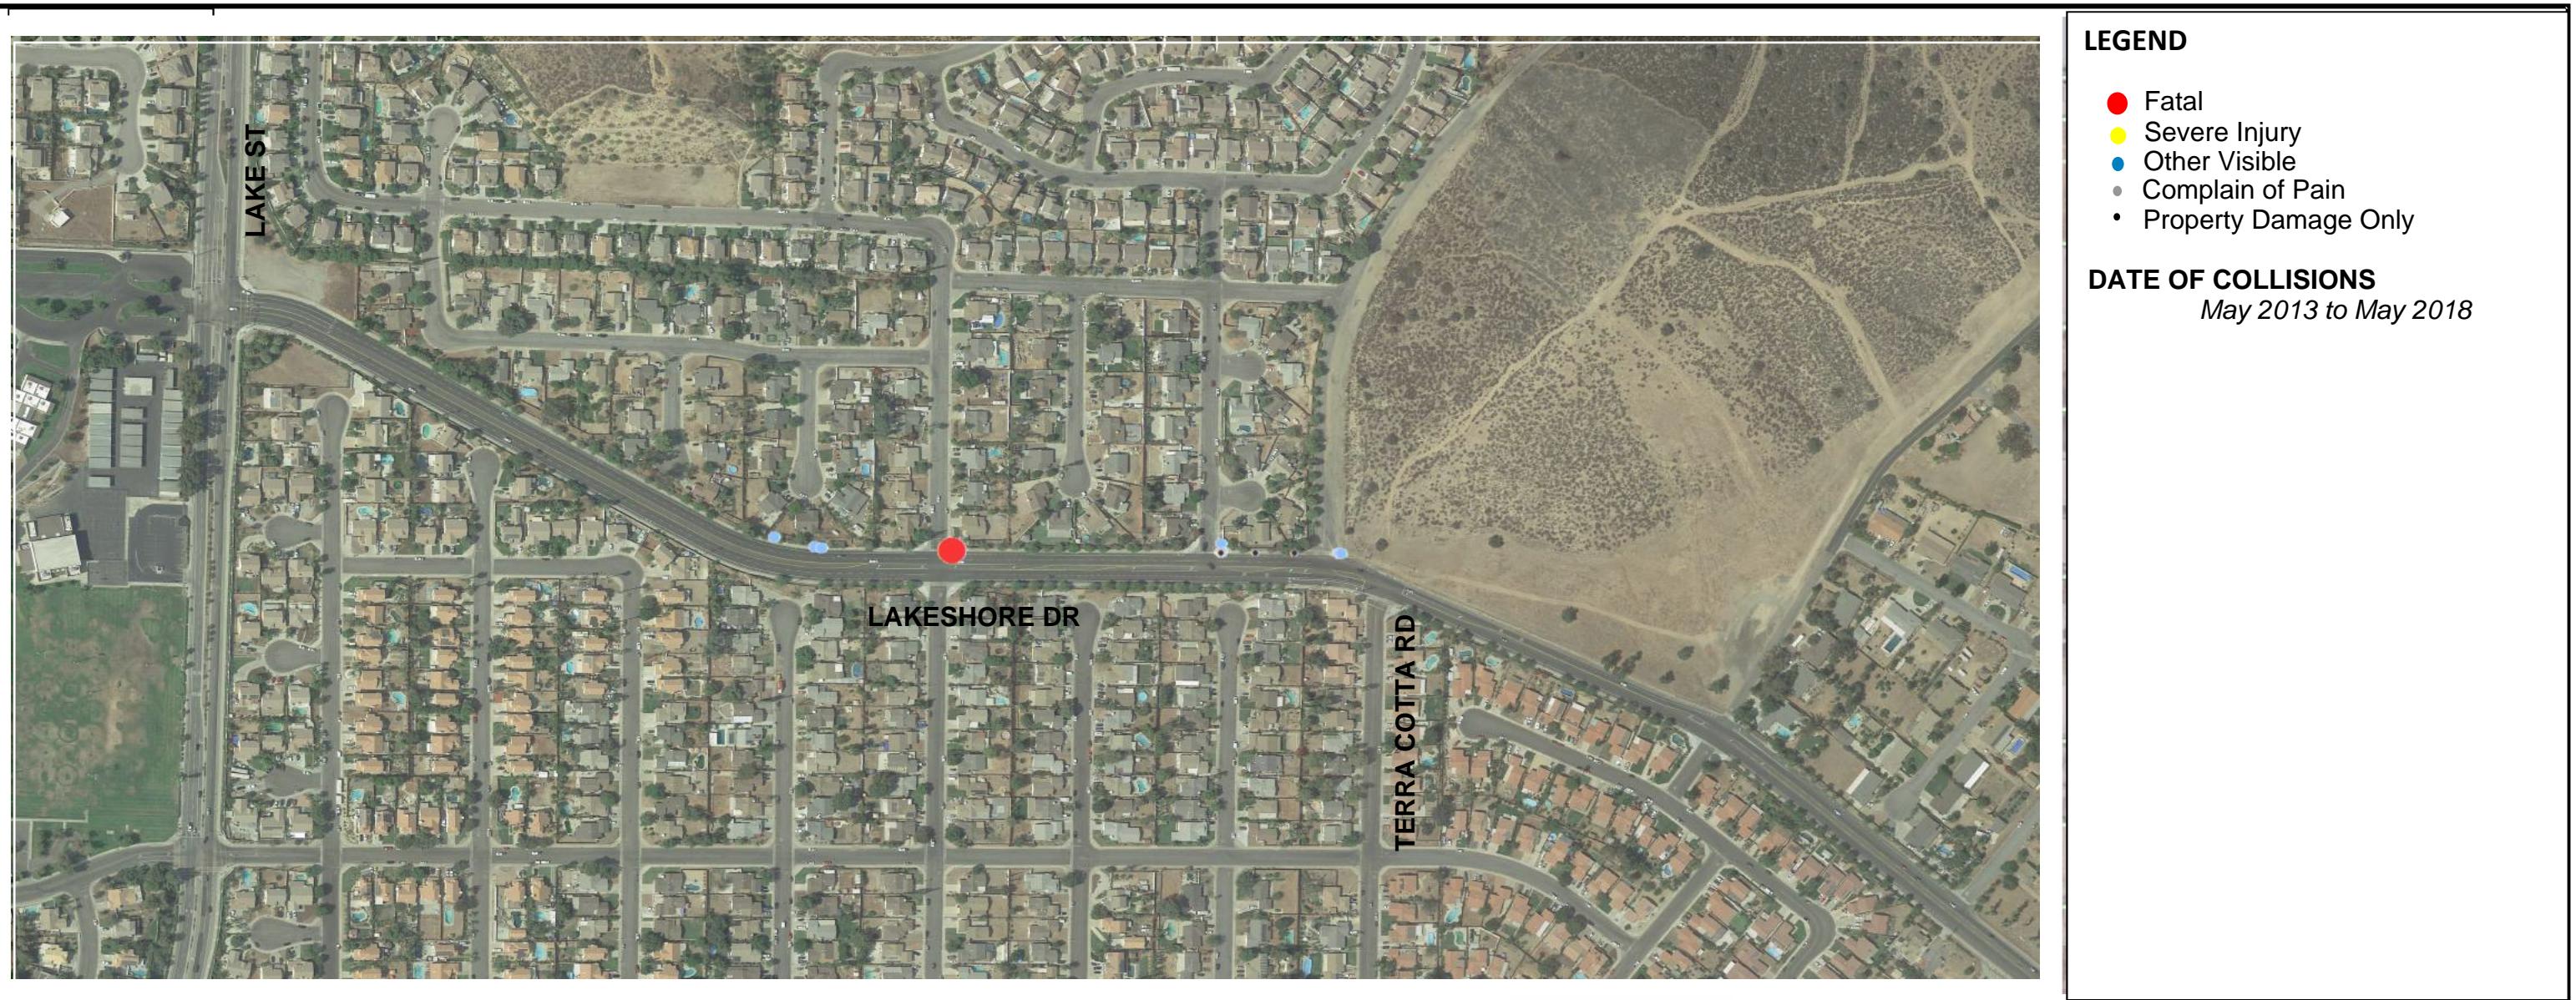
8. LAKESHORE DRIVE FROM LAKE STREET TO TERRA COTTA

- Lakeshore Drive from Lake Street to Terra Cotta is a four lane roadway.
- The roadway segment is surrounded by residential houses.
- Lakeshore Drive is identified as Urban Arterial (120'ROW) in the City of Lake Elsinore General Plan Circulation Element.
- The length of the segment is 0.5 Miles.
- The collisions per mile rate of the segment is 34.

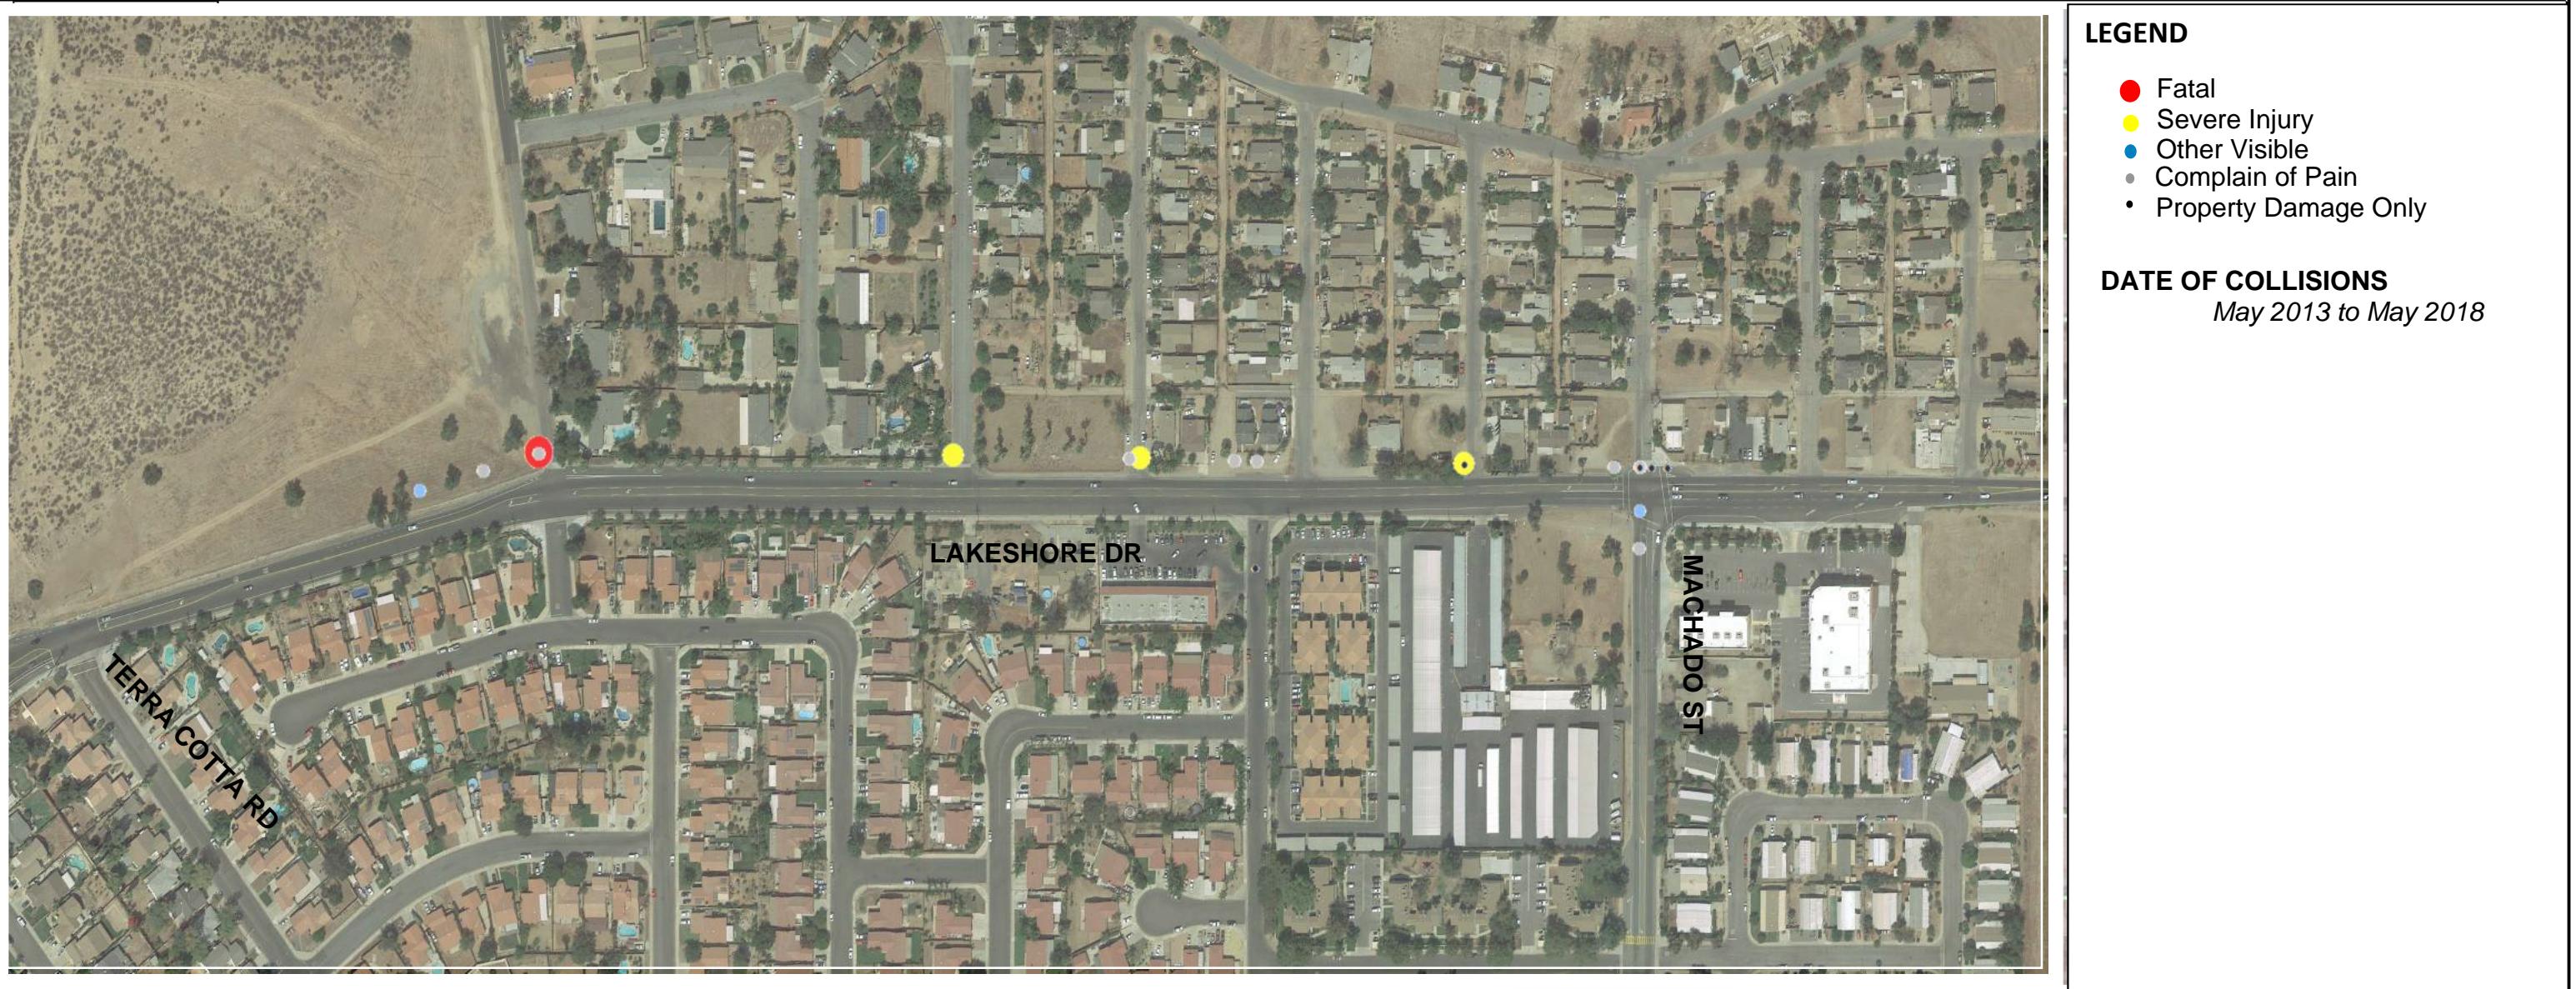
9. LAKESHORE DRIVE FROM TERRA COTTA RD TO MACHADO ST

- Lakeshore Drive from Lake Street to Terra Cotta is a four lane roadway.
- The roadway segment is surrounded by residential houses and vacant land.
- Lakeshore Drive is identified as Urban Arterial (120'ROW) in the City of Lake Elsinore General Plan Circulation Element.
- The length of the segment is 0.5 Miles.
- The rate of Collision of the segment is 50.
