Systemic Safety Analysis Report

CITY OF LAKE ELSINORE

RE: Systemic Safety Analysis Report Program (SSARP)

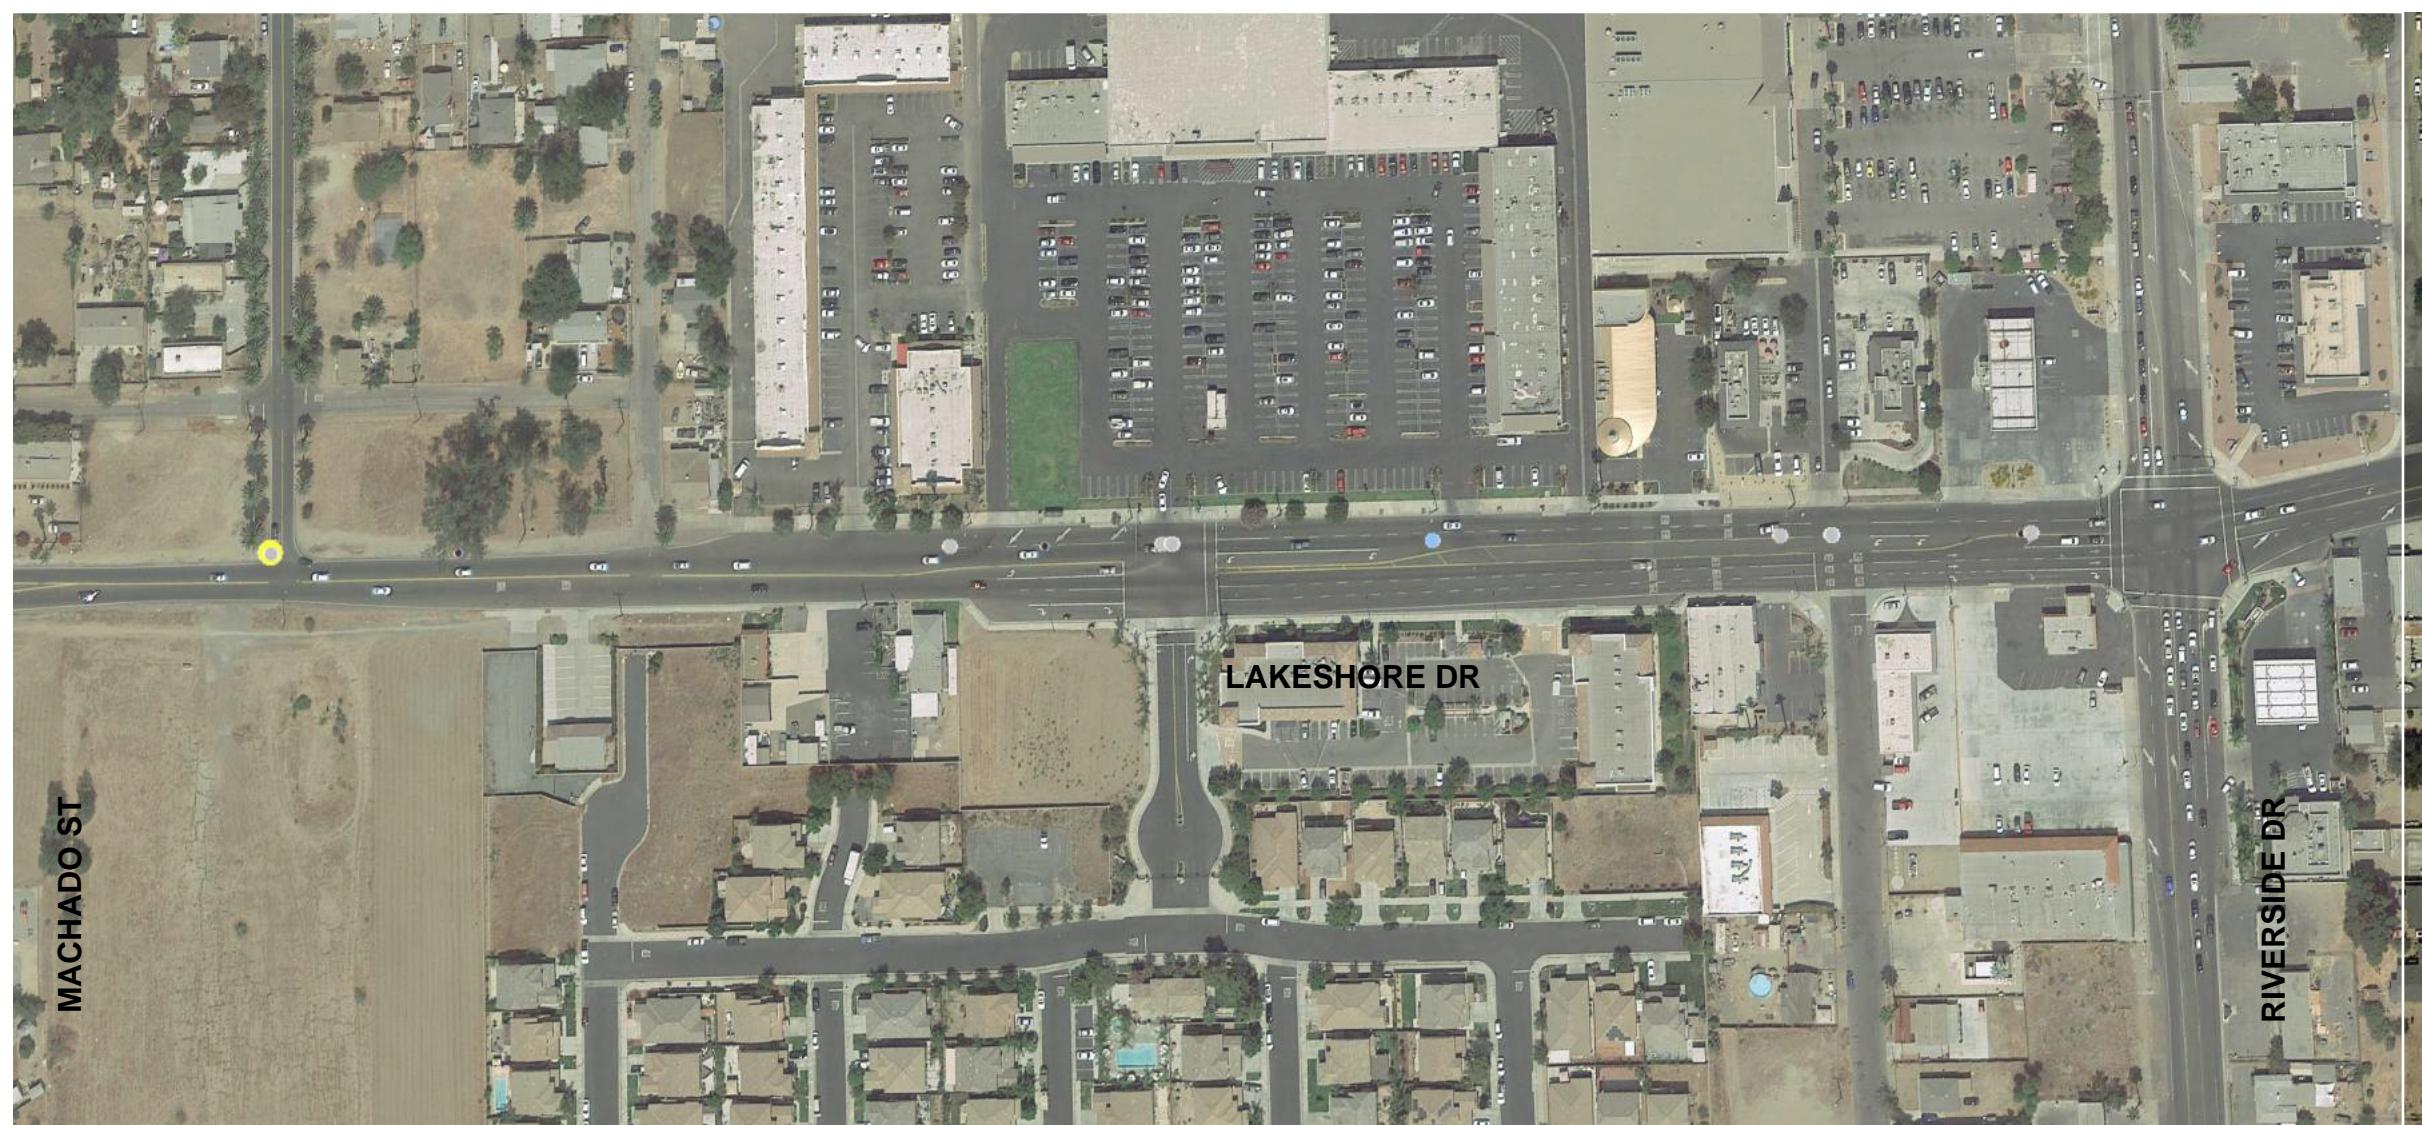
10. LAKESHORE DRIVE FROM MACHADO ST TO RIVERSIDE DR

- Lakeshore Drive from Machado Street to Riverside Drive is a four lane roadway.
- The roadway segment is surrounded by residential houses and open space.
- Lakeshore Drive is identified as Urban Arterial (120'ROW) in the City of Lake Elsinore General Plan Circulation Element.
- The length of the segment is 0.5 Miles.
- The collision rate of the segment is 56.

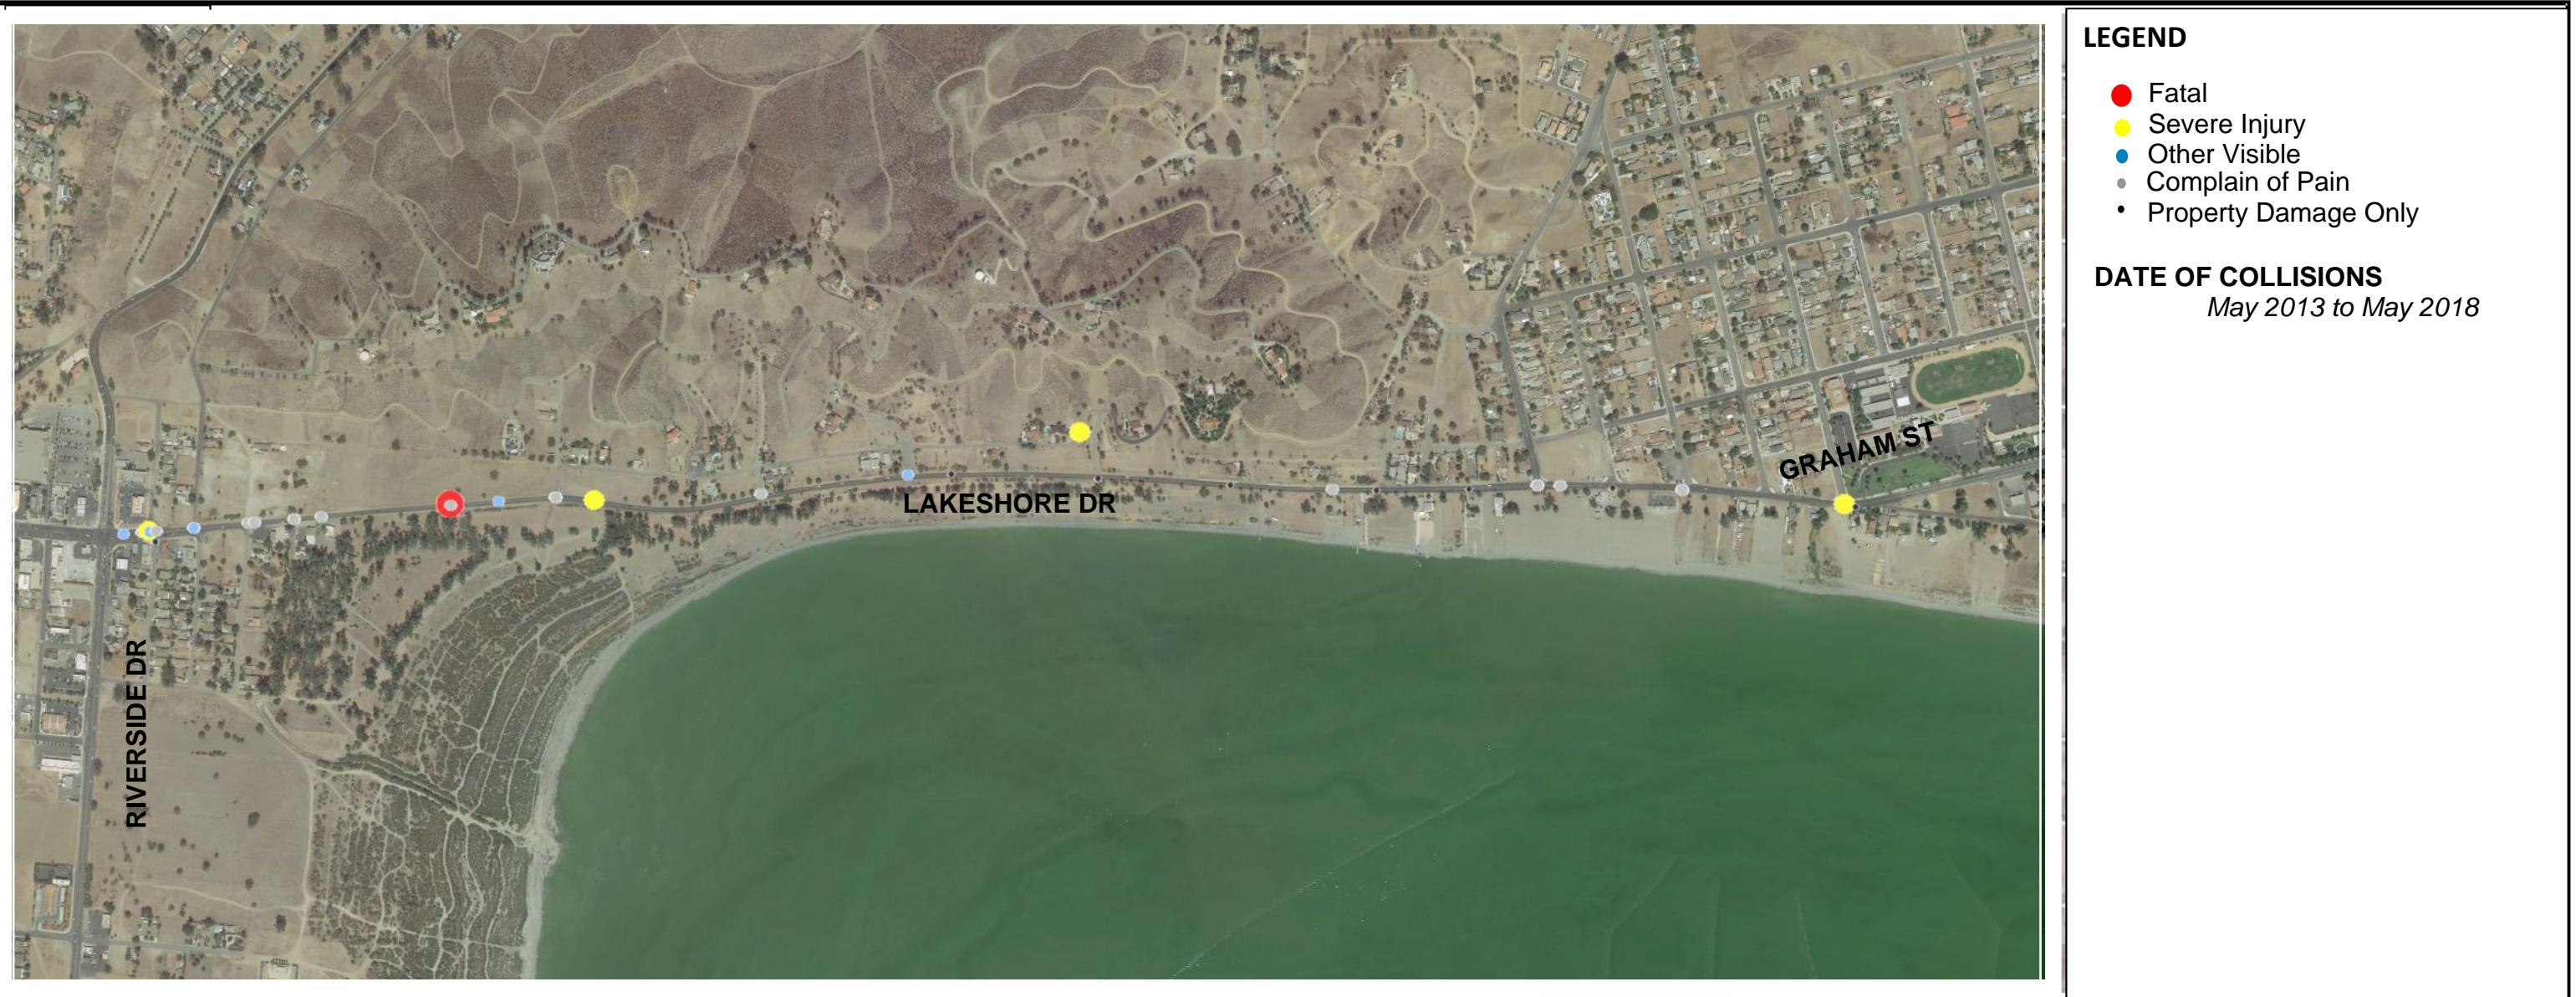
11. LAKESHORE DRIVE FROM RIVERSIDE DR TO GRAHAM ST

- Lakeshore Drive from Riverside Drive to Graham St is a four lane roadway.
- The roadway segment is surrounded by residential houses and vacant land.
- Lakeshore Drive is identified as Urban Arterial (120'ROW) in the City of Lake Elsinore General Plan Circulation Element.
- The length of the segment is 1.7 Miles.
- The rate of Collision of the segment is 36.4.

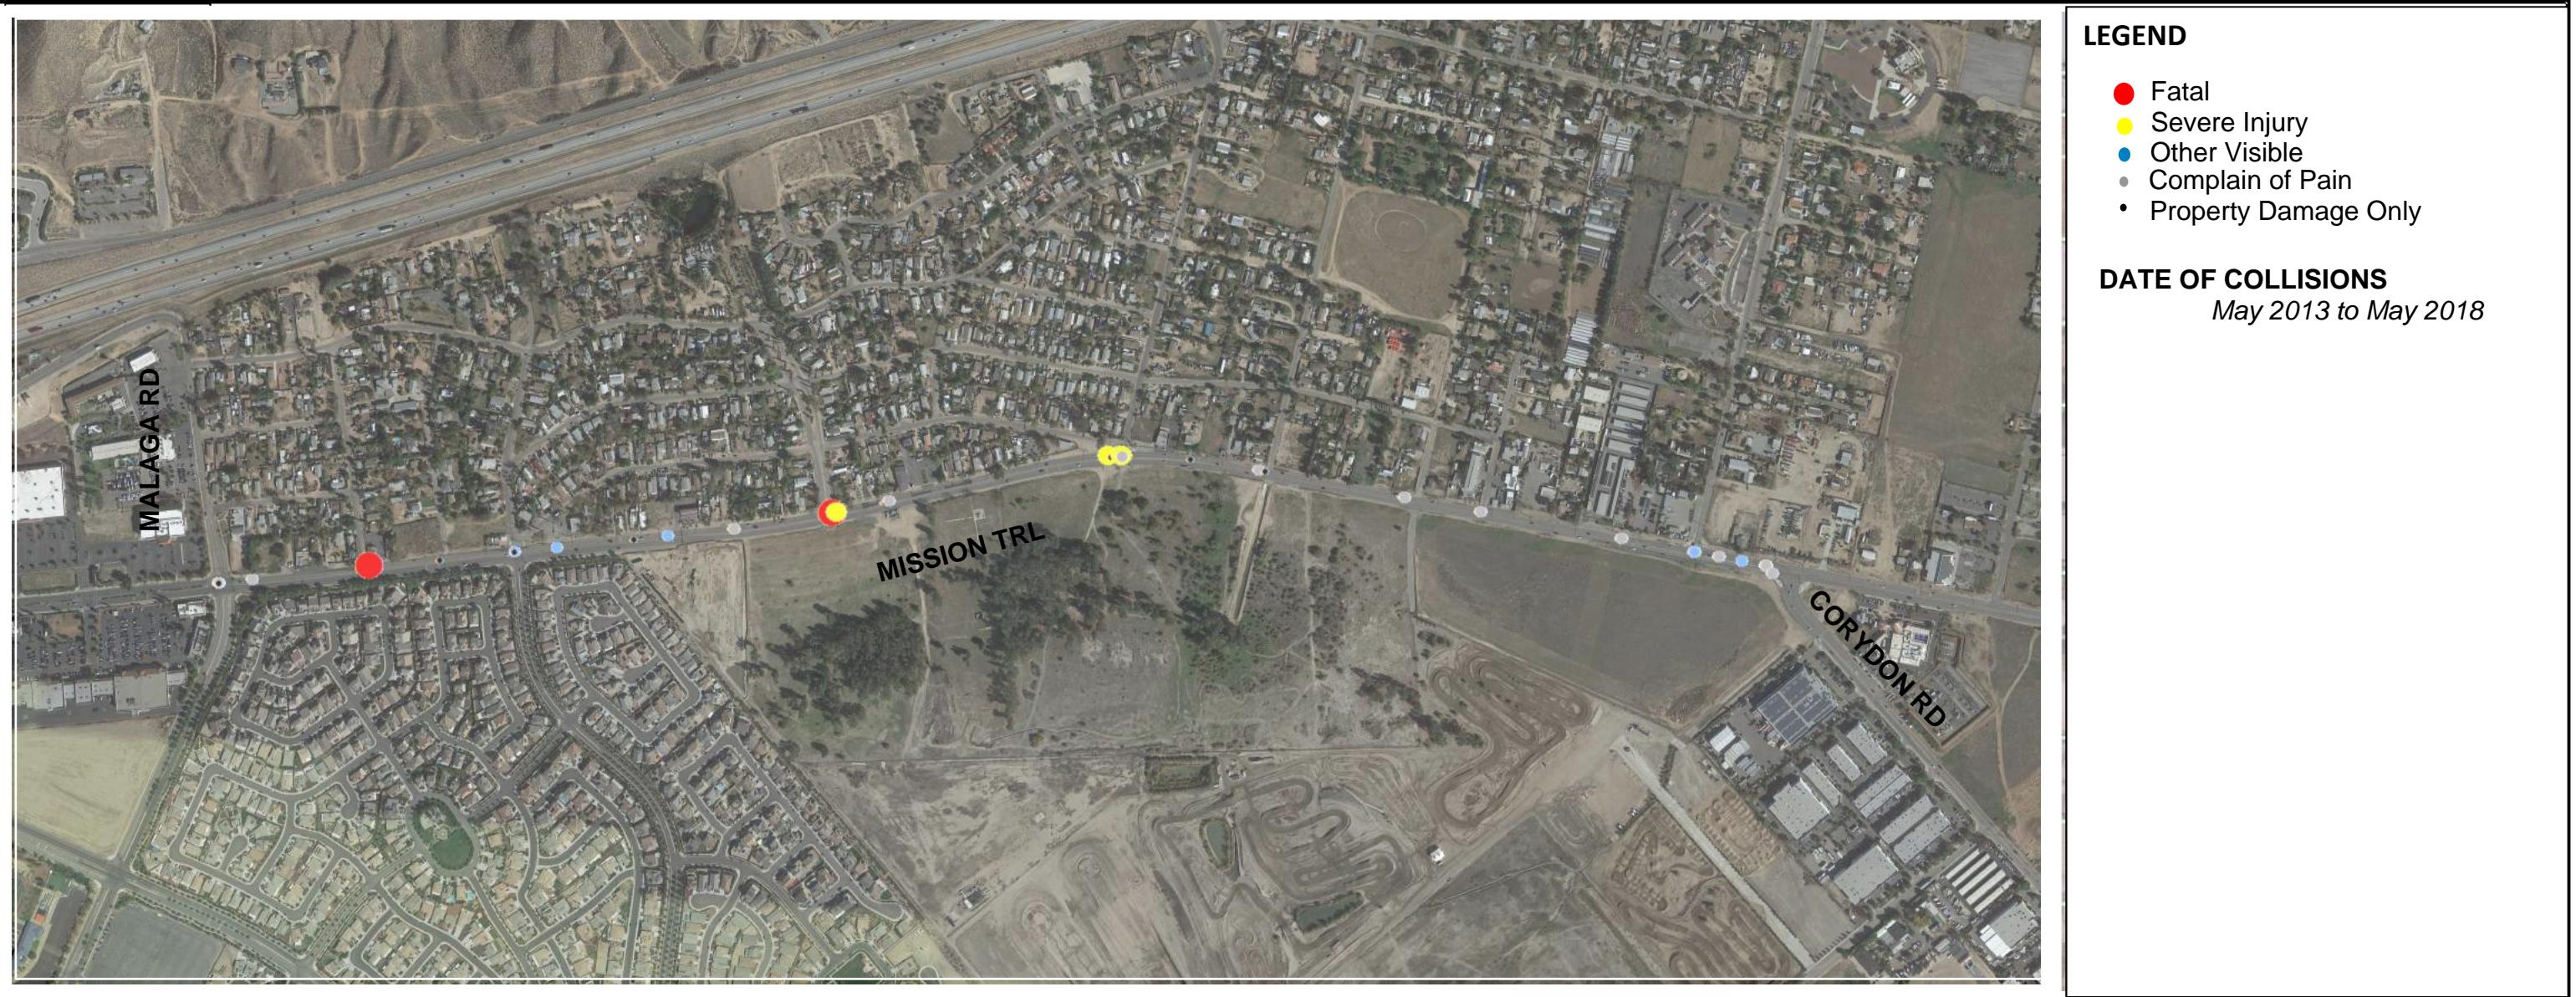
12. MISSION TRAIL FROM MALAGA RD TO CARYDON RD

- Mission Trail from Malaga Rd to Corydon St is a four lane roadway.
- The roadway segment is surrounded by residential houses and vacant land.
- Mission Trail is identified as Urban Arterial (120'ROW) in the City of Lake Elsinore General Plan Circulation Element.
- The length of the segment is 1.4 Miles.
- The rate of collision of the segment is 31.4.

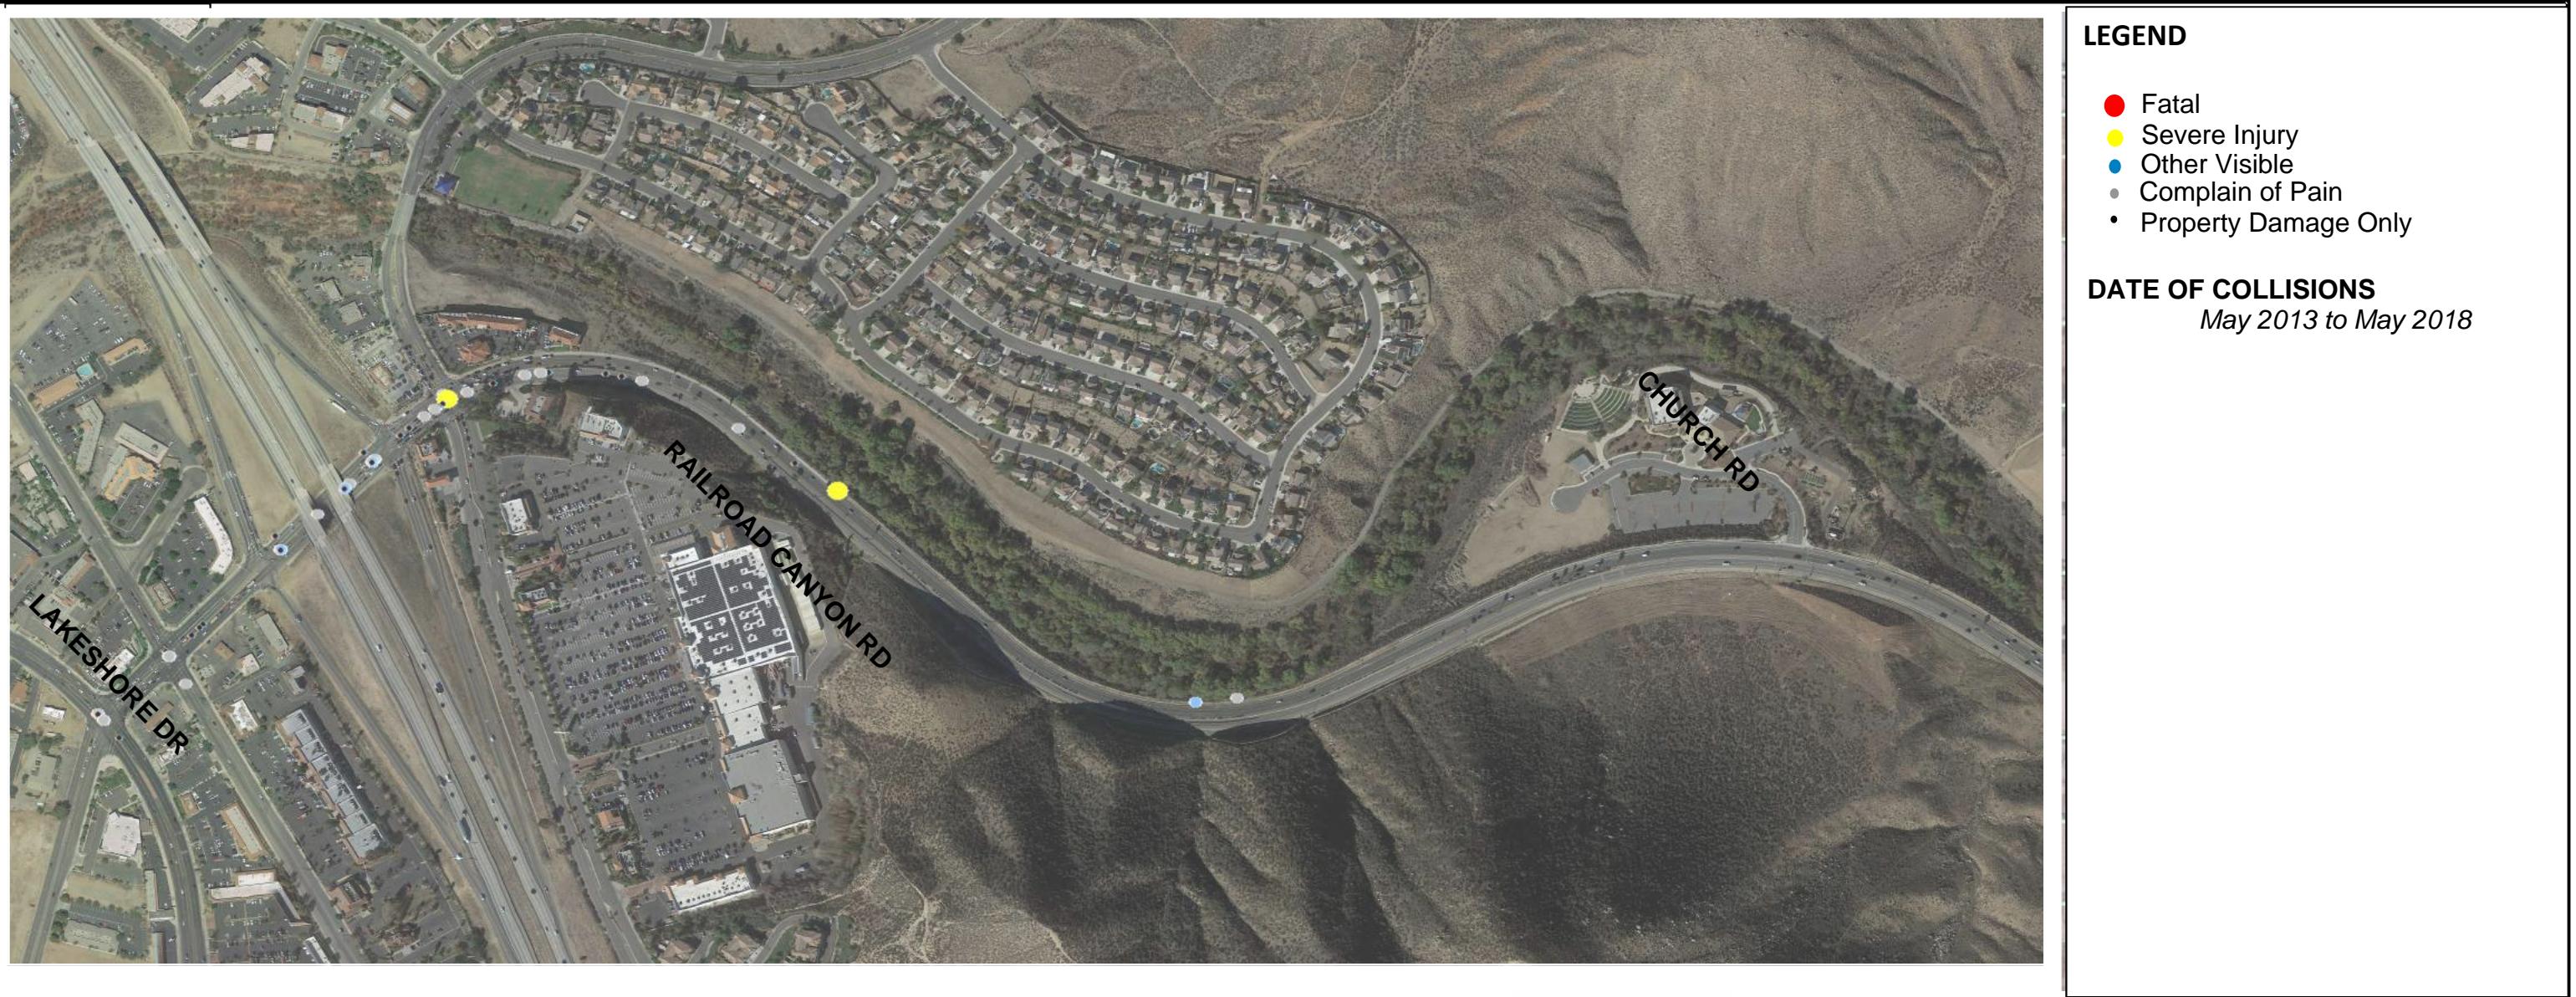
13. Railroad Canyon Rd from Lakeshore Dr to Church Rd

- Railroad Canyon Rd from Lakeshore Dr to Church Rd is a four lane roadway.
- The roadway segment is surrounded by residential houses, commercial and vacant lots.
- Railroad Canyon is identified as Augmented Urban Arterial (120'ROW) in the City of Lake Elsinore General Plan Circulation Element.
- The length of the segment is 1.1 Miles.
- The rate of Collision of the segment is 128.

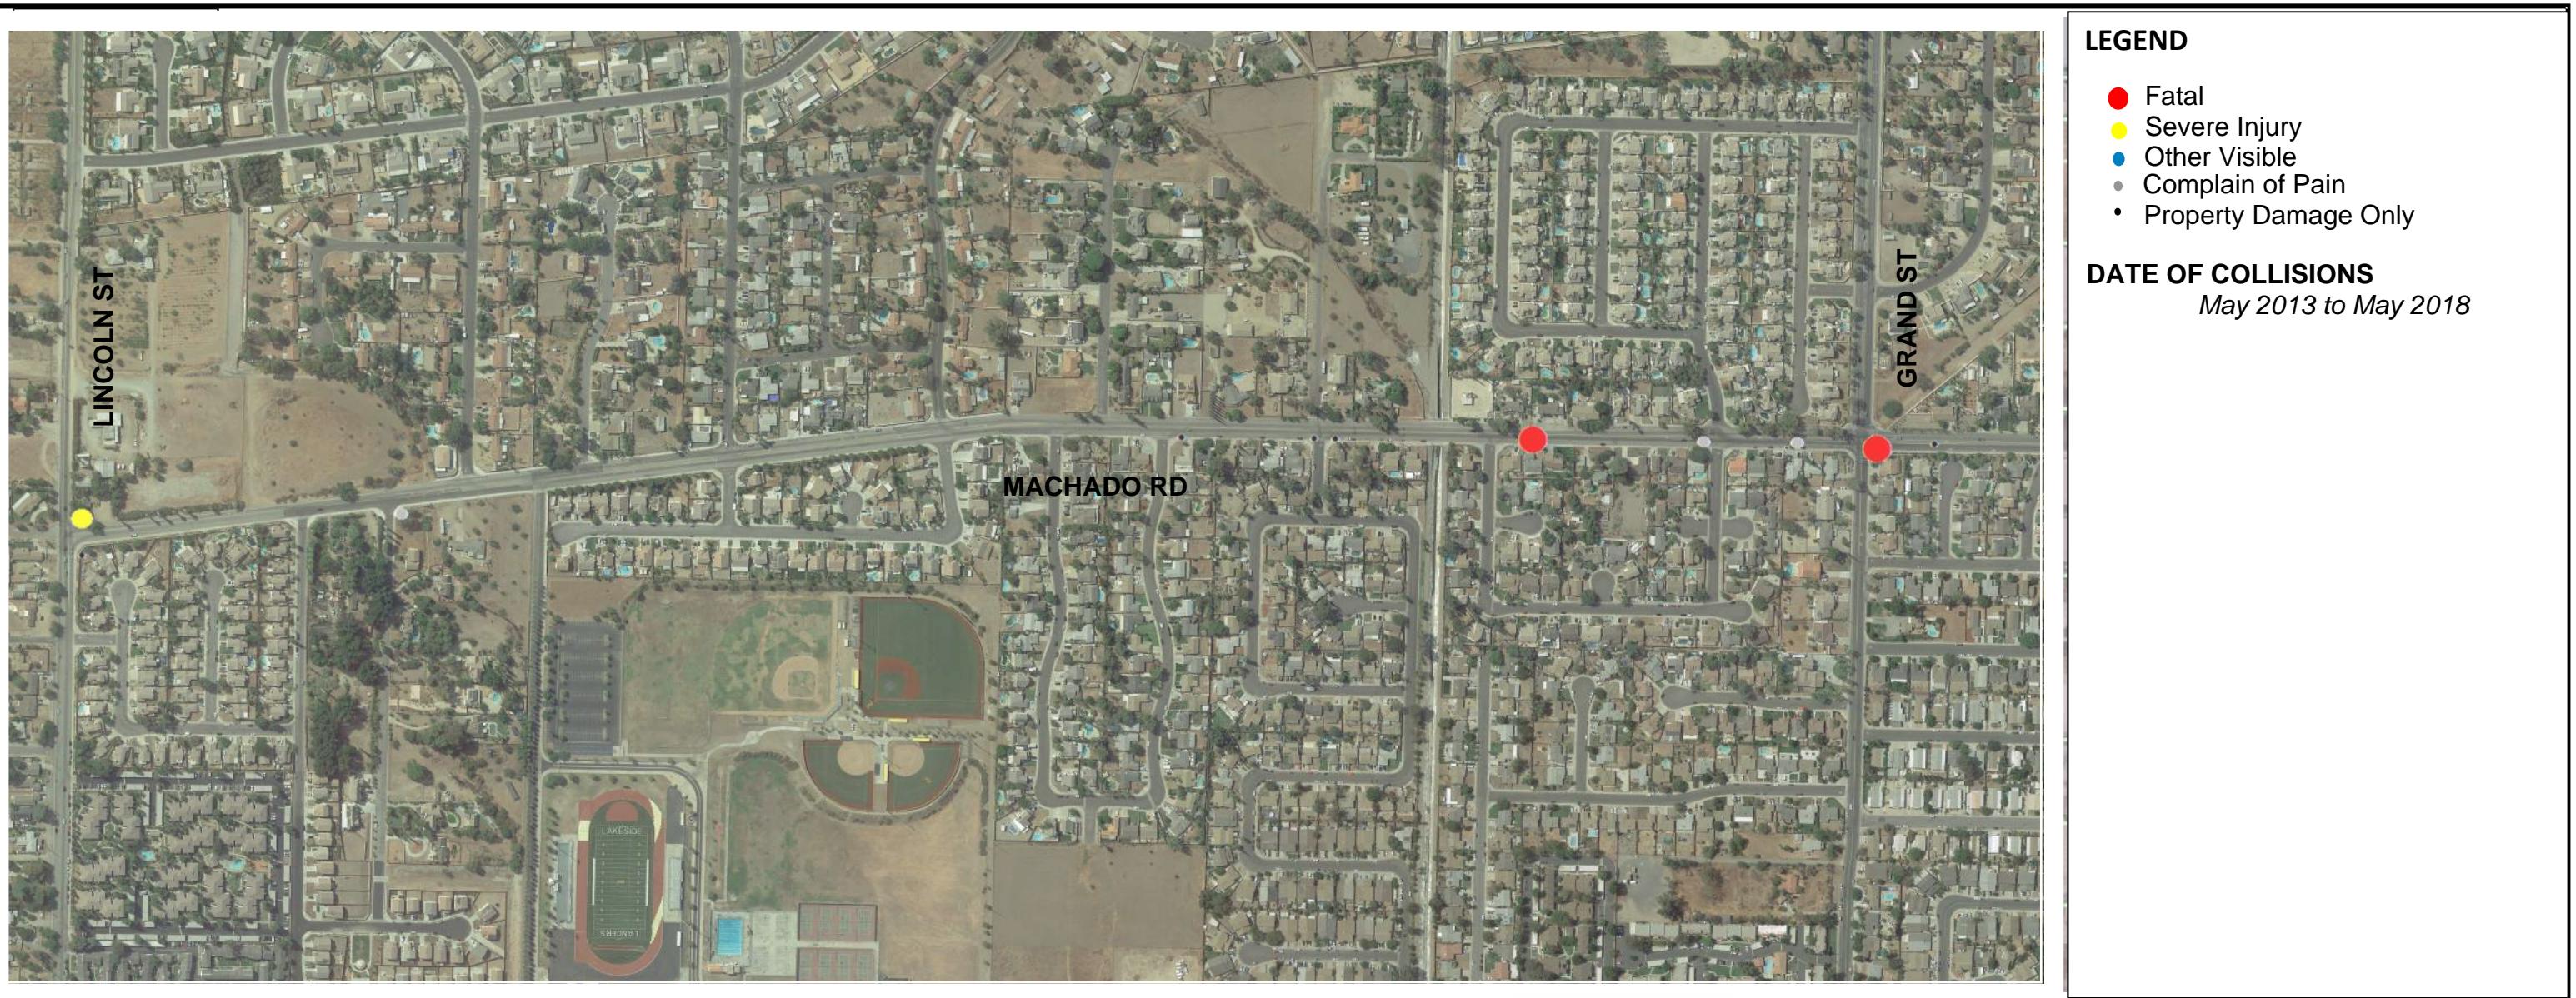
14. Machado Road from Lincoln St to Grand Avenue

- Machado Rd from Lincoln St to Grand Ave is a two lane roadway.
- The roadway segment is surrounded by residential houses, commercial and open space.
- Machado Rd is identified as Secondary (120'ROW) in the City of Lake Elsinore General Plan Circulation Element.
- The length of the segment is 1.4 Miles.
- The rate of collision of the segment is 17.14.

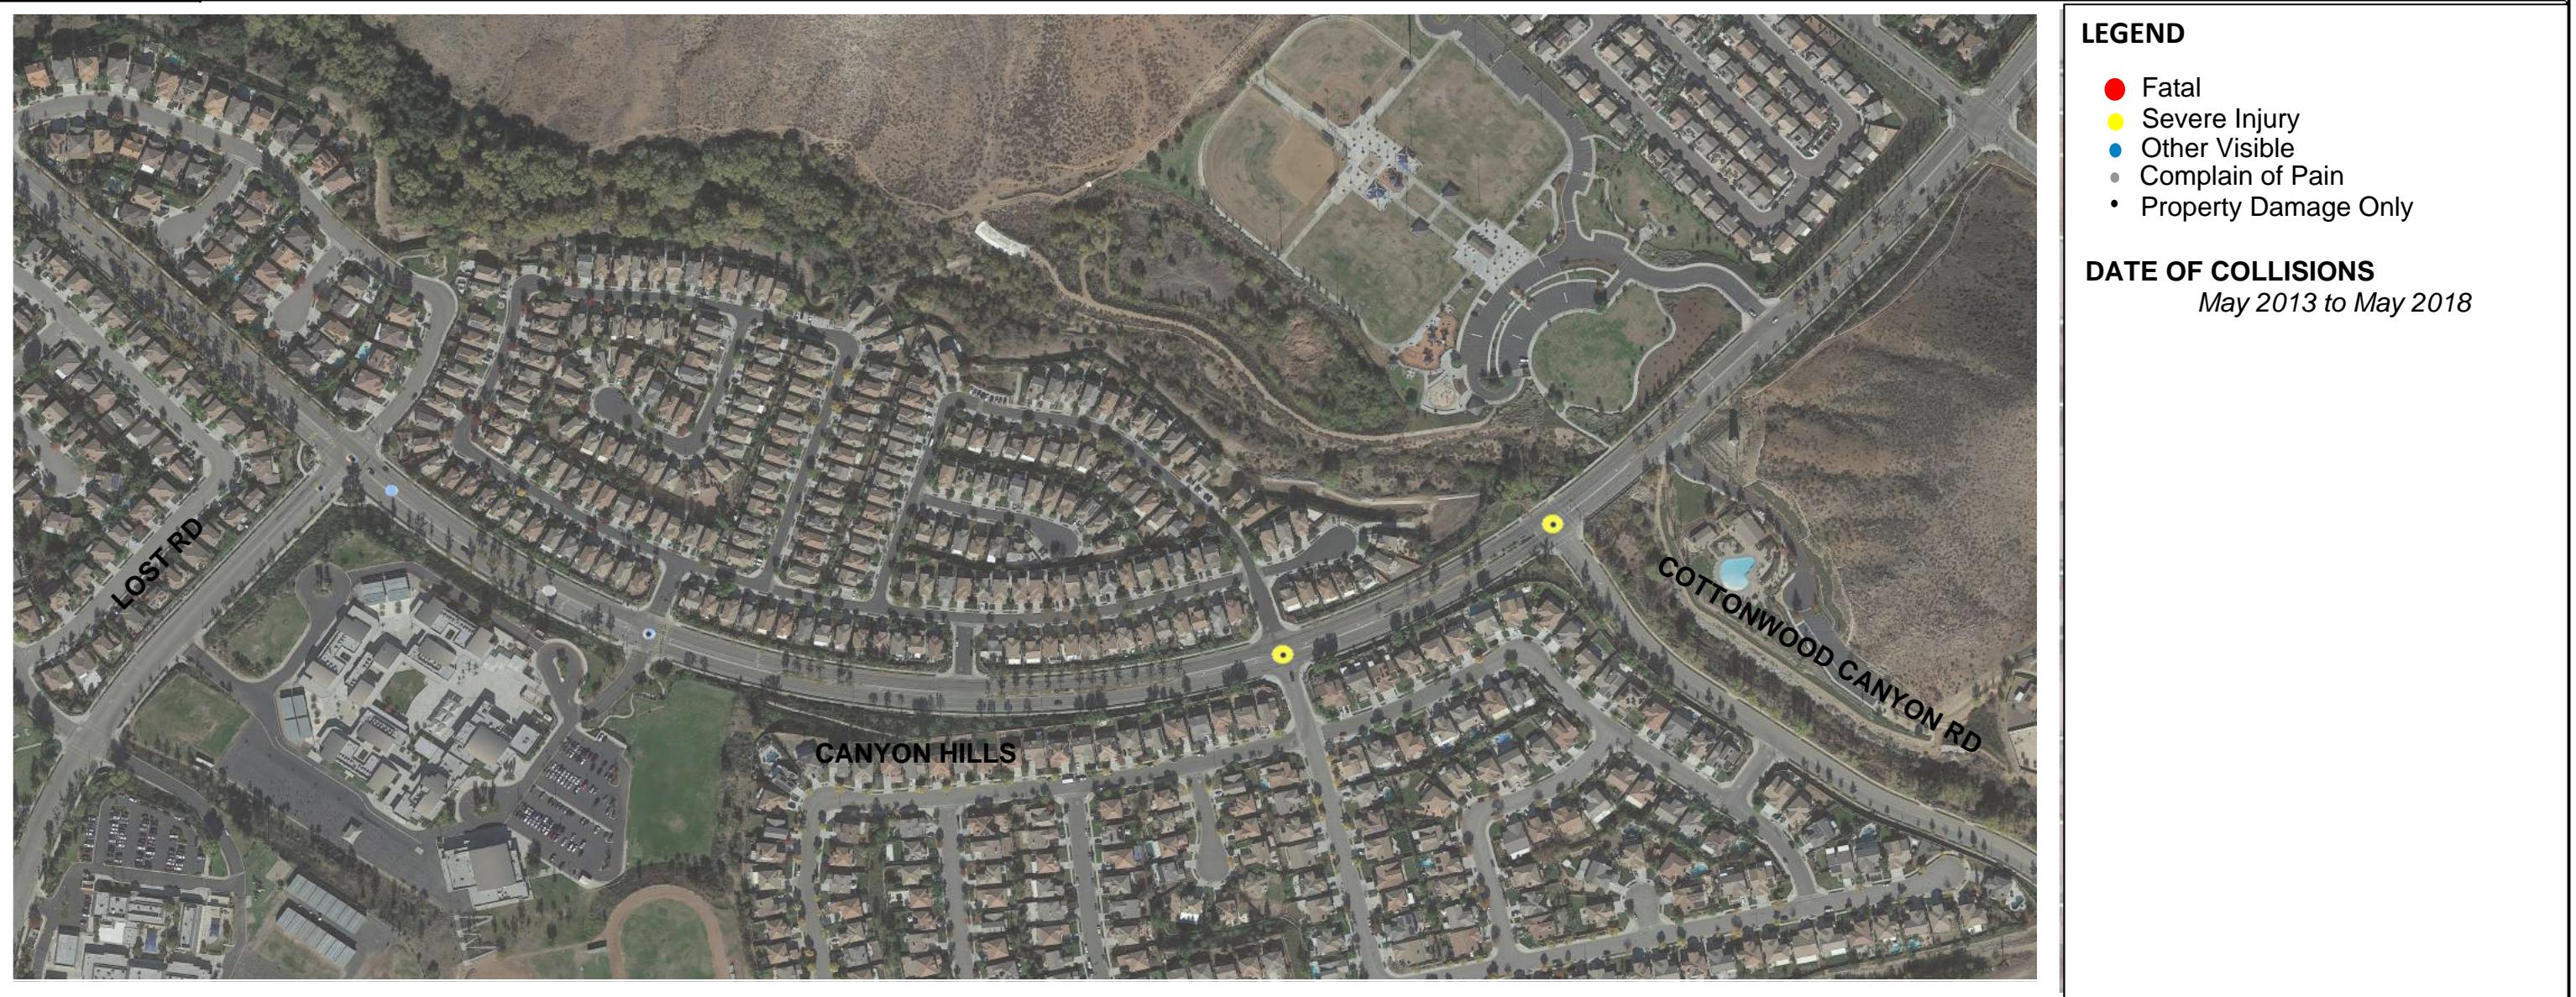
15. Canyon Hills from Lost Road to Cottonwood Canyon Rd

- Canyon Hills from Lost Road to Cottonwood Canyon Rd is a four lane roadway.
- The roadway segment is surrounded by residential houses, commercial and open space.
- Canyon Hills is identified as Urban Arterial (120'ROW) in the City of Lake Elsinore General Plan Circulation Element.
- The length of the segment is 0.5 Miles.
- The rate of collision of the segment is 32.4.

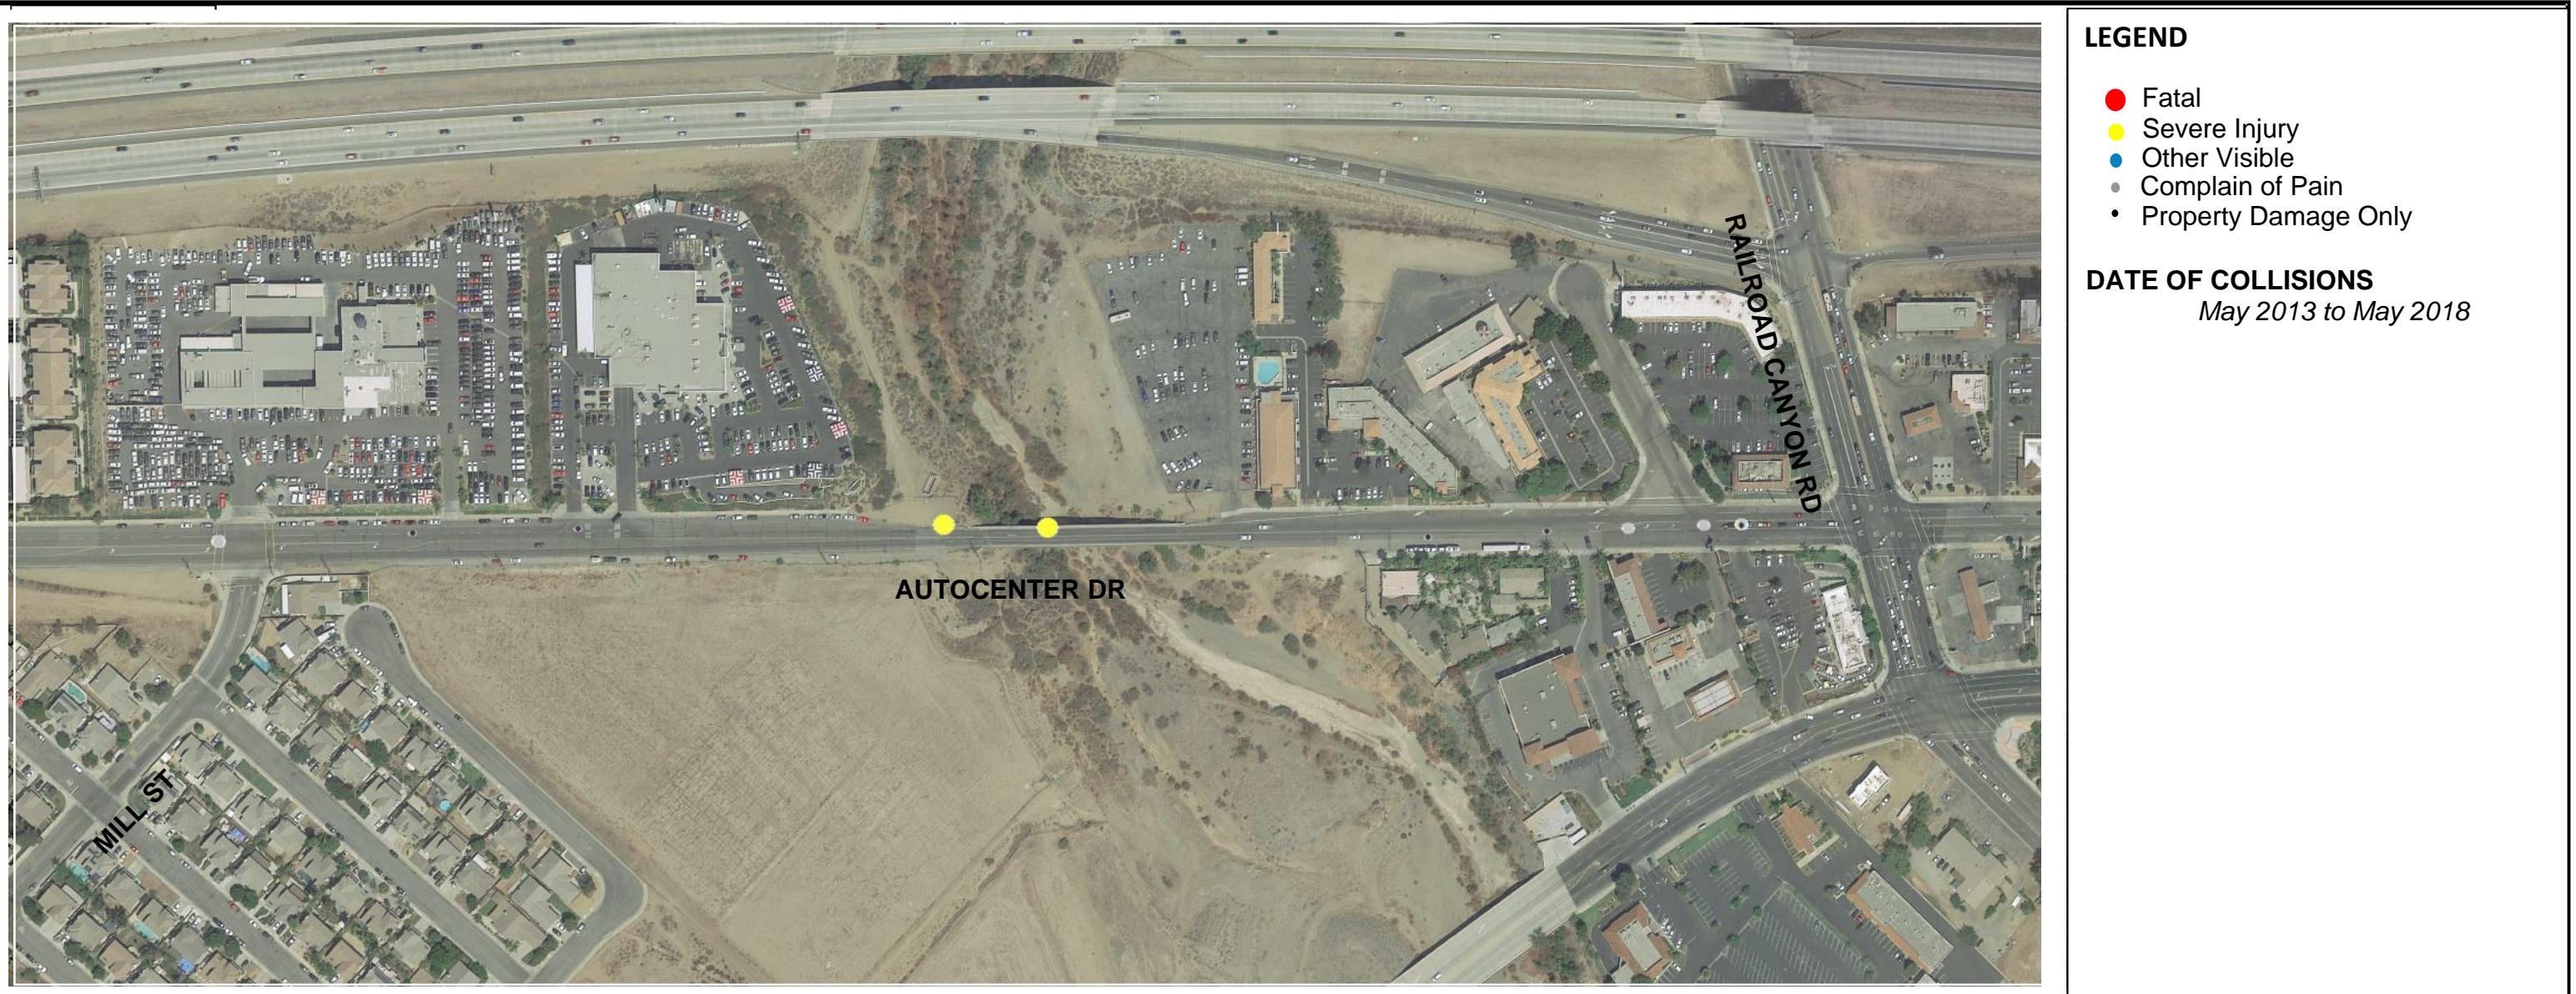
17. AUTO CENTER DR FROM MILL ST TO RAILROAD CANYON RD

- Auto Center Drive from Mill Street to Railroad Canyon Road is a four lane roadway.
- The roadway segment is surrounded by residential houses, commercial and open space.
- Auto Center Drive is identified as Major (100'ROW) in the City of Lake Elsinore General Plan Circulation Element.
- The length of the segment is 0.75 Miles.
- The rate of collision of the segment is 24.

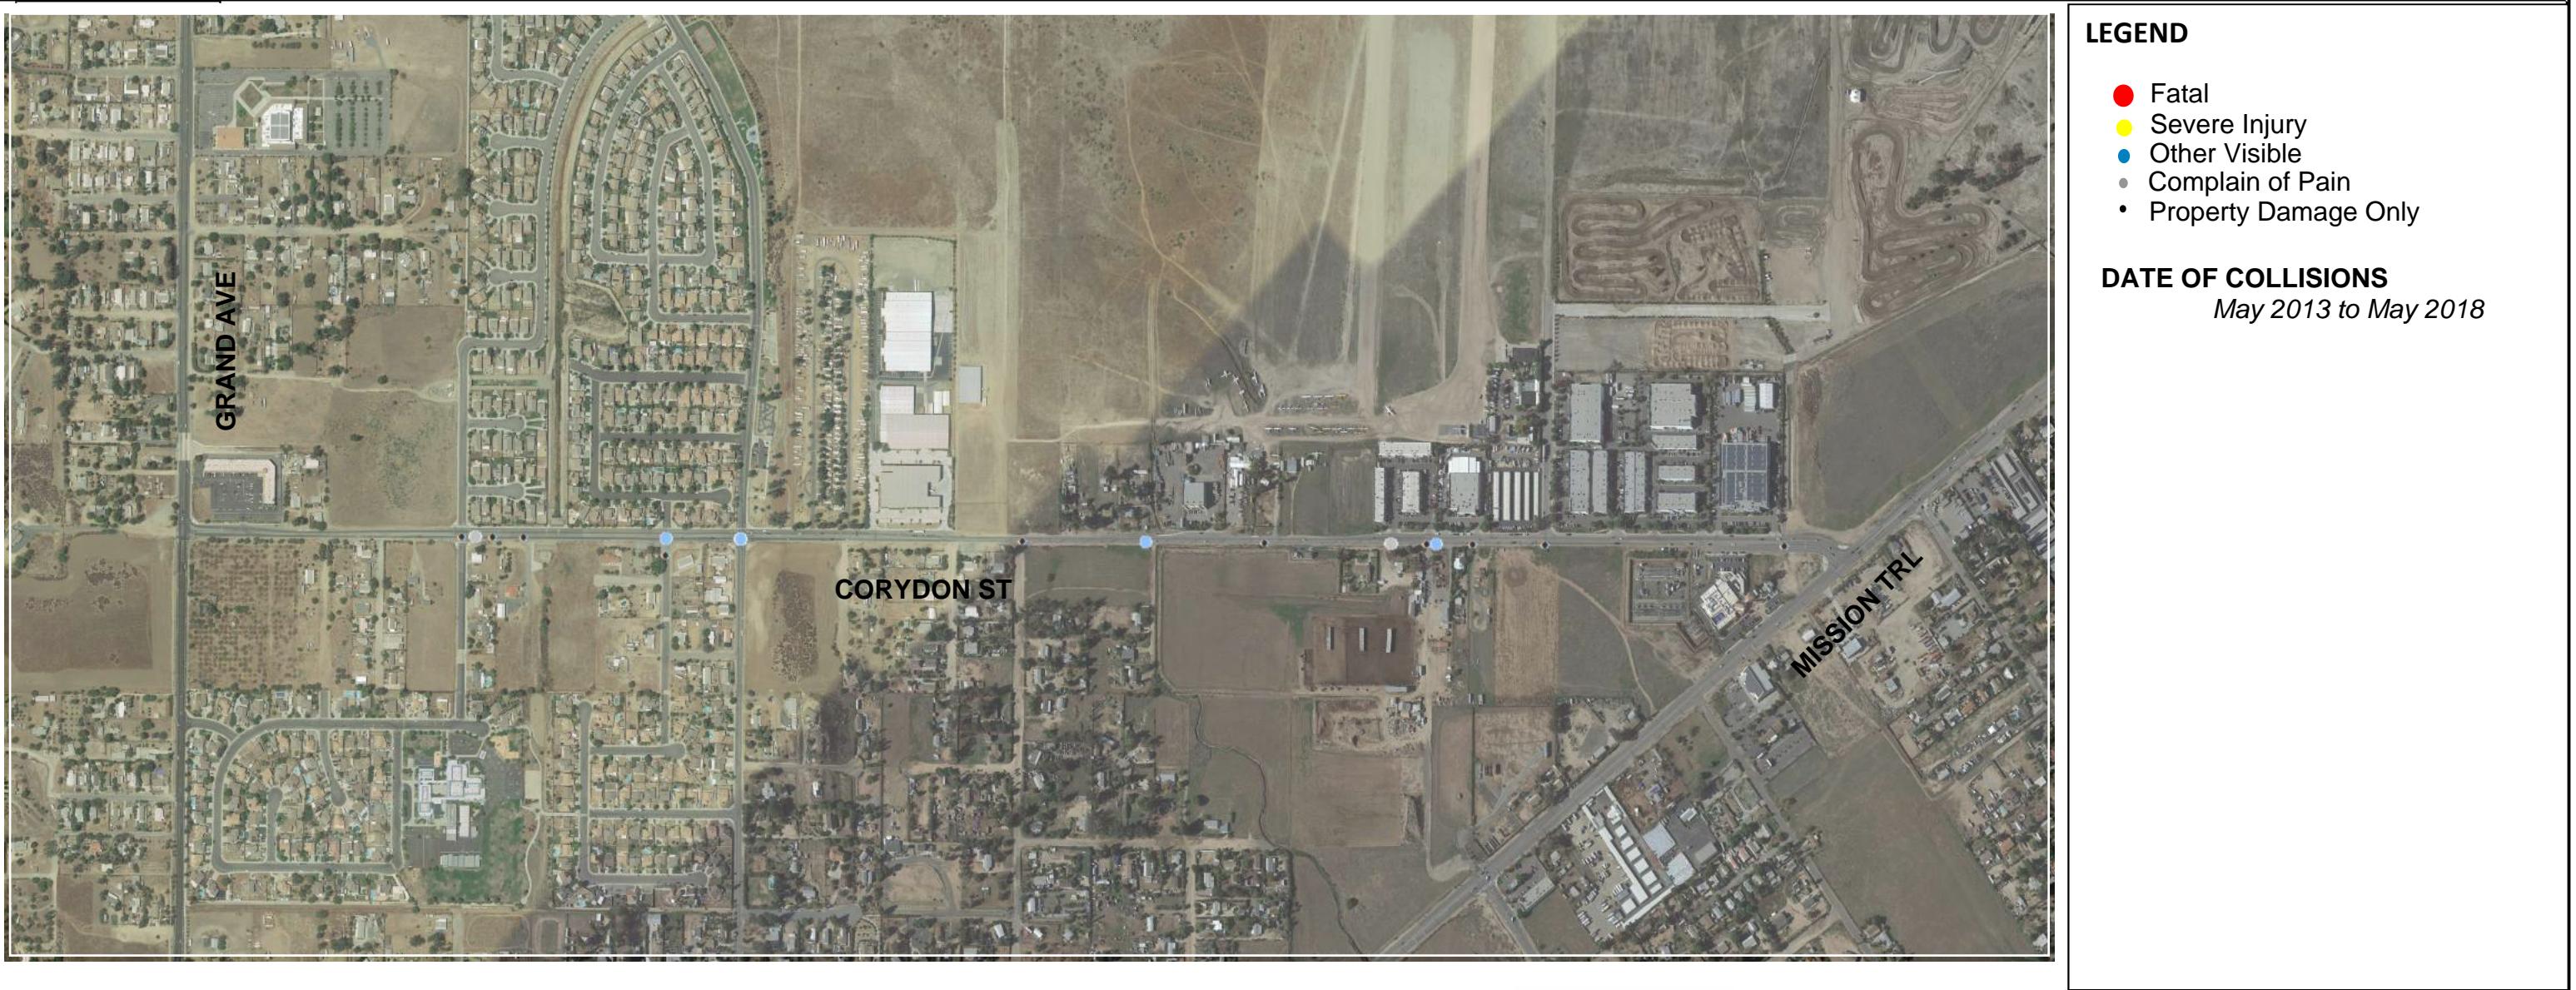
18. CORYDON ST FROM GRAND AVE TO MISSION TRL

- Corydon St from Grand Ave to Mission Trail is a four lane roadway.
- The roadway segment is surrounded by residential houses, commercial and open space.
- Corydon St is identified as Major (100'ROW) in the City of Lake Elsinore General Plan Circulation Element.
- The length of the segment is 1.53 Miles.
- The rate of collision of the segment is 12.41.
