Systemic Safety Analysis Report

CITY OF LAKE ELSINORE

RE: Systemic Safety Analysis Report Program (SSARP)

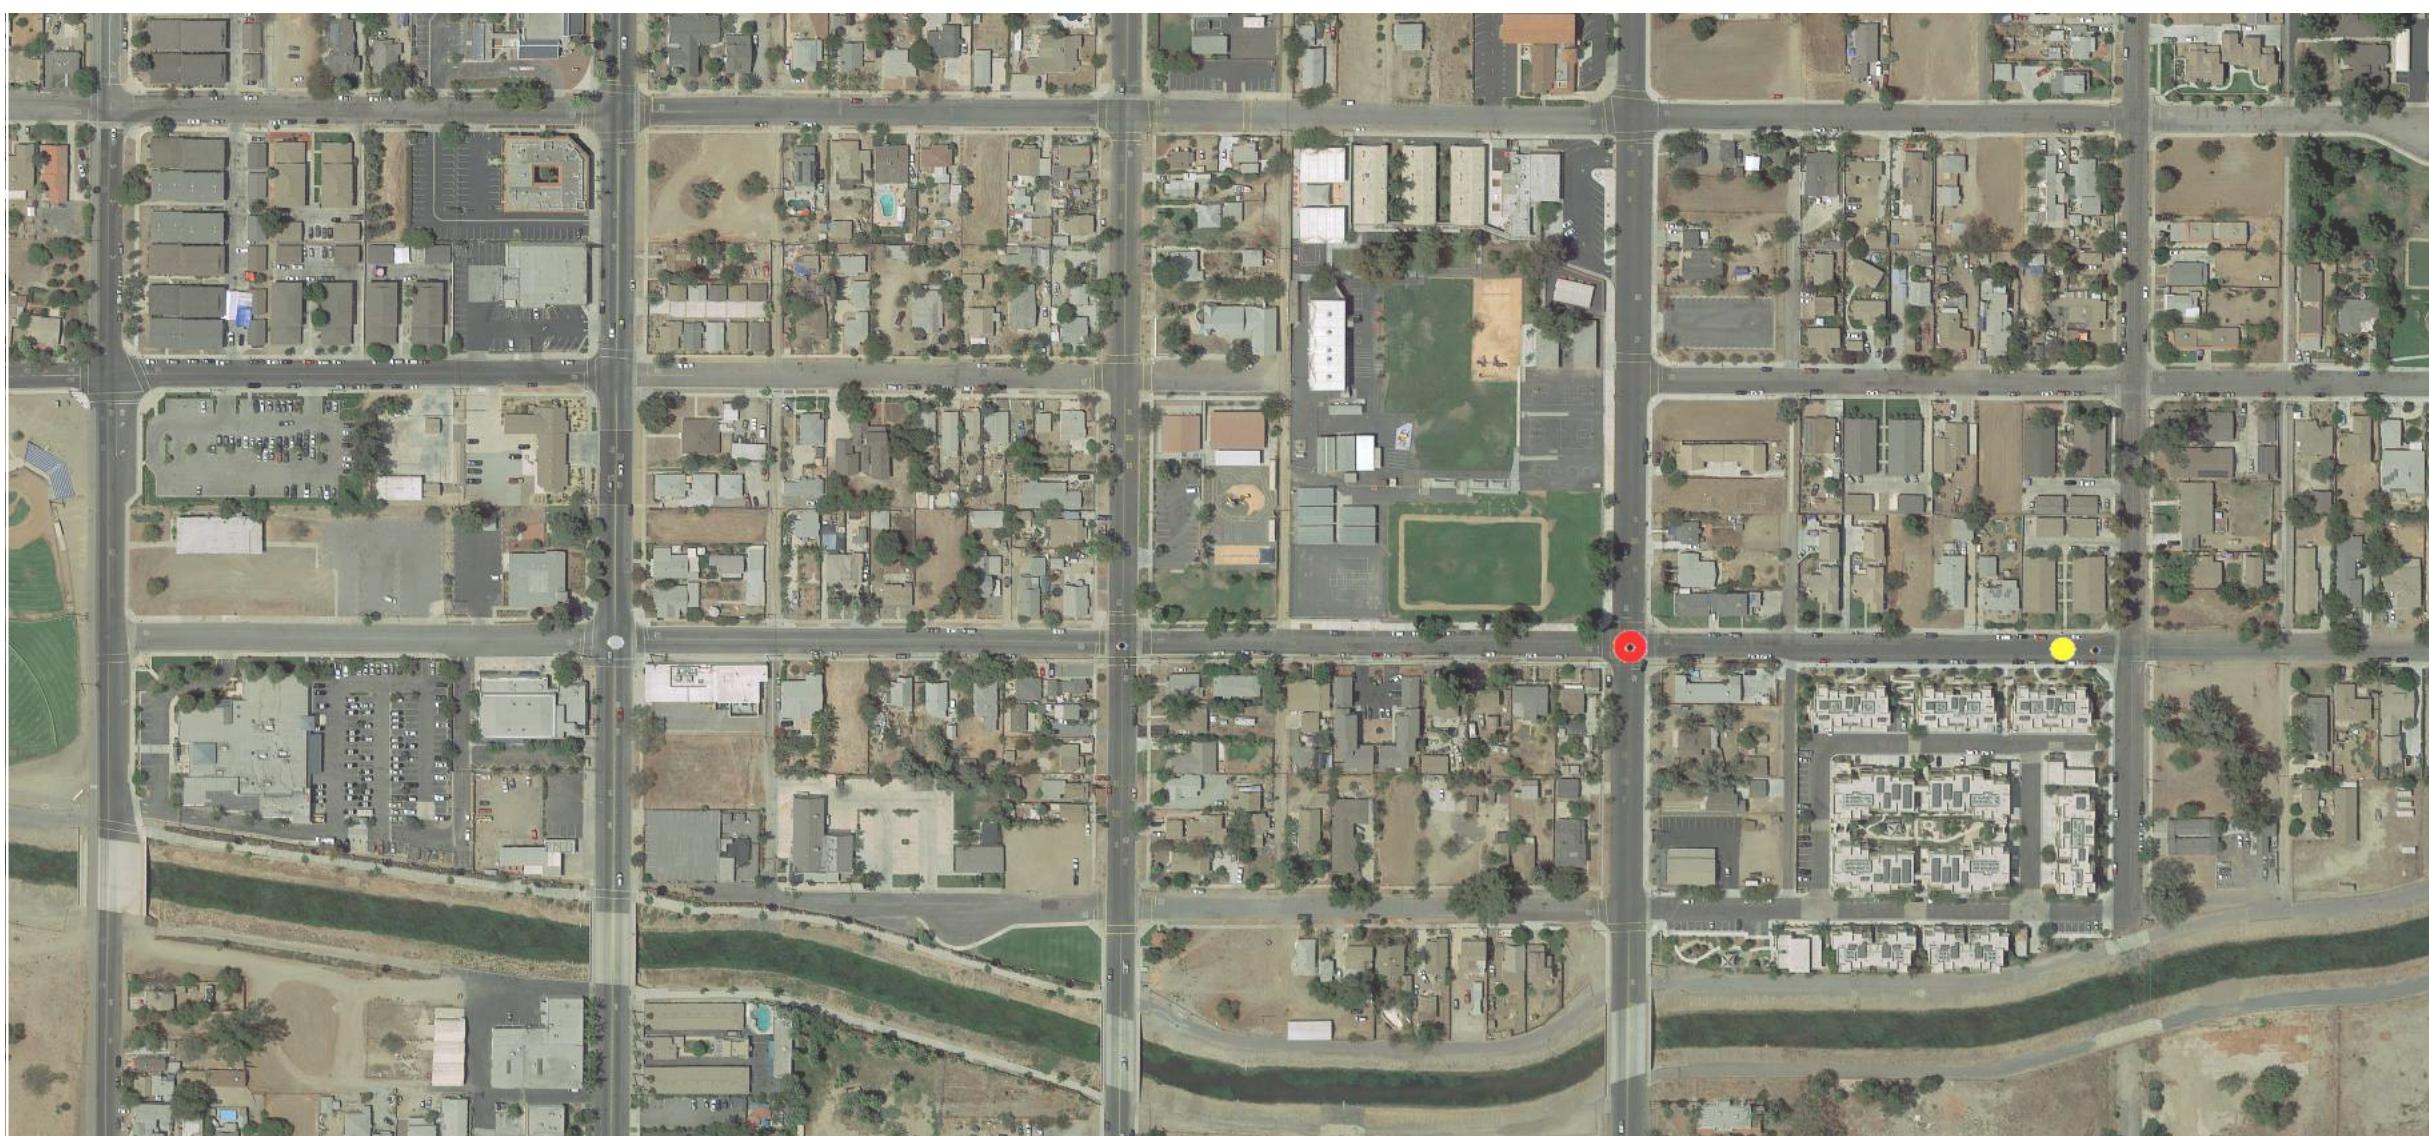
20. LANGSTAFF RD FROM LIMITED ST TO POTTERY ST

- Driving Under Influence (2) and Improper Turning (1) are the major causes of collisions on this segment of Langstaff Rd.
- Most of the collision types on this segments were Broadside (2) or Hit-Object (2) collisions.

Potential Countermeasures	
<ul style="list-style-type: none"> • Install/Upgrade signs with new fluorescent sheeting (R26). • Install delineators, reflectors and/or object markers (R31).

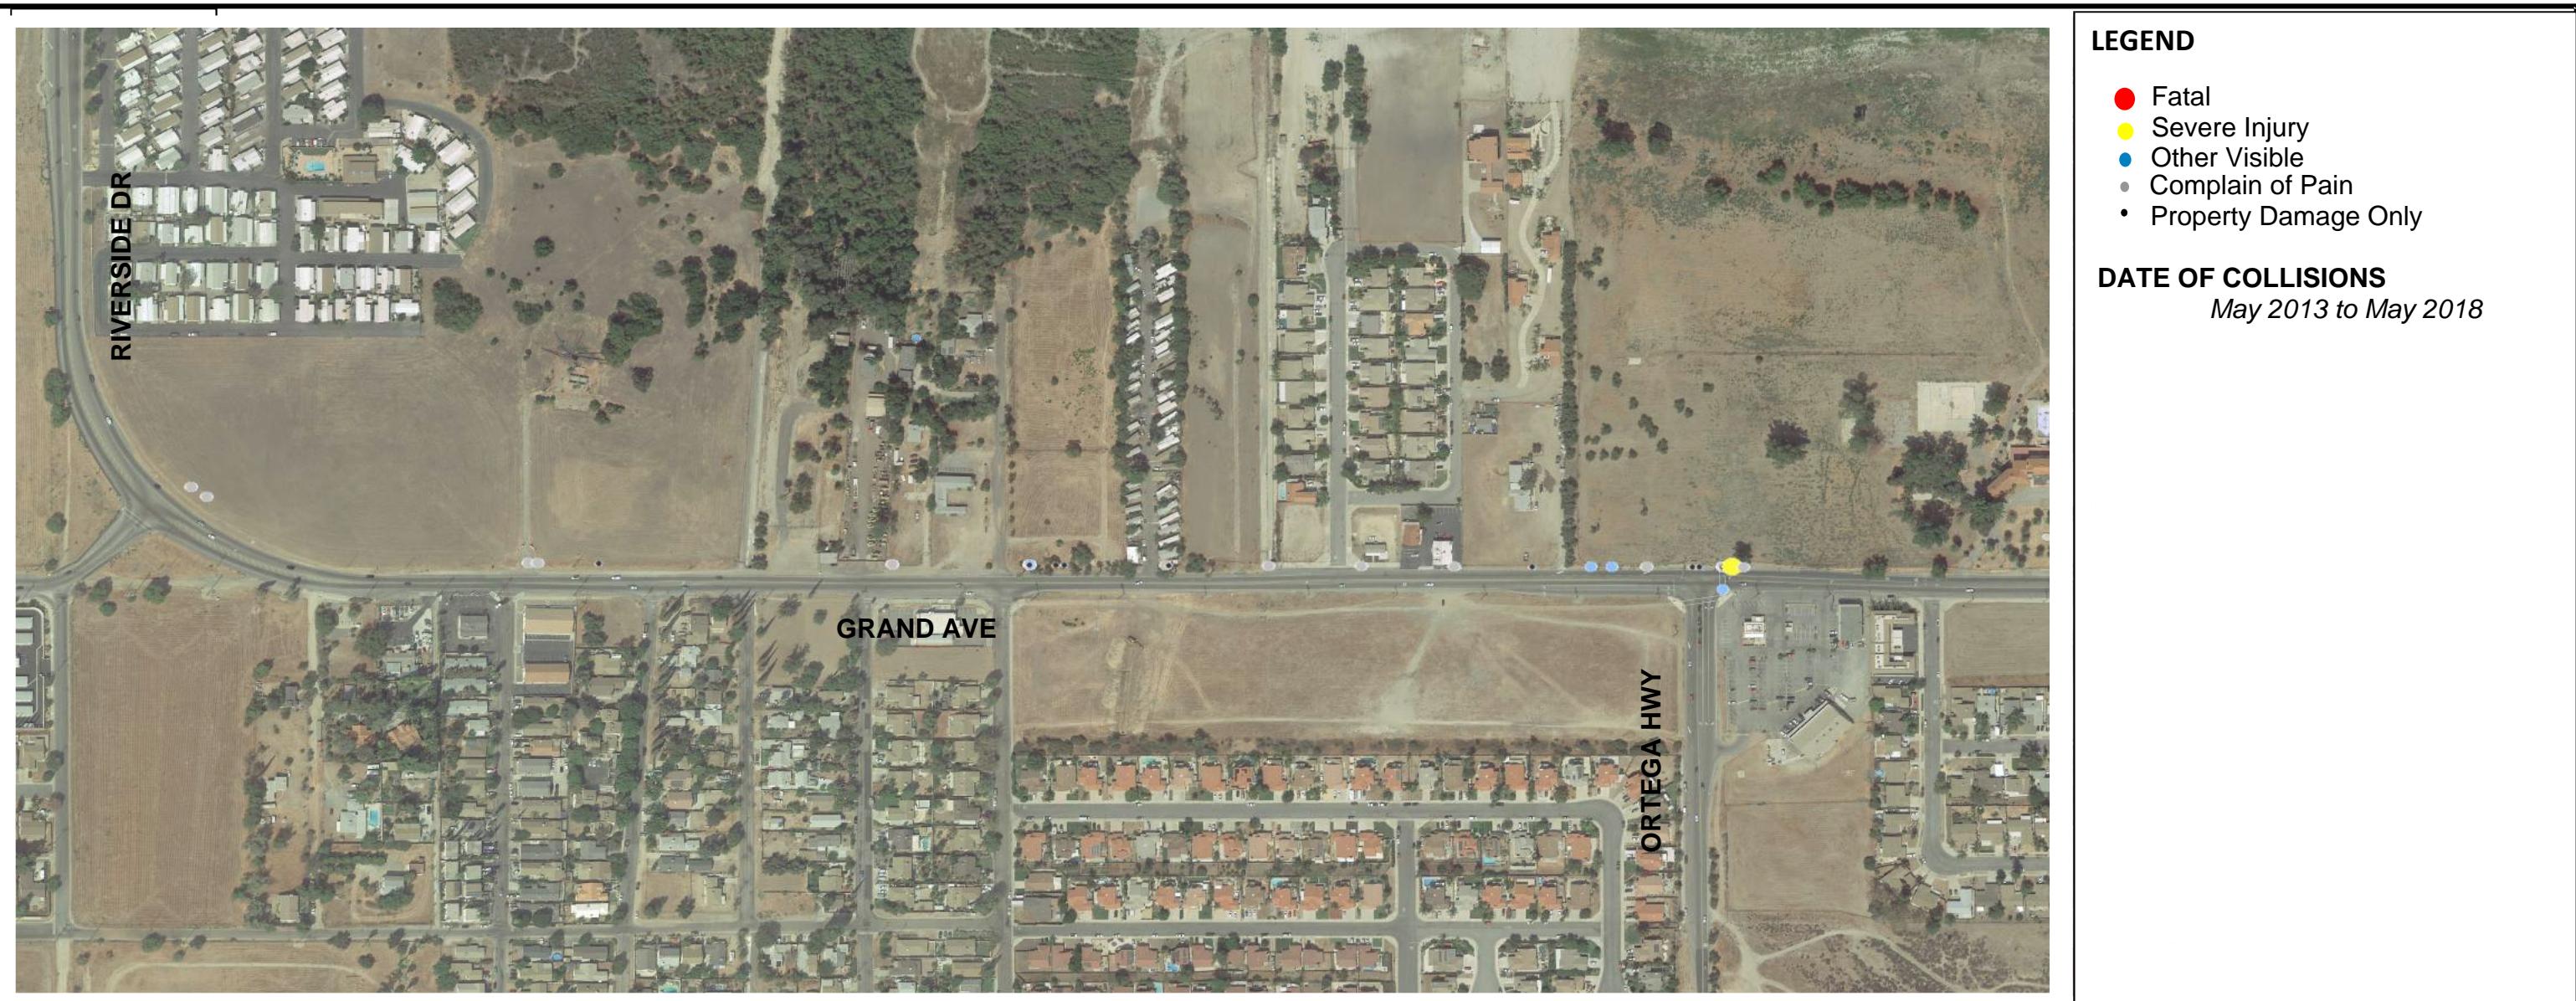
21. GRAND AVENUE FROM ORTEGA HWY TO RIVERSIDE DR

- Grand Avenue from Ortega Hwy to Riverside Drive is a two lane roadway.
- The roadway segment is surrounded by residential houses and open space.
- Grand Avenue is identified as Collector (68'ROW) in the City of Lake Elsinore General Plan Circulation Element.
- The length of the segment is 0.65 Miles.
- The rate of collision of the segment is 75.

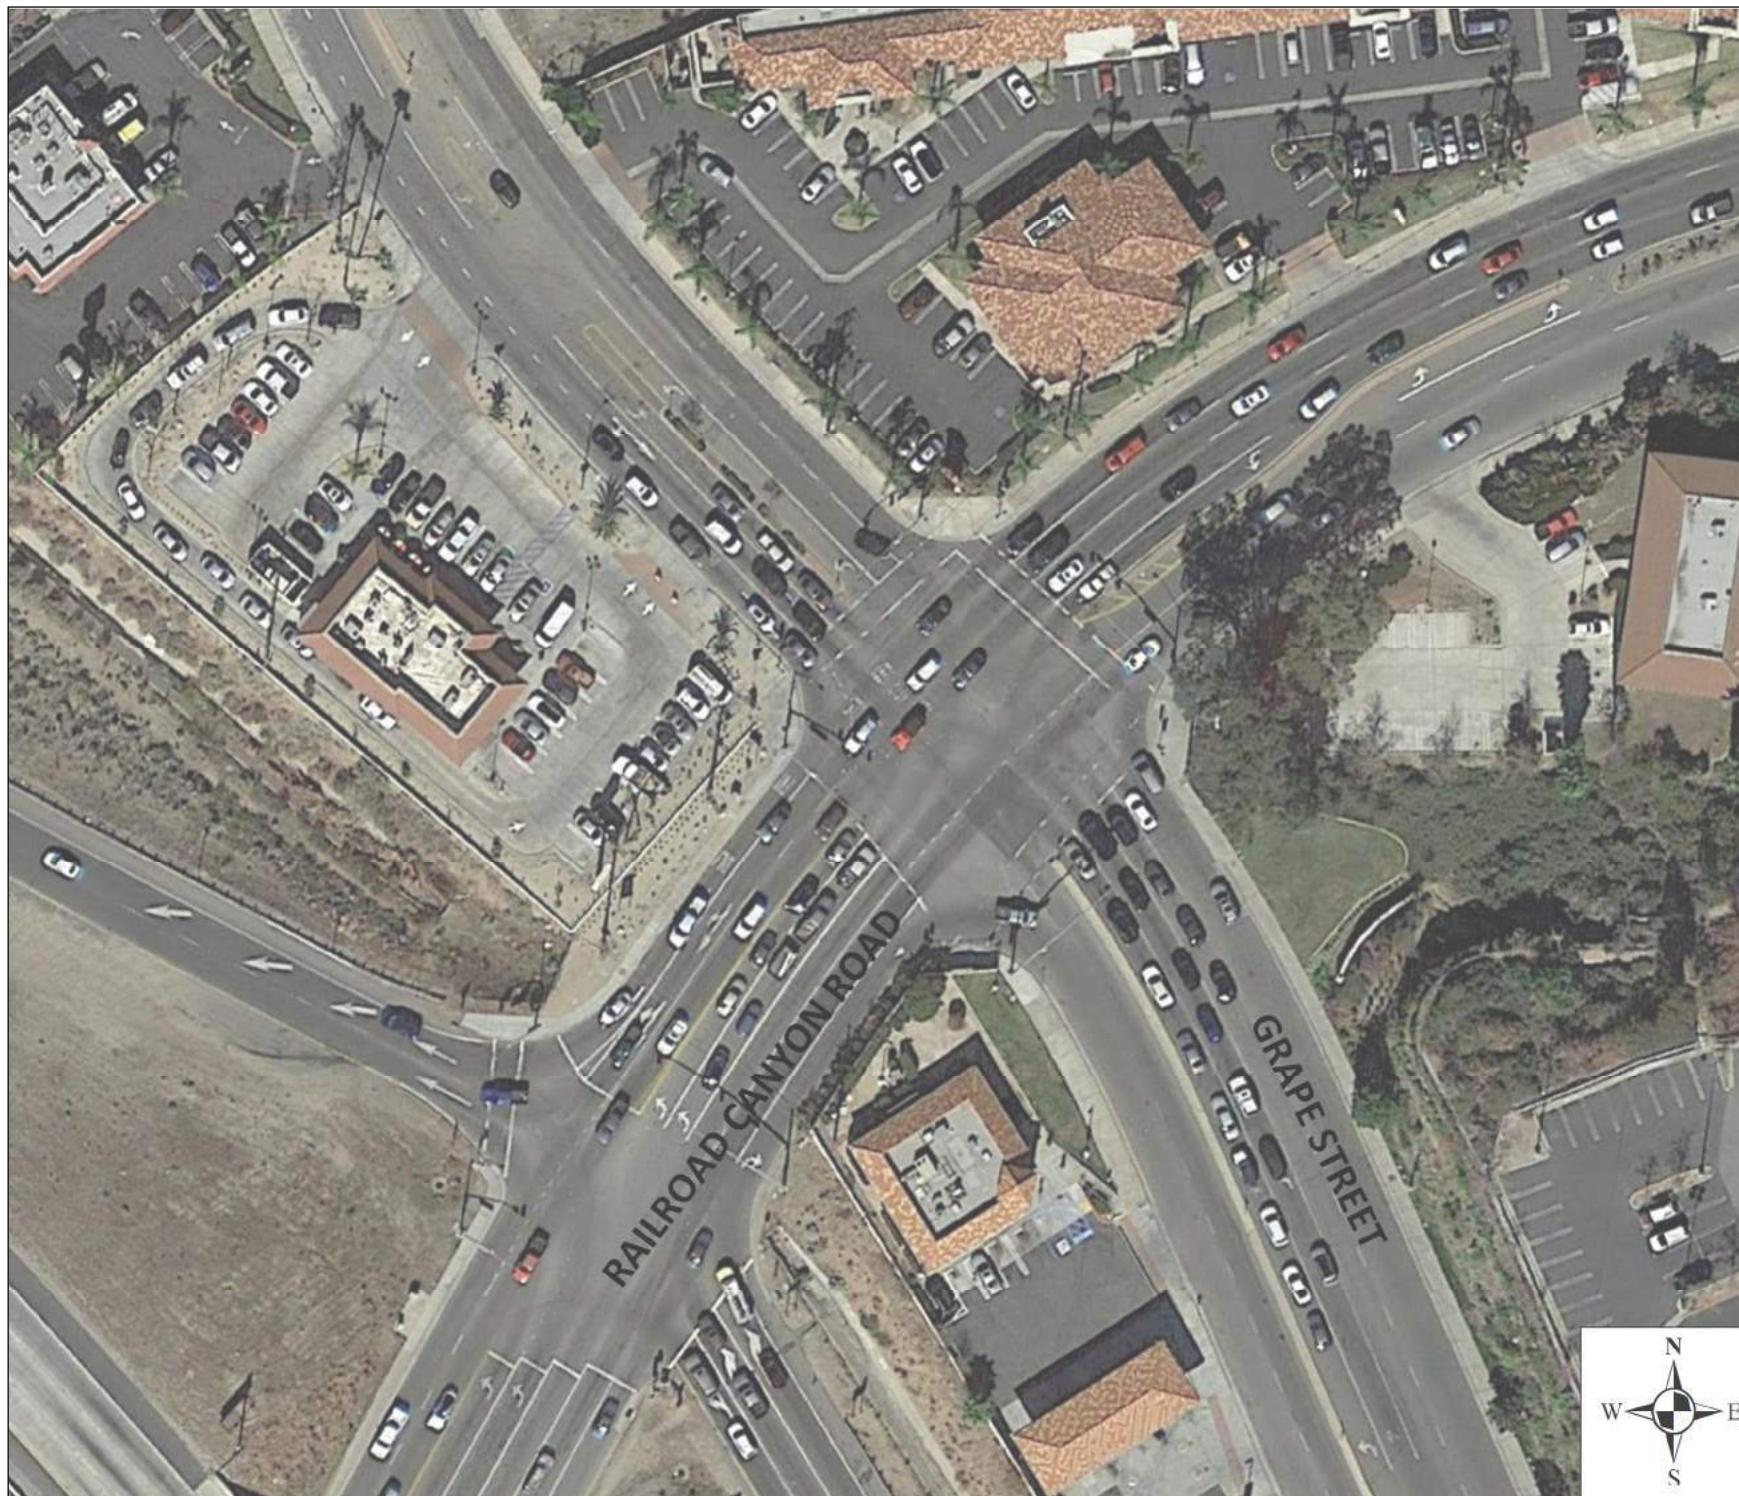
1. GRAPE STREET AND RAILROAD CANYON ROAD

- The intersection of Grape Street and Railroad Canyon Road is a signalized intersection.
- Median is installed on the North, South, and East approaches of the intersection.
- Existing bus stops in the vicinity of the intersection on Grape Street.
- Three 12' wide crosswalk markings across three legs of the intersection.
- There is no existing bulb out at any corner of the intersection.
- The Unsafe Speed (12) and Improper Turning (14) are the major causes of collision at the intersection.
- The majority of the collisions occurred at the intersection are Rear End (21) and Broadside (15).
- Surrounding Land Use
 - North: Shopping Center
 - West: Restaurant
 - South: Gasoline Station
 - East: Shopping Center

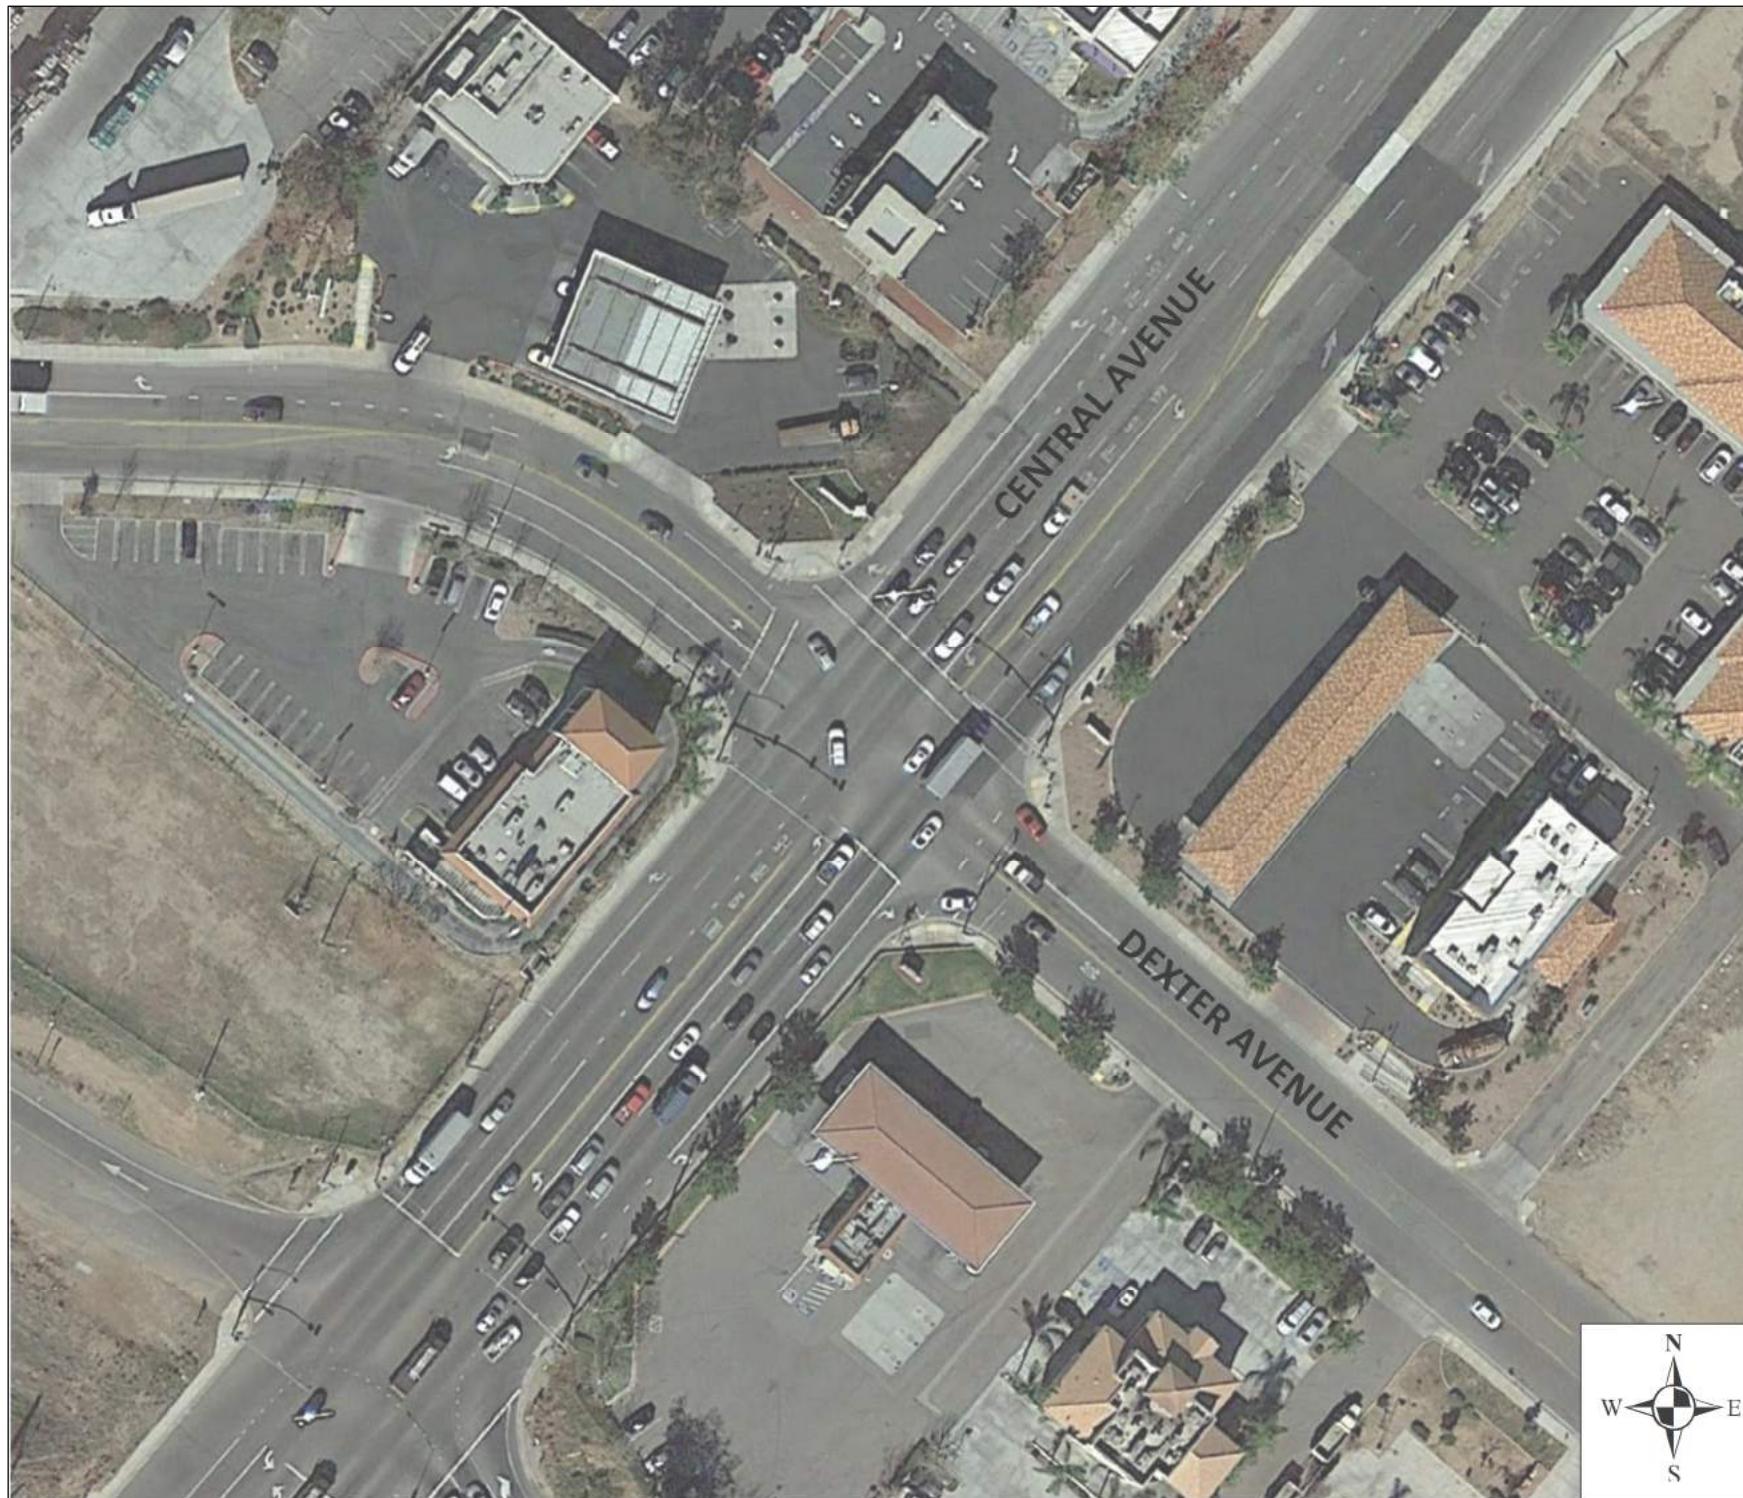
2. CENTRAL AVENUE AND DEXTER AVENUE

- The intersection of Central Avenue and Dexter Avenue is a signalized intersection.
- There is no existing median at the intersection.
- Existing bus stops in the vicinity of the intersection on Central Avenue.
- Three 12' wide crosswalk markings across three legs of the intersection.
- There is no existing bulb out at any corner of the intersection.
- The Traffic Signal and Signs (8) and Automobile R/W (10) are the major causes of collision at the intersection.
- The majority of the collisions occurred at the intersection are Rear End (6) and Broadside (21).
- Surrounding Land Use
 - North: Gasoline Station
 - West: Restaurant
 - South: Gasoline Station
 - East: Gasoline Station

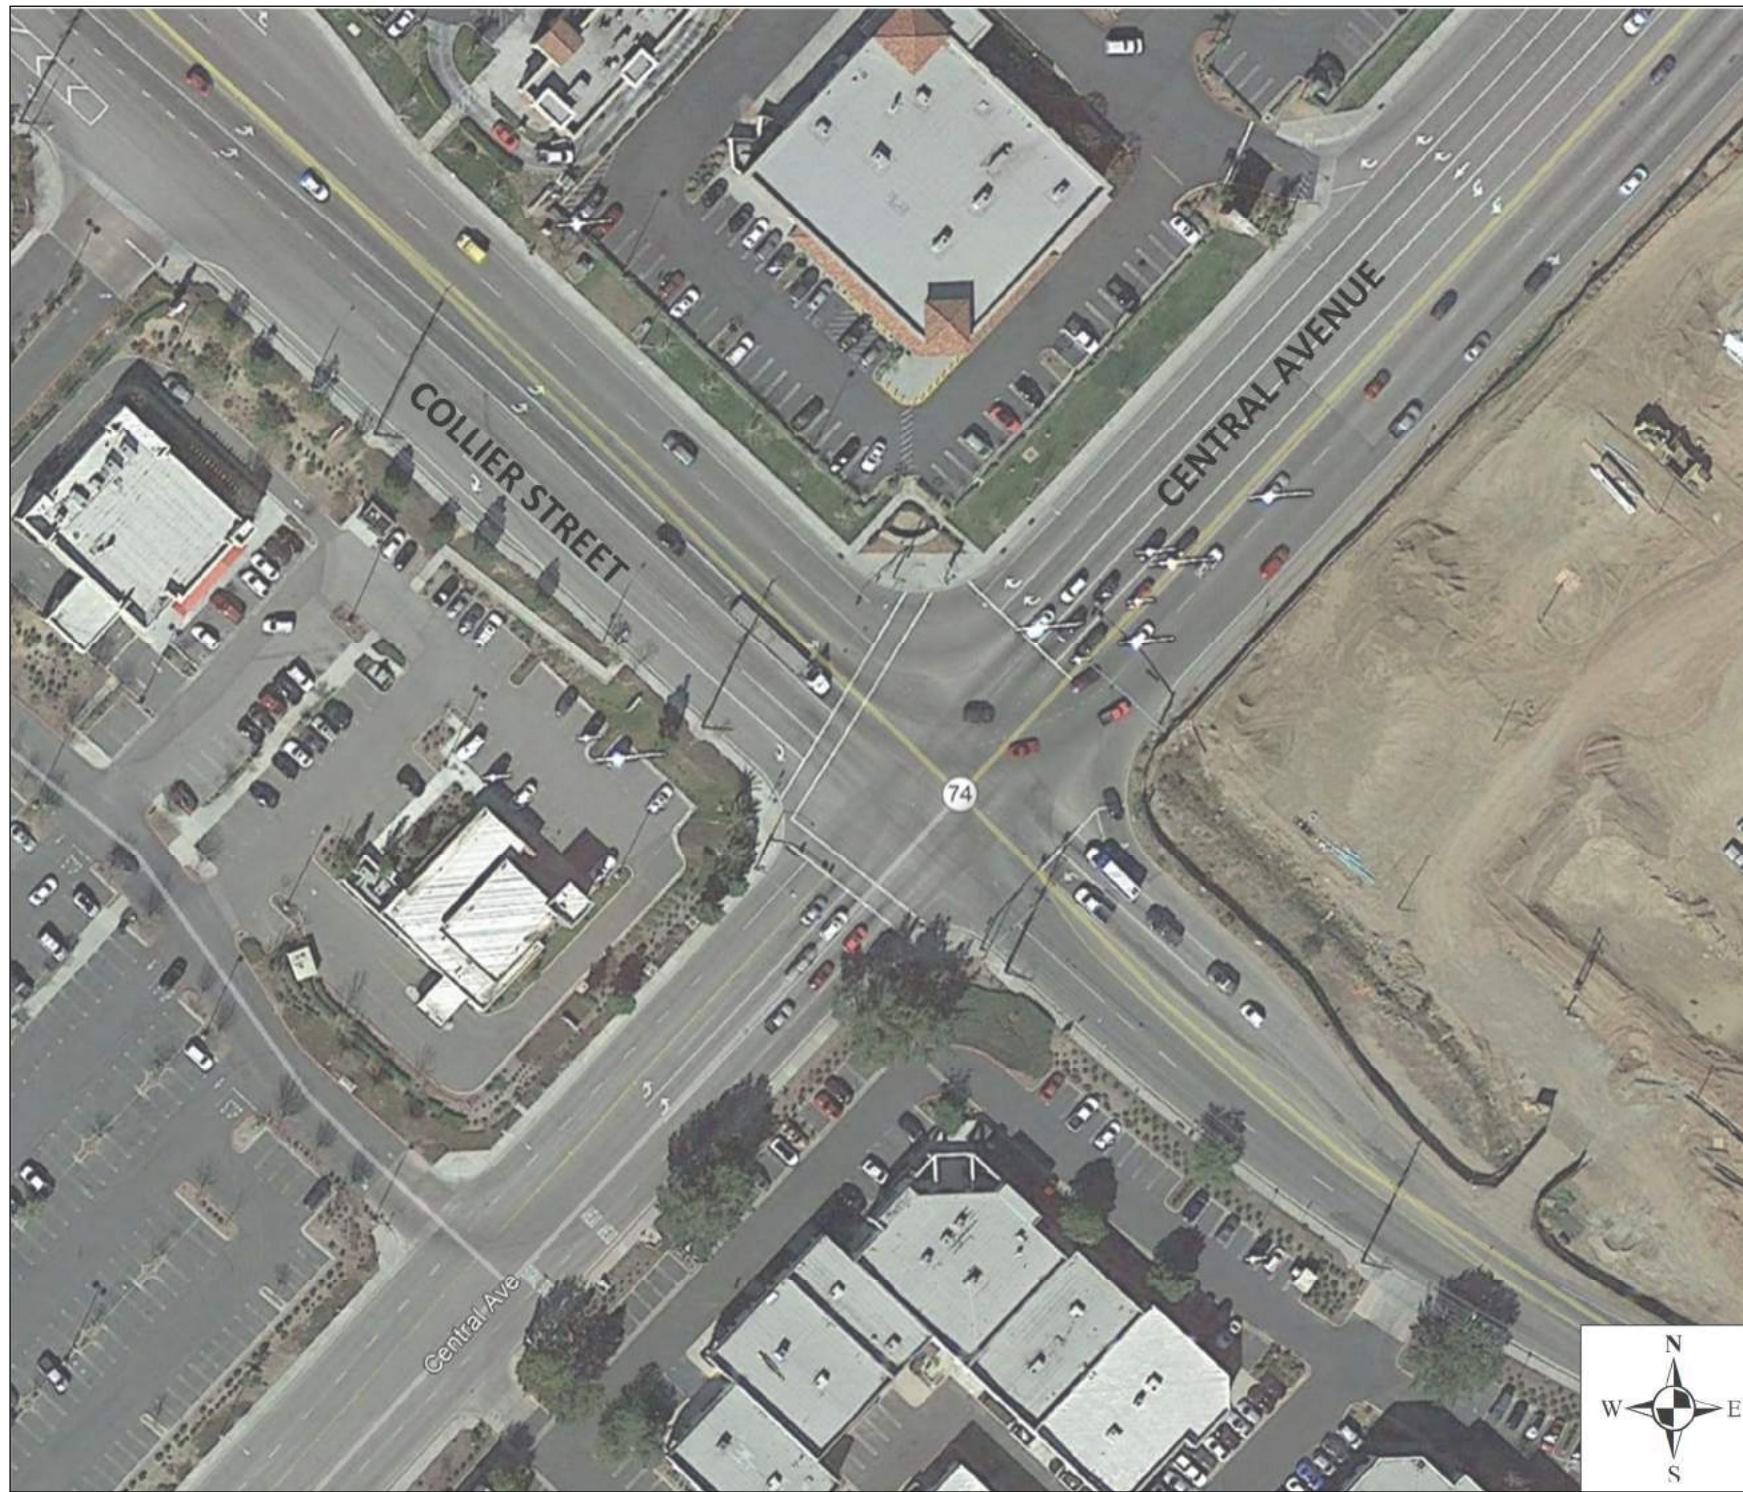
3. COLLIER STREET AND CENTRAL AVENUE

- The intersection of Collier Street and Central Avenue is a signalized intersection.
- There is no existing median at the intersection.
- Existing bus stops in the vicinity of the intersection on Collier Avenue.
- Two 12' wide crosswalk markings across two legs of the intersection.
- There is no existing bulb out at any corner of the intersection.
- The Unsafe Speed (12) and Improper Turning (6) are the major causes of collision at the intersection.
- The majority of the collisions occurred at the intersection are Rear End (9) and Broadside (10).
- Surrounding Land Use
 - North: Shopping Center
 - West: Shopping Center
 - South: Business Offices
 - East: Shopping Center Development

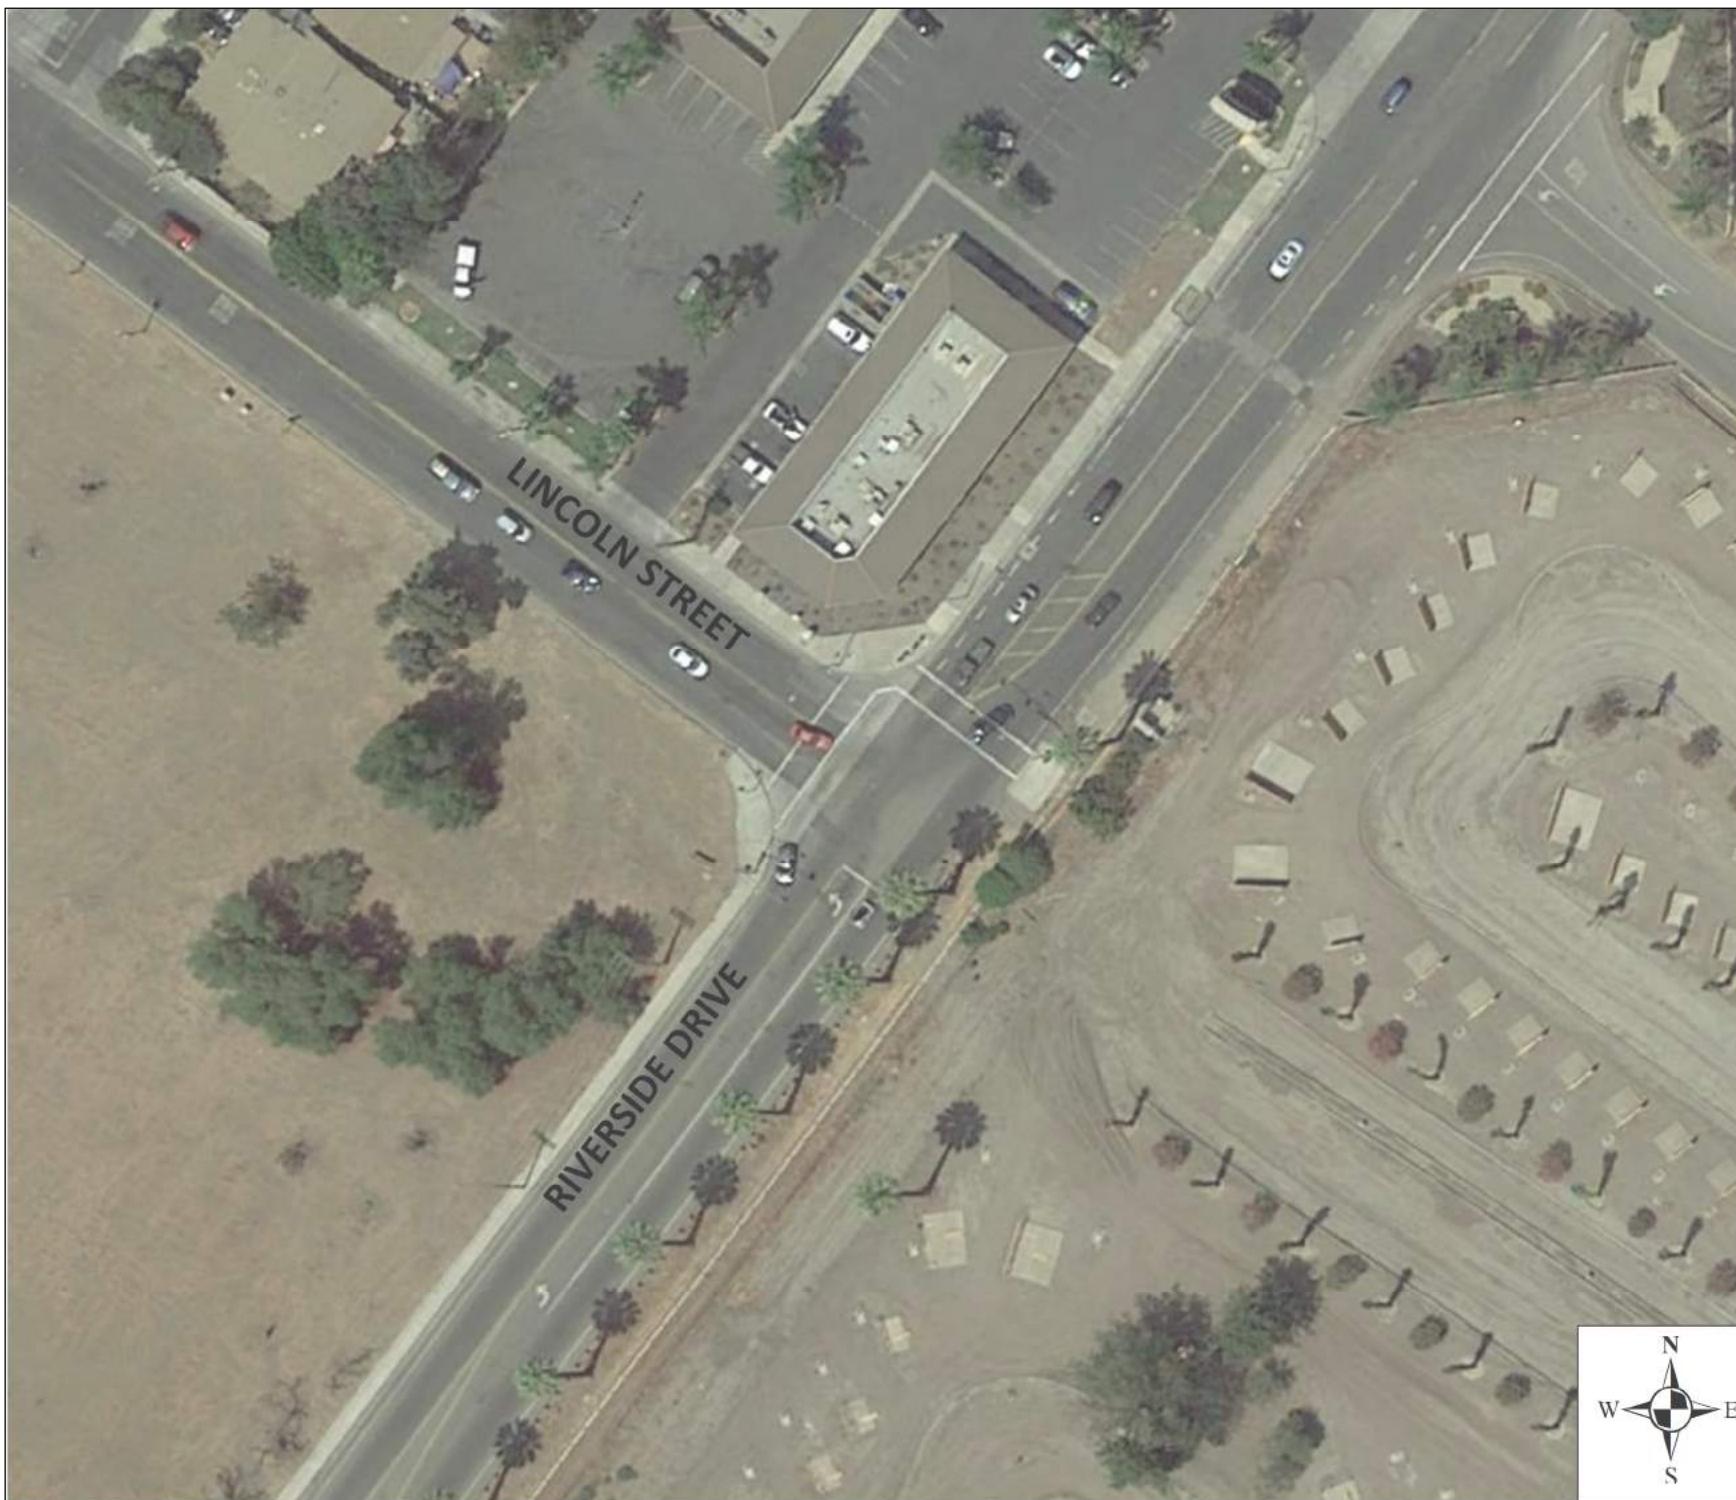
4. RIVERSIDE DRIVE AND LINCOLN STREET

- The intersection of Riverside Drive and Lincoln Street is a signalized intersection.
- There is no existing median at the intersection.
- Existing bus stops in the vicinity of the intersection on Lincoln Street.
- Two 12' wide crosswalk markings across two legs of the intersection.
- There is no existing bulb out at any corner of the intersection.
- The Unsafe Speed (18) and Driving Under Influence (3) are the major causes of collision at the intersection.
- The majority of the collisions occurred at the intersection are Rear End (21) and Broadside (2).
- Surrounding Land Use
 - North: Restaurant
 - West: Vacant
 - South: Boat Launch
 - East: Boat Launch

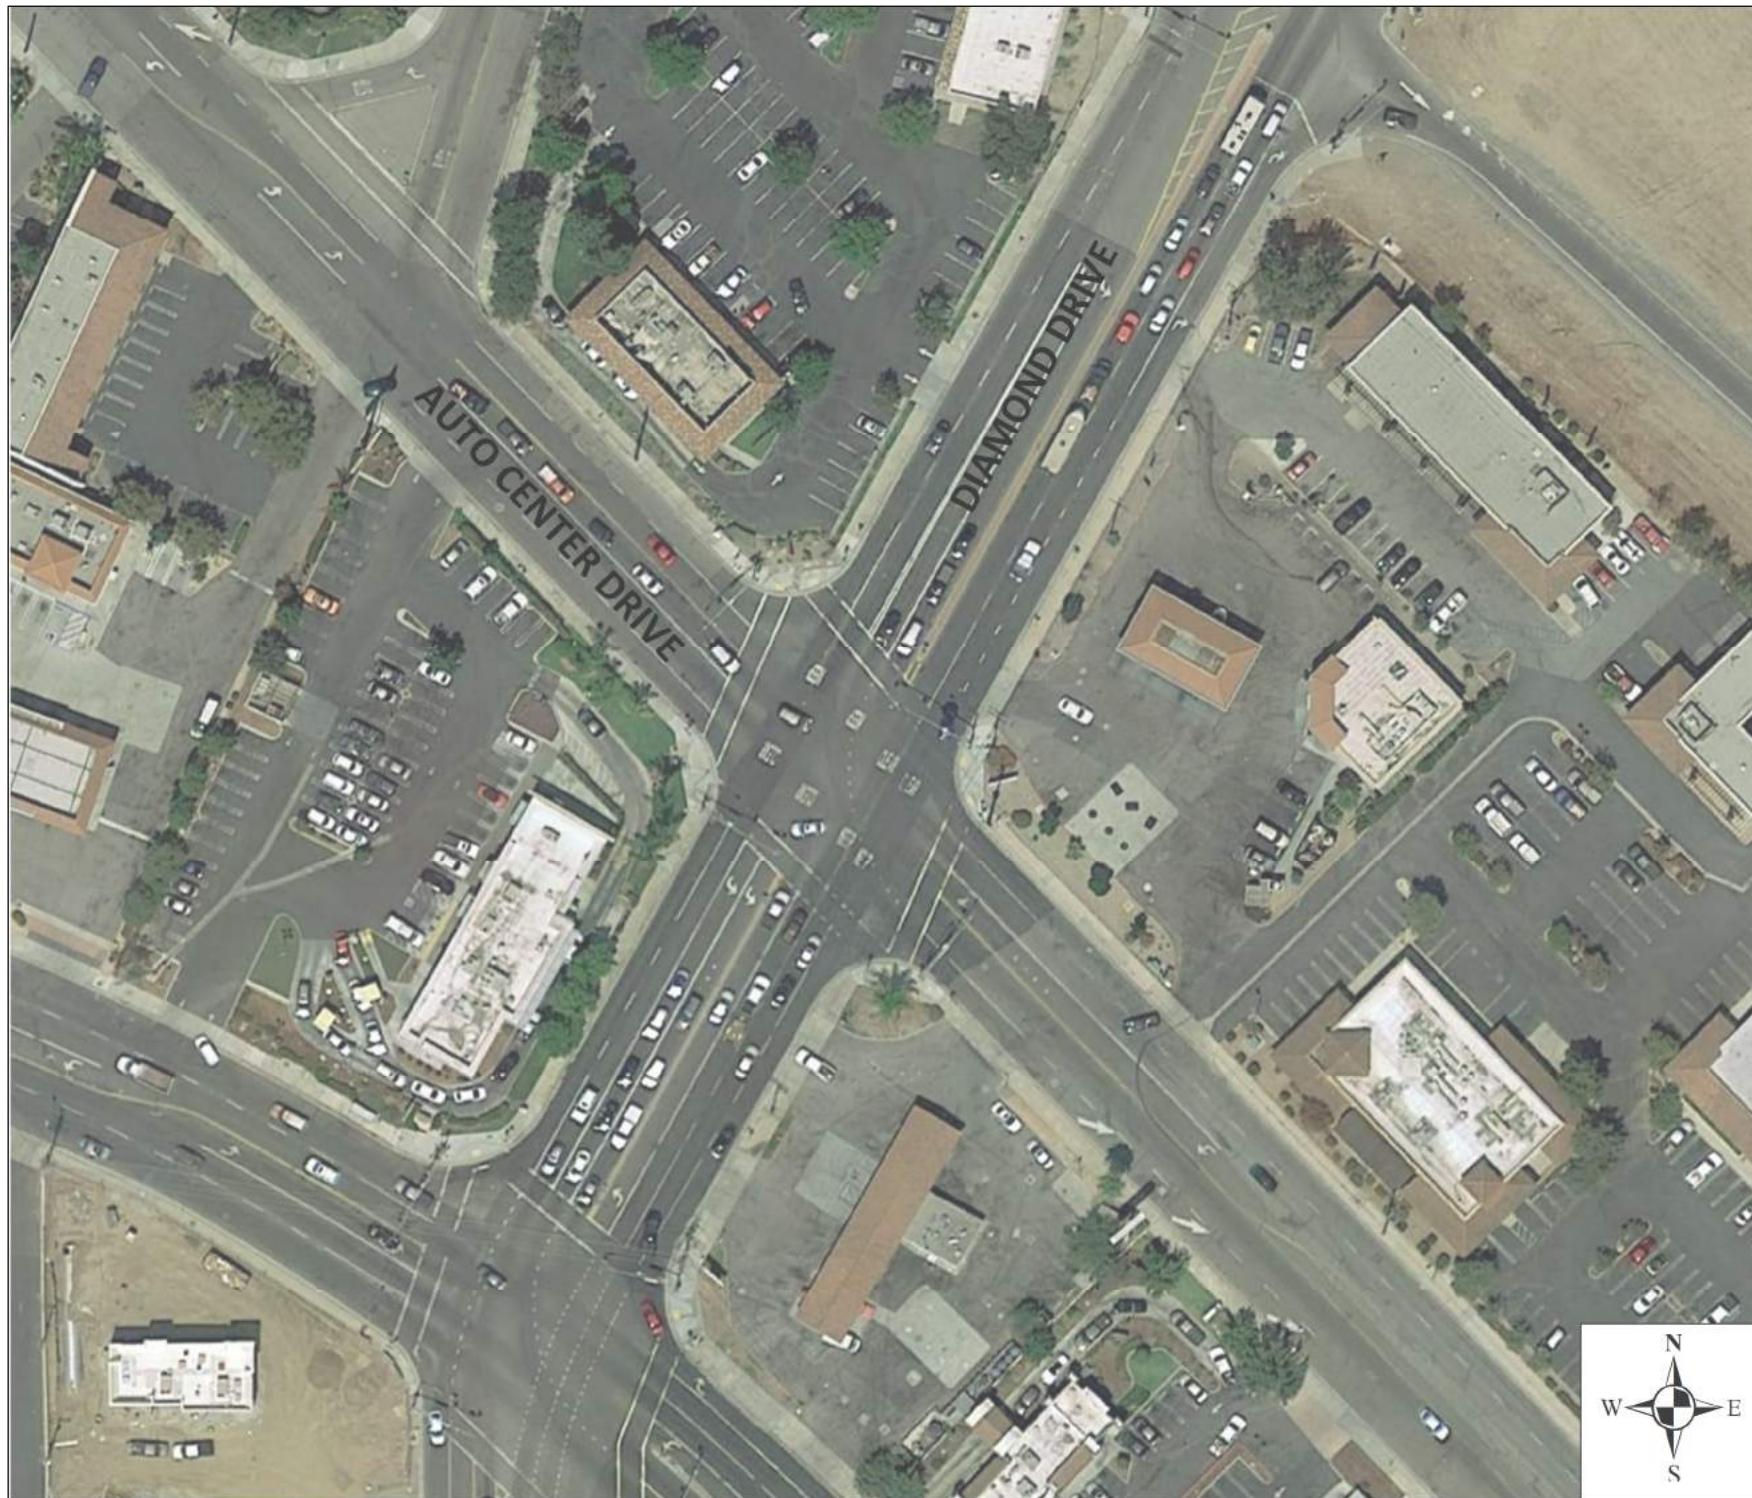
5. DIAMOND DRIVE AND AUTO CENTER DRIVE

- The intersection of Diamond Drive and Auto Center Drive is a signalized intersection.
- Median is installed on the North-South approaches of the intersection.
- Existing bus stops in the vicinity of the intersection on Diamond Drive.
- Four 12' wide crosswalk markings across four legs of the intersection.
- There is no existing bulb out at any corner of the intersection.
- The Unsafe Speed (5) and Improper Turning (6) are the major causes of collision at the intersection.
- The majority of the collisions occurred at the intersection are Broadside (13) and Rear-End (7).
- Surrounding Land Use
 - North: Restaurant
 - West: Restaurant
 - South: Gasoline Station
 - East: Gasoline Station

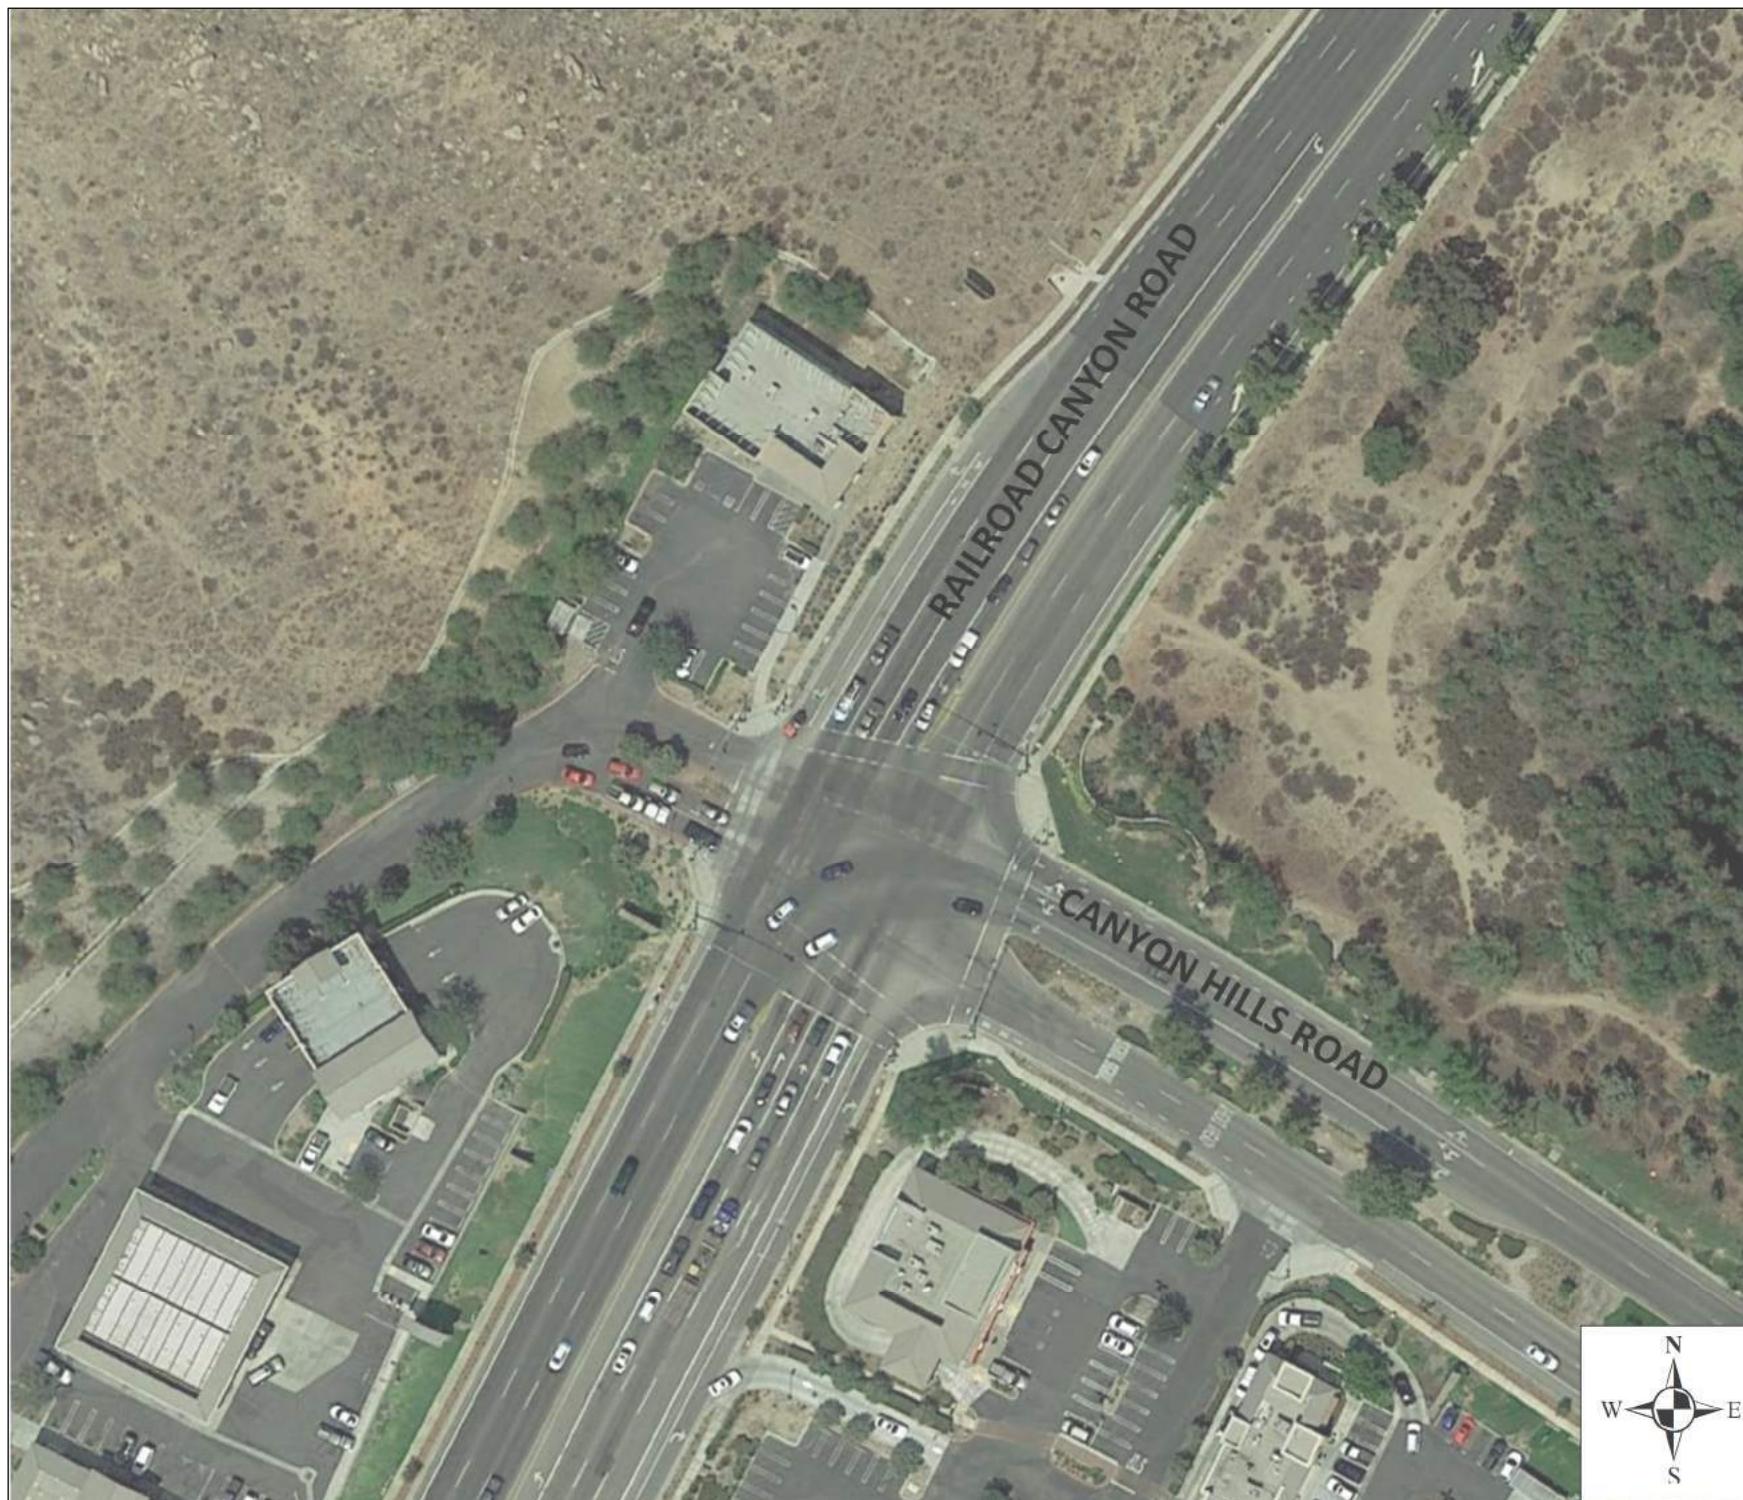
6. CANYON HILLS ROAD AND RAILROAD CANYON ROAD

- The intersection of Canyon Hills Drive and Railroad Canyon Drive is a signalized intersection.
- Median is installed on all approaches of the intersection.
- Existing bus stops in the vicinity of the intersection on Railroad Canyon Road.
- Four 12' wide crosswalk markings across four legs of the intersection.
- There is no existing bulb out at any corner of the intersection.
- The Auto R/W (4) and Improper Turning (2) are the major causes of collision at the intersection.
- The majority of the collisions occurred at the intersection are Rear End (3) and Broadside (10).
- Surrounding Land Use
 - North: Restaurant
 - West: Gasoline Station
 - South: Shopping Center
 - East: Vacant
