Systemic Safety Analysis Report

CITY OF LAKE ELSINORE

RE: Systemic Safety Analysis Report Program (SSARP)

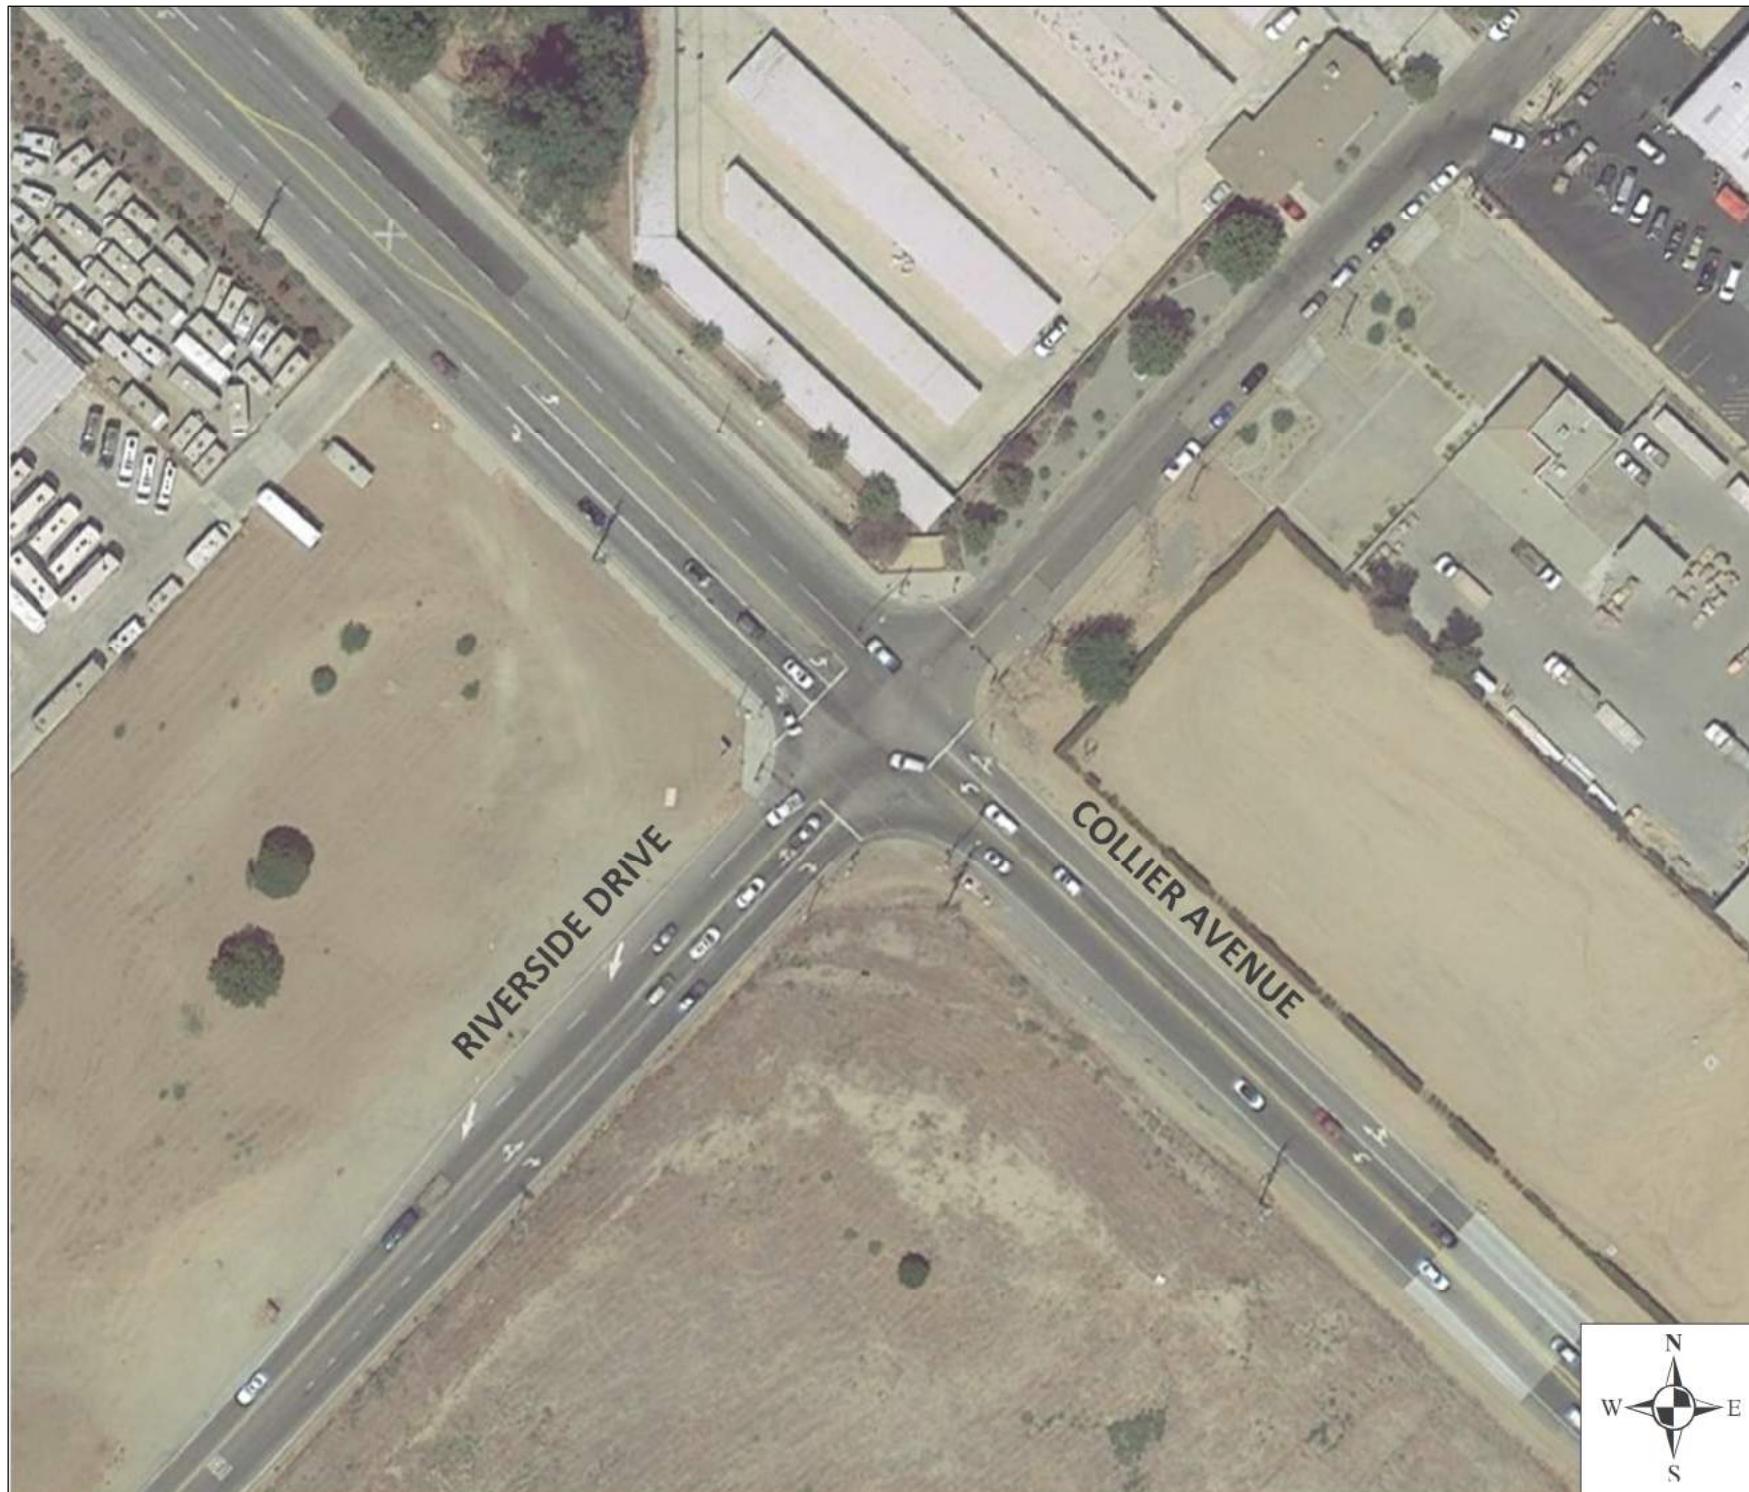
7. COLLIER AVENUE AND RIVERSIDE DRIVE

- The intersection of Collier Avenue and Riverside Drive is a signalized intersection.
- There is no existing median at the intersection.
- Existing bus stops in the vicinity of the intersection on Collier Avenue.
- There are no crosswalk markings across all four legs of the intersection.
- There is no existing bulb out at any corner of the intersection.
- The Unsafe Speed (11) and DUI (2) are the major causes of collision at the intersection.
- The majority of the collisions occurred at the intersection are Rear End (16) and Broadside (5).
- Surrounding Land Use
 - North: Self-Storage
 - West: Vacant
 - South: Vacant
 - East: Vacant

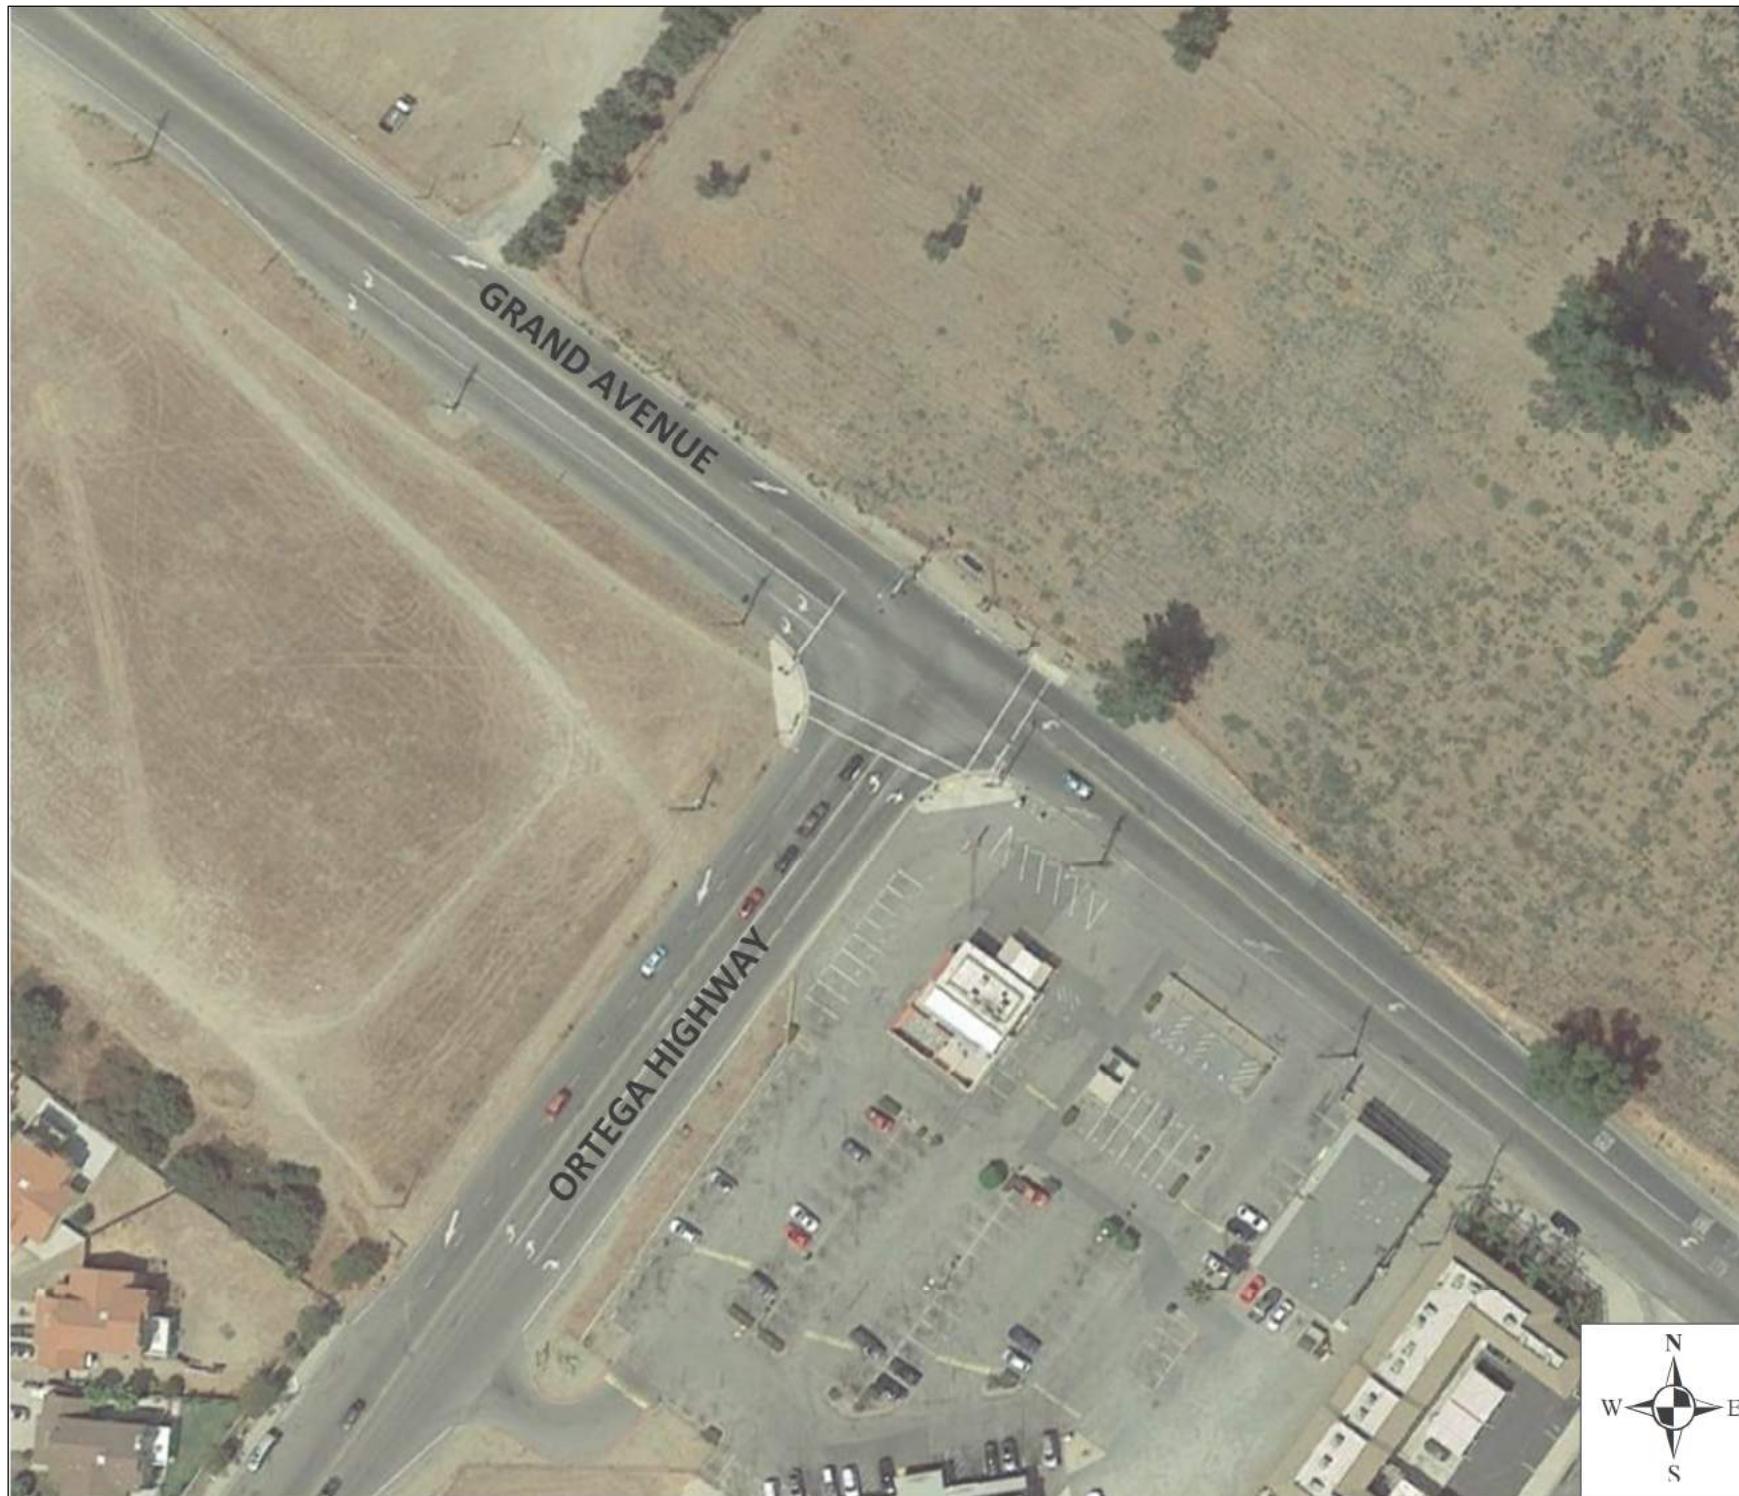
8. GRAND AVENUE AND ORTEGA HIGHWAY

- The intersection of Grand Avenue and Ortega Highway is a signalized intersection.
- There is no existing median at the intersection.
- Existing bus stops in the vicinity of the intersection on Grand Avenue.
- Two 12' wide existing crosswalk markings across two legs of the intersection.
- There is no existing bulb out at any corner of the intersection.
- The Unsafe Speed (8) and Improper Turning (3) are the major causes of collision at the intersection.
- The majority of the collisions occurred at the intersection are Hit Object (2) and Head-On (2).
- Surrounding Land Use
 - North: Vacant
 - West: Vacant
 - South: Restaurant
 - East: Vacant

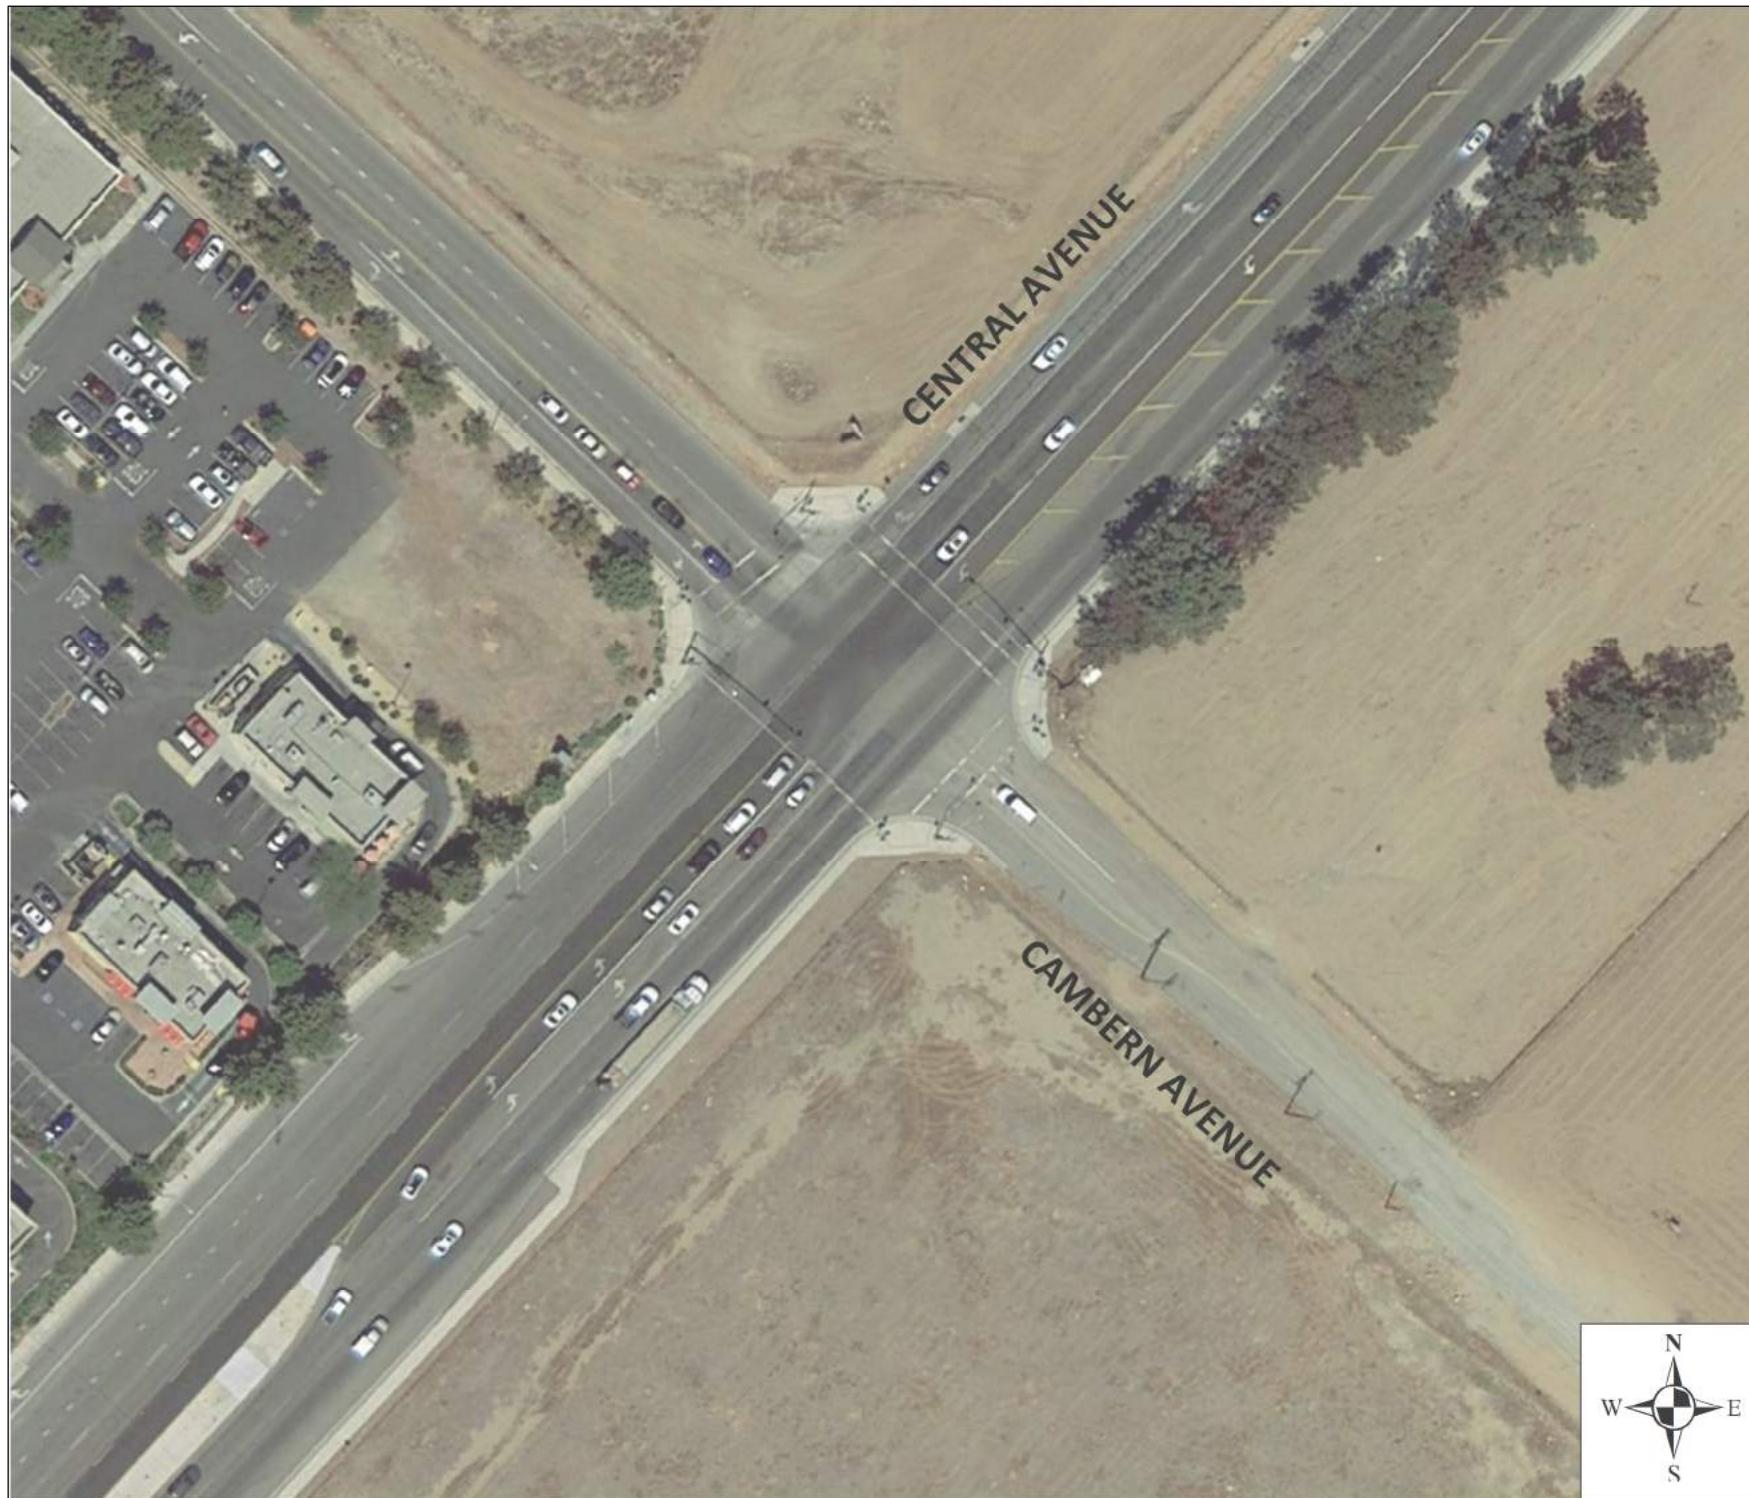
9. CAMBERN AVENUE AND CENTRAL AVENUE

- The intersection of Cambern Avenue and Central Avenue is a signalized intersection.
- There is no existing median at the intersection.
- Existing bus stops in the vicinity of the intersection on Central Avenue.
- Existing crosswalk markings across three legs of the intersection.
- There is no existing bulb out at any corner of the intersection.
- The Unsafe Speed (8) and Automobile R/W (2) are the major causes of collision at the intersection.
- The majority of the collisions occurred at the intersection are Rear End (12) and Broadside (2).
- Surrounding Land Use
 - North: Vacant
 - West: Restaurant
 - South: Vacant
 - East: Vacant

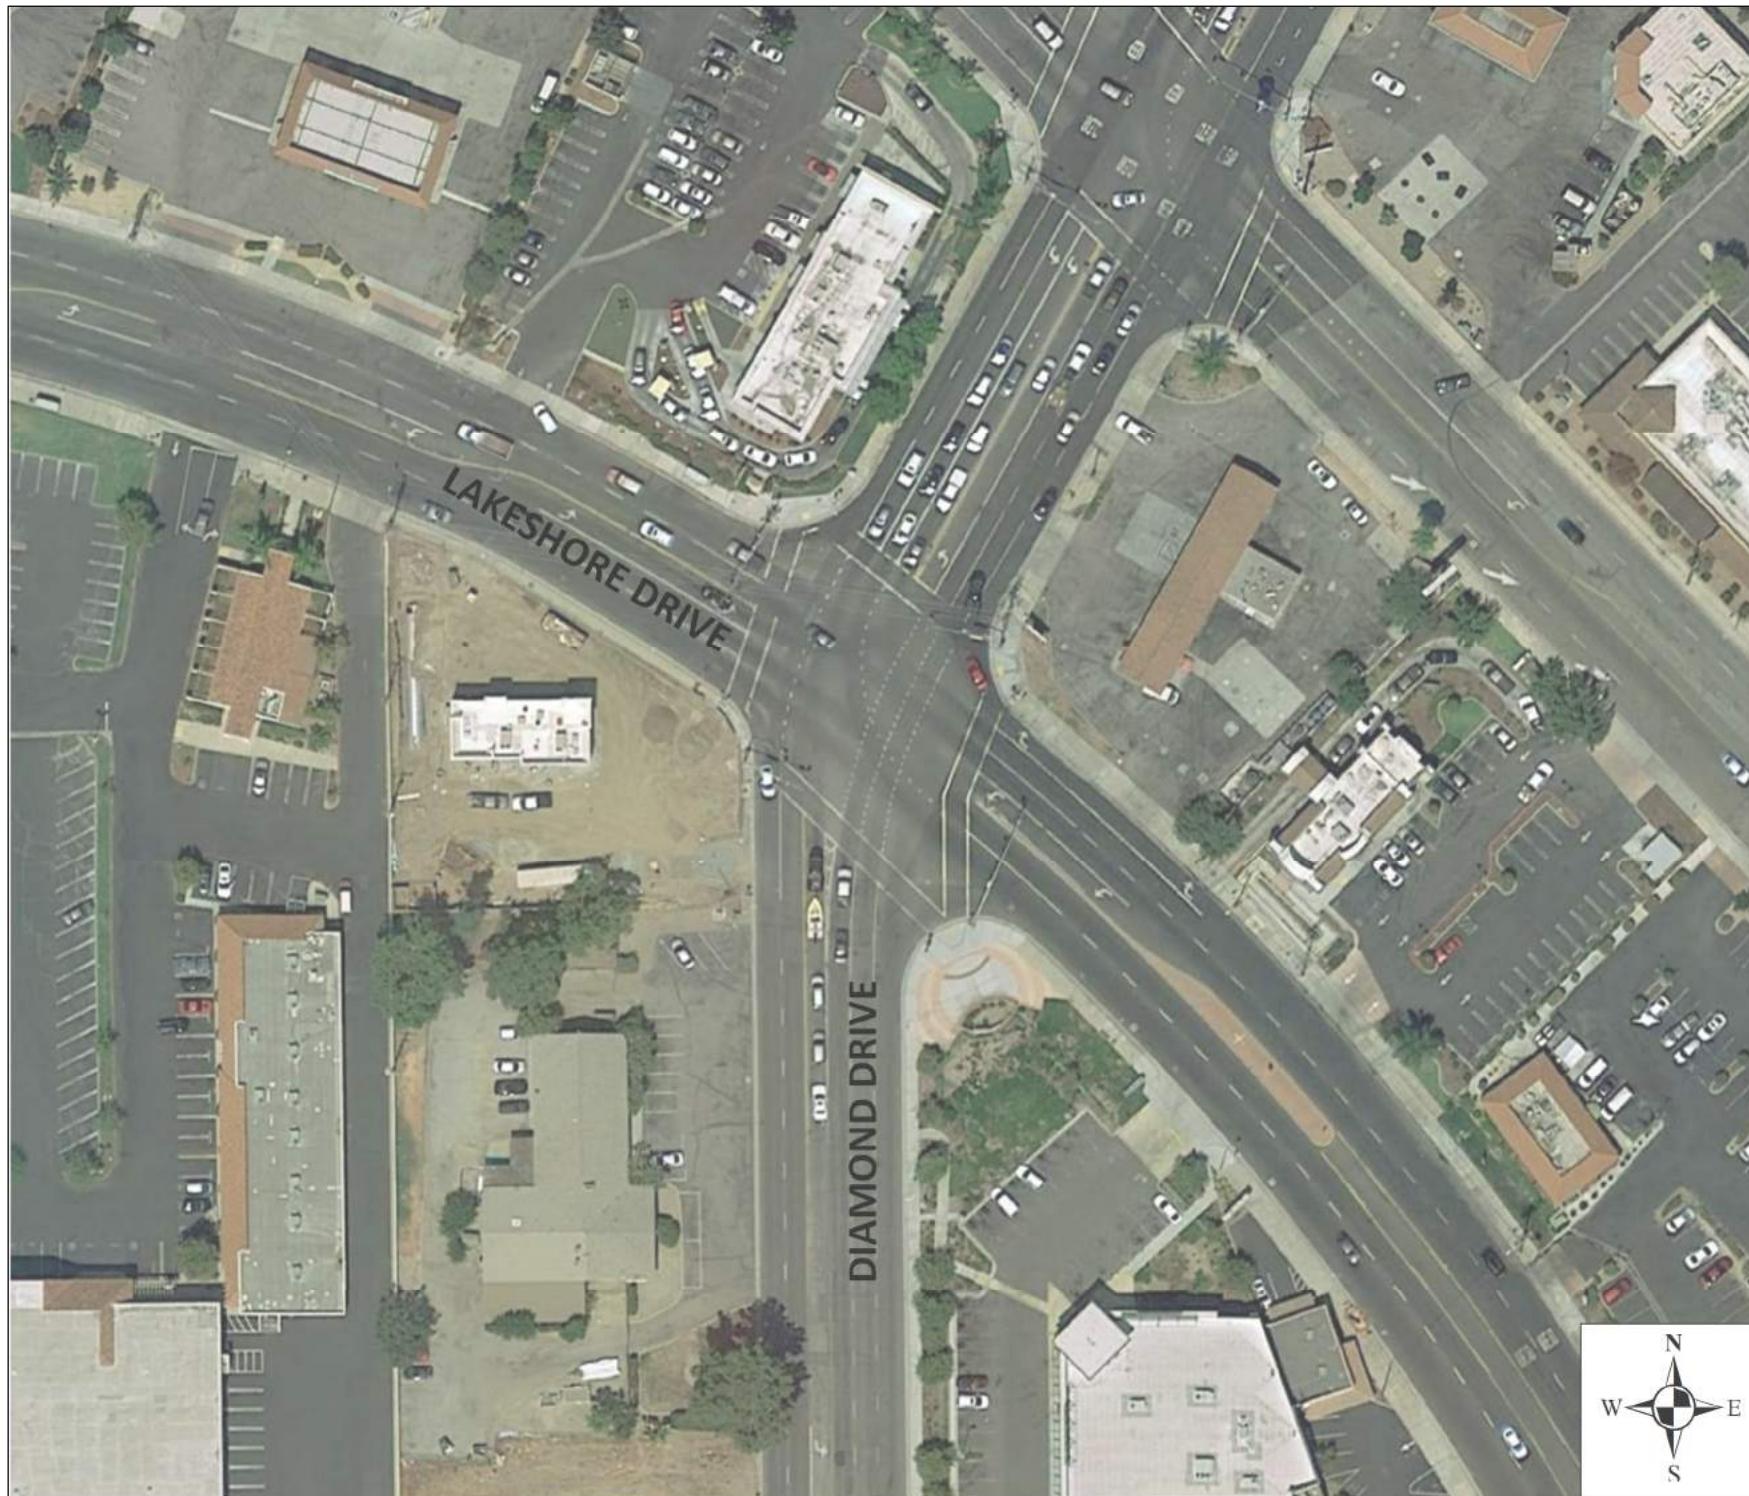
10. DIAMOND DRIVE AND LAKESHORE DRIVE

- The intersection of Diamond Drive and Lakeshore Drive is a signalized intersection.
- There is existing median on the North and East approaches of the intersection.
- Existing bus stops in the vicinity of the intersection on Lakeshore Drive.
- Existing crosswalk markings across four legs of the intersection.
- There is no existing bulb out at any corner of the intersection.
- The Auto R/W Violation (4) and Improper Turning (2) are the major causes of collision at the intersection.
- The majority of the collisions occurred at the intersection are Rear End (3) and Broadside (10).
- Surrounding Land Use
 - North: Restaurant
 - West: Shopping Center
 - South: Pharmacy
 - East: Gasoline Station

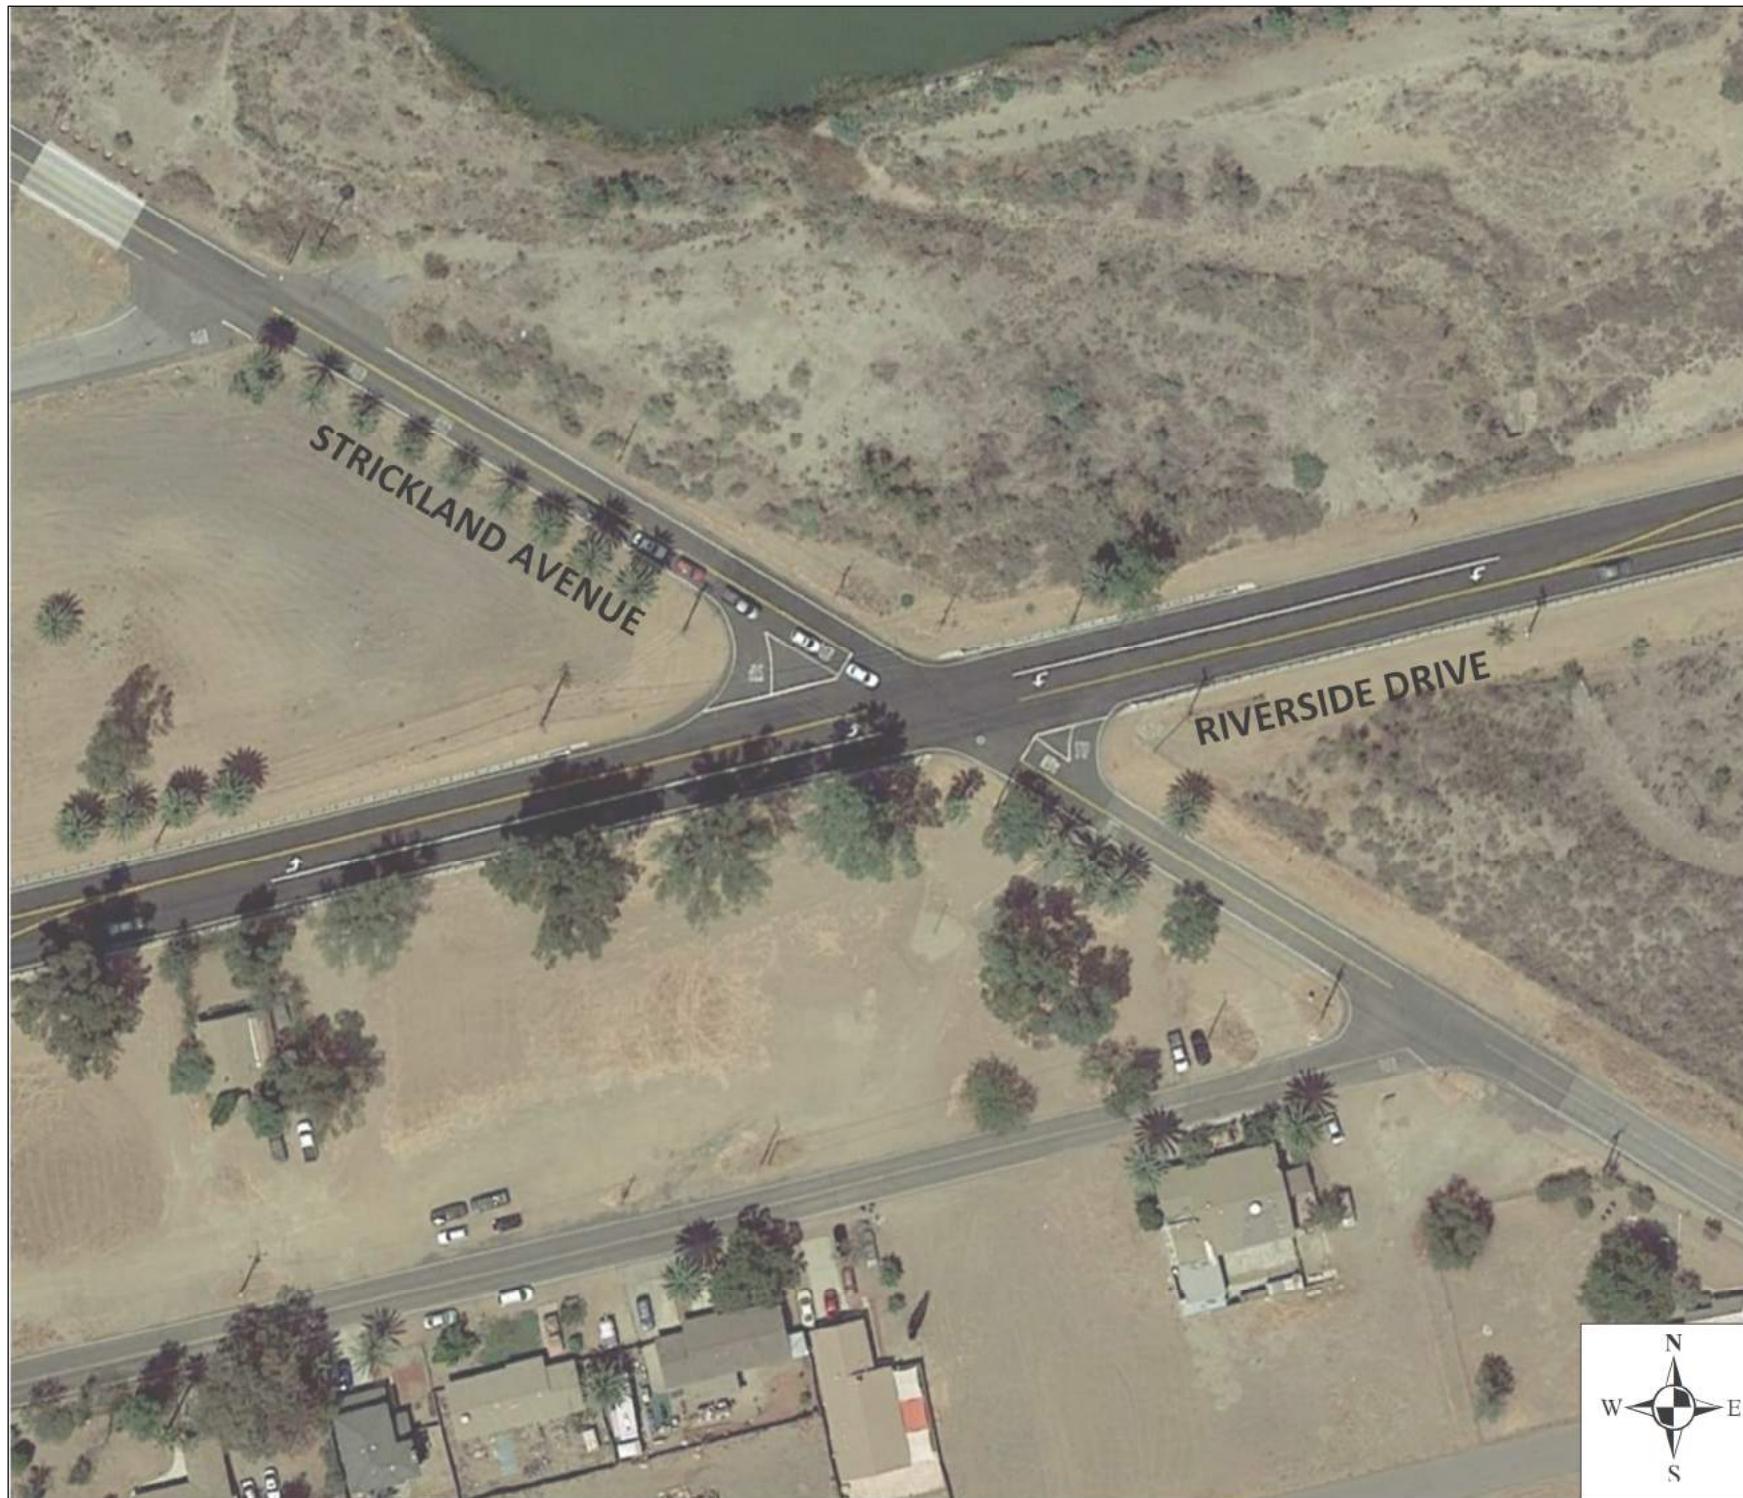
11. RIVERSIDE DRIVE AND STRICKLAND AVENUE

- The intersection of Riverside Drive and Strickland Avenue is an unsignalized intersection.
- There is no existing median at the intersection.
- Existing bus stops in the vicinity of the intersection on Riverside Drive.
- There are no existing crosswalk markings across any leg of the intersection.
- There is no existing bulb out at any corner of the intersection.
- The Unsafe Speed (6) and DUI (3) are the major causes of collision at the intersection.
- The majority of the collisions occurred at the intersection are Rear End (8) and Head-On (5).
- Surrounding Land Use
 - North: Vacant
 - West: Vacant
 - South: Vacant
 - East: Vacant

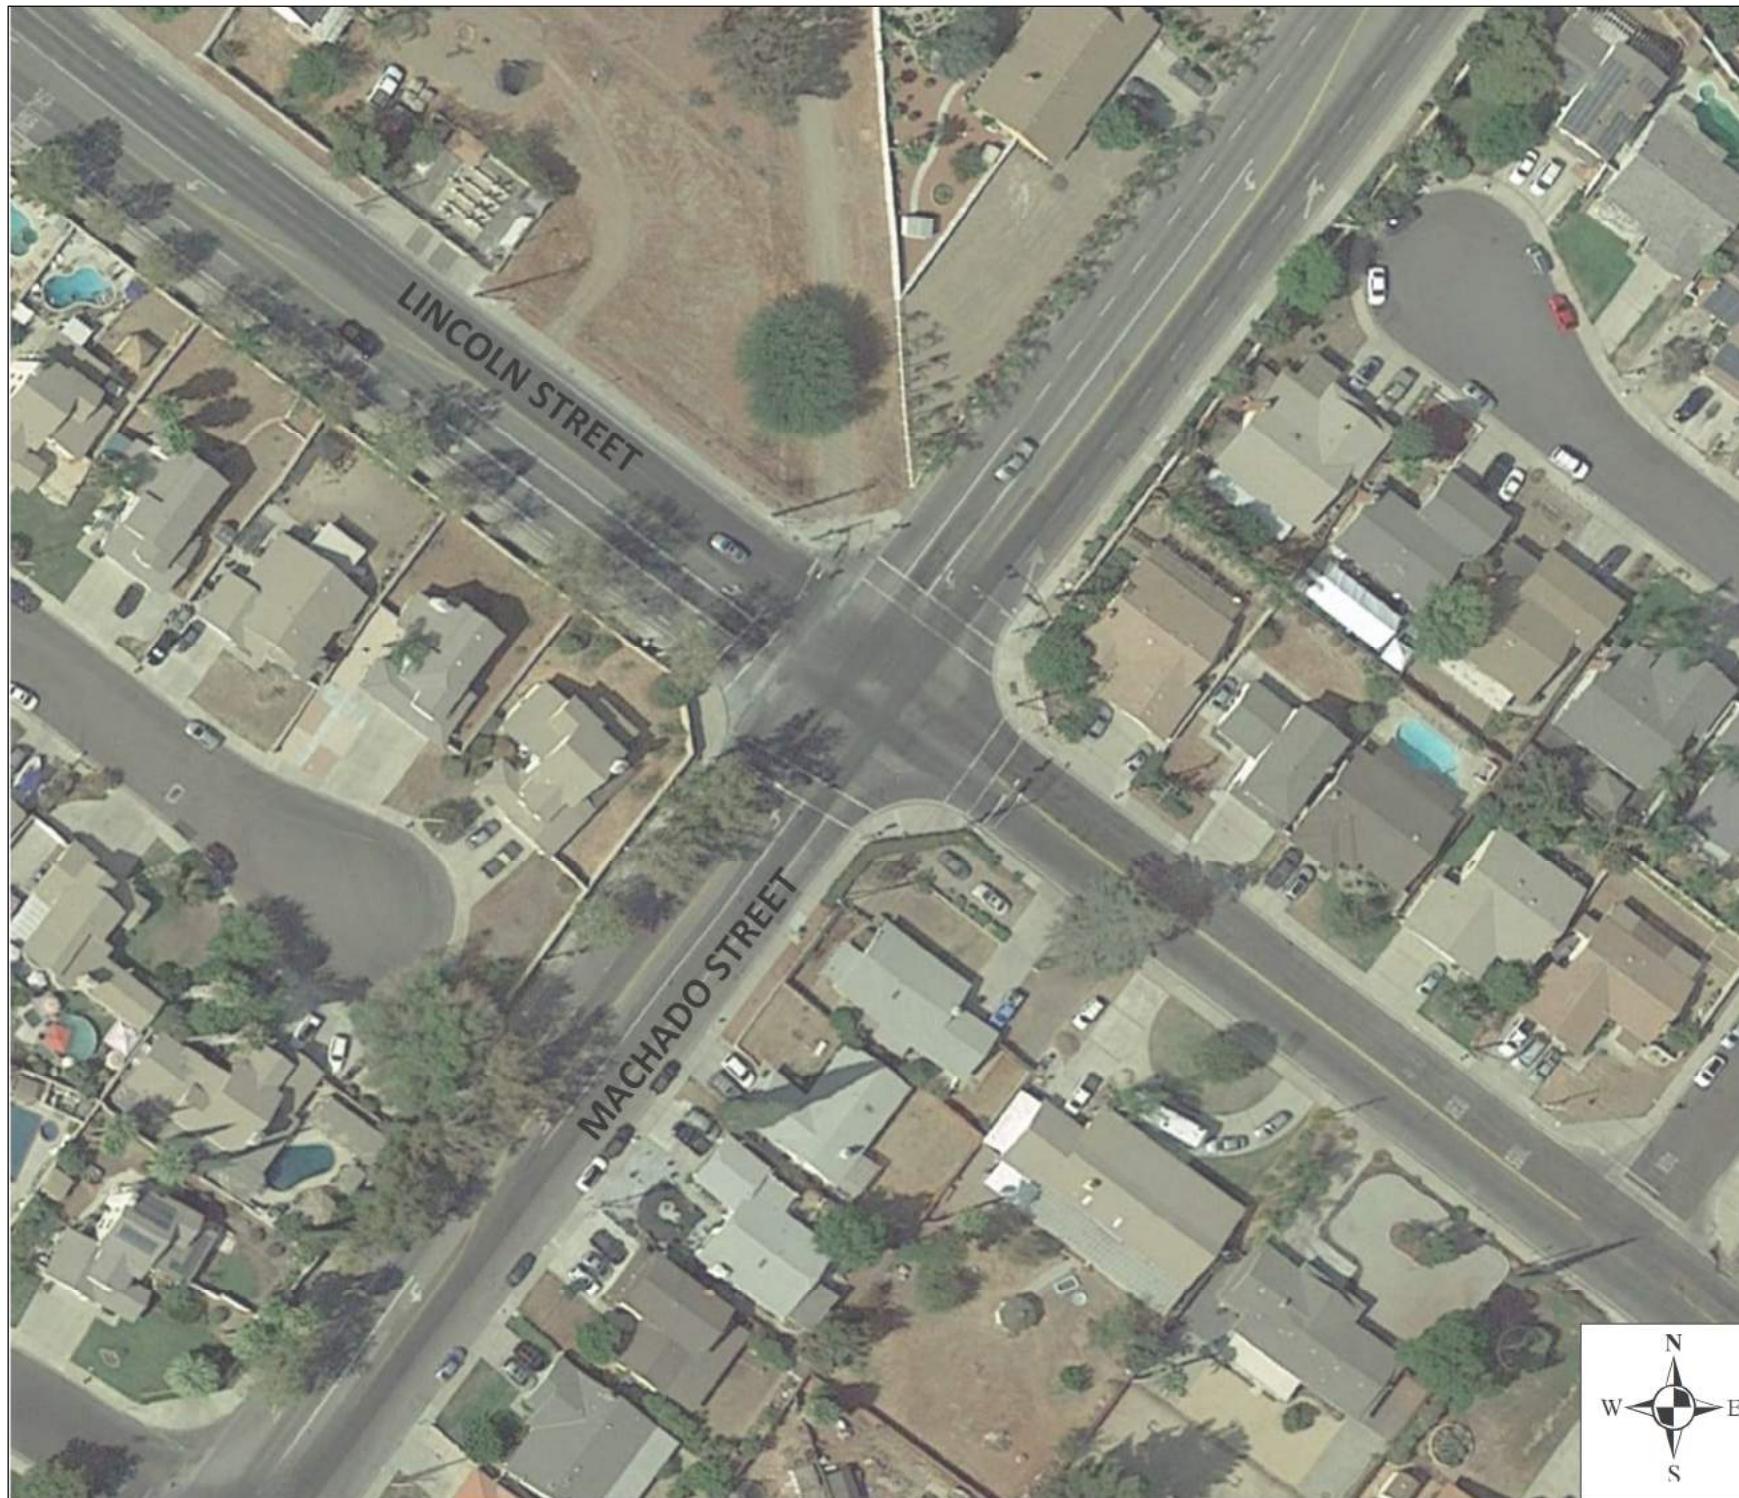
13. MACHADO STREET AND LINCOLN STREET

- The intersection of Machado Street and Lincoln Street is a signalized intersection.
- There is no existing median at the intersection.
- Existing bus stops in the vicinity of the intersection on Machado Street.
- Four 12' wide existing crosswalk markings across four legs of the intersection.
- There is no existing bulb out at any corner of the intersection.
- The Unsafe Speed (2) and Automobile R/W (3) are the major causes of collision at the intersection.
- The majority of the collisions occurred at the intersection are Broadside (10) and Hit Object (2).
- Surrounding Land Use
 - North: Residential
 - West: Residential
 - South: Residential
 - East: Residential

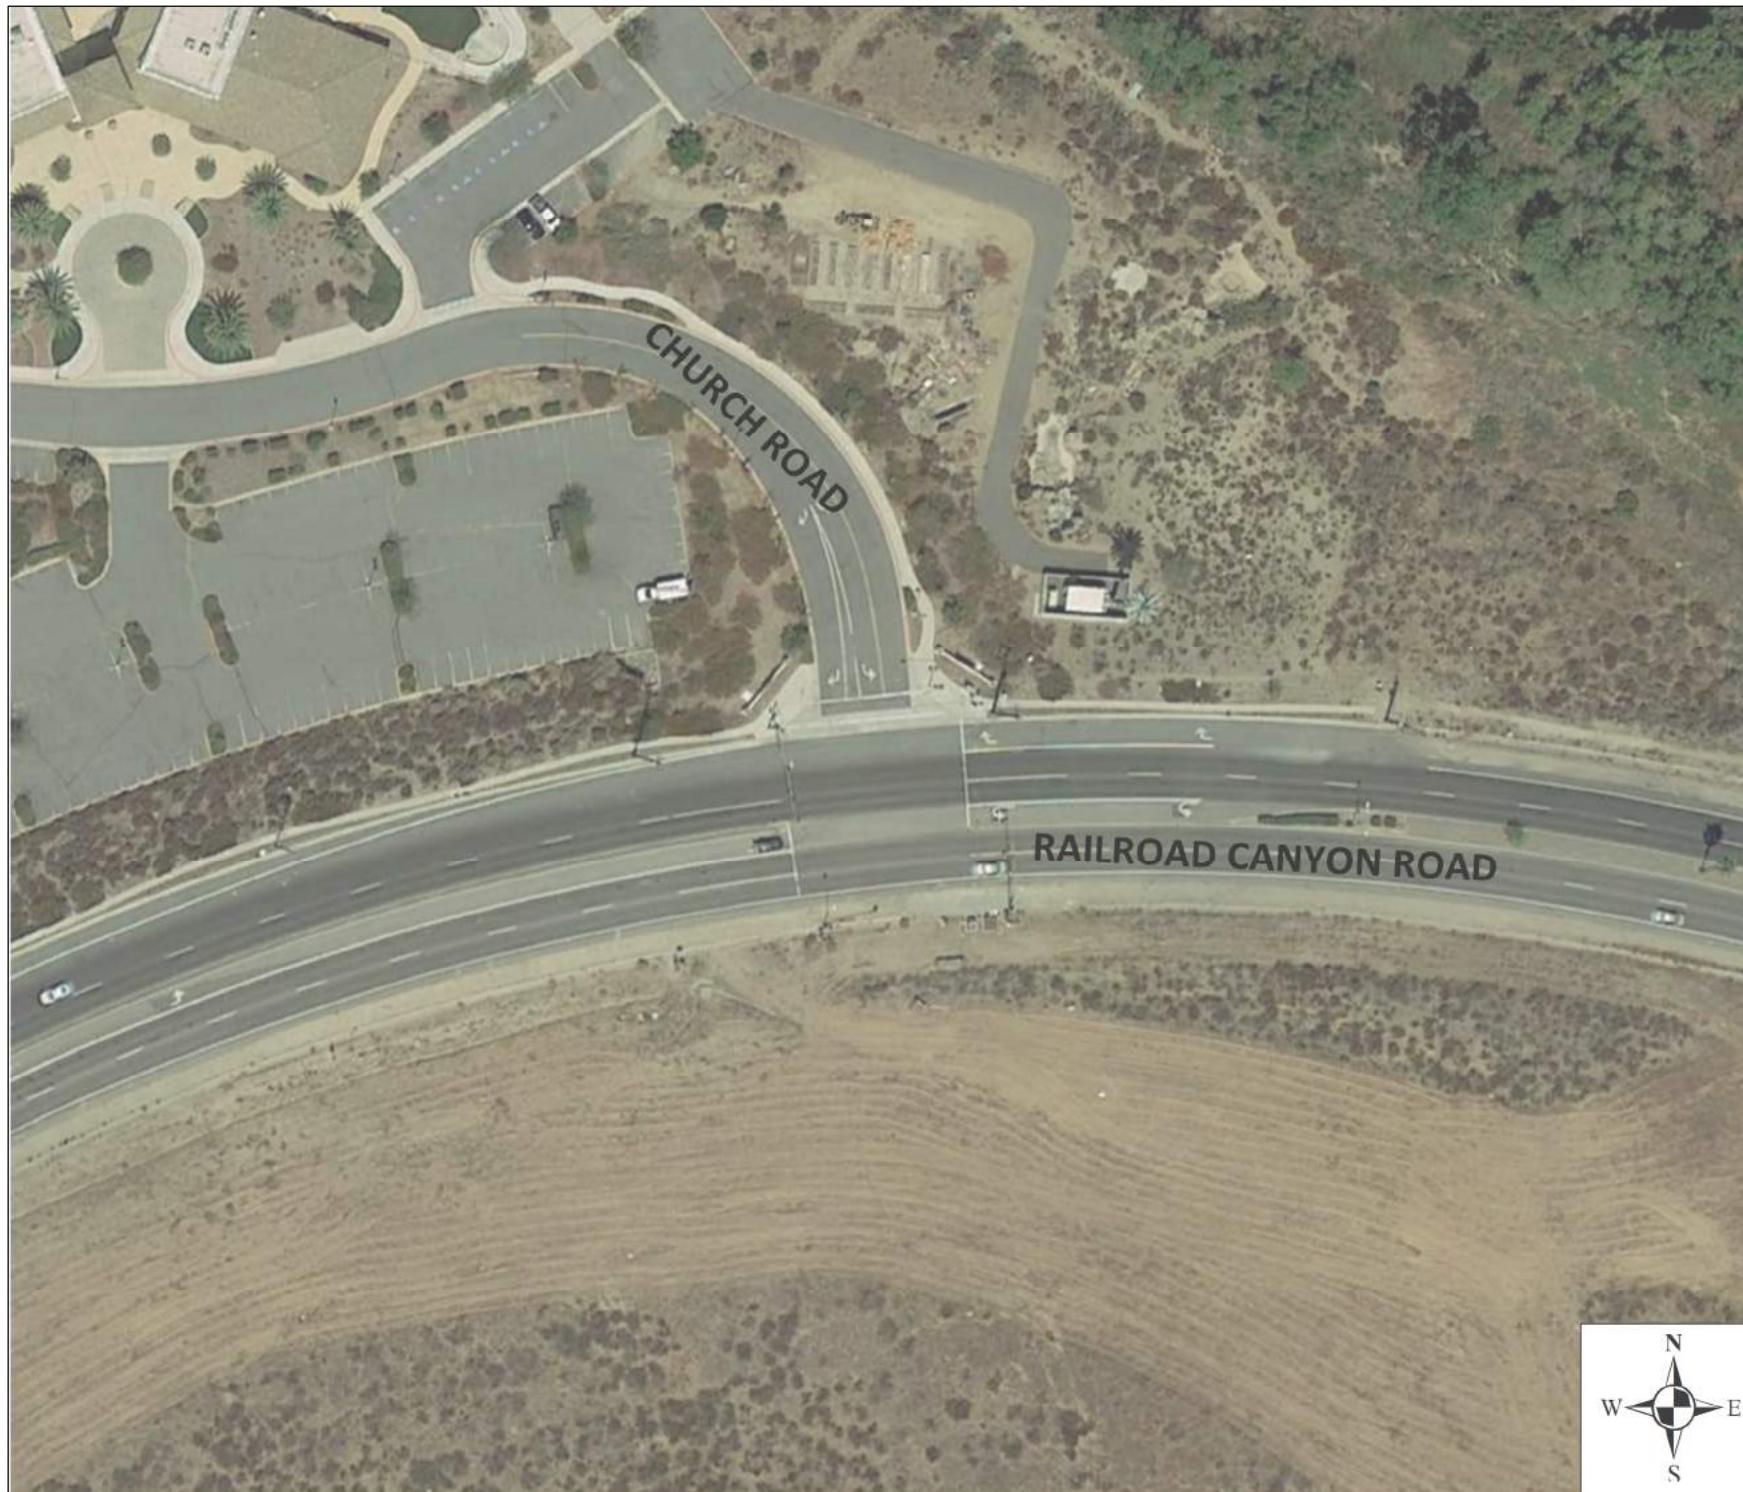
14. RAILROAD CANYON ROAD AND CHURCH ROAD

- The intersection of Railroad Canyon Road and Church Road is a signalized intersection.
- Median is installed on the East-West approaches of the intersection.
- There are no existing bus stops in the vicinity of the intersection.
- One 12' wide existing crosswalk marking across one leg of the intersection.
- There is no existing bulb out at any corner of the intersection.
- The Unsafe Speed (16) and Improper Turning (12) are the major causes of collision at the intersection.
- The majority of the collisions occurred at the intersection are Rear End (14) and Hit Object (15).
- Surrounding Land Use
 - North: Church
 - West: Vacant
 - South: Vacant
 - East: Vacant

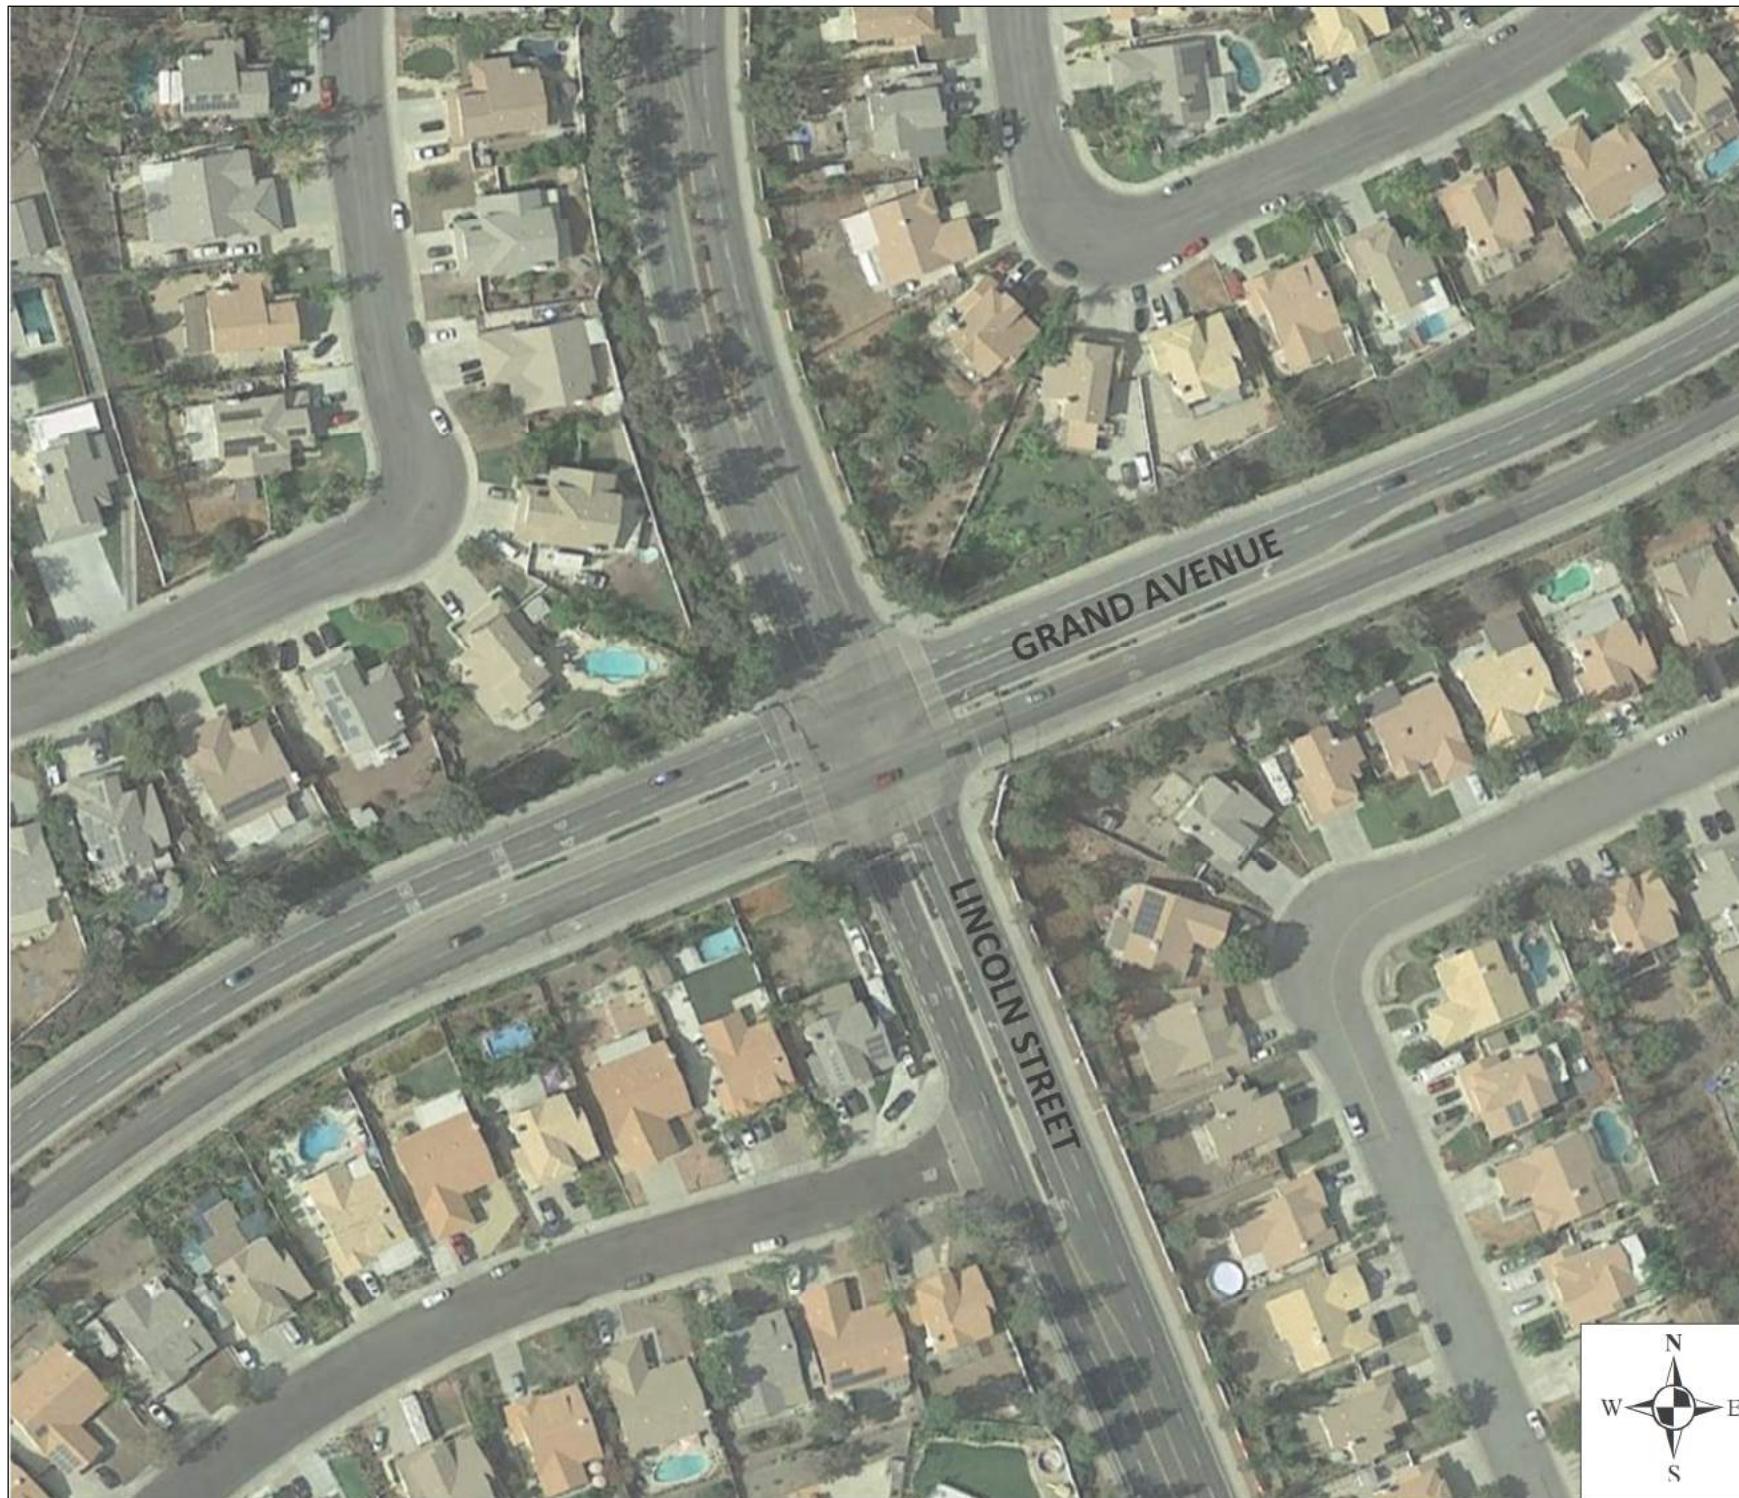
15.GRAND AVENUE AND LINCOLN STREET

- The intersection of Grand Avenue and Lincoln Street is a signalized intersection.
- Median is installed on the East, West, and South approaches of the intersection.
- There are no existing bus stops in the vicinity of the intersection.
- Four 12' wide existing crosswalk marking across four legs of the intersection.
- There is no existing bulb out at any corner of the intersection.
- The Auto R/W Violation (3) and Traffic Signals and Signs (2) are the major causes of collision at the intersection.
- The majority of the collisions occurred at the intersection are Broadside (7) and Rear-End (1).
- Surrounding Land Use
 - North: Residential
 - West: Residential
 - South: Residential
 - East: Residential
