Systemic Safety Analysis Report

CITY OF LAKE ELSINORE

RE: Systemic Safety Analysis Report Program (SSARP)

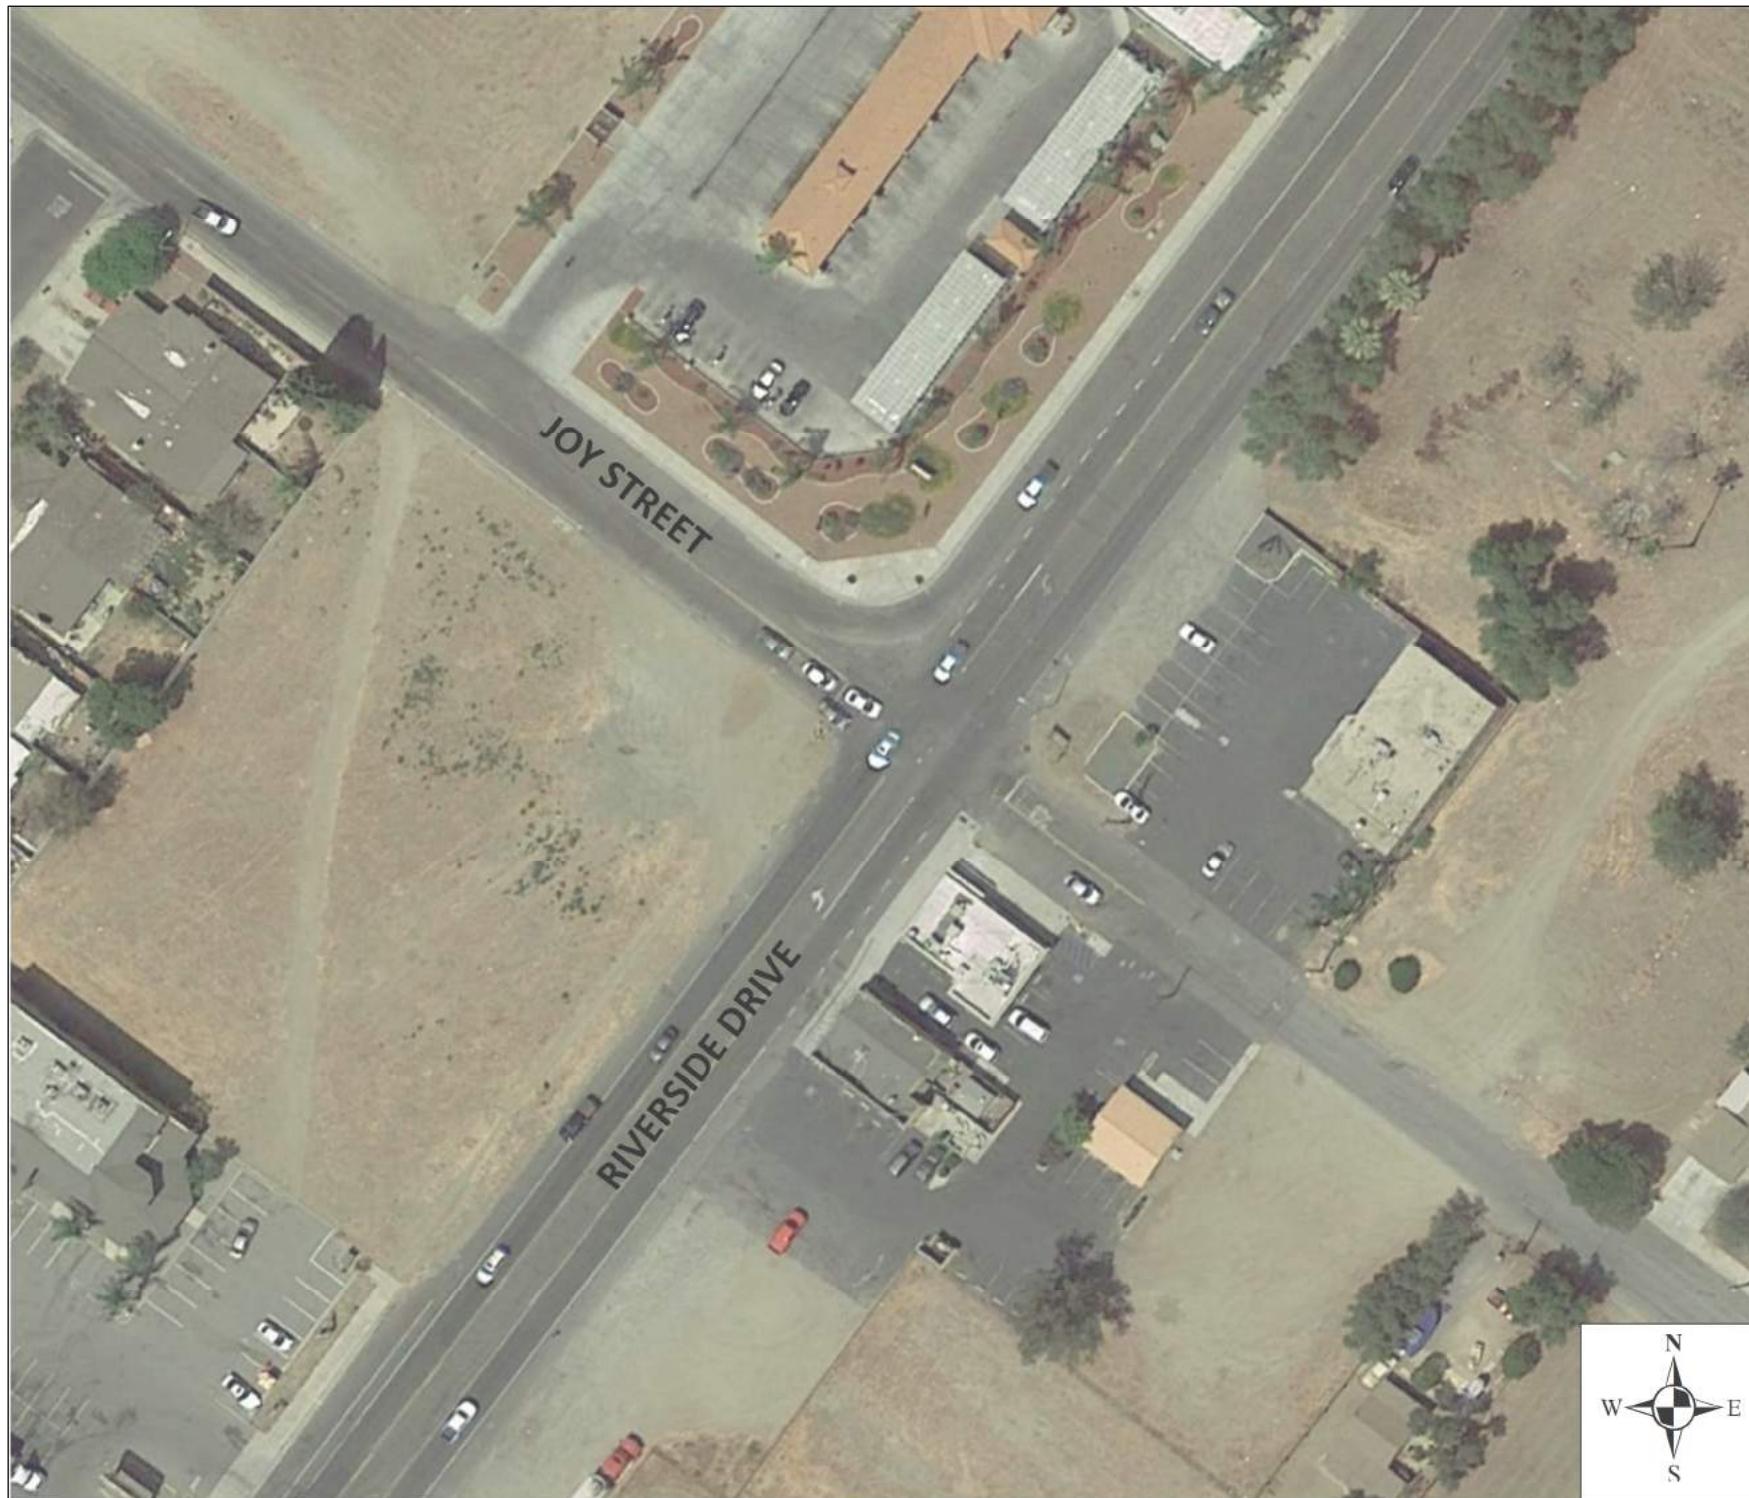
16. RIVERSIDE DRIVE AND JOY STREET

- The intersection of Riverside Drive and Joy Street is a signalized intersection.
- There is no existing median at the intersection.
- There are no existing bus stops in the vicinity of the intersection.
- There are no existing crosswalk markings across any leg of the intersection.
- There is no existing bulb out at any corner of the intersection.
- The DUI (3) and Unsafe Speed (2) are the major causes of collision at the intersection.
- The majority of the collisions occurred at the intersection are Broadside (6) and Rear-End (4).
- Surrounding Land Use
 - North: Car Wash
 - West: Vacant
 - South: Restaurant
 - East: Bar

- Upgrade intersection pavement markings (NS6).
- Install flashing beacon as advance warning (NS8).

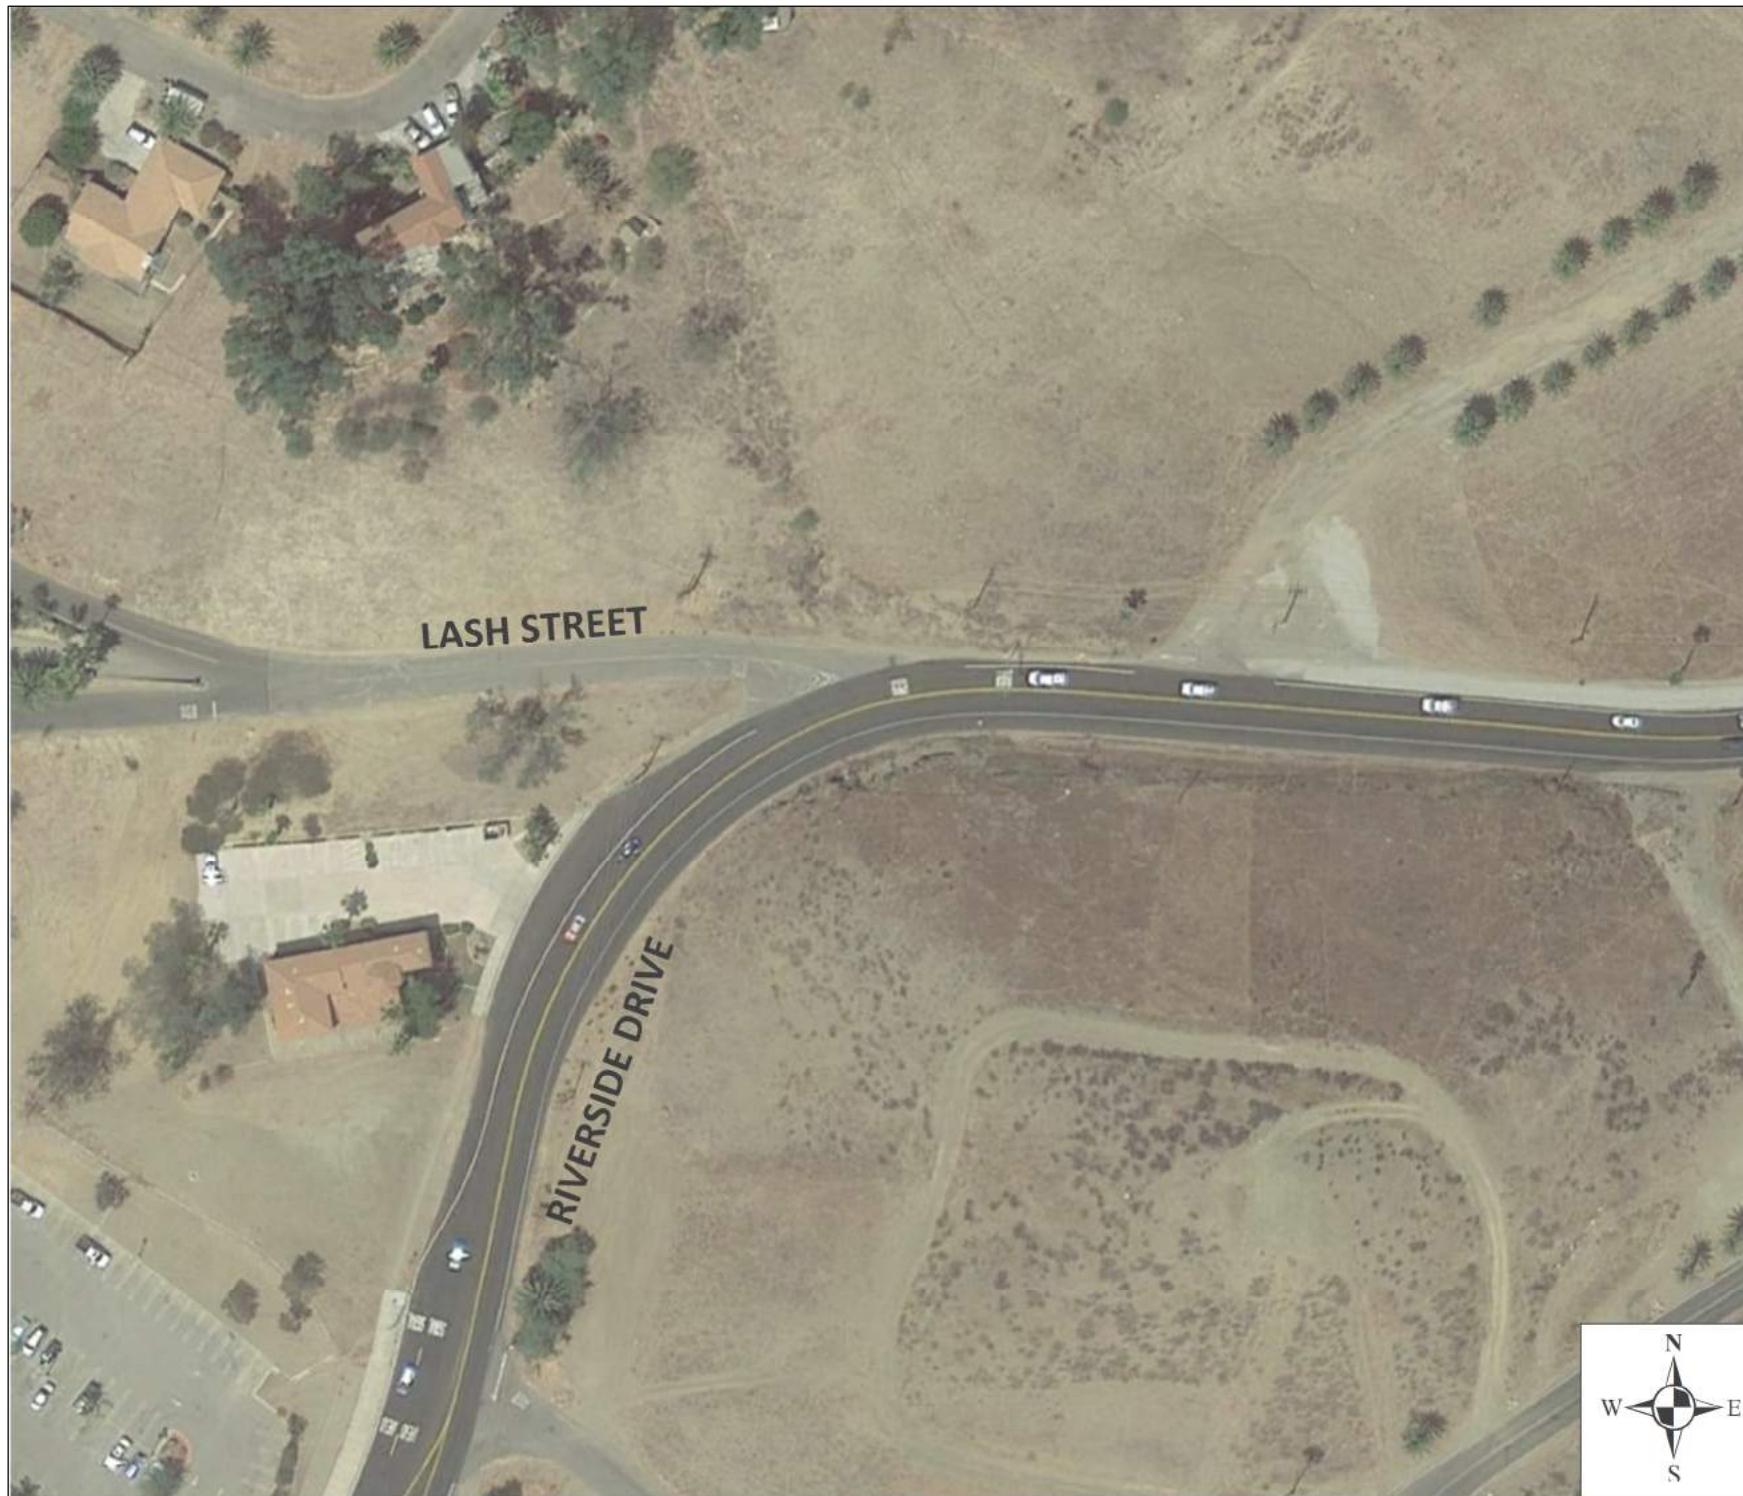
17. RIVERSIDE DRIVE AND LASH STREET

- The intersection of Riverside Drive and Lash Street is an unsignalized intersection.
- There is no existing median at the intersection.
- There are no existing bus stops in the vicinity of the intersection.
- There are no existing crosswalk markings across any leg of the intersection.
- There is no existing bulb out at any corner of the intersection.
- The Improper Turning (2) and DUI (3) are the major causes of collision at the intersection.
- The majority of the collisions occurred at the intersection are Hit-Object (3) Head-On (2).
- Surrounding Land Use
 - North: Vacant
 - West: Massage Therapy
 - South: Vacant
 - East: Vacant

Potential Countermeasures	
<ul style="list-style-type: none"> • Add intersection lighting (NS1). • Upgrade intersection pavement markings (NS6). • Install flashing beacons as advance warning (NS8). • Improve sight distance to intersection (NS10). • Improve pavement friction (NS20).

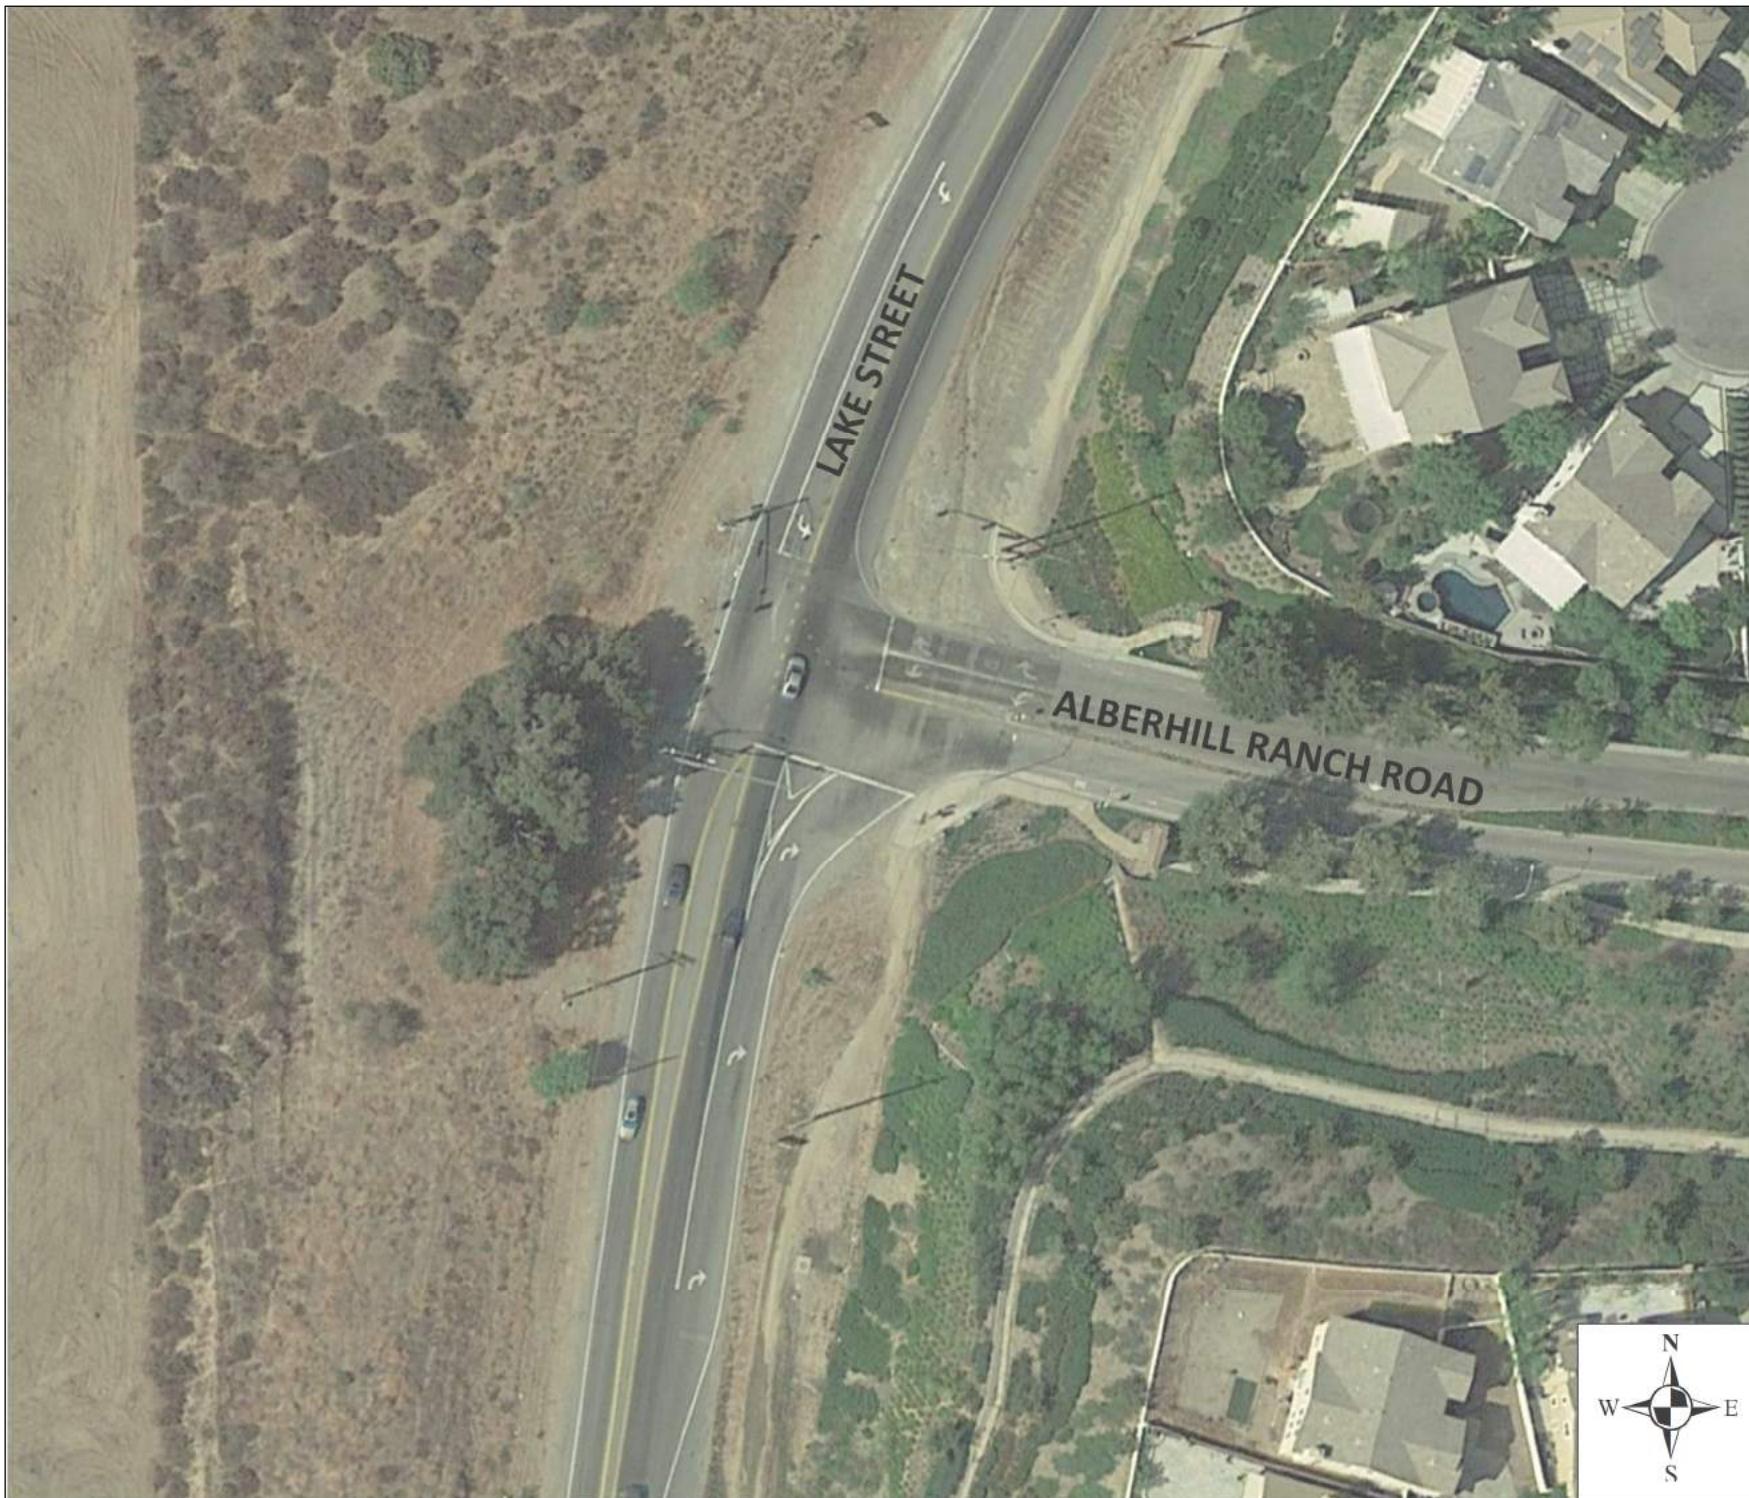
18. ALBERHILL RANCH ROAD AND LAKE STREET

- The intersection of Alberhill Ranch Road and Lake Street is a signalized intersection.
- Median is installed on the East approach of the intersection.
- There are no existing bus stops in the vicinity of the intersection.
- There are no existing crosswalk markings across any leg of the intersection.
- There is no existing bulb out at any corner of the intersection.
- The Unsafe Speed (3) and Improper Turning (3) are the major causes of collision at the intersection.
- The majority of the collisions occurred at the intersection are Rear-End (5) and Broadside (1).
- Surrounding Land Use
 - North: Vacant
 - West: Vacant
 - South: Residential
 - East: Residential

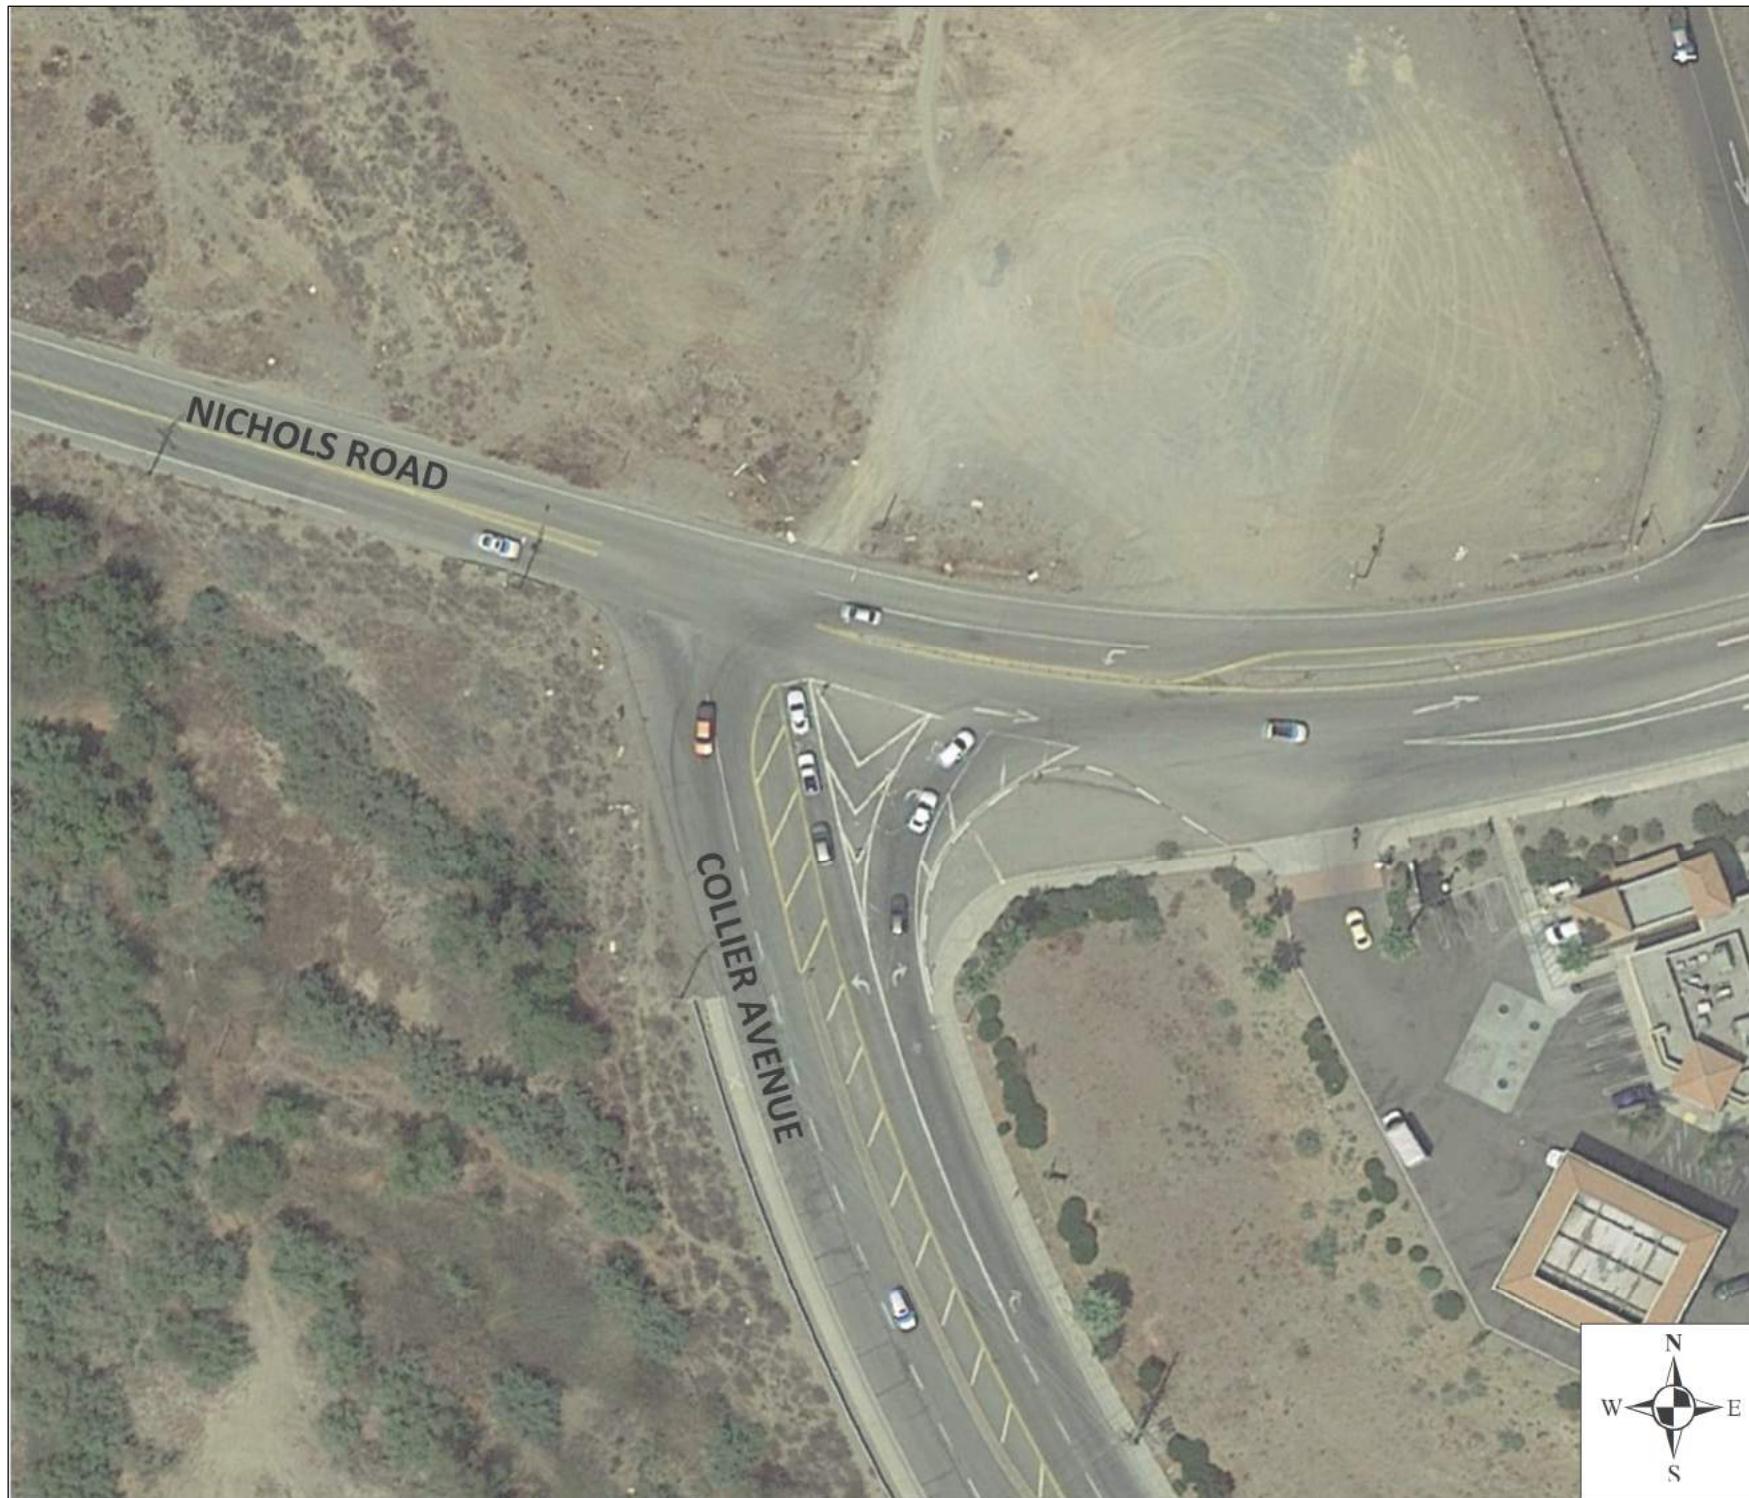
19. COLLIER AVENUE AND NICHOLS ROAD

- The intersection of Collier Avenue and Nichols Road is an unsignalized intersection.
- Median is installed on the South approach of the intersection.
- There are no existing bus stops in the vicinity of the intersection.
- There are no existing crosswalk markings across any leg of the intersection.
- There is no existing bulb out at any corner of the intersection.
- The Auto R/W (3) and Improper Turning (1) are the major causes of collision at the intersection.
- The majority of the collisions occurred at the intersection are Broadside (5) and Hit Object (2).
- Surrounding Land Use
 - North: Vacant
 - West: Vacant
 - South: Vacant
 - East: Gasoline Station

- Add intersection lighting (NS1).
- Install/upgrade larger or additional stop signs or other intersection warning/regulatory signs (NS5).
- Upgrade intersection pavement markings (NS6).
- Improve pavement friction (NS20).

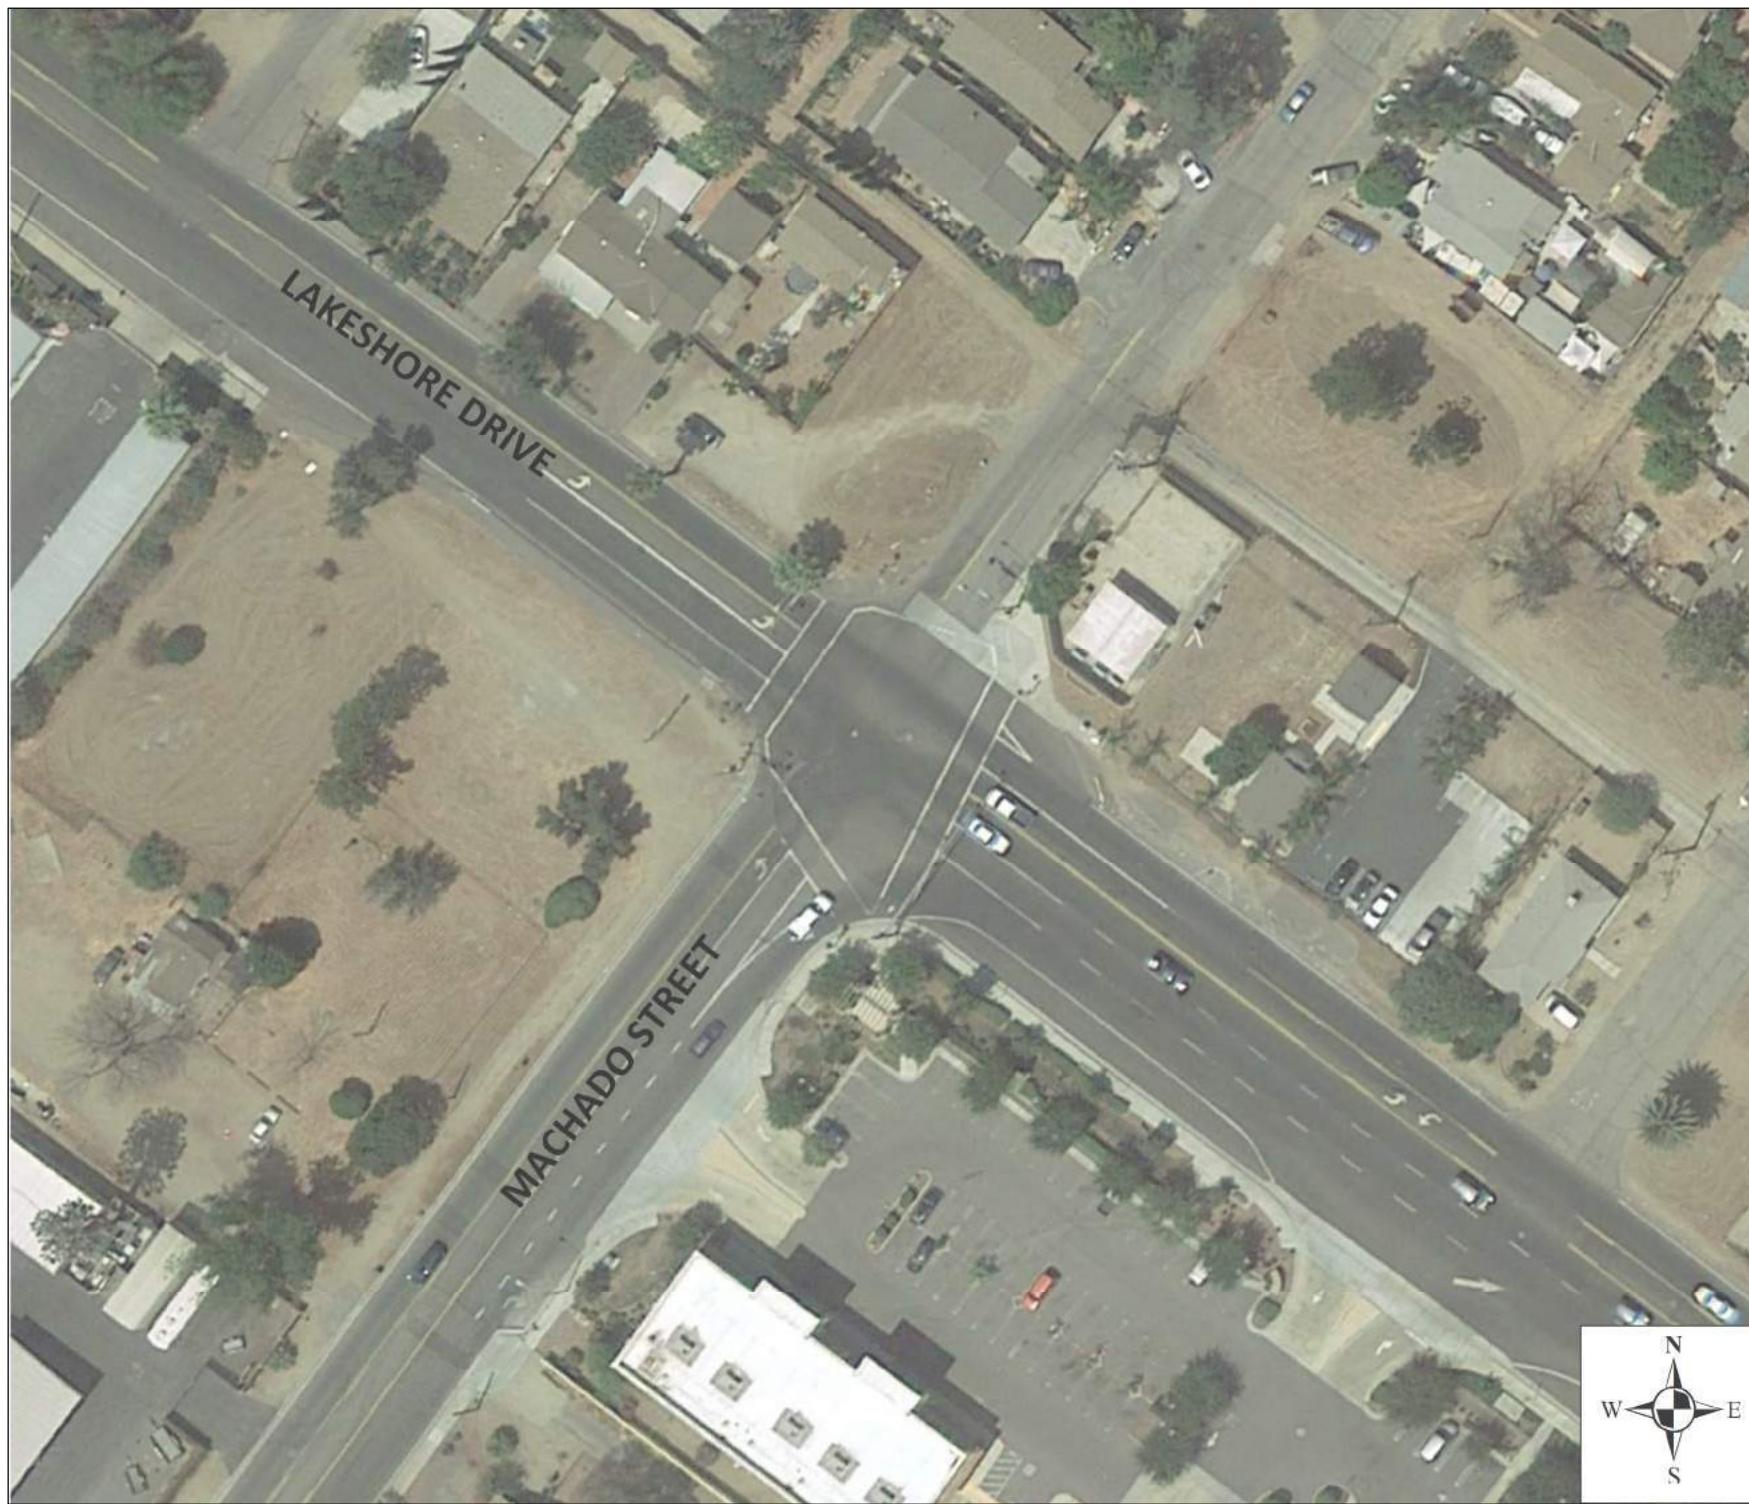
20. LAKESHORE DRIVE AND MACHADO STREET

- The intersection of Lakeshore Drive and Machado Street is a signalized intersection.
- There is no existing median at the intersection.
- Existing bus stops in the vicinity of the intersection on Lakeshore Drive.
- Four 12' wide crosswalk markings across four legs of the intersection.
- There is no existing bulb out at any corner of the intersection.
- The Traffic Signal and Signs (3) and Auto R/W (2) are the major causes of collision at the intersection.
- The majority of the collisions occurred at the intersection are Broadside (5) and Head-On (3).
- Surrounding Land Use
 - North: Residential
 - West: Residential
 - South: Shopping Center
 - East: Residential

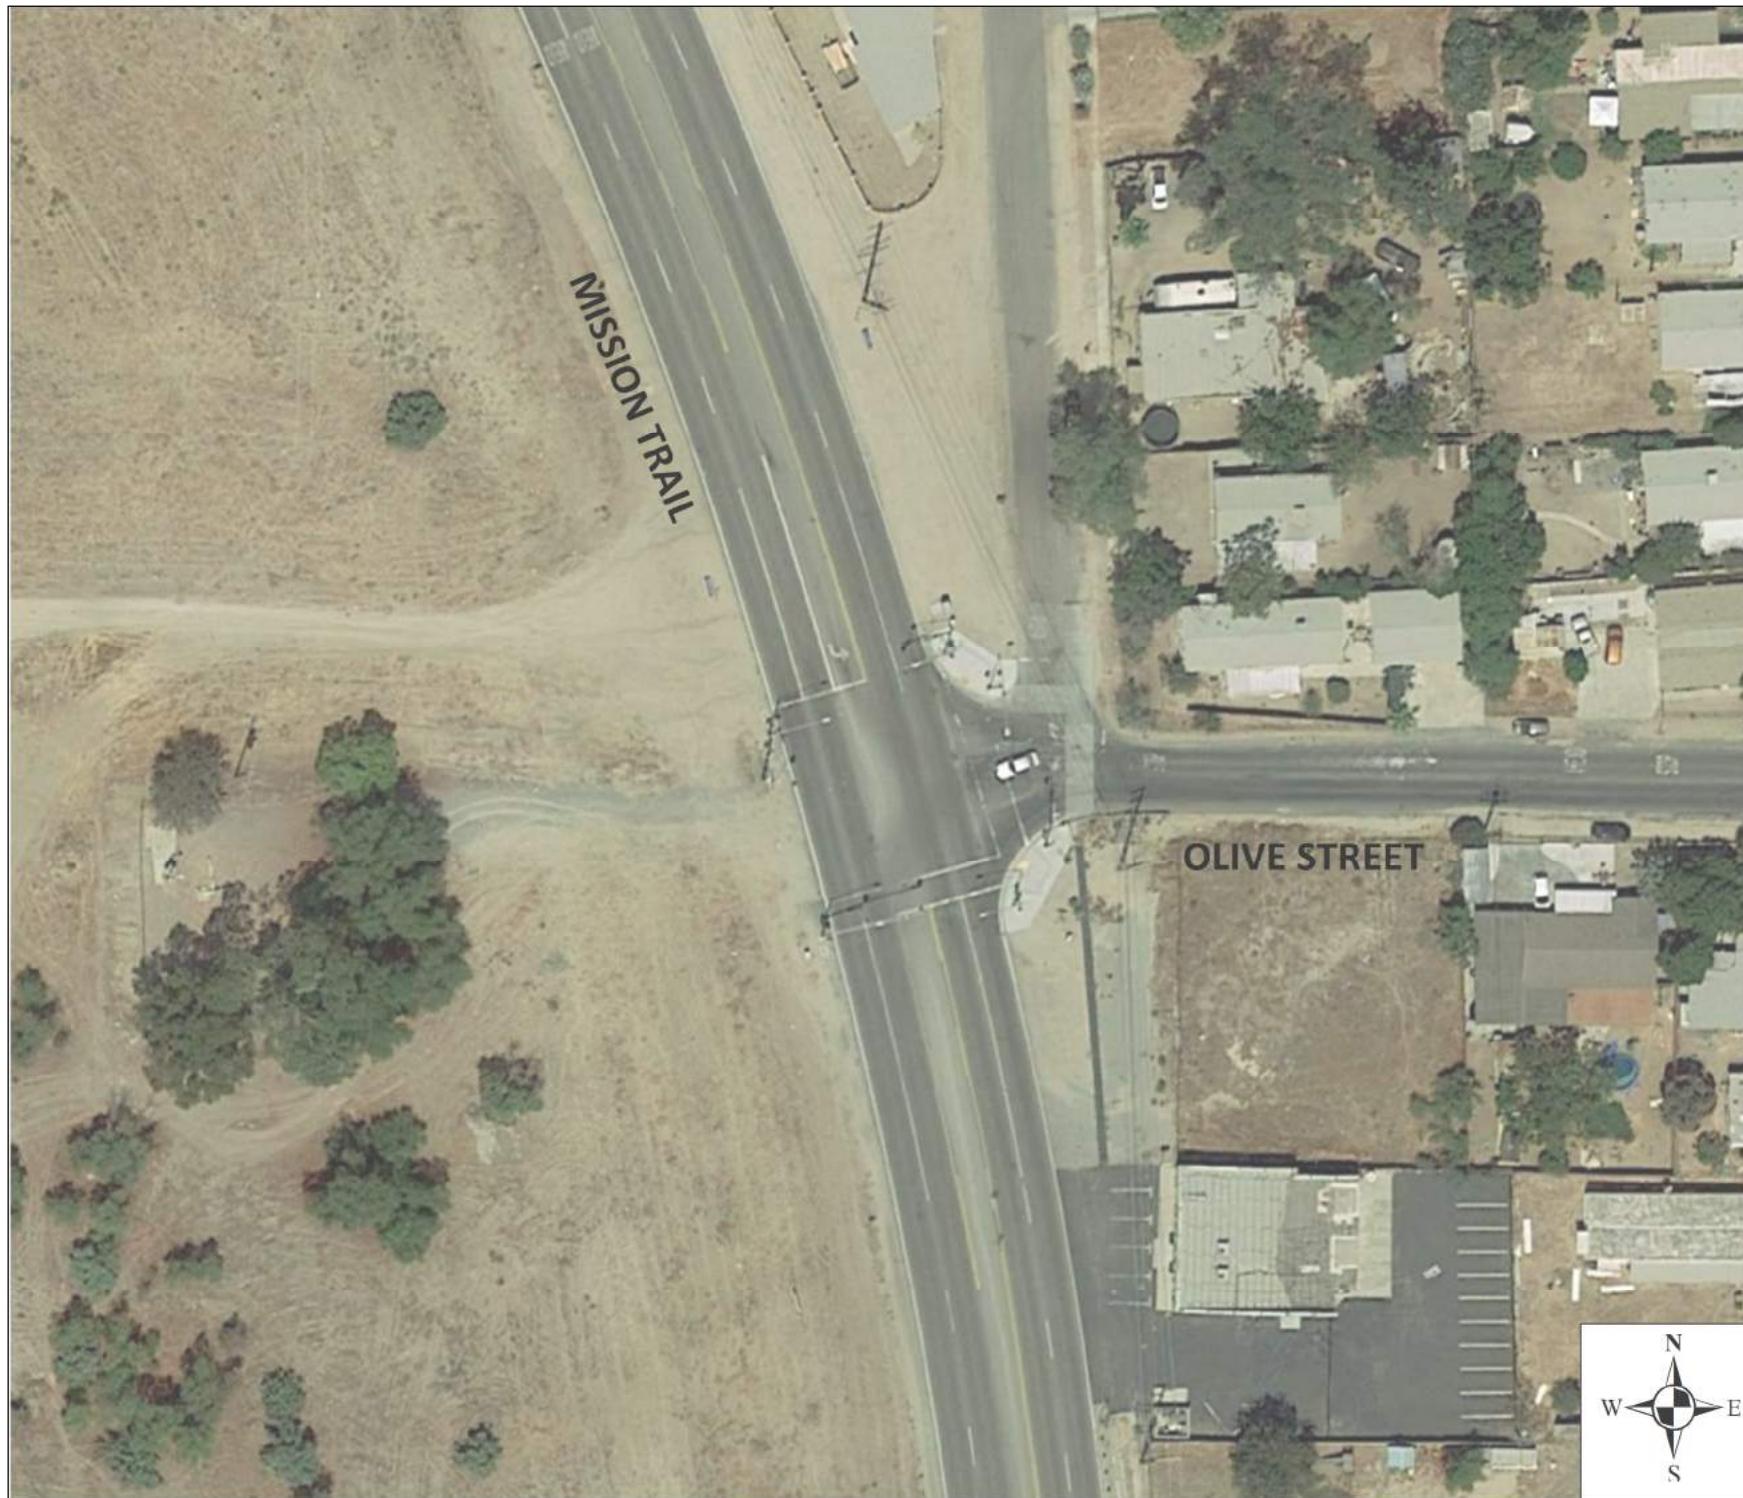
21.MISSION TRAIL AND OLIVE STREET

- The intersection of Mission Trail and Olive Street is a signalized intersection.
- There is no existing median at the intersection.
- Existing bus stops in the vicinity of the intersection on Mission Trail.
- Three 12' wide crosswalk markings across three legs of the intersection.
- There is no existing bulb out at any corner of the intersection.
- The Unsafe Speed (4) and DUI (1) are the major causes of collision at the intersection.
- The majority of the collisions occurred at the intersection are Rear-End (2) and Hit-Object (2).
- Surrounding Land Use
 - North: Residential
 - West: Vacant
 - South: Counseling Center
 - East: Residential

- Improve signal hardware: lenses, back-plates, mounting, size, and number (S2).
- Provide advanced dilemma zone detection system (S4).
- Improve pavement friction (S11).
- Install pedestrian countdown signal heads (S19).

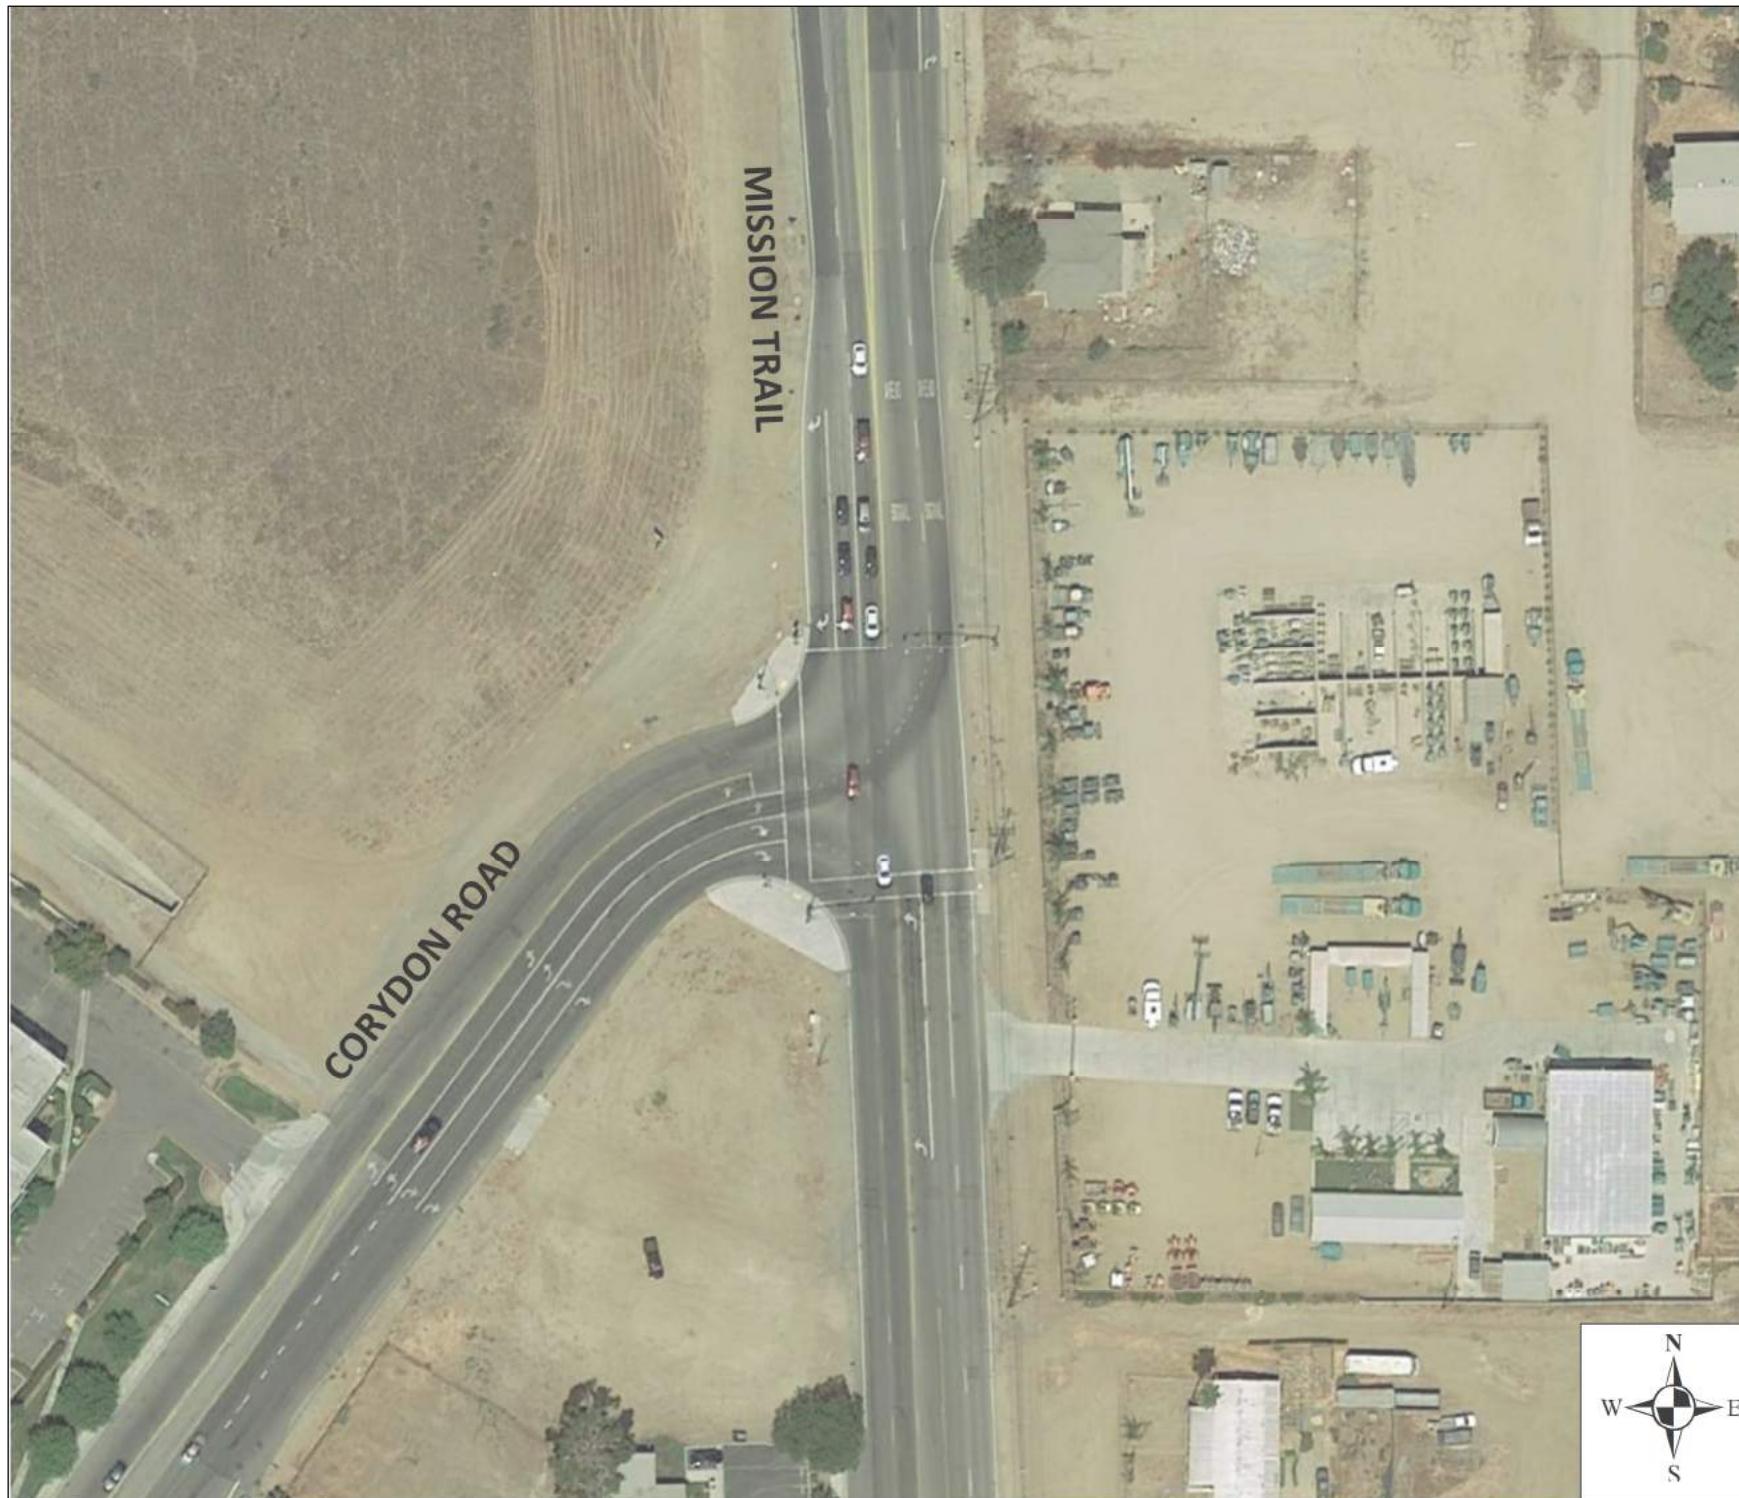
22. CORYDON ROAD AND MISSION TRAIL

- The intersection of Corydon Road and Mission Trail is a signalized intersection.
- There is no existing median at the intersection.
- There are no existing bus stops in the vicinity of the intersection.
- Two 12' wide crosswalk markings across two legs of the intersection.
- There is no existing bulb out at any corner of the intersection.
- The Auto R/W Violation (2) and Improper Turning (1) are the major causes of collision at the intersection.
- The majority of the collisions occurred at the intersection are Head-On (3) and Broadside (2).
- Surrounding Land Use
 - North: Vacant
 - West: Vacant
 - South: Animal Shelter
 - East: Heavy Equipment Rental

- Improve signal hardware: lenses, back-plates, mounting, size, and number (S2).
- Provide advanced dilemma zone detection system (S4).
- Install flashing beacons as advance warning (S9).
- Improve pavement friction (S11).
- Install pedestrian countdown signal heads (S18).
- Install pedestrian crossing (S20).

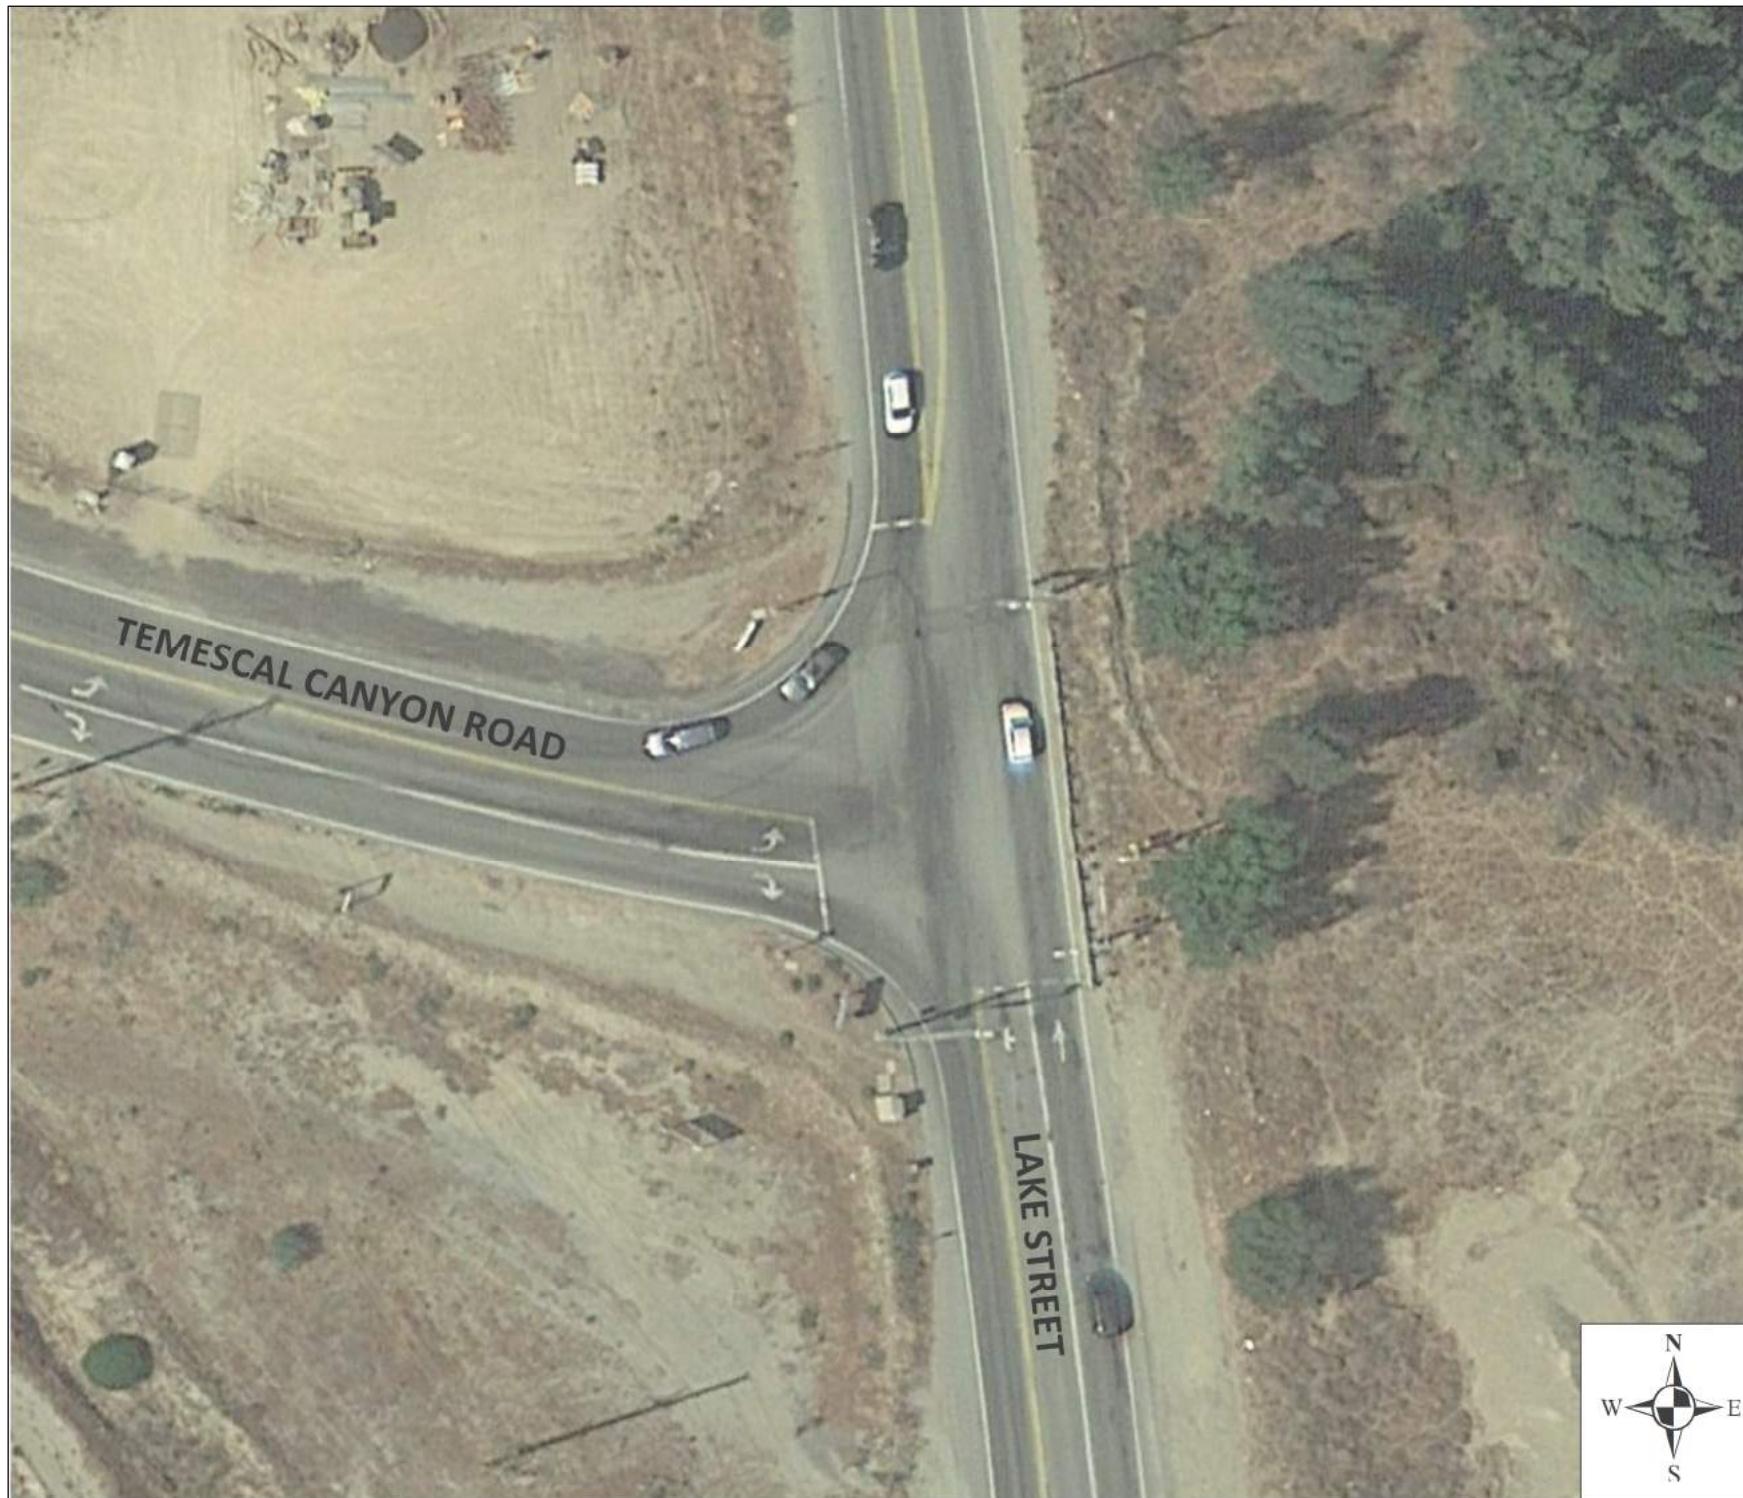
23. LAKE STREET AND TEMESCAL CANYON ROAD

- The intersection of Lake Street and Temescal Canyon Road is a signalized intersection.
- There is no existing median at the intersection.
- There are no existing bus stops in the vicinity of the intersection.
- There are no existing crosswalk markings across any leg of the intersection.
- There is no existing bulb out at any corner of the intersection.
- The Unsafe Speed (2) and DUI (1) are the major causes of collision at the intersection.
- The majority of the collisions occurred at the intersection are Broadside (1) and Rear-End (3).
- Surrounding Land Use
 - North: Vacant
 - West: Vacant
 - South: Vacant
 - East: Vacant

Potential Countermeasures	
<ul style="list-style-type: none"> Install/upgrade larger or additional stop signs or other intersection warning/regulatory signs (NS5). Upgrade intersection pavement markings (NS6). Install flashing beacons as advance warning (NS8).
