Systemic Safety Analysis Report

CITY OF LAKE ELSINORE

RE: Systemic Safety Analysis Report Program (SSARP)

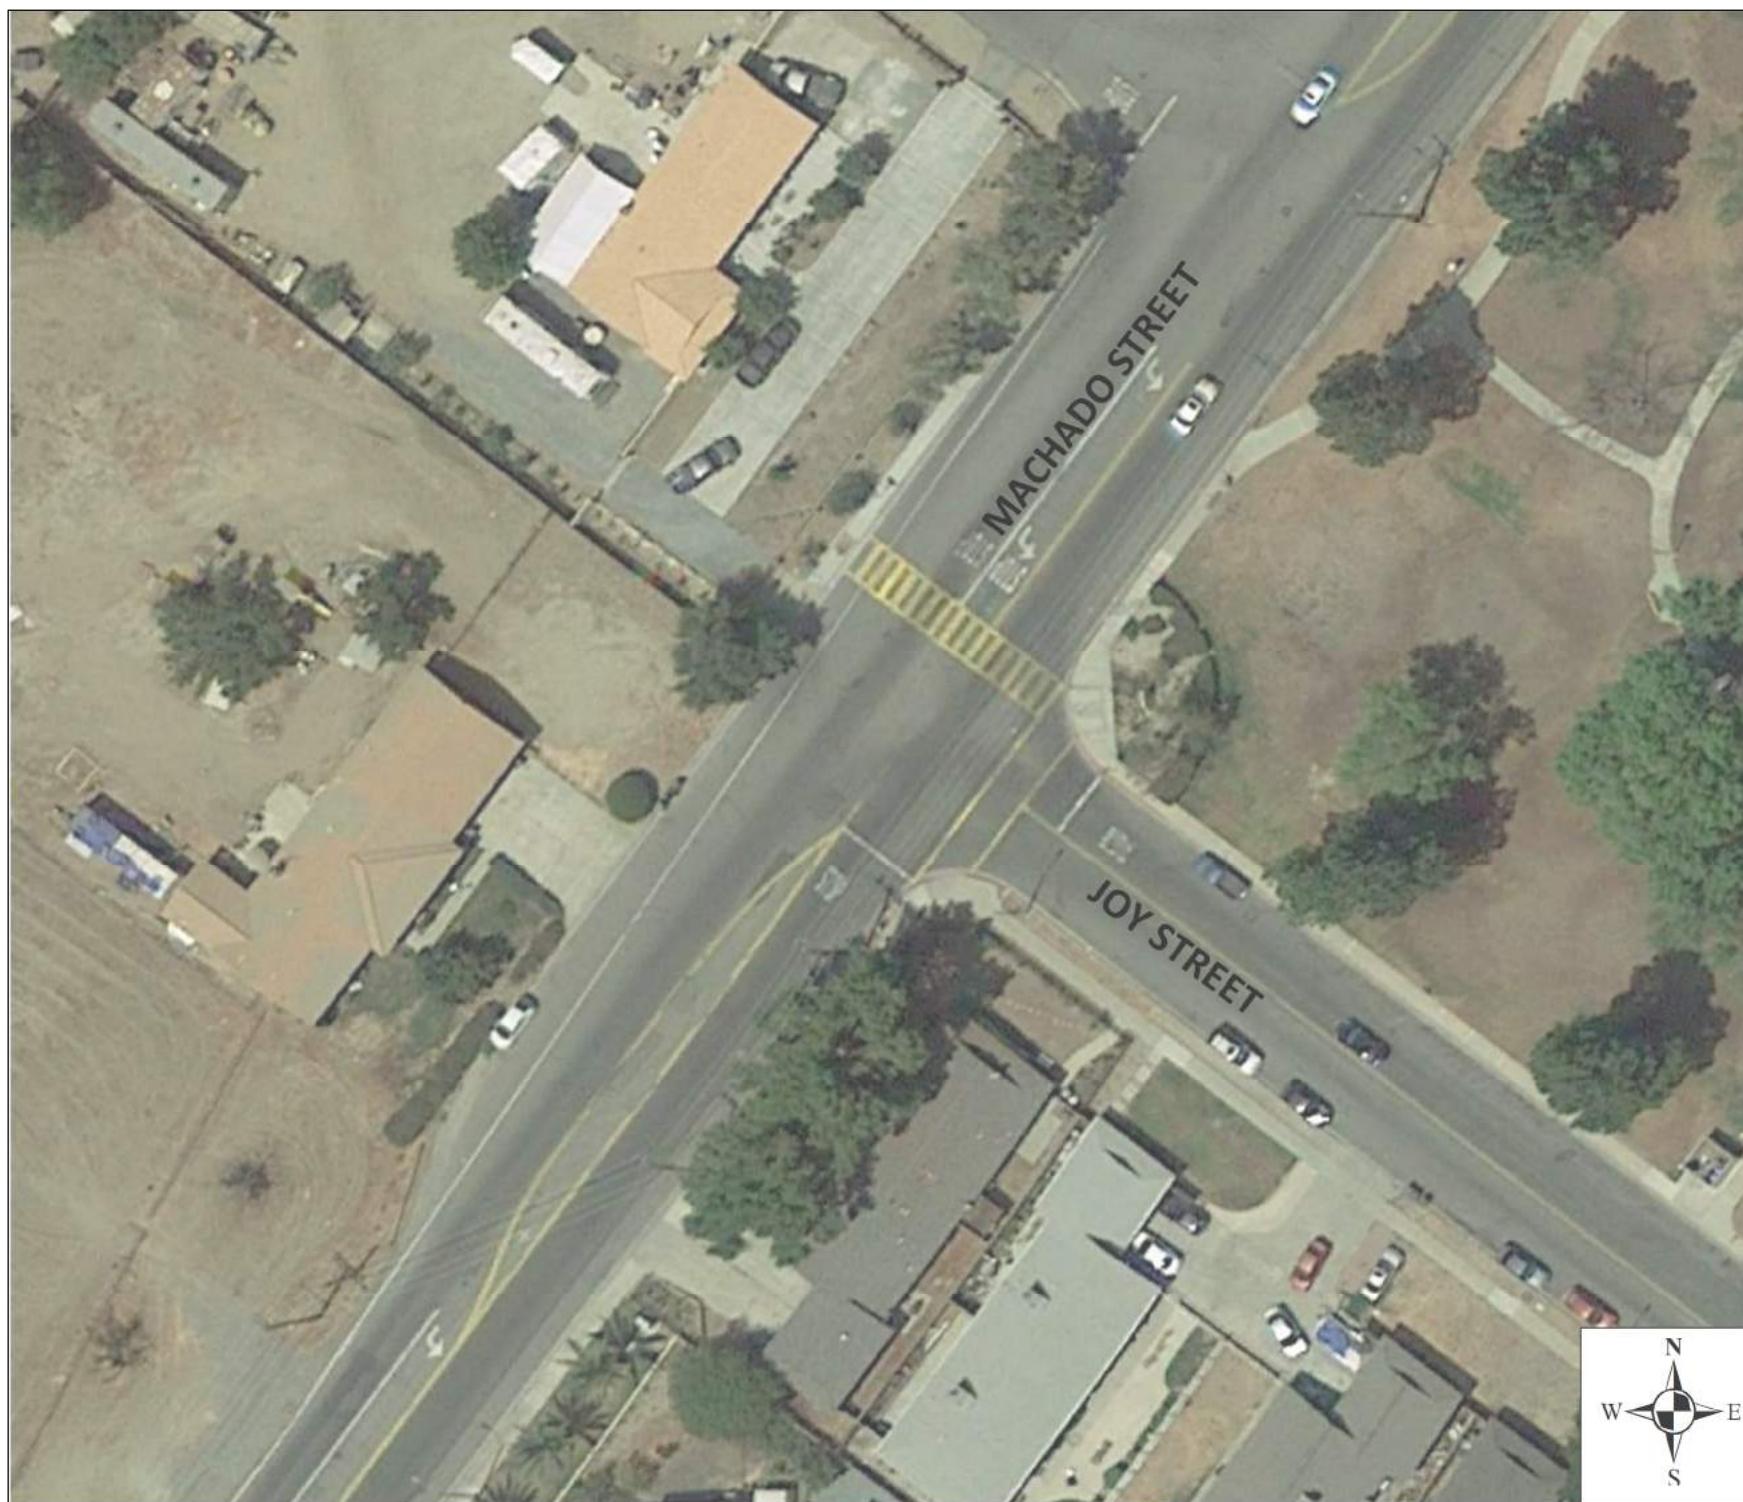
24. MACHADO STREET AND JOY STREET

- The intersection of Machado Street and Joy Street is a non-signalized intersection.
- There is no existing median at the intersection.
- Bus stops in the vicinity of the intersection on Machado Street.
- Two 12' crosswalk markings across two legs of the intersection.
- There is no existing bulb out at any corner of the intersection.
- The Unsafe Speed (2) and DUI (1) are the major causes of collision at the intersection.
- The majority of the collisions occurred at the intersection are Hit Object (2) and Rear-End (2).
- Surrounding Land Use
 - North: Residential
 - West: Residential
 - South: Residential
 - East: Park

Potential Countermeasures	
<ul style="list-style-type: none"> Install flashing beacons as advance warning (NS8). Improve pavement friction (NS20).

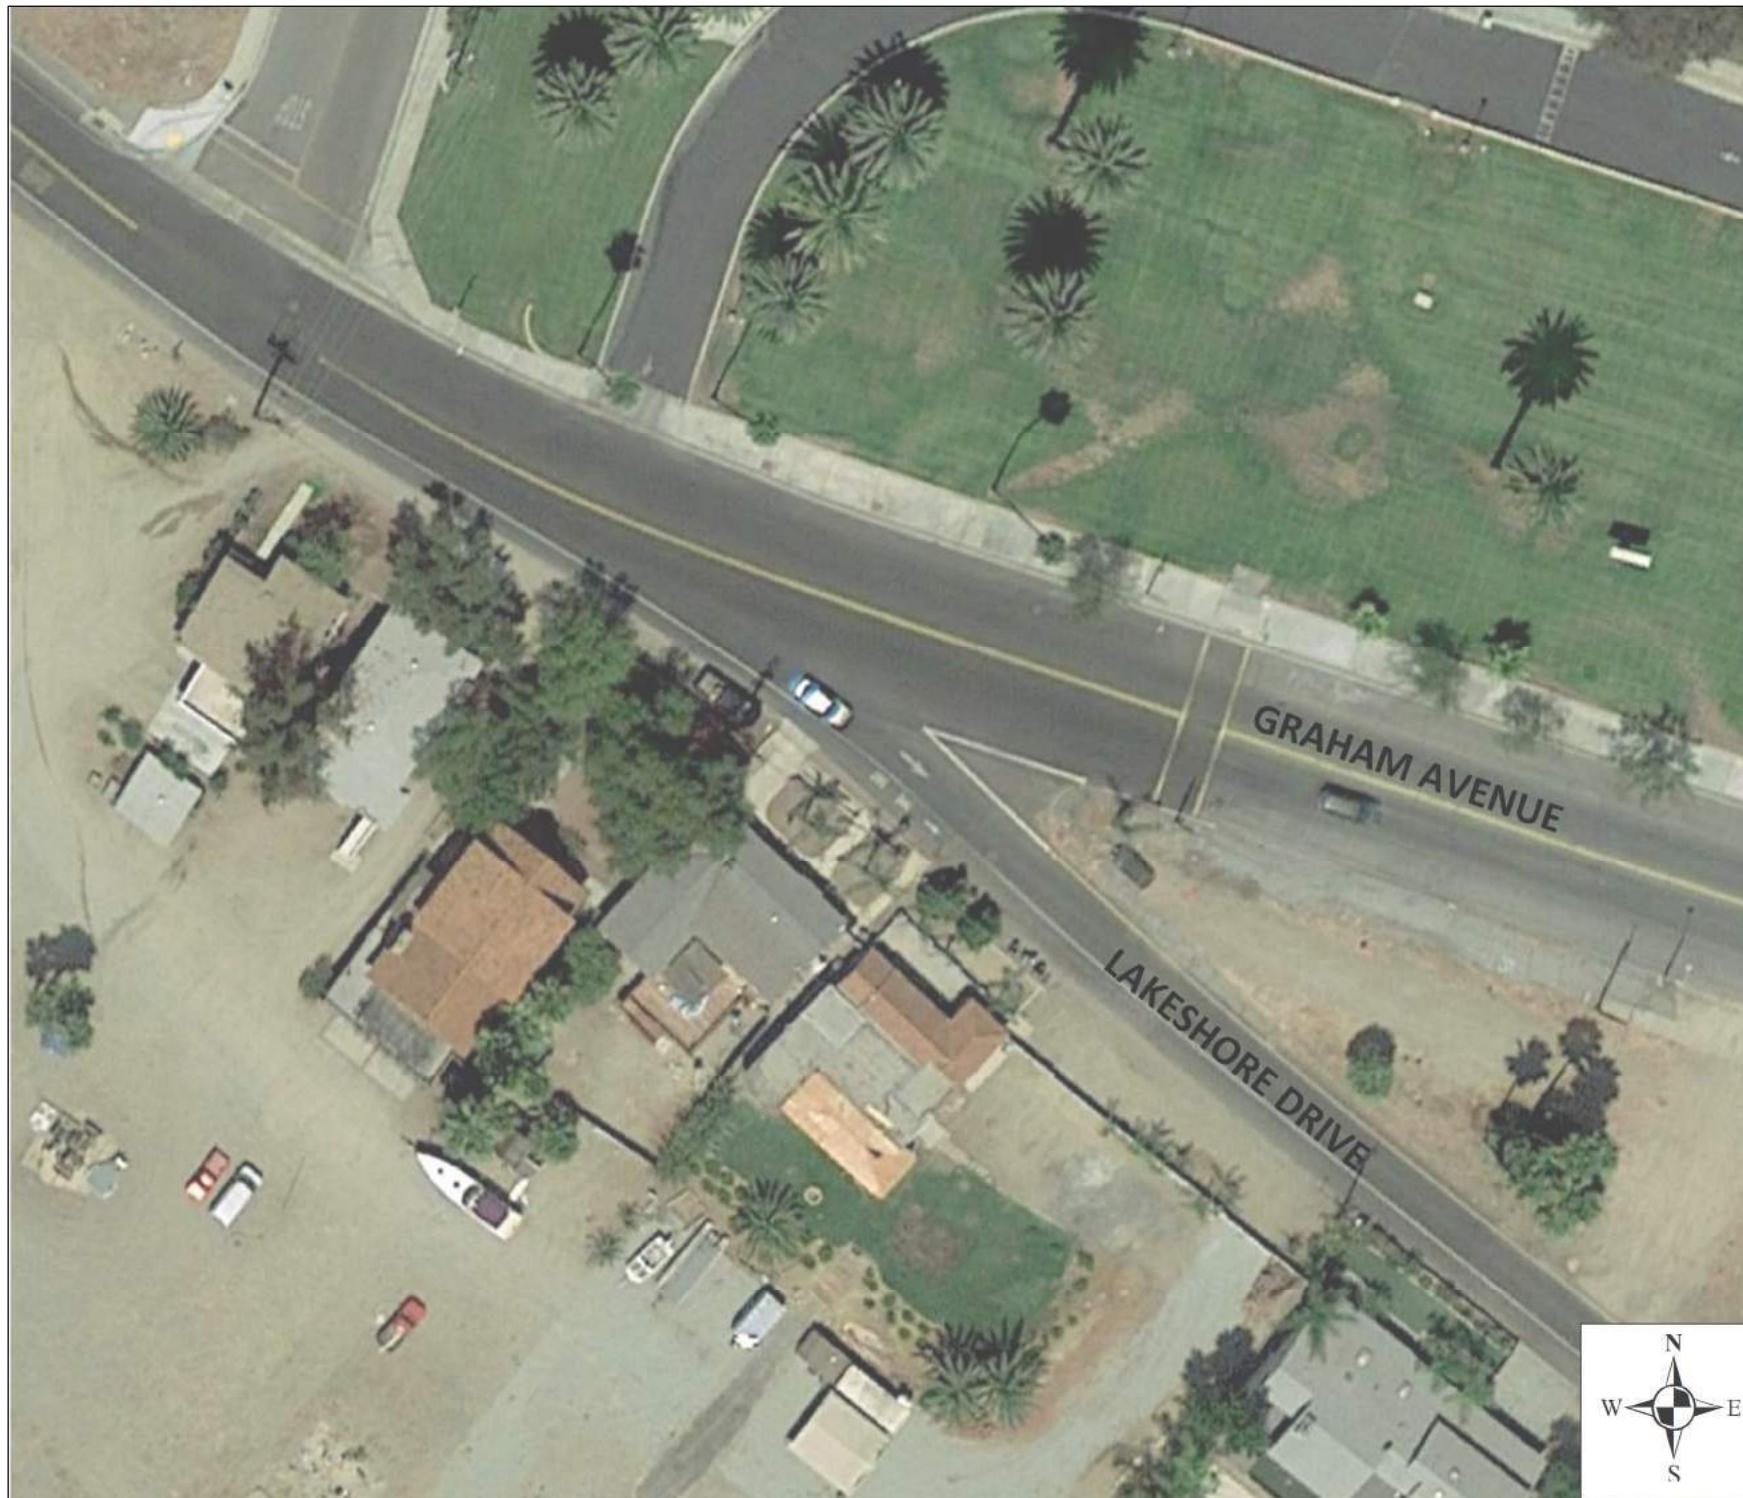
25. LAKESHORE DRIVE AND GRAHAM AVENUE

- The intersection of Lakeshore Drive and Graham Avenue is a non-signalized intersection.
- There is no existing median at the intersection.
- There are no existing bus stops in the vicinity of the intersection.
- There are no existing crosswalk markings across any leg of the intersection.
- There is no existing bulb out at any corner of the intersection.
- The Unsafe Speed (2) and Improper Turning (2) are the major causes of collision at the intersection.
- The majority of the collisions occurred at the intersection are Hit Object (2) and Broadside (1).
- Surrounding Land Use
 - North: School
 - West: Residential
 - South: Residential
 - East: School

- Install/upgrade larger or additional stop signs or other intersection warning/regulatory signs (NS5).
- Install flashing beacons as advance warning (NS8).

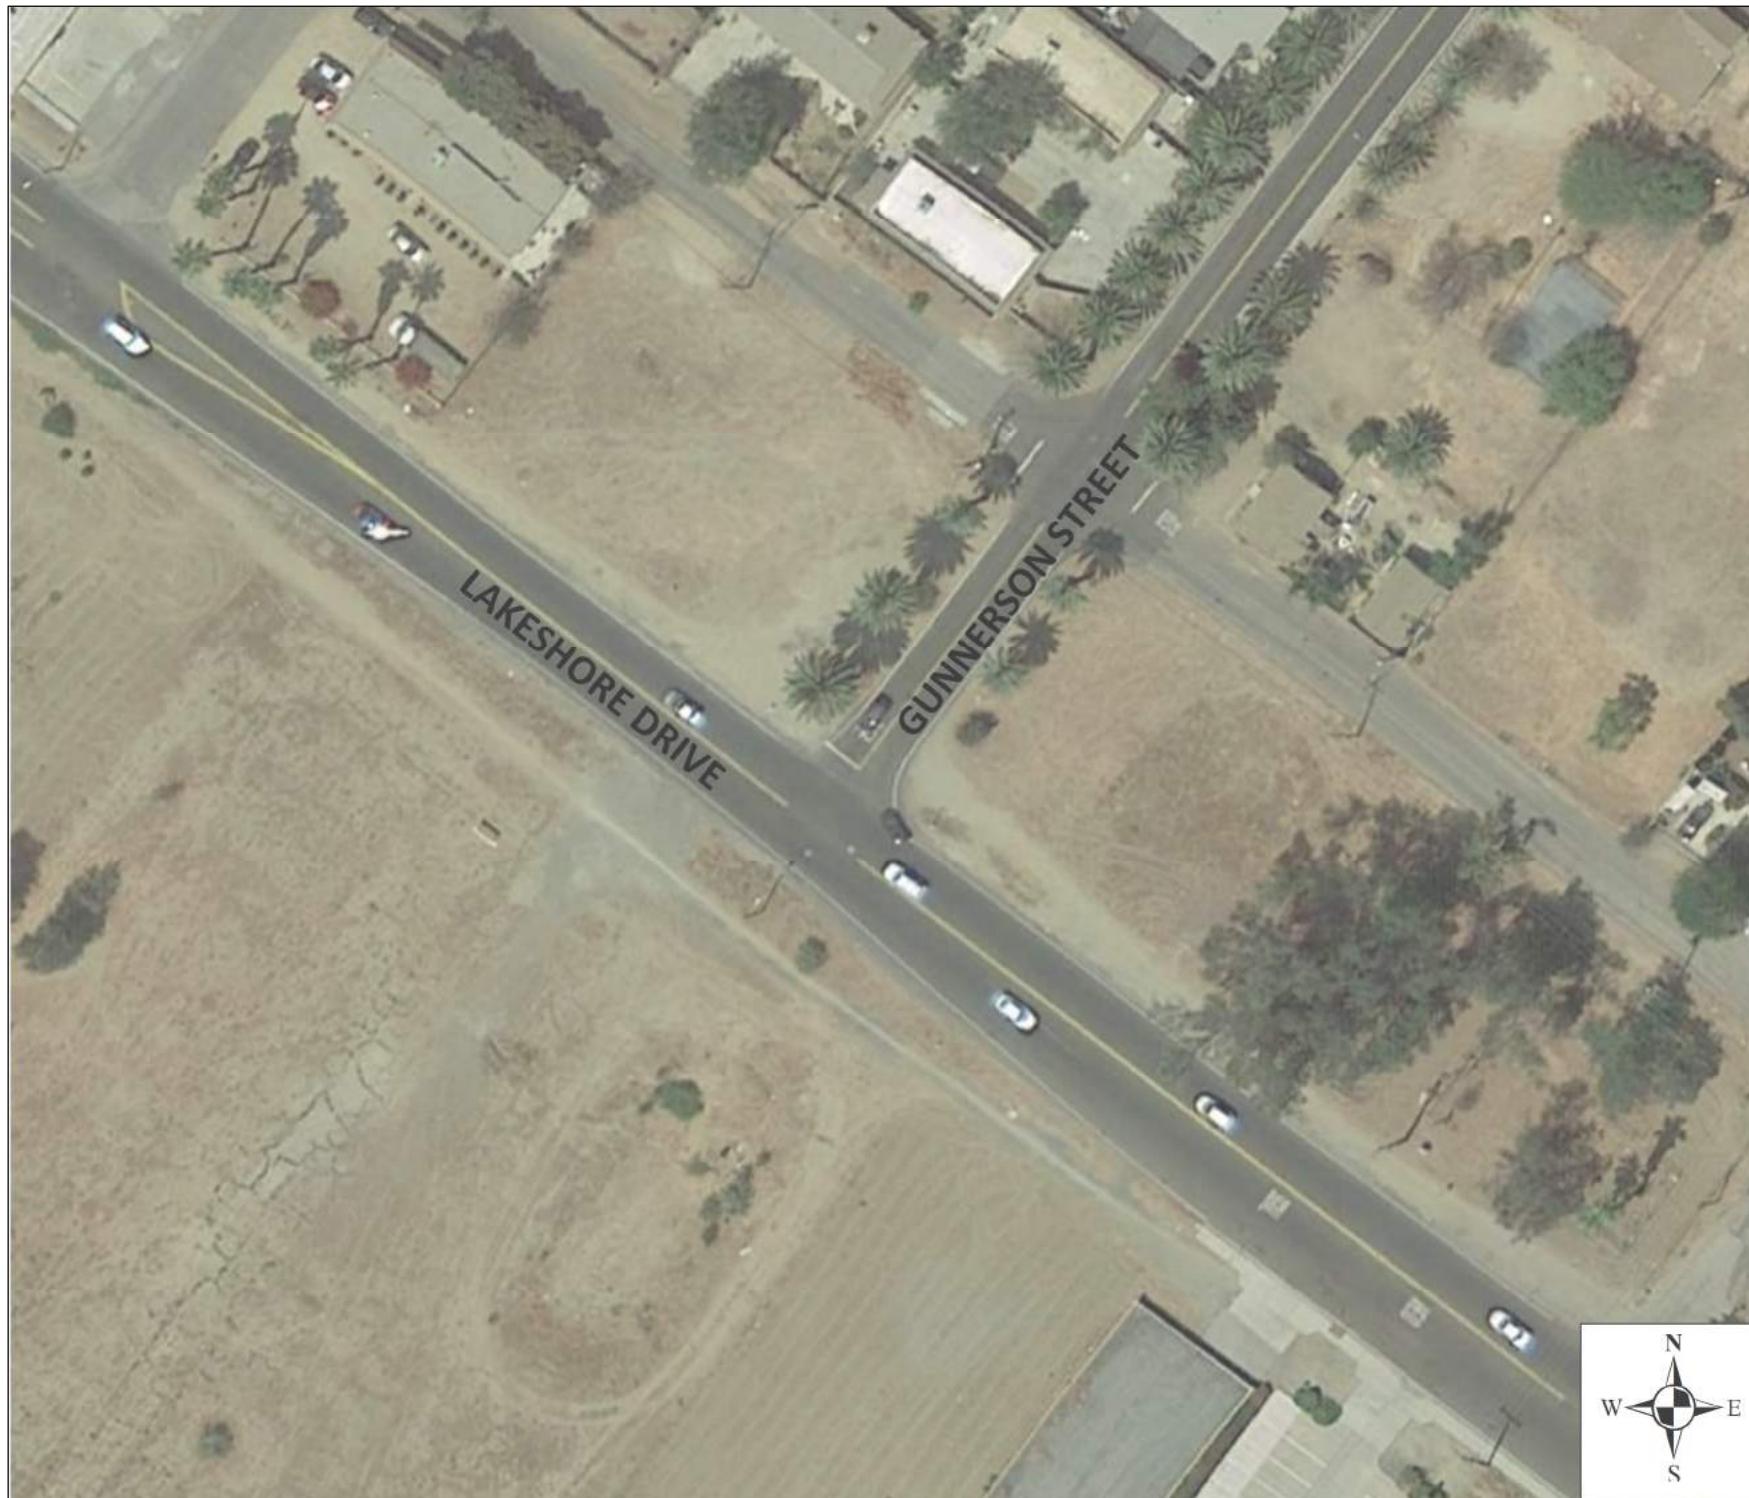
26. LAKESHORE DRIVE AND GUNNERSON STREET

- The intersection of Lakeshore Drive and Gunnerson Street is an unsignalized intersection.
- There is no existing median at the intersection.
- There are no existing bus stops in the vicinity of the intersection.
- There are no existing crosswalk markings across any leg of the intersection.
- There is no existing bulb out at any corner of the intersection.
- The Unsafe Speed (2) and Improper Turning (1) are the major causes of collision at the intersection.
- The majority of the collisions occurred at the intersection are Rear End (3) and Sideswipe (1).
- Surrounding Land Use
 - North: Vacant
 - West: Vacant
 - South: Vacant
 - East: Vacant

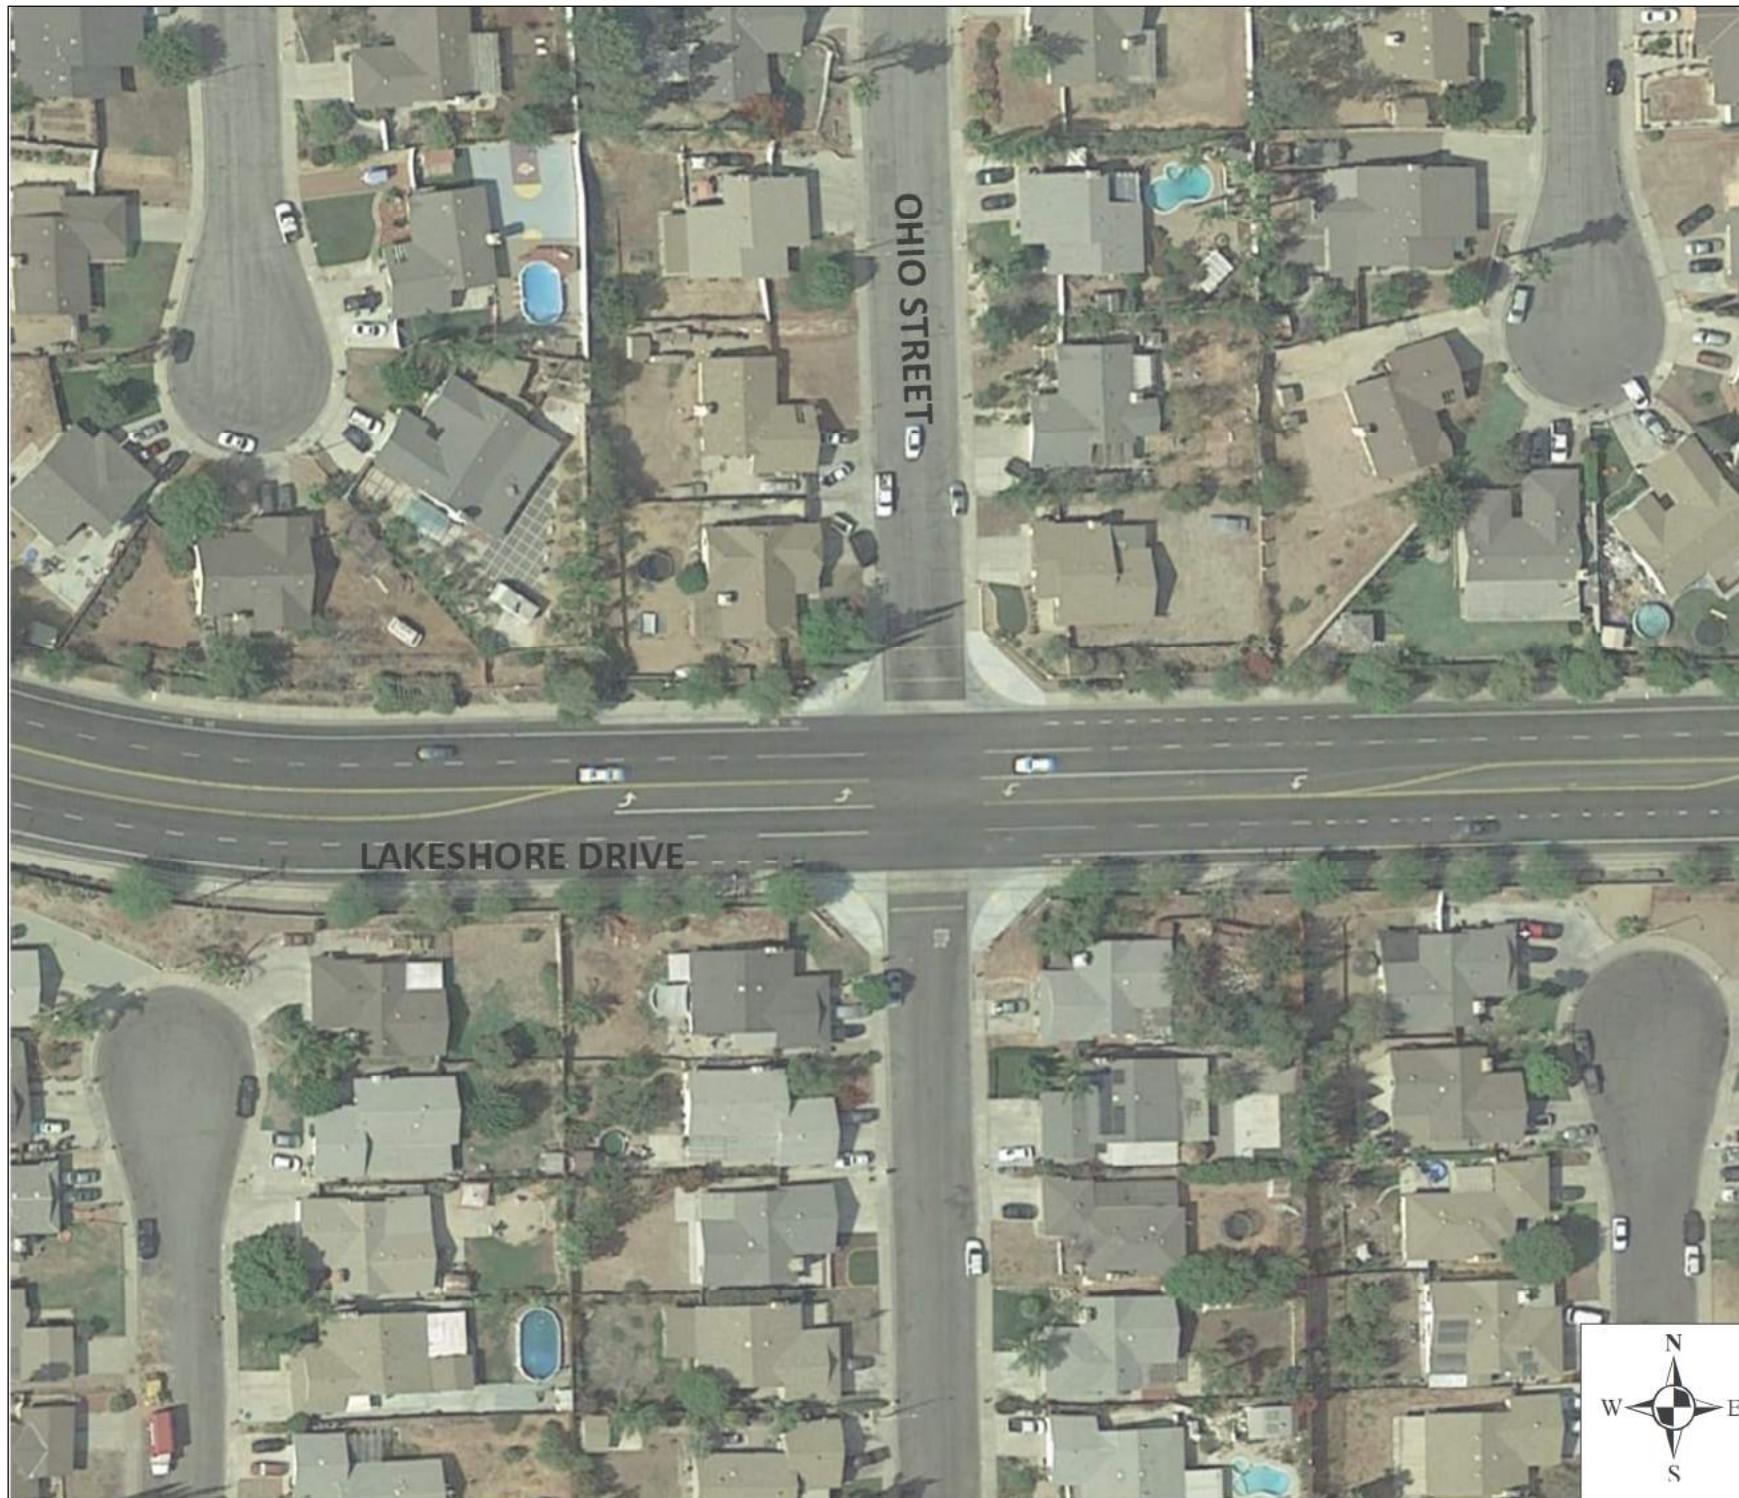
29. LAKESHORE DRIVE AND OHIO STREET

- The intersection of Lakeshore Drive and Ohio Street is an unsignalized intersection.
- There is no existing median at the intersection.
- There are no existing bus stops in the vicinity of the intersection.
- Two 12' wide crosswalk marking across two legs of the intersection.
- There is no existing bulb out at any corner of the intersection.
- The Auto R/W Violation (1) and Other Collisions (1) are the major causes of collision at the intersection.
- The majority of the collisions occurred at the intersection are Broadside (2) and Head-On (1).
- Surrounding Land Use
 - North: Residential
 - West: Residential
 - South: Residential
 - East: Residential
