**DISTRICT PRELIMINARY GEOTECHNICAL REPORT  
TEMESCAL CANYON ROAD PROJECT  
LAKE ELSINORE, CA**

**Federal-Aid Project No. BRLO-5074 (015)**

GDC Project No. IR-617  
April 4, 2016

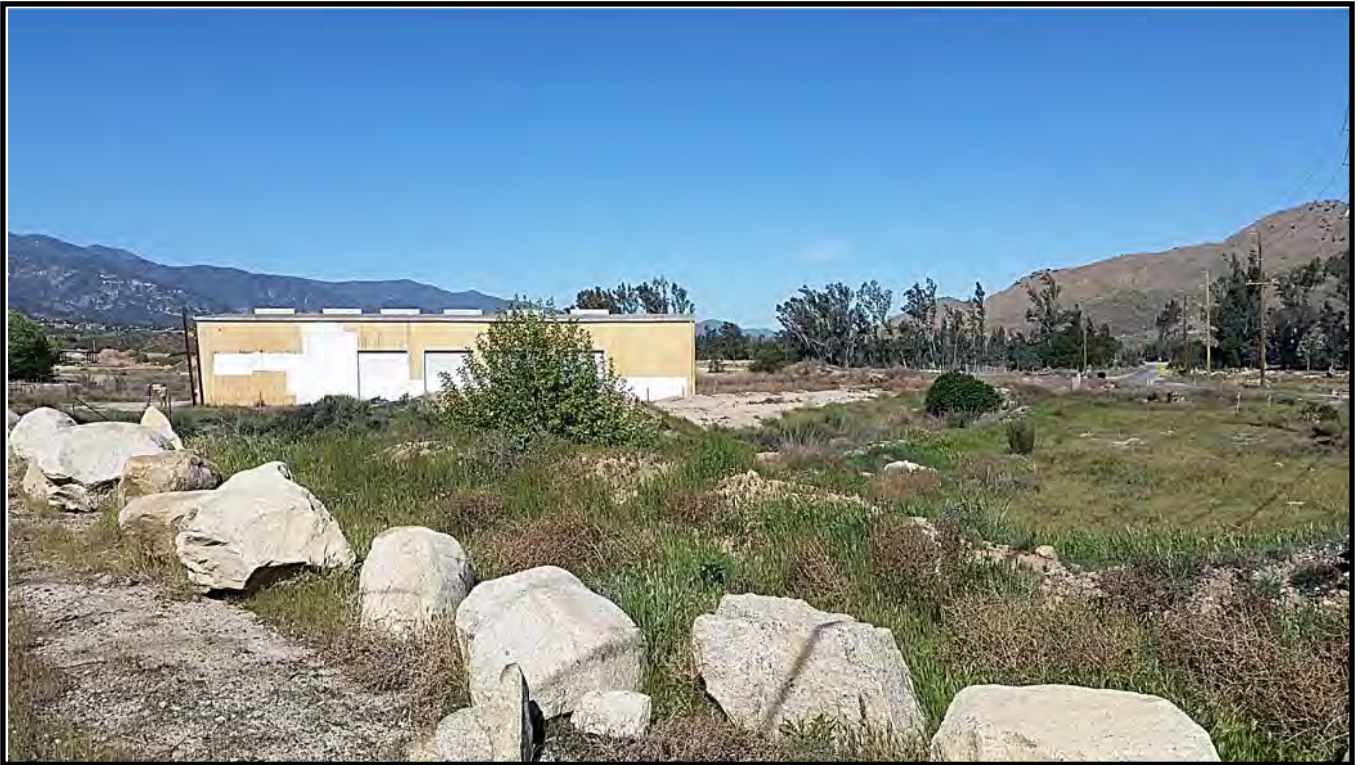
(3)

Looking west along the proposed Temescal Canyon Road realignment  
(The realignment will require the existing storage building be demolished)

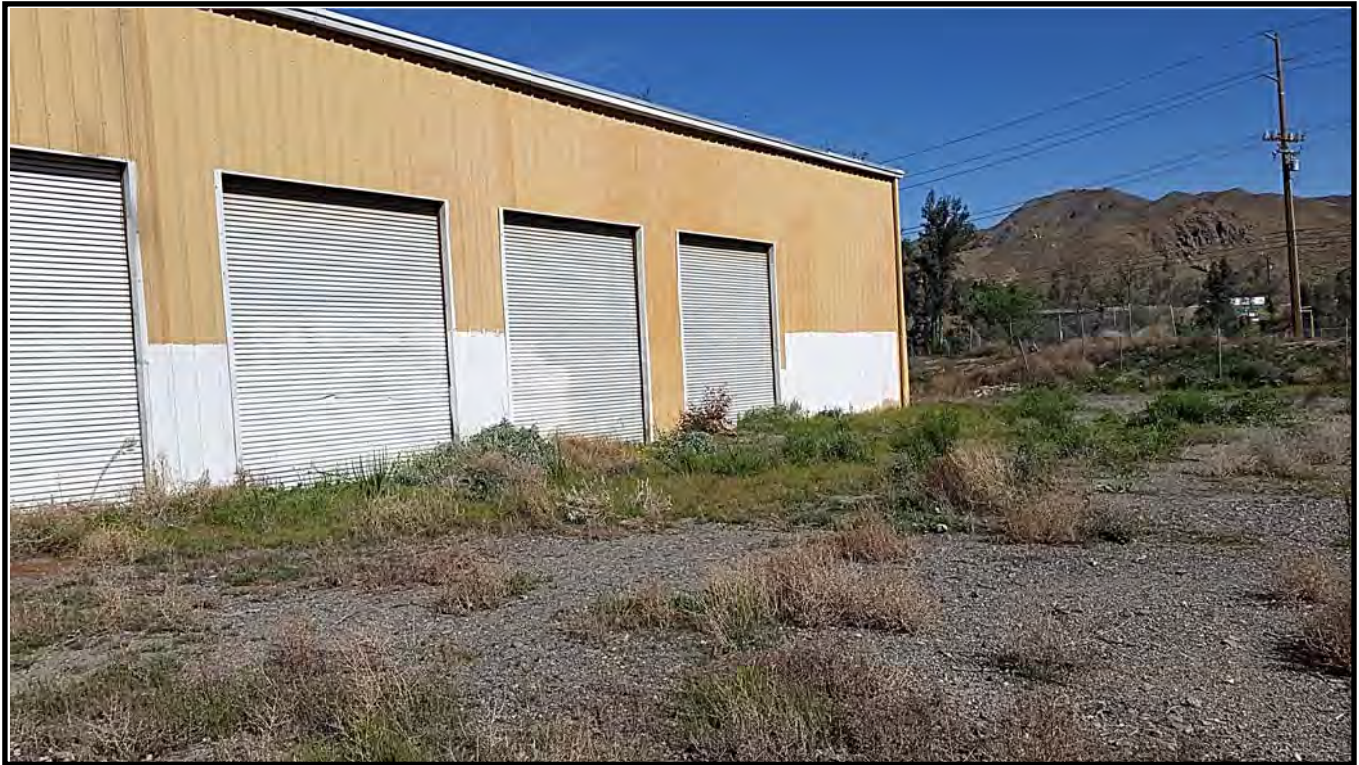
(7)

Looking north; The existing storage building to be demolished

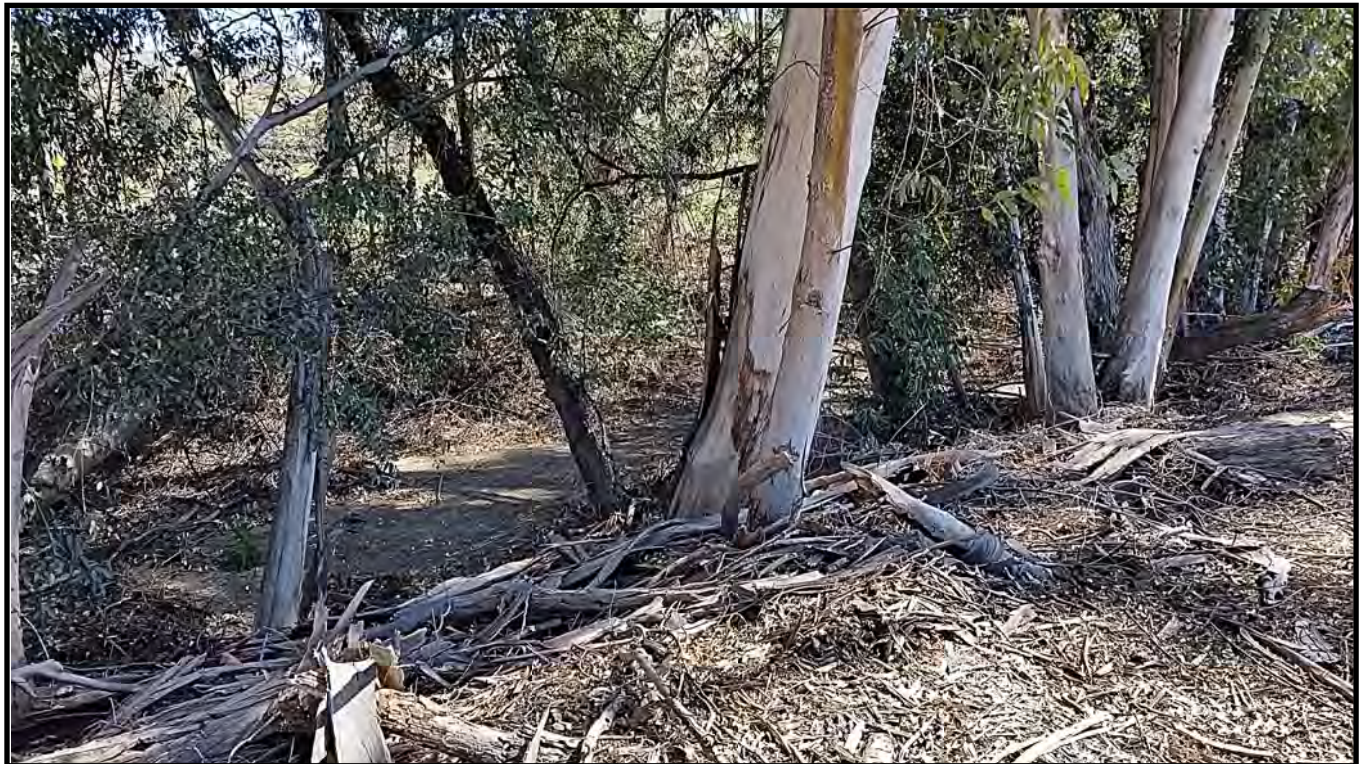
(20)

Looking at the Temescal Wash (Dry at the time of site visit)

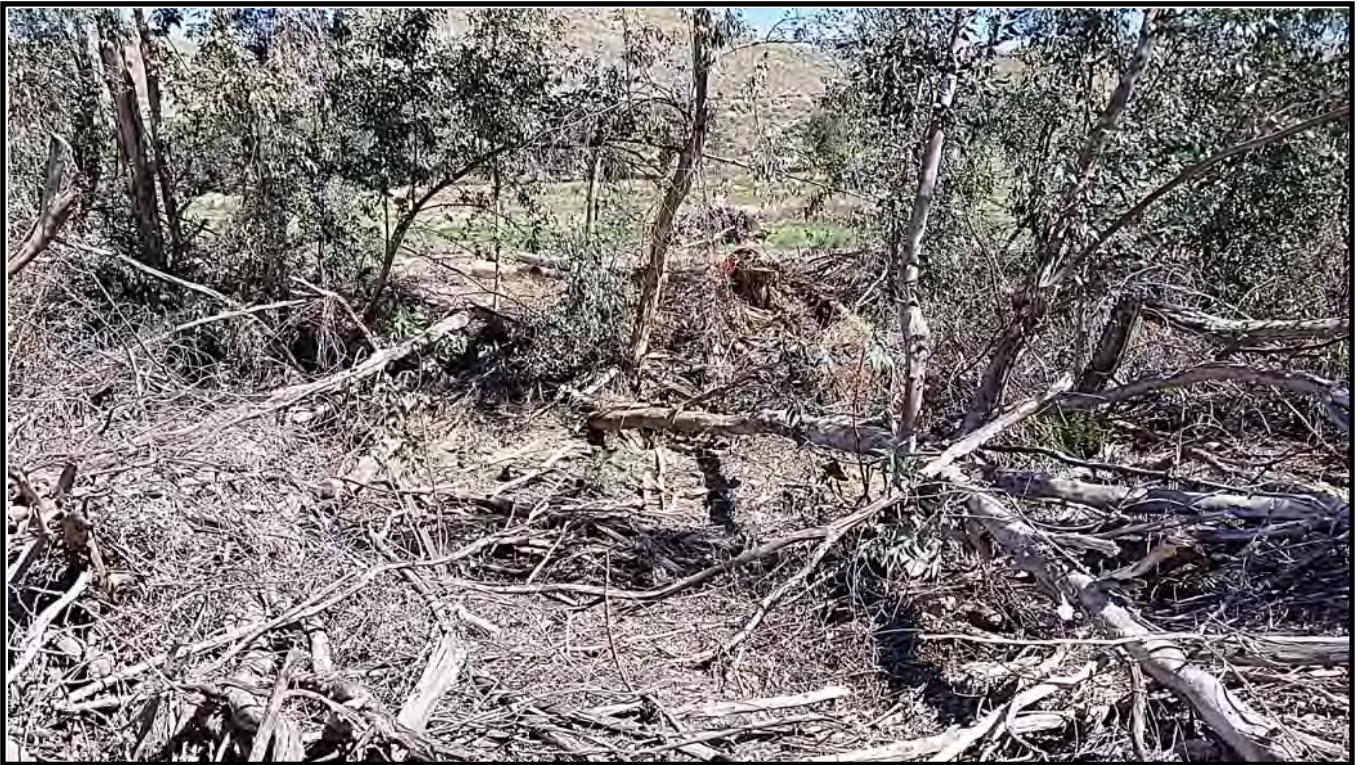
(21)

Looking at the Temescal Wash (Dry at the time of site visit)
